# CJ DENS EAST SUBDIVISION

## PRELIMINARY SUBDIVISION PLANS

COVER SHEET  
CJ DENS SUBDIVISION  
CJ DENS LACAMAS II LLC  
CAMAS, WASHINGTON

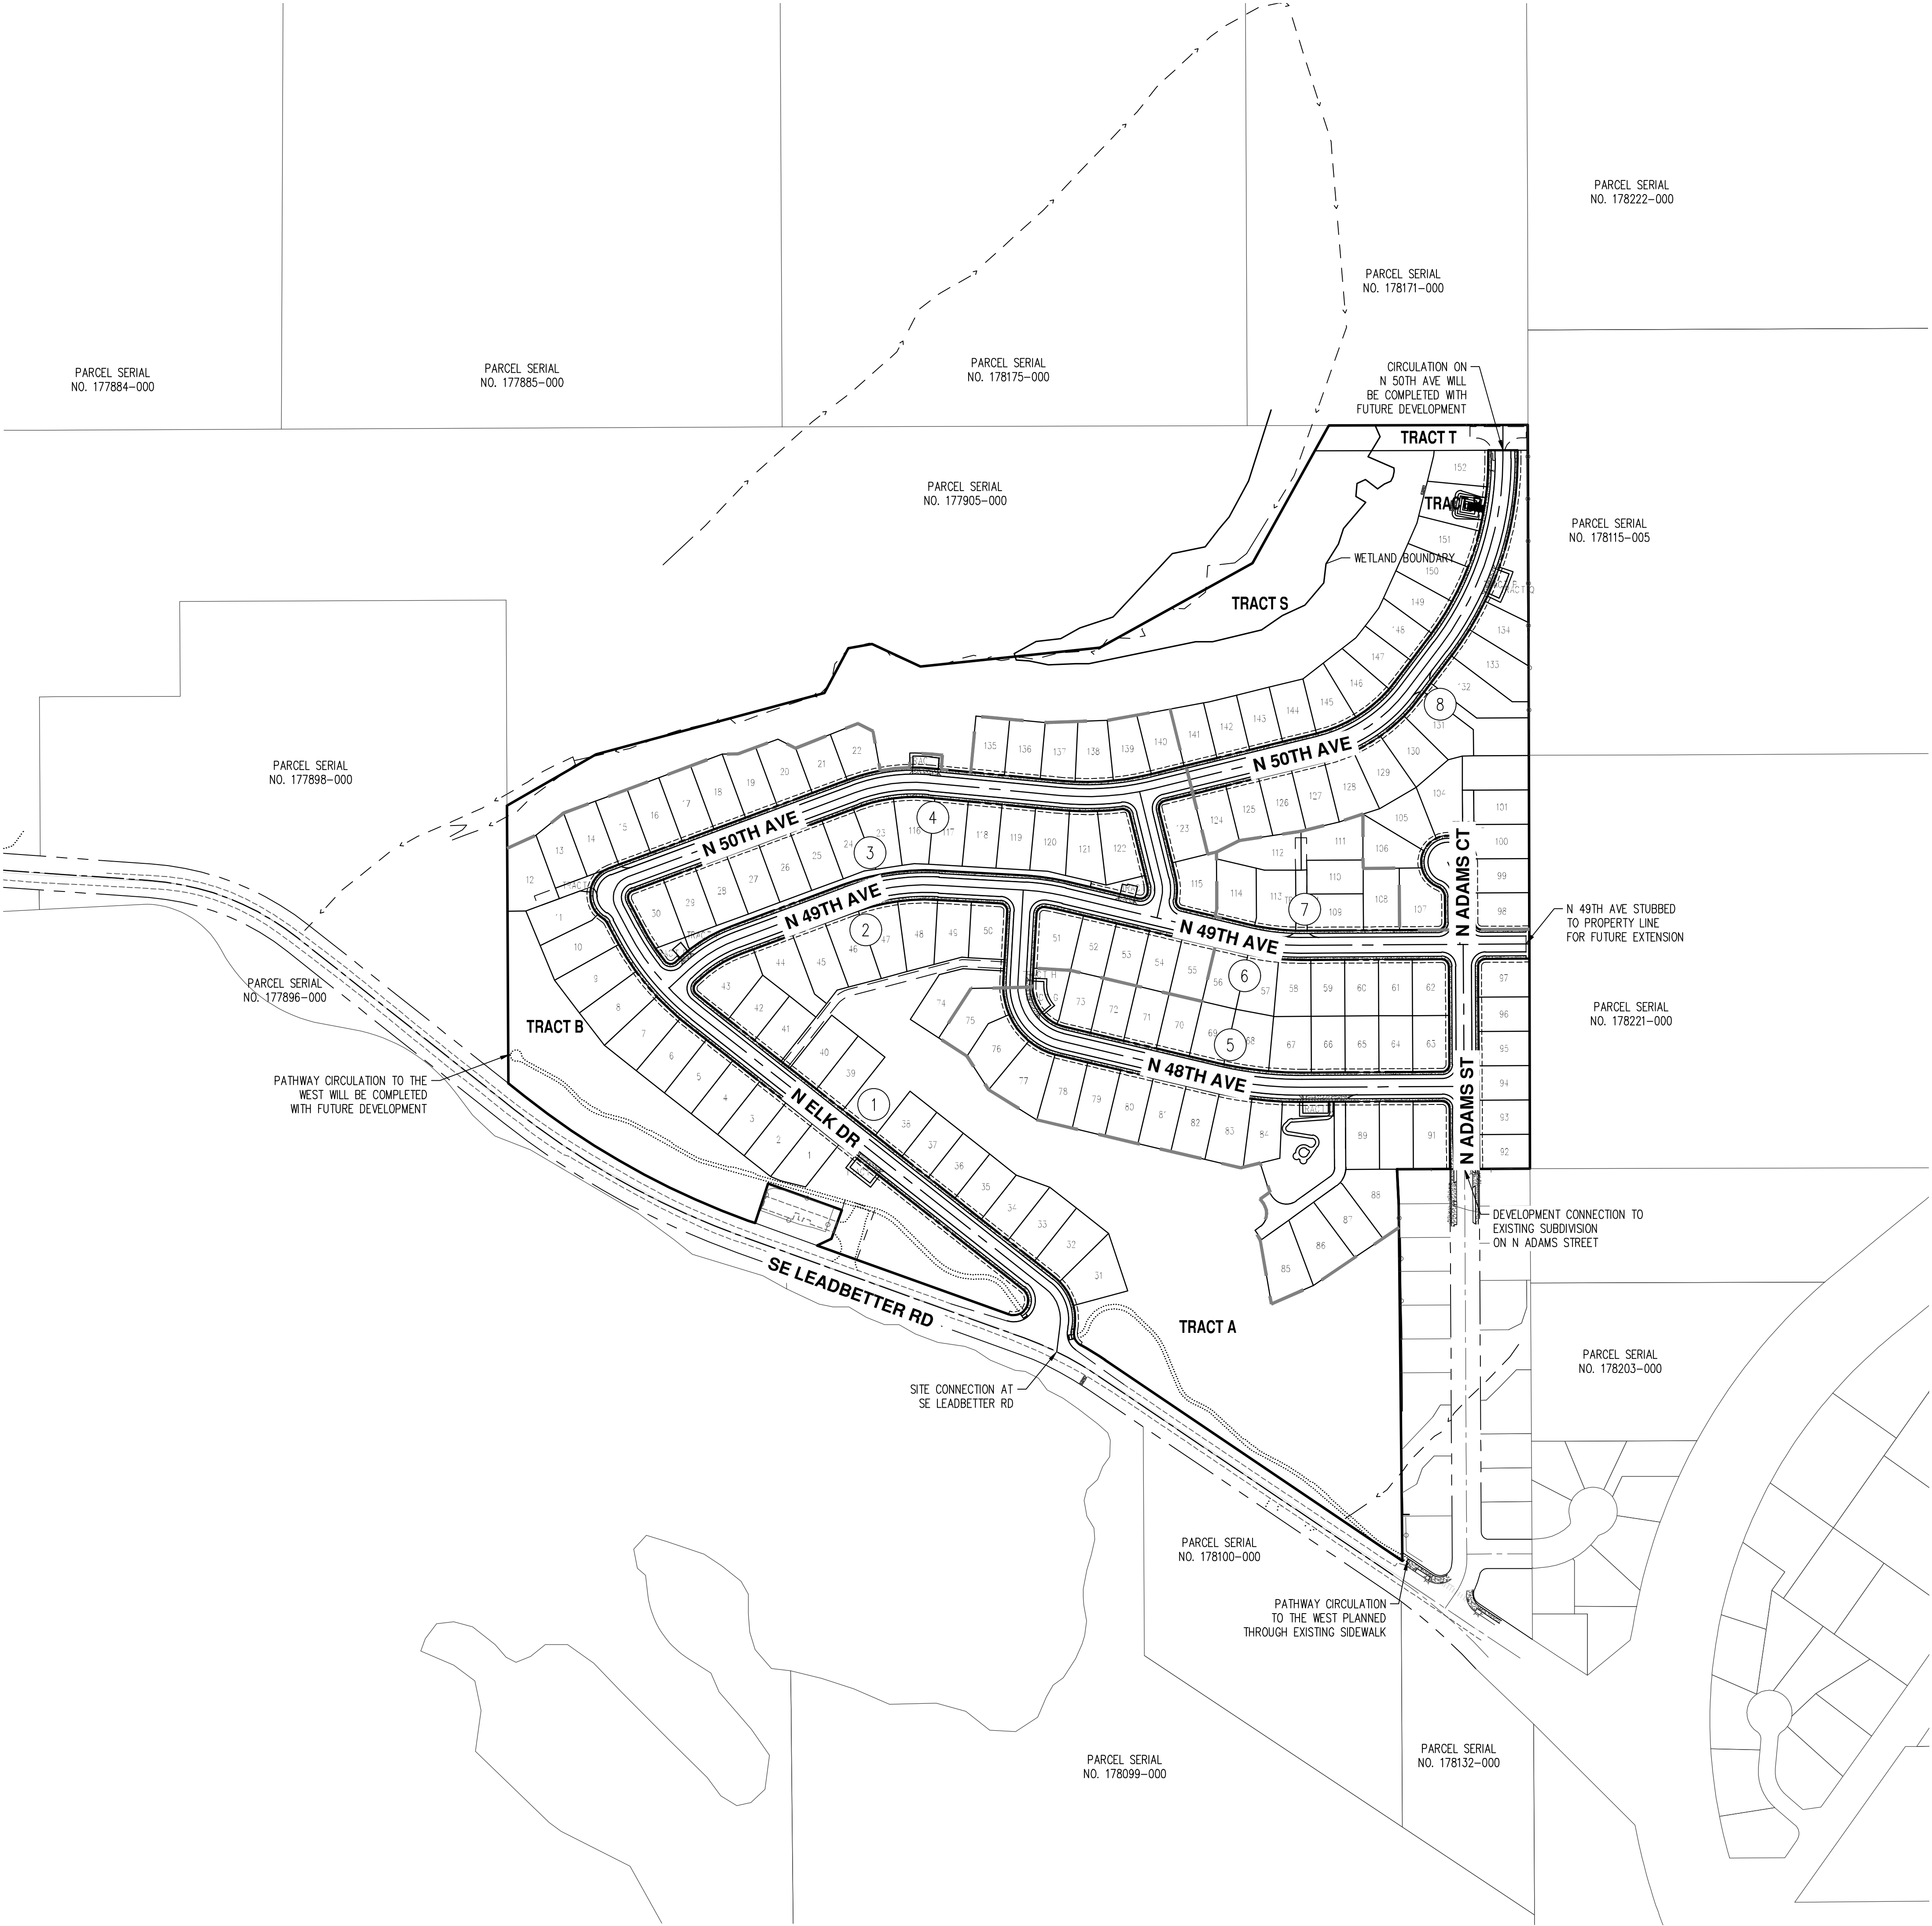
PRELIMINARY CIRCULATION PLAN  
CJ DENS SUBDIVISION  
CJ DENS LACAMAS II LLC  
CAMAS, WASHINGTON

- 1. 951.82' MEASURED ROW TO ROW SPACING
- 2. 582.83' MEASURED ROW TO ROW SPACING
- 3. 883.12' MEASURED ROW TO ROW SPACING
- 4. 911.65' MEASURED ROW TO ROW SPACING
- 5. 911.55' MEASURED ROW TO ROW SPACING
- 6. 729.84' MEASURED ROW TO ROW SPACING
- 7. 471.45' MEASURED ROW TO ROW SPACING
- 8. 999.29' MEASURED ROW TO ROW SPACING

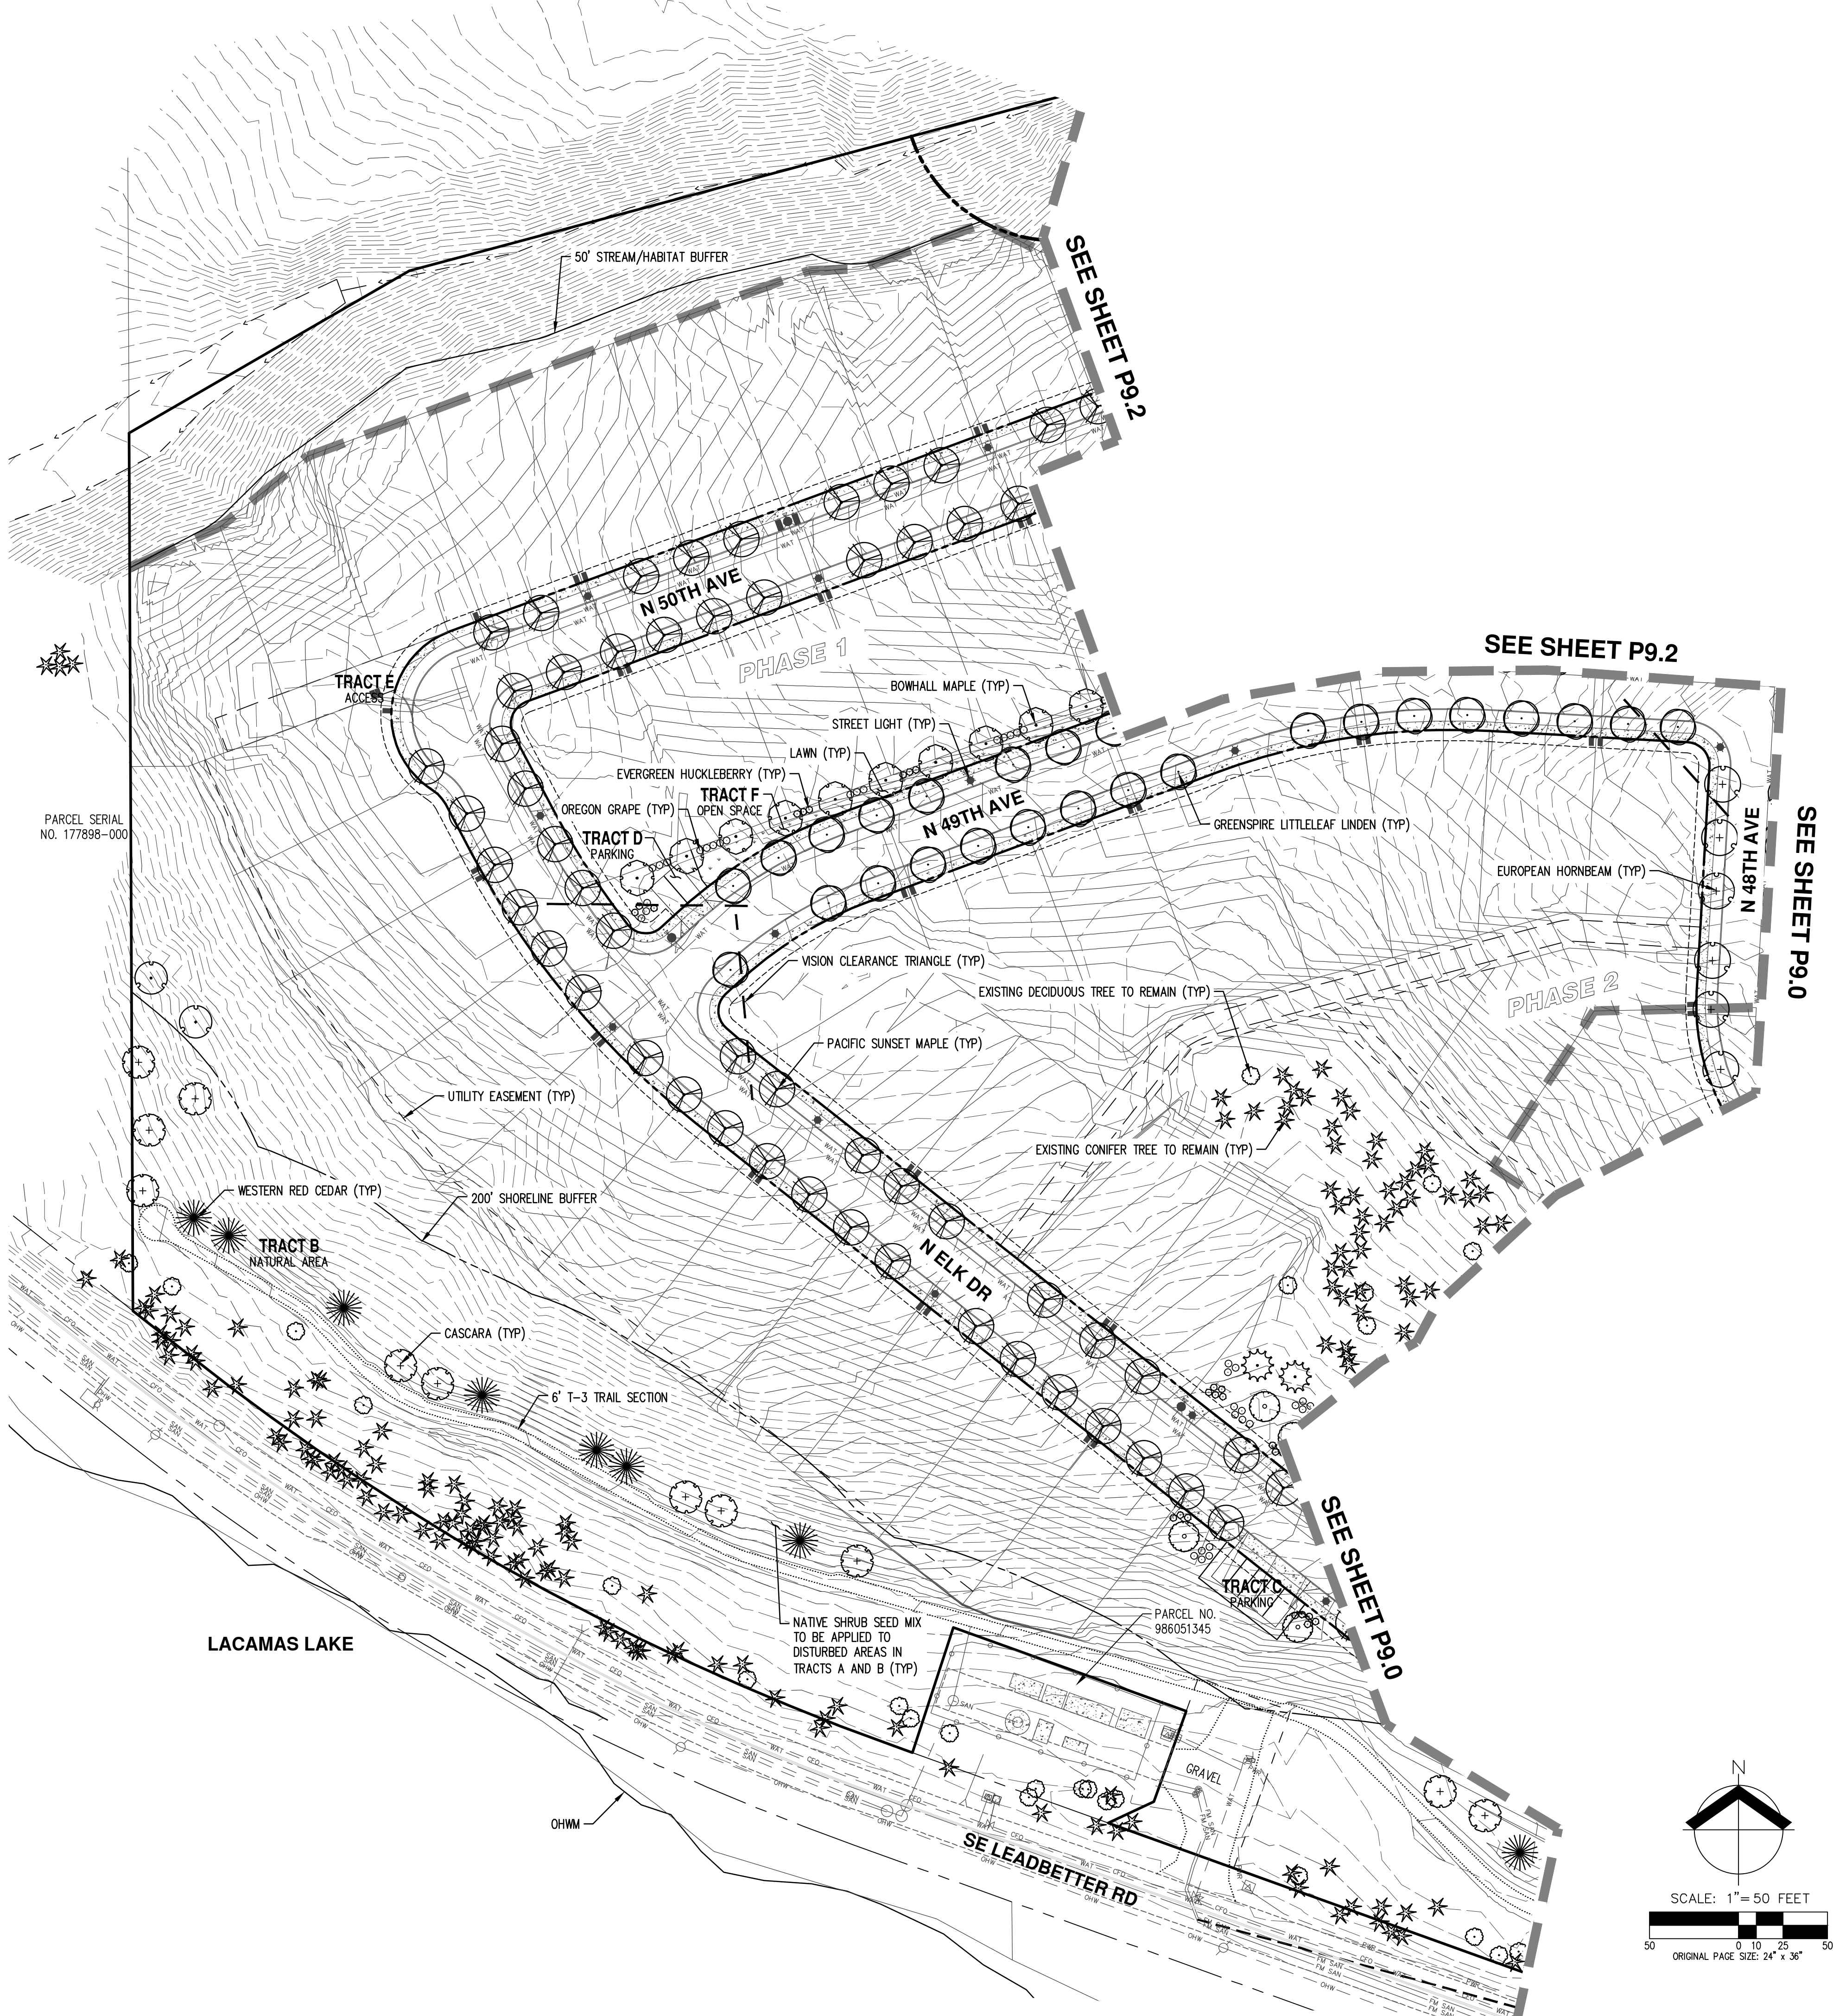
PRELIMINARY LANDSCAPE AND LIGHTING PLAN (WEST)  
CJ DENS SUBDIVISION  
CJ DENS LACAMAS II LLC  
CAMAS, WASHINGTON

1. REFER TO SHEET P9.2 FOR PRELIMINARY PLANT SCHEDULE AND LANDSCAPE NOTES.
2. ROBUST PLANTING IS PROVIDED THROUGHOUT THE DEVELOPMENT BY PROVIDING PLANTINGS IN OPEN SPACE TRACTS ABOVE CODE REQUIREMENTS. SPECIFICALLY, ADDITIONAL PLANTINGS IN TRACTS A AND B WILL PROVIDE 93 NEW TREES AND A NATIVE SHRUB SEED MIX TO HELP RE-ESTABLISH UNDERSTORY PLANTS IN AREAS DISTURBED BY CONSTRUCTION.

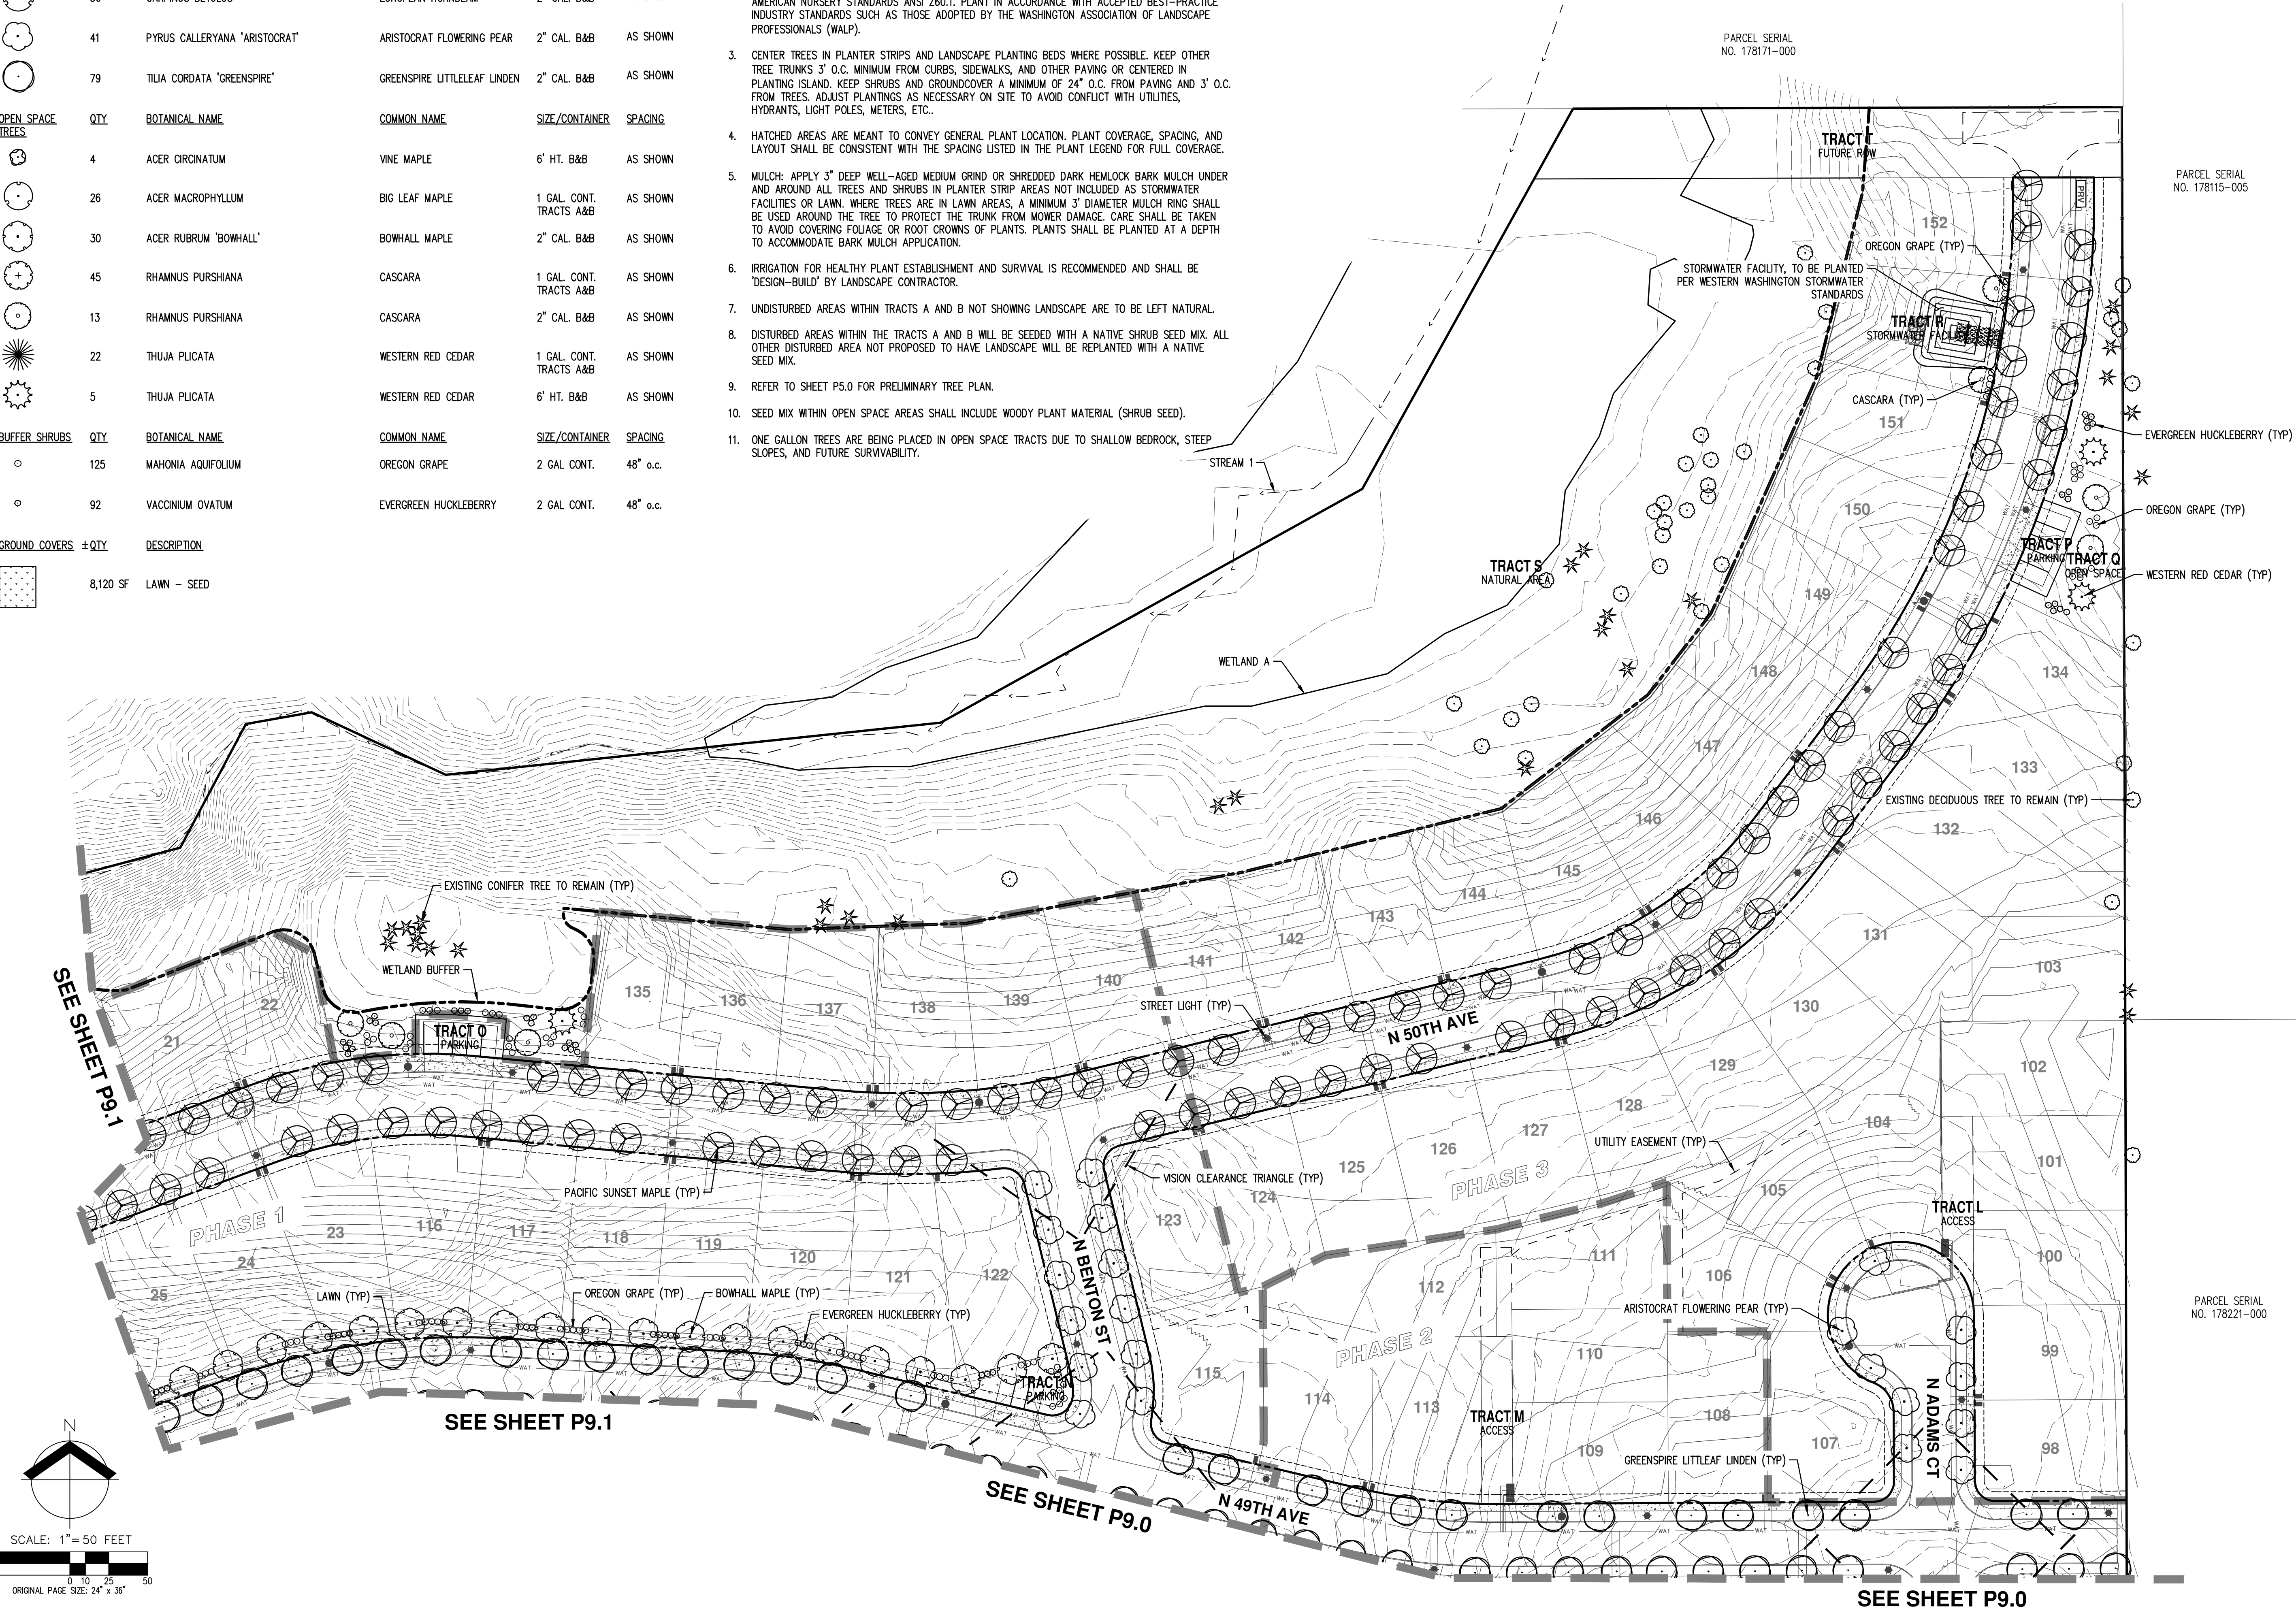
PRELIMINARY LANDSCAPE AND LIGHTING PLAN (NORTH)

- REFER TO THIS SHEET FOR PRELIMINARY PLANT SCHEDULE AND LANDSCAPE NOTES.
- ROBUST PLANTING IS PROVIDED THROUGHOUT THE DEVELOPMENT BY PROVIDING PLANTINGS IN OPEN SPACE TRACTS ABOVE CODE REQUIREMENTS. SPECIFICALLY, ADDITIONAL PLANTINGS IN TRACTS A AND B WILL PROVIDE 93 NEW TREES AND A NATIVE SHRUB SEED MIX TO HELP RE-ESTABLISH UNDERSTORY PLANTS IN AREAS DISTURBED BY CONSTRUCTION.

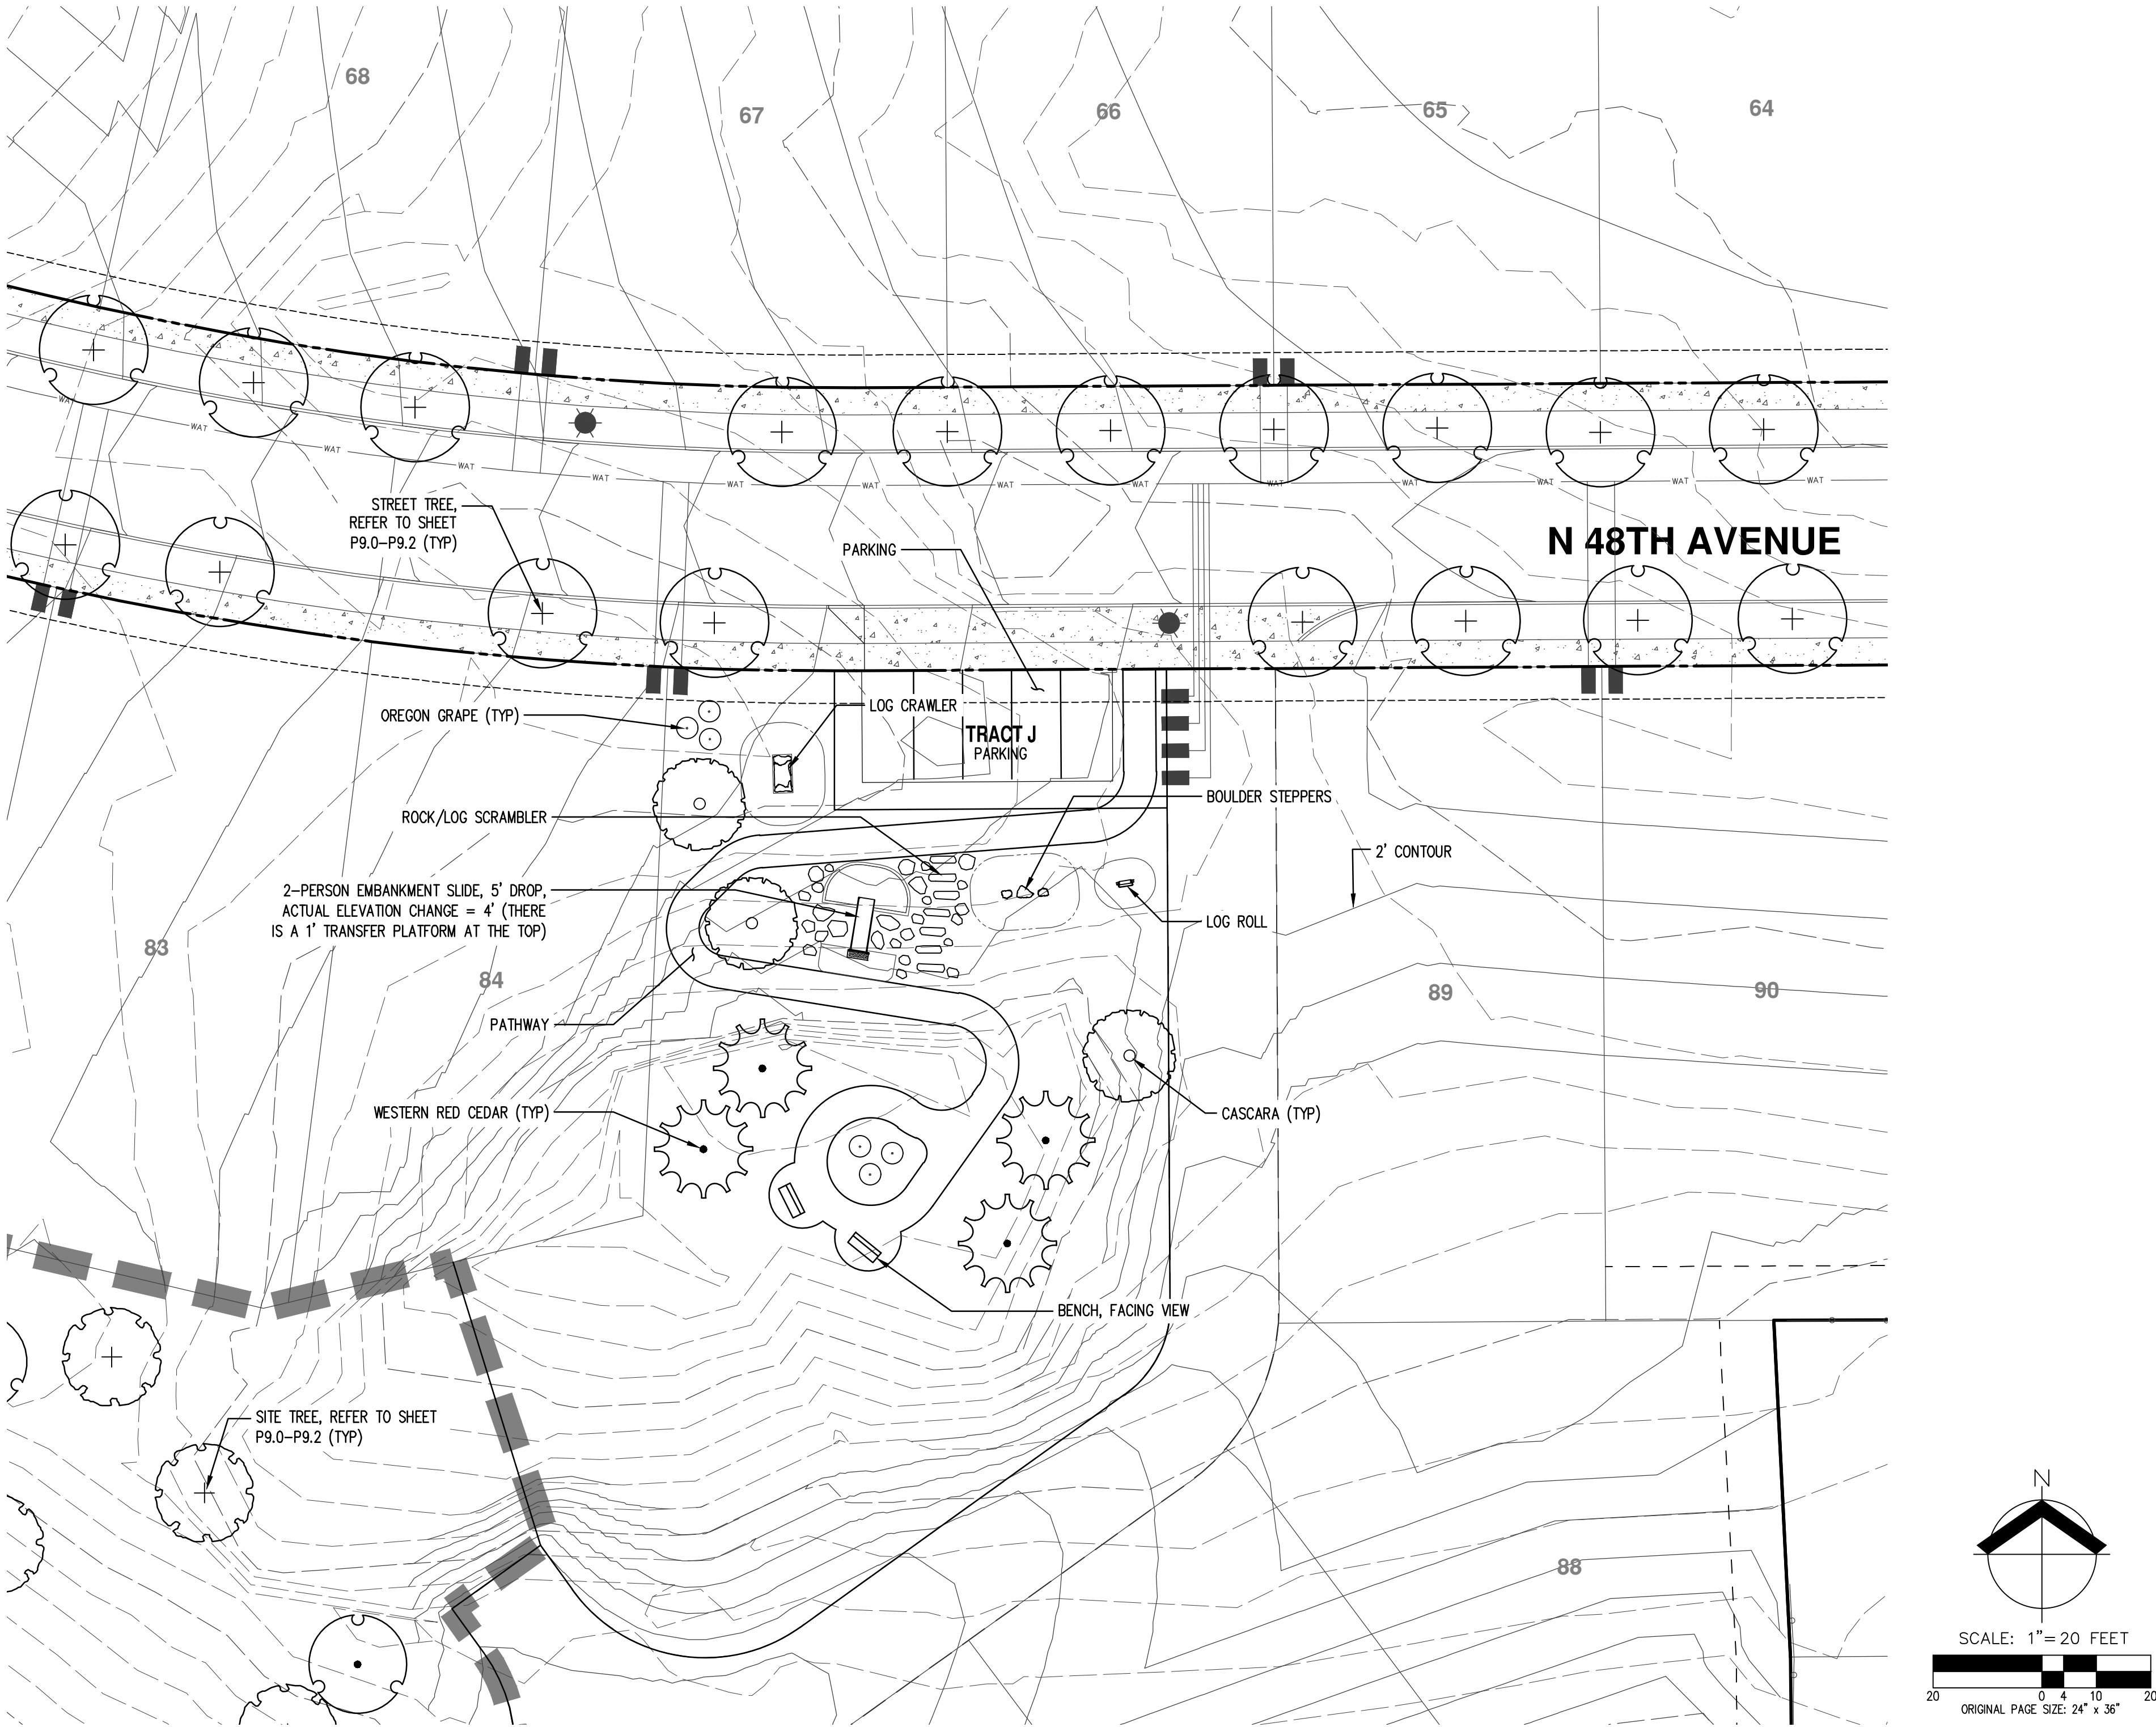
PRELIMINARY TRACT I PARK PLANTING PLAN  
CJ DENS SUBDIVISION  
CJ DENS LACAMAS II LLC  
CAMAS, WASHINGTON

- REFER TO SHEET P9.2 FOR PRELIMINARY PLANT SCHEDULE AND LANDSCAPE NOTES.
- ROBUST PLANTING IS PROVIDED THROUGHOUT THE DEVELOPMENT BY PROVIDING PLANTINGS IN OPEN SPACE TRACTS ABOVE CODE REQUIREMENTS. SPECIFICALLY, ADDITIONAL PLANTINGS IN TRACTS A AND B WILL PROVIDE 93 NEW TREES AND A NATIVE SHRUB SEED MIX TO HELP RE-ESTABLISH UNDERSTORY PLANTS IN AREAS DISTURBED BY CONSTRUCTION.
