# CJ DENS EAST SUBDIVISION

## PRELIMINARY SUBDIVISION PLANS

CJ DENS SUBDIVISION  
CJ DENS LACAMAS II LLC  
CAMAS, WASHINGTON

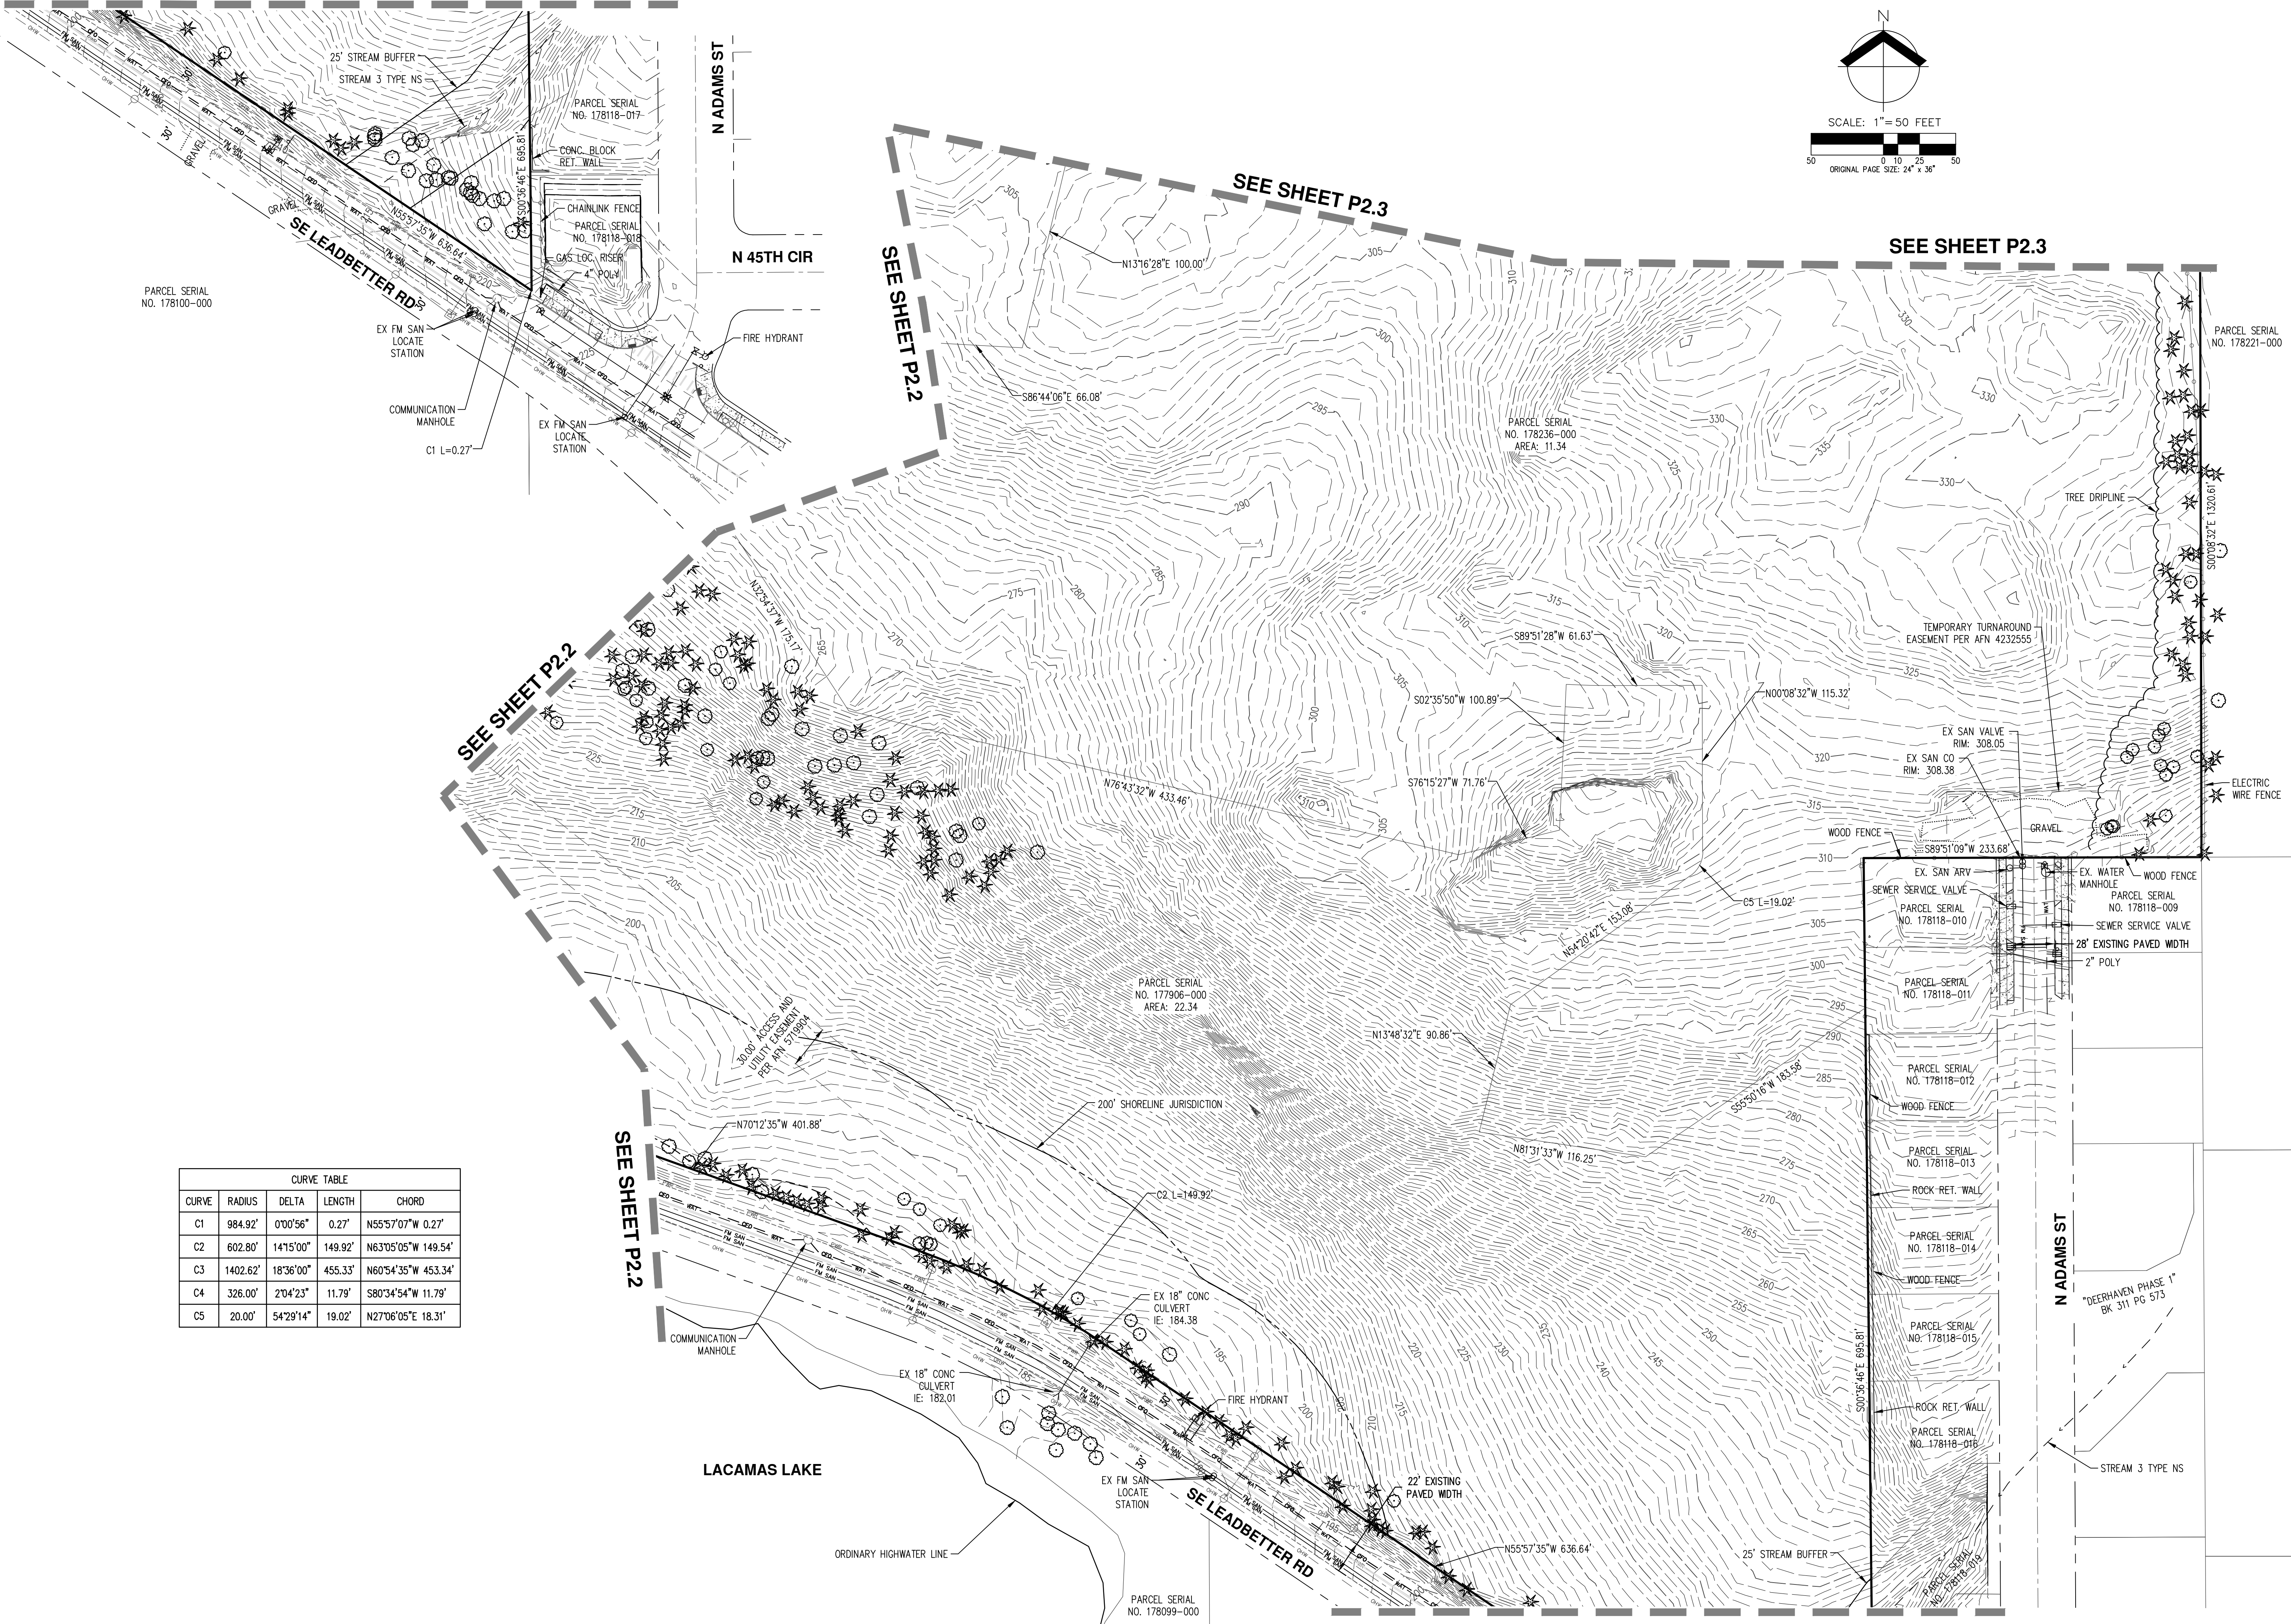
EXISTING CONDITIONS (SOUTH)  
CJ DENS SUBDIVISION  
CJ DENS LACAMAS II LLC  
CAMAS, WASHINGTON

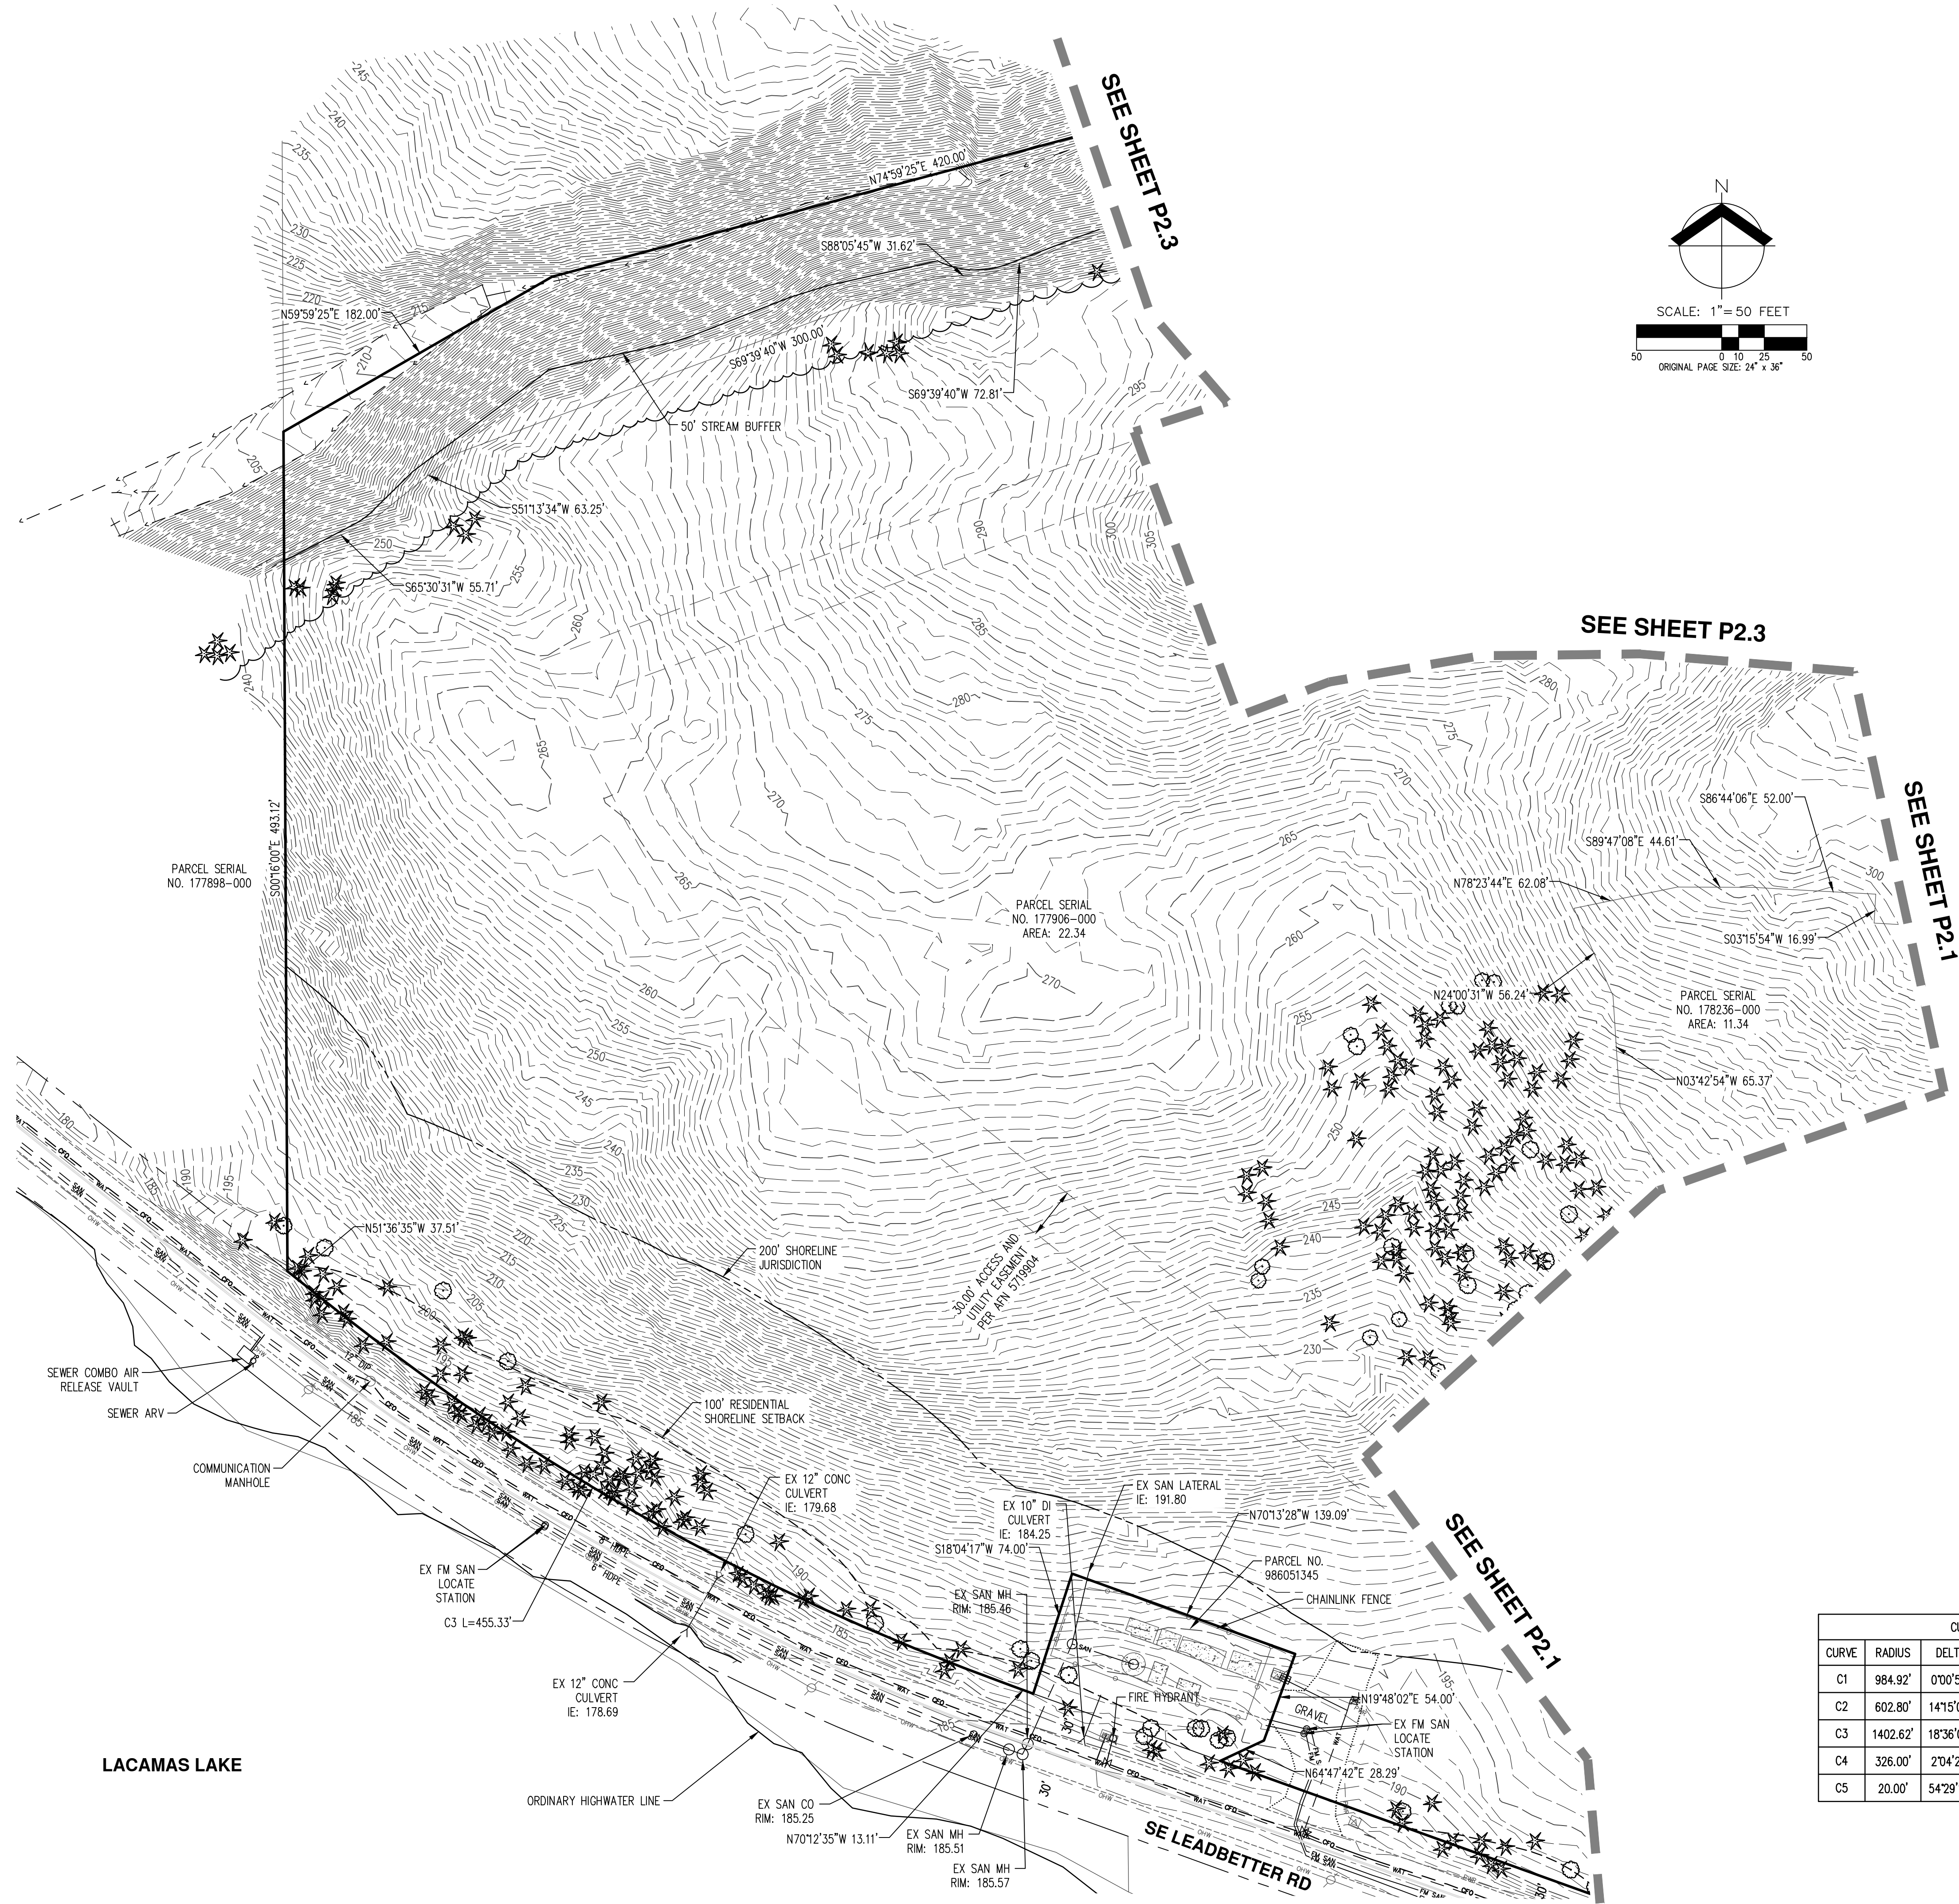
EXISTING CONDITIONS (WEST)  
CJ DENS SUBDIVISION  
CJ DENS LACAMAS II LLC  
CAMAS, WASHINGTON

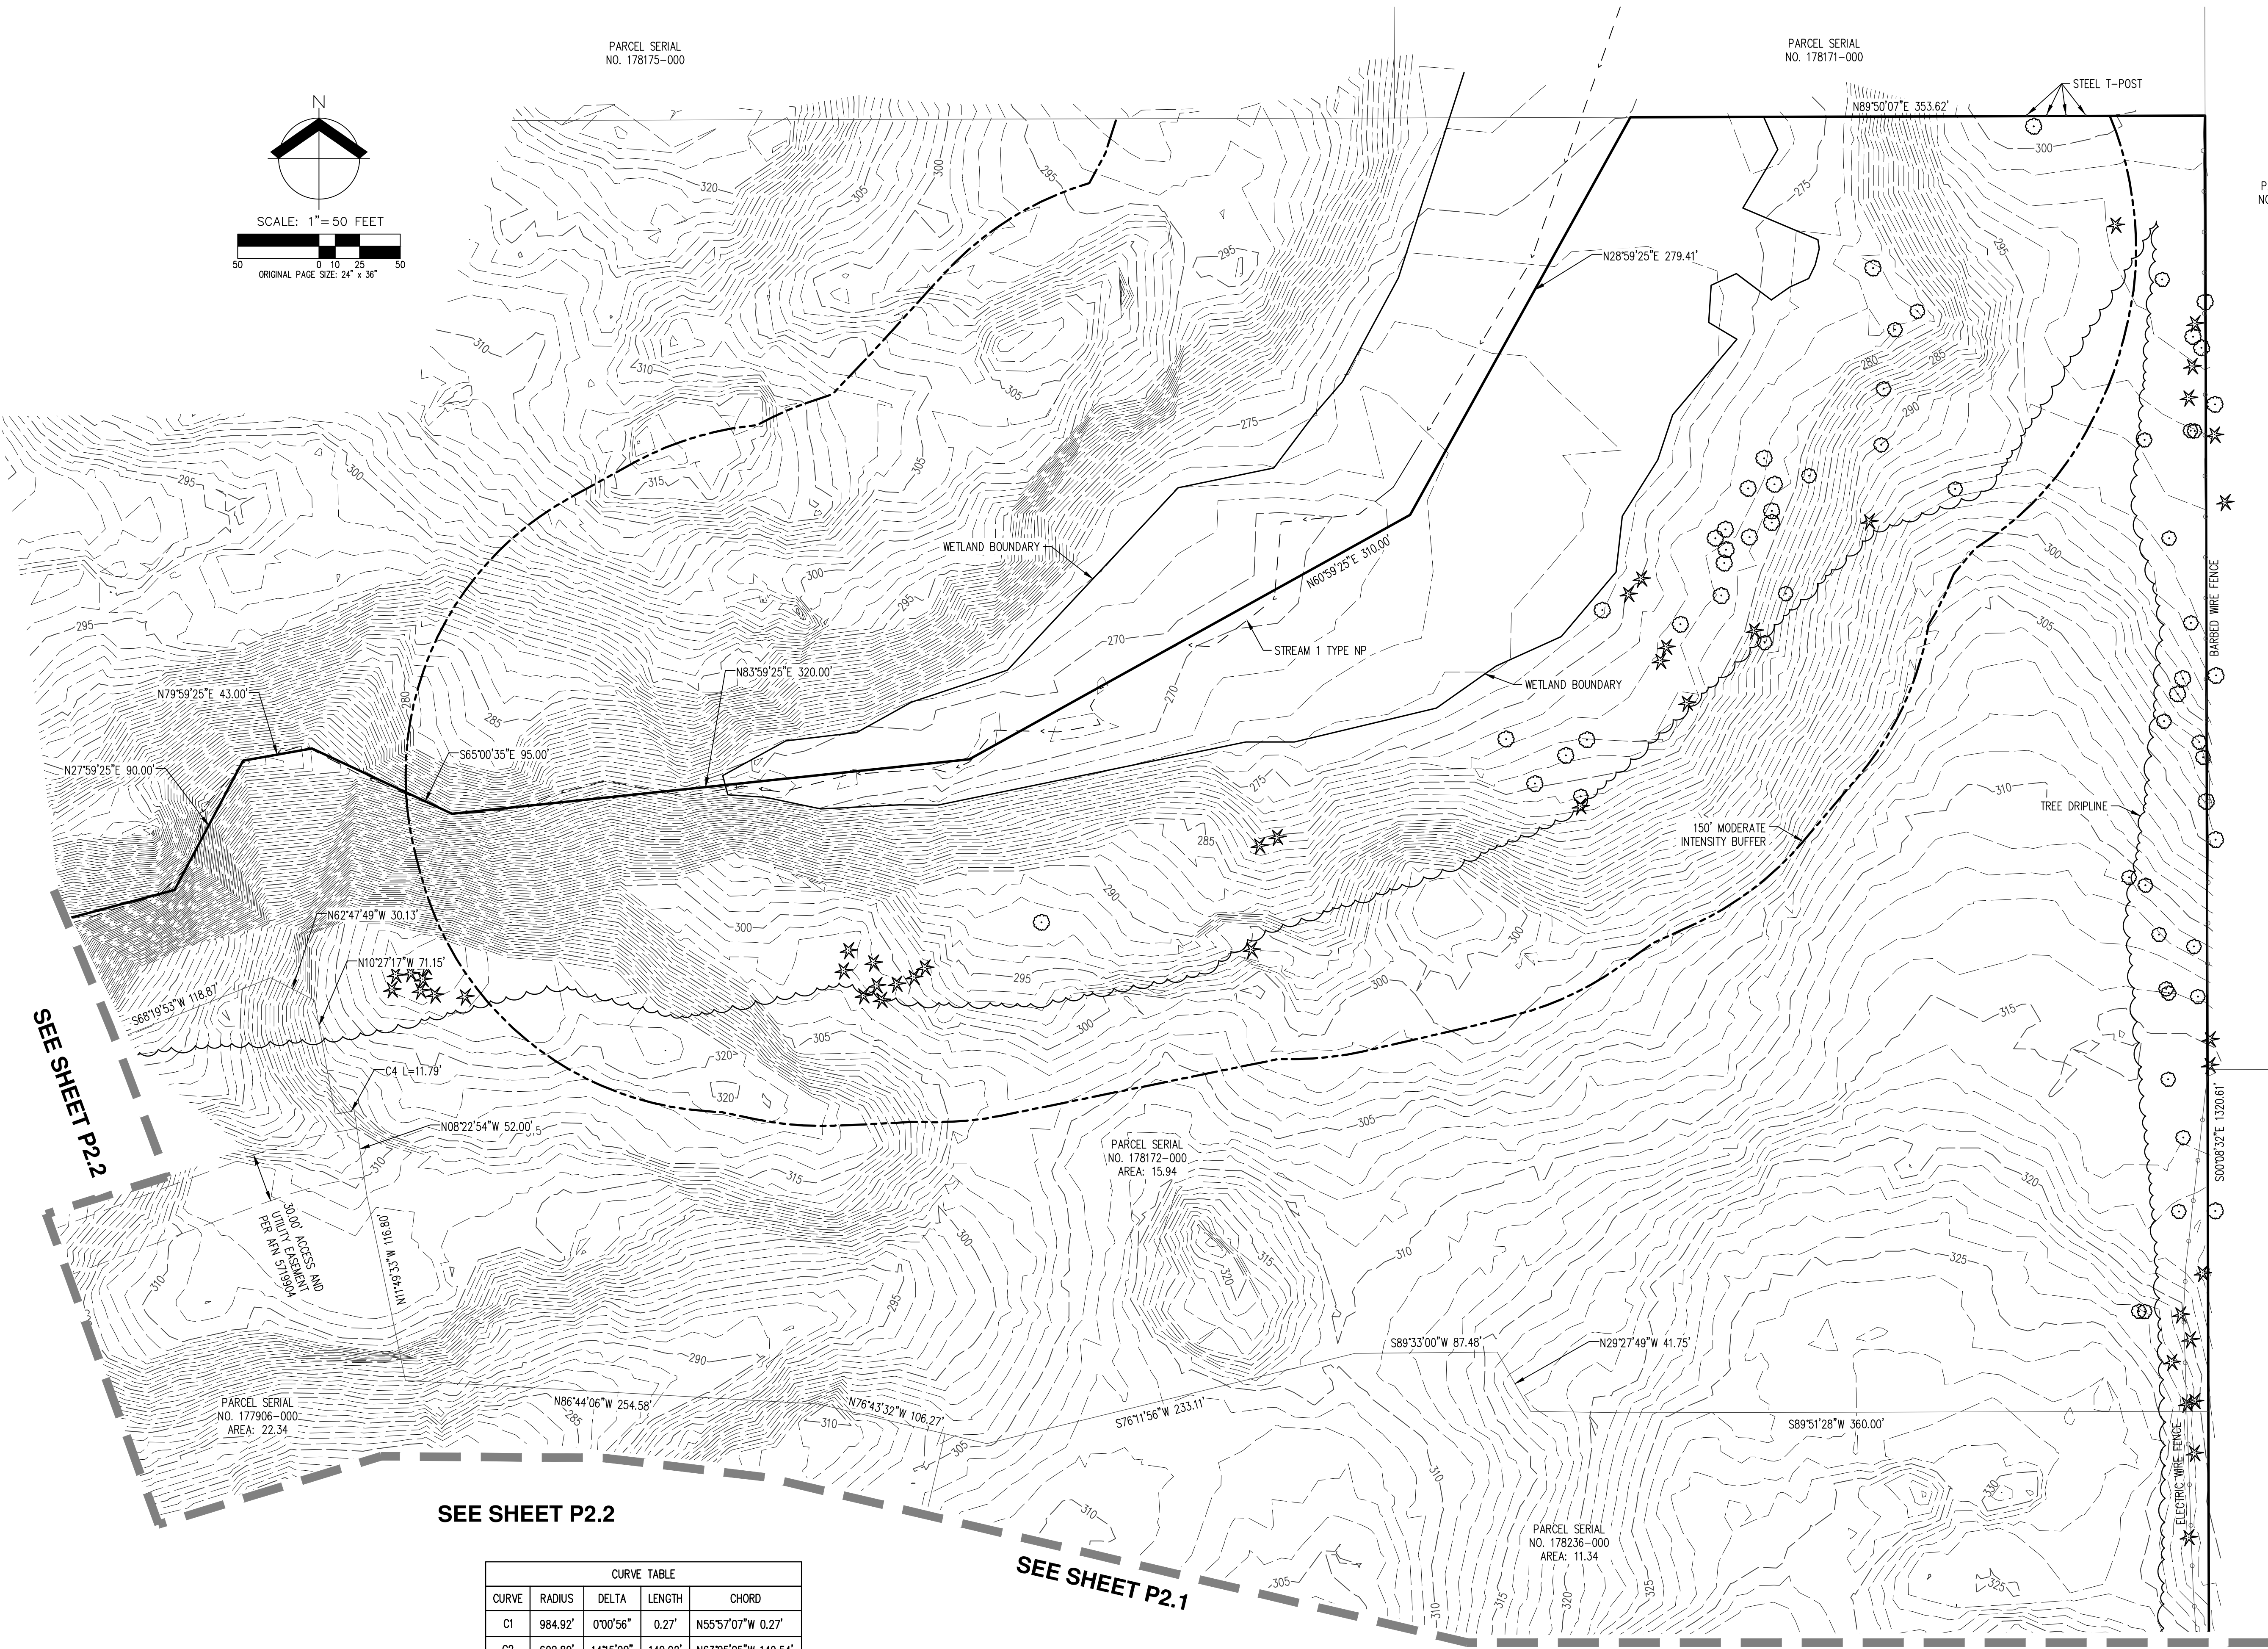
P2.3

EXISTING CONDITIONS (NORTH)  
CJ DENS SUBDIVISION  
CJ DENS LACAMAS II LLC  
CAMAS, WASHINGTON

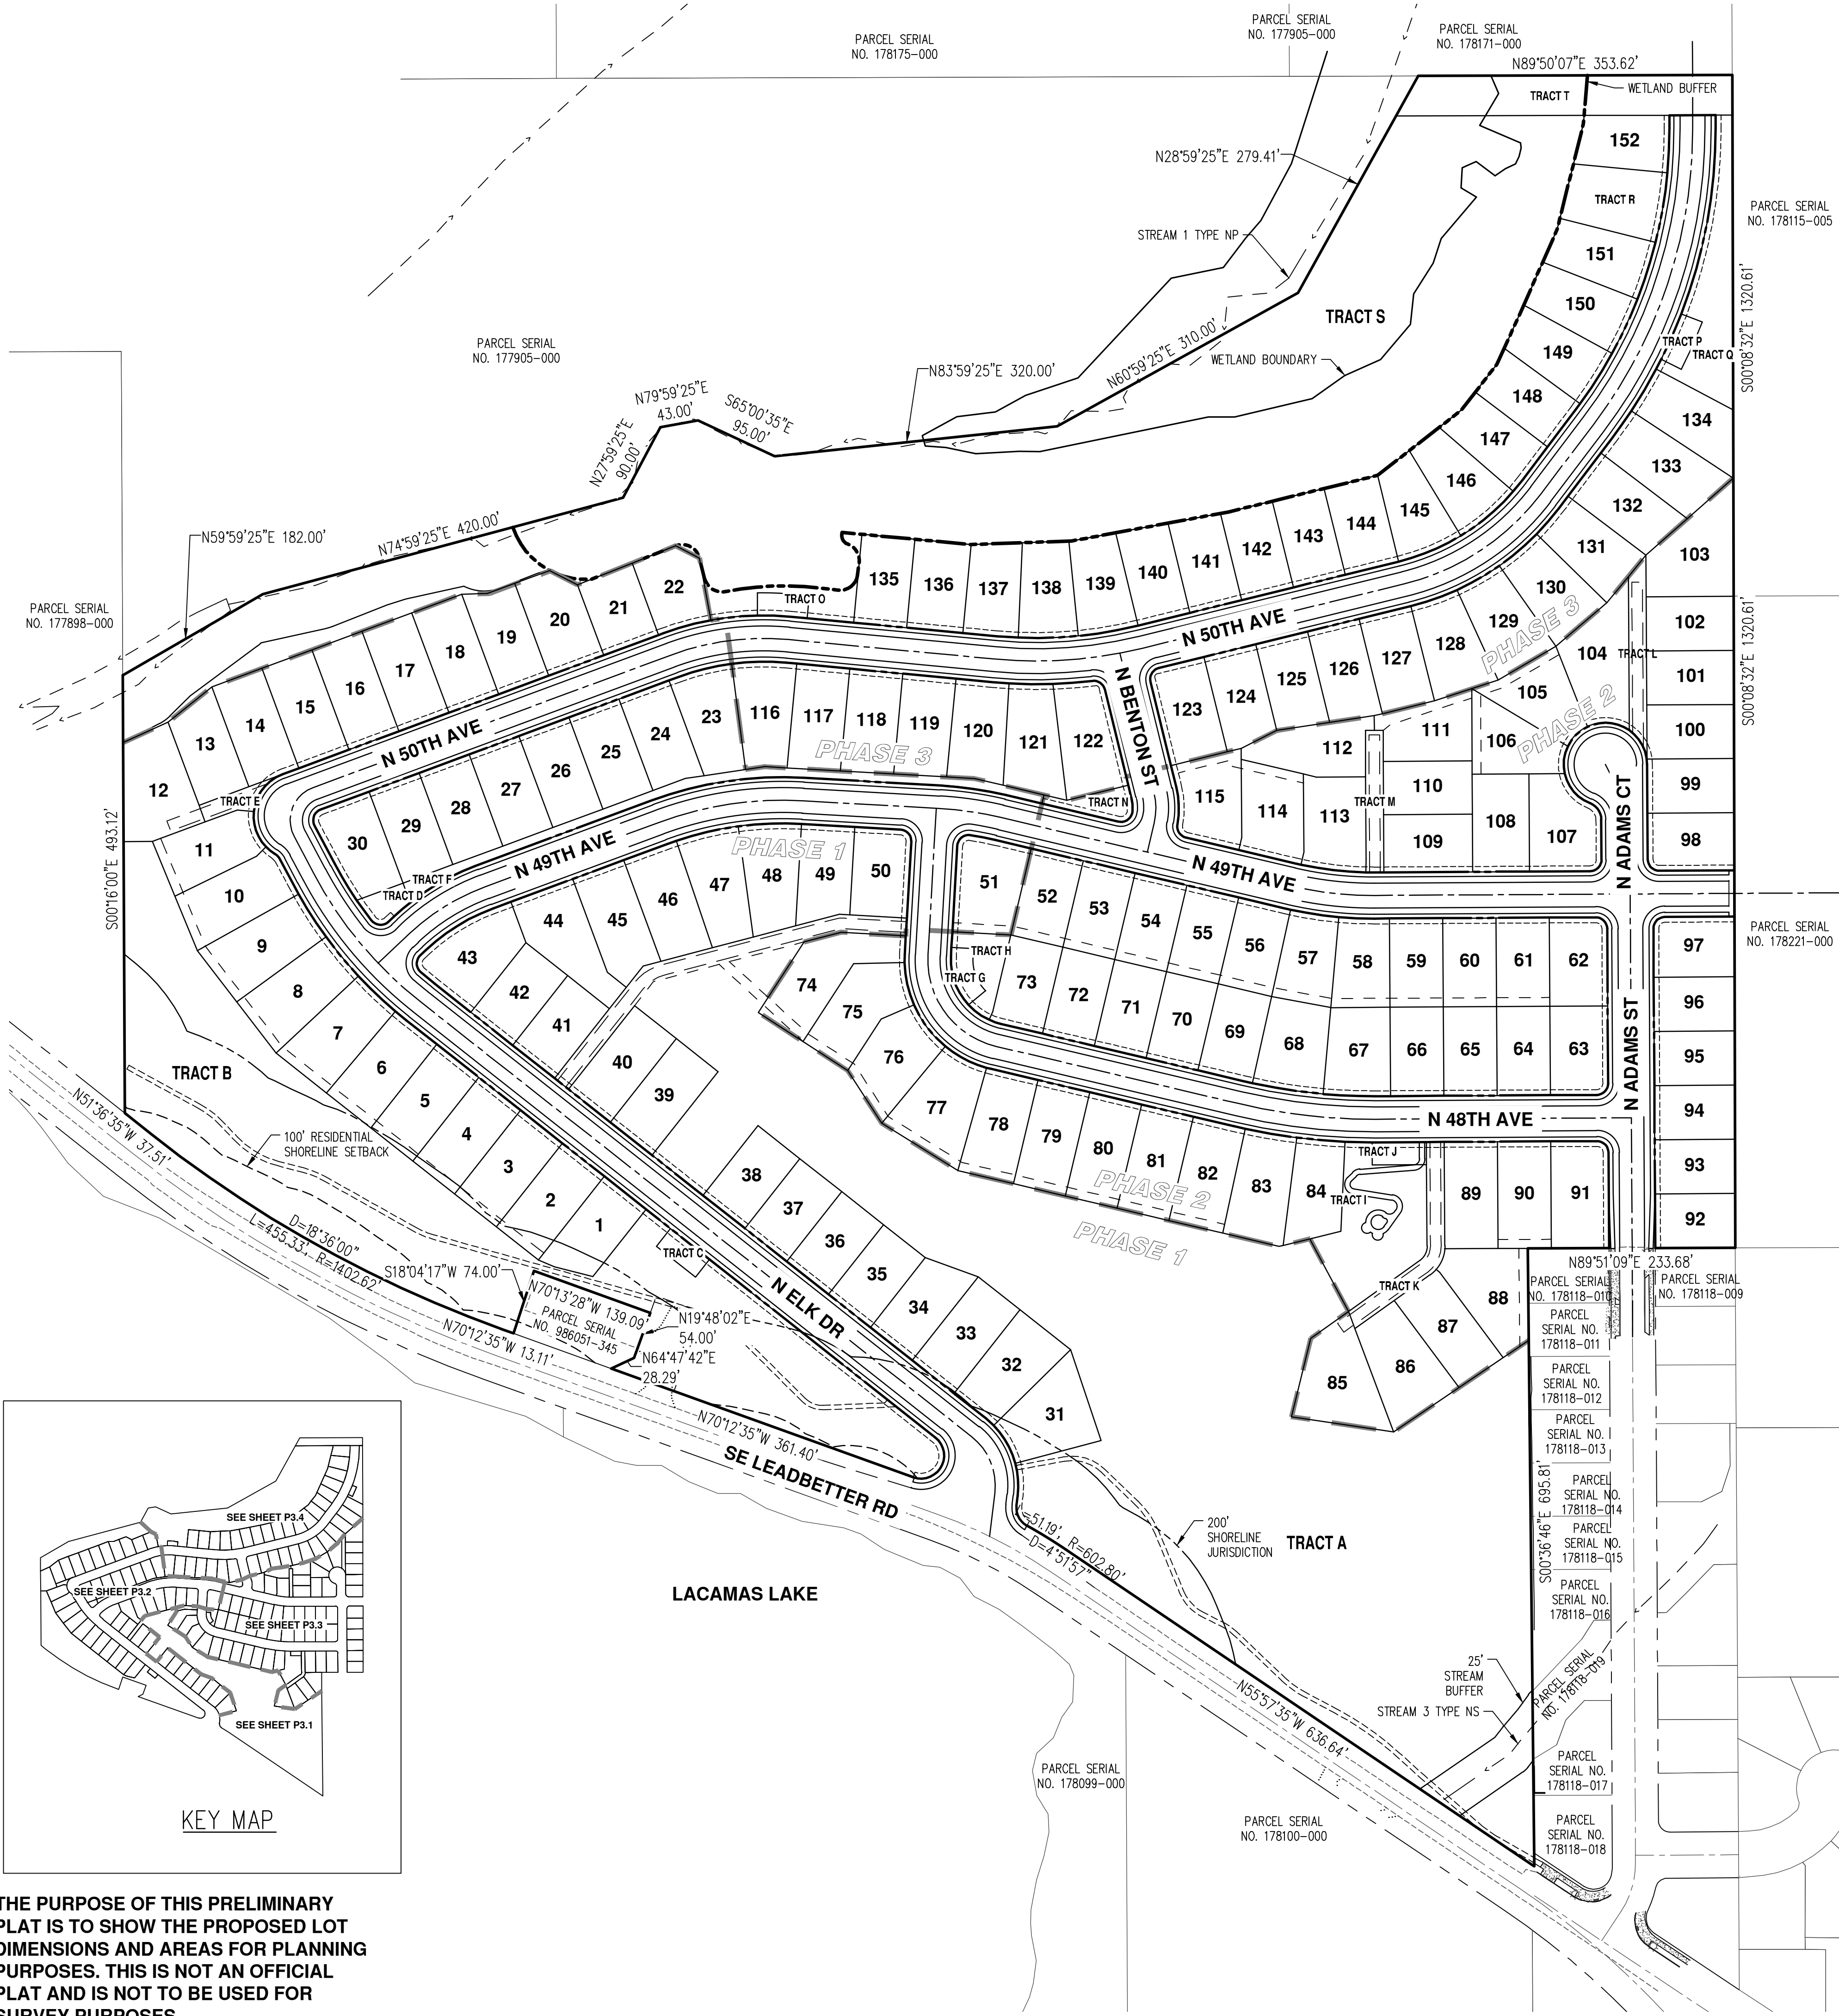
THE PURPOSE OF THIS PRELIMINARY PLAT IS TO SHOW THE PROPOSED LOT DIMENSIONS AND AREAS FOR PLANNING PURPOSES. THIS IS NOT AN OFFICIAL PLAT AND IS NOT TO BE USED FOR SURVEY PURPOSES.

PRELIMINARY PLAT OVERVIEW  
CJ DENS SUBDIVISION  
CJ DENS LACAMAS II LLC  
CAMAS, WASHINGTON

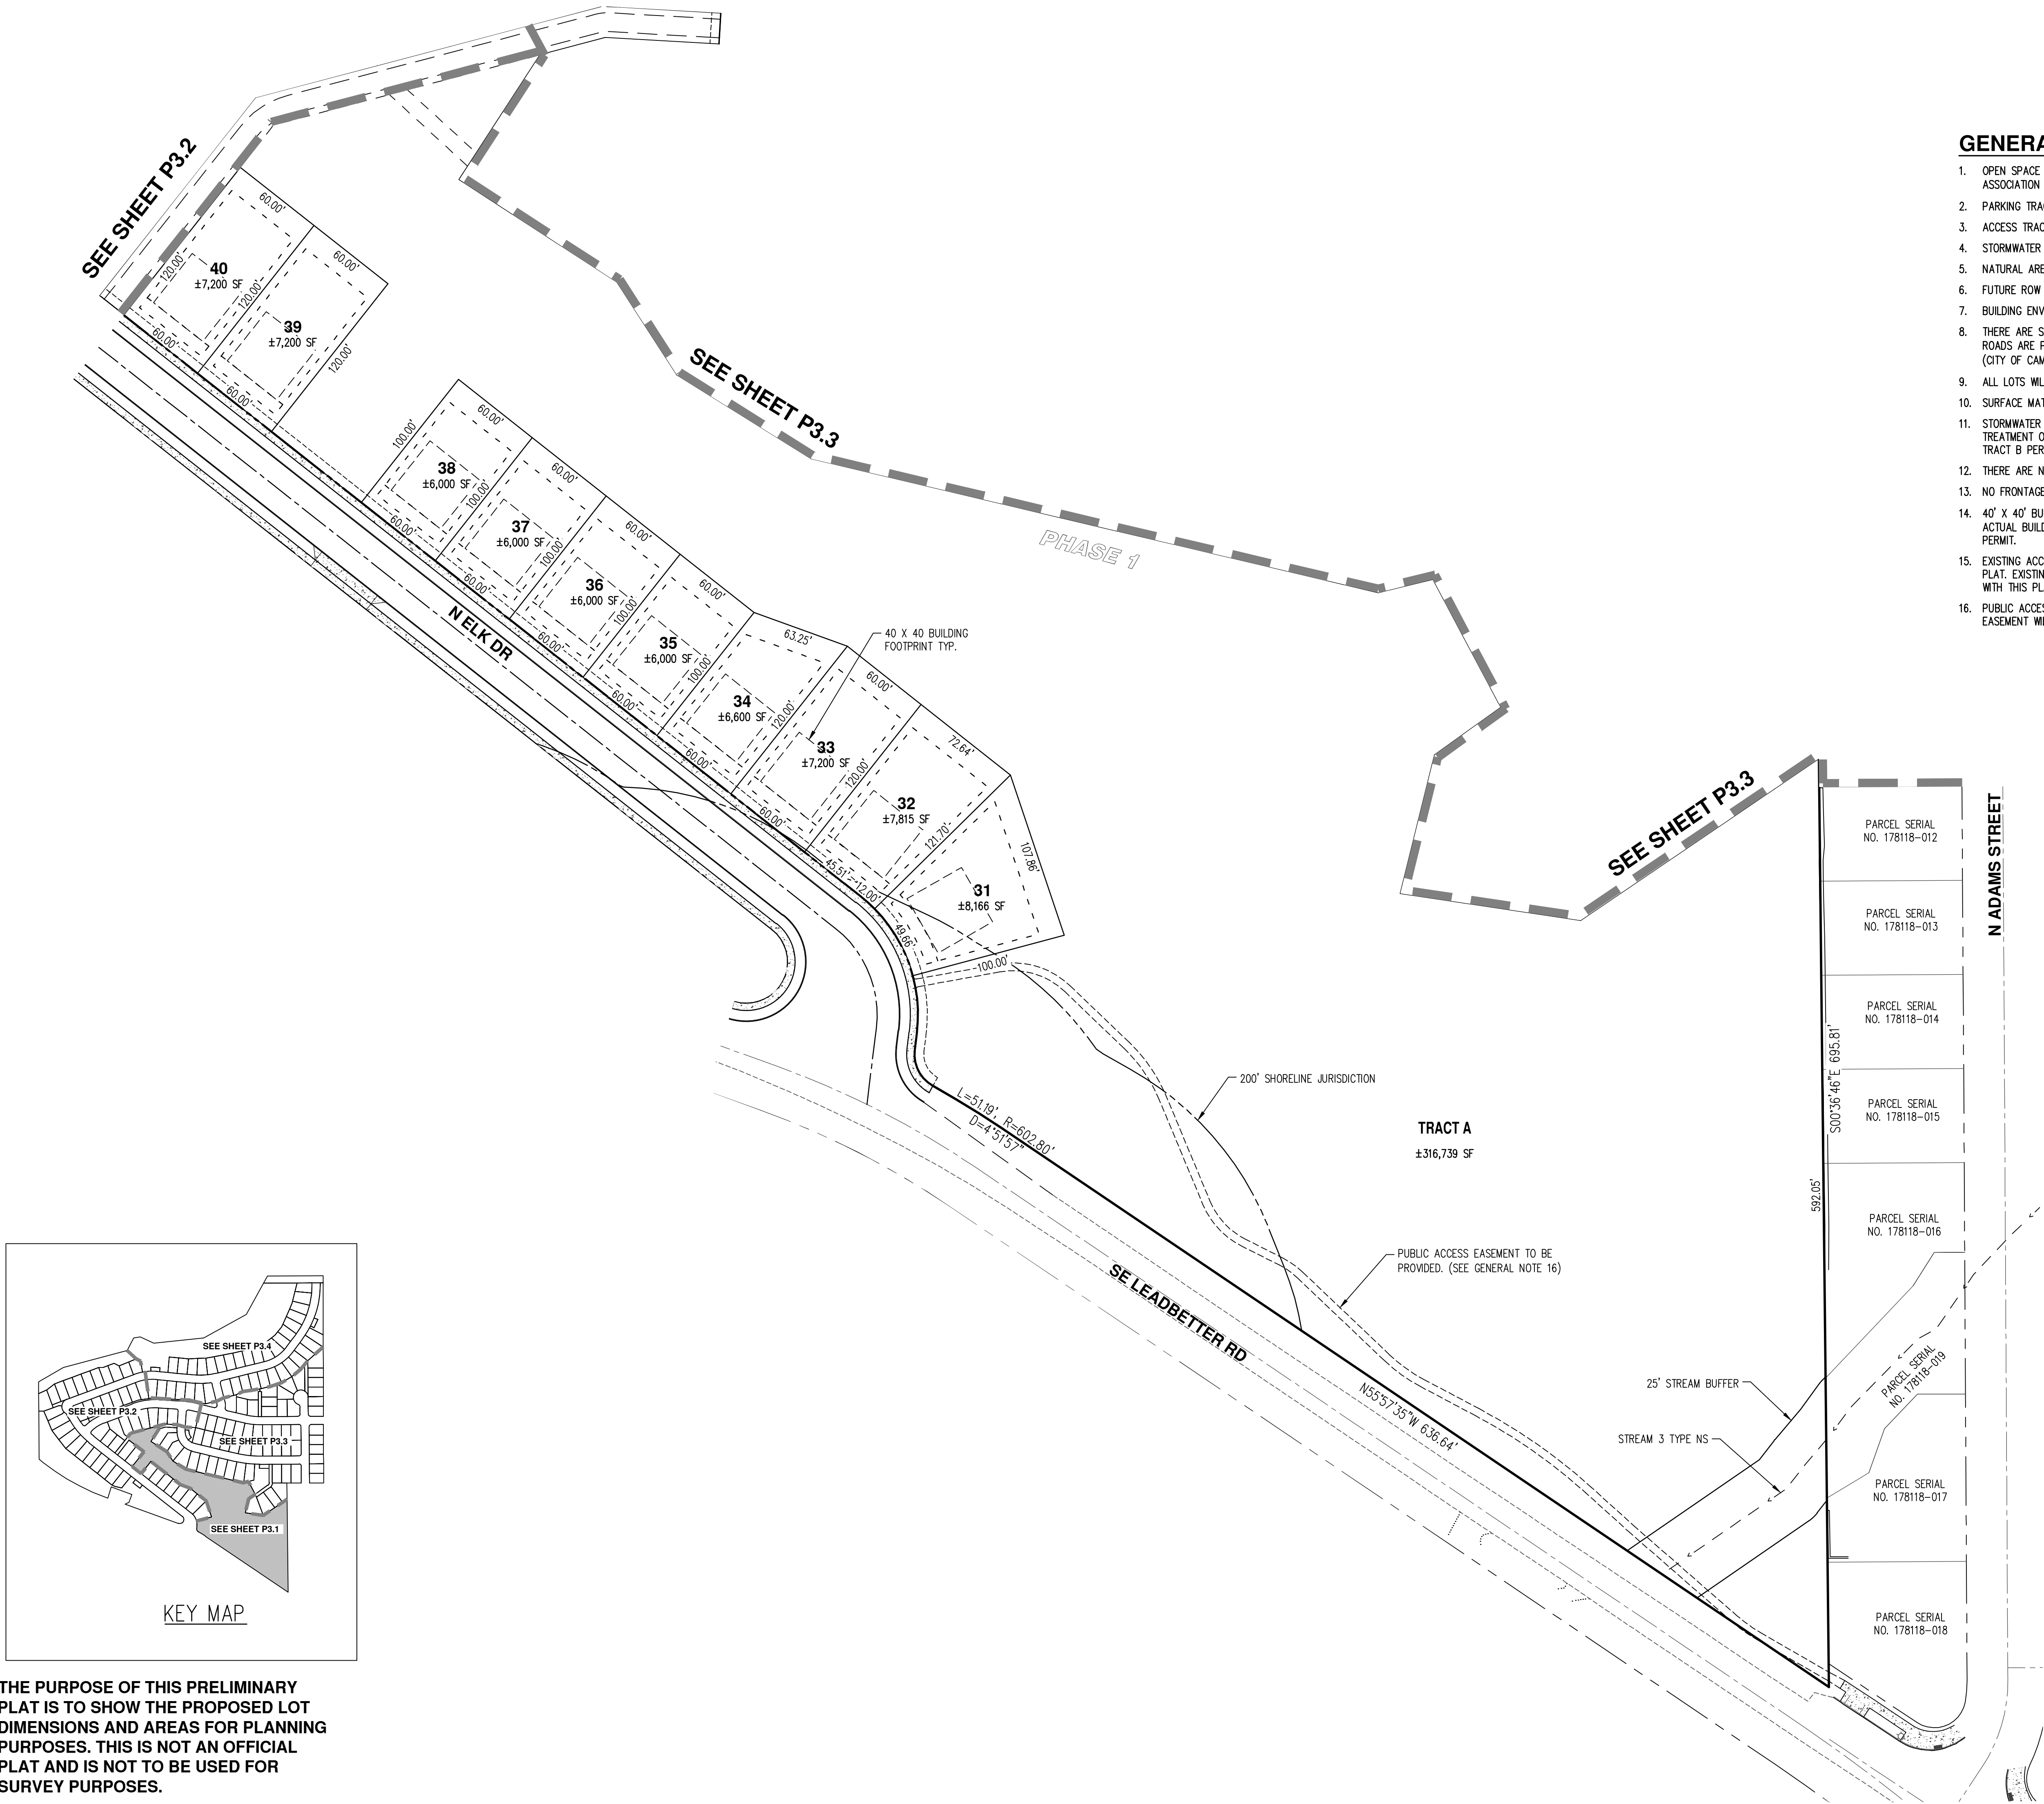
### P3.1

**PRELIMINARY PLAT - PHASE 1  
CJ DENS SUBDIVISION  
CJ DENS LACAMAS II LLC  
CAMAS, WASHINGTON**

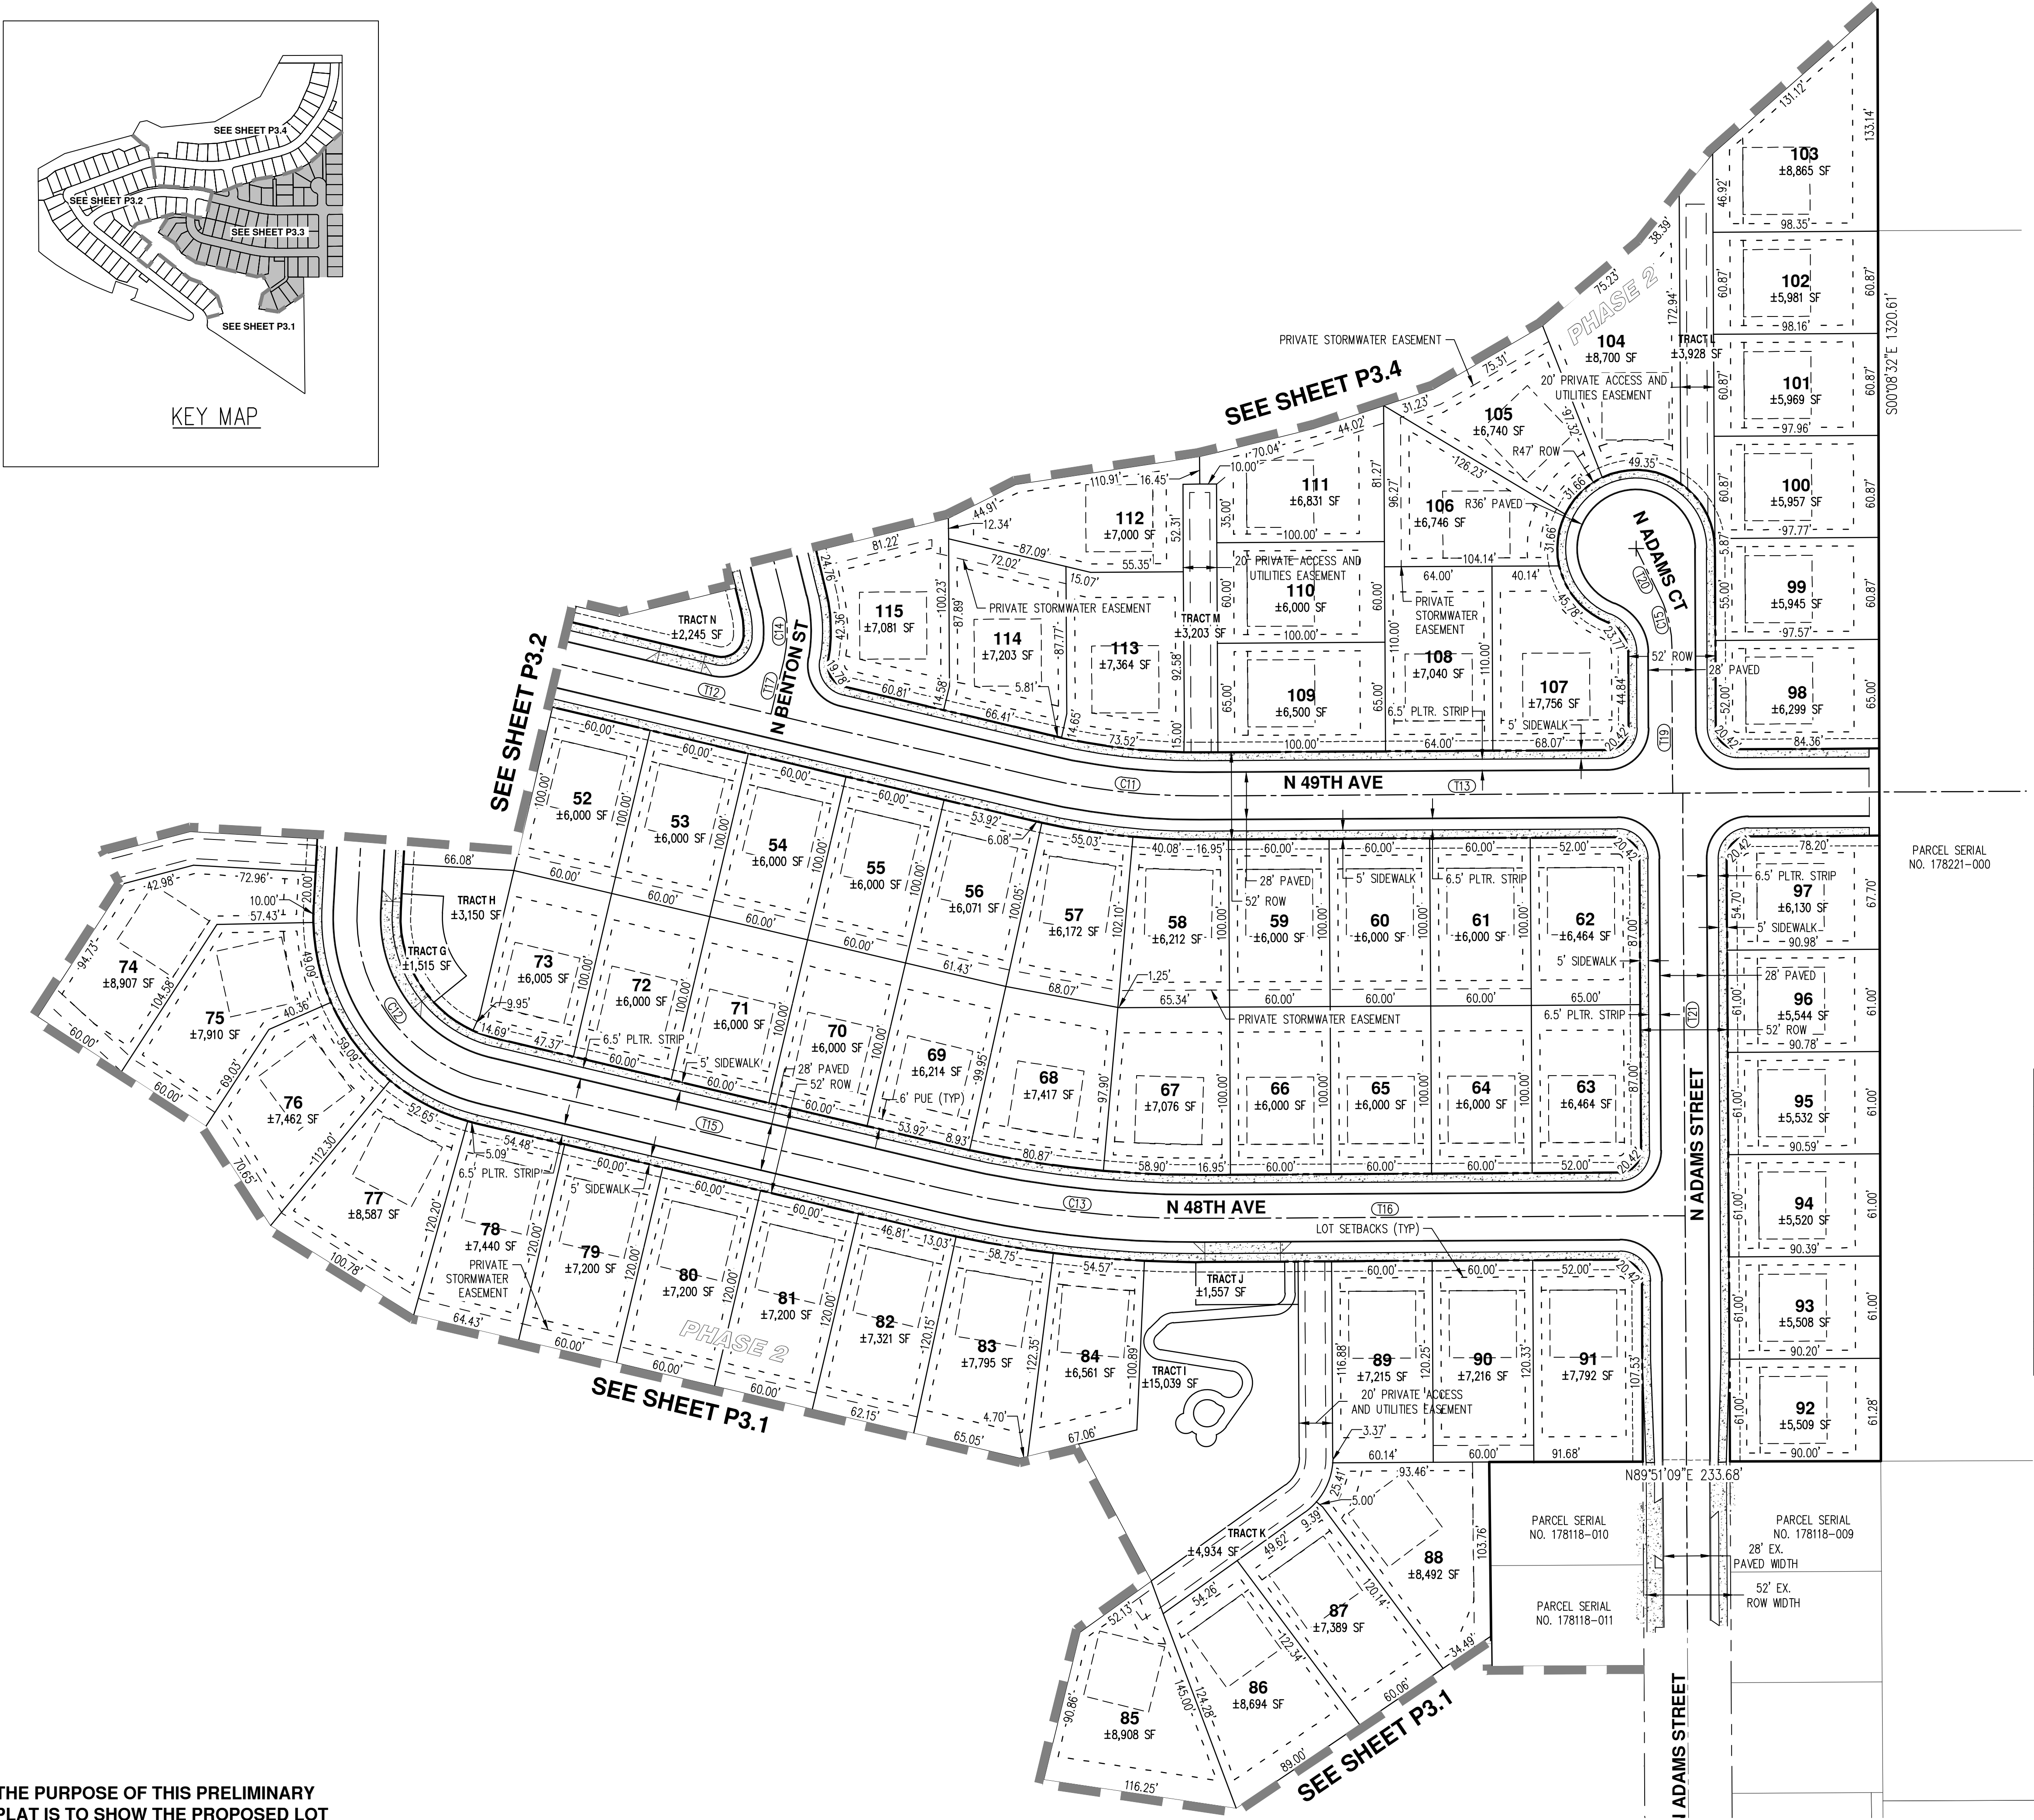
P3.2

PRELIMINARY PLAT - PHASE 1  
CJ DENS SUBDIVISION  
CJ DENS LACAMAS II LLC  
CAMAS, WASHINGTON
