# CJ DENS EAST SUBDIVISION

## PRELIMINARY SUBDIVISION PLANS

CJ DENS SUBDIVISION  
CJ DENS LACAMAS II LLC  
CAMAS, WASHINGTON

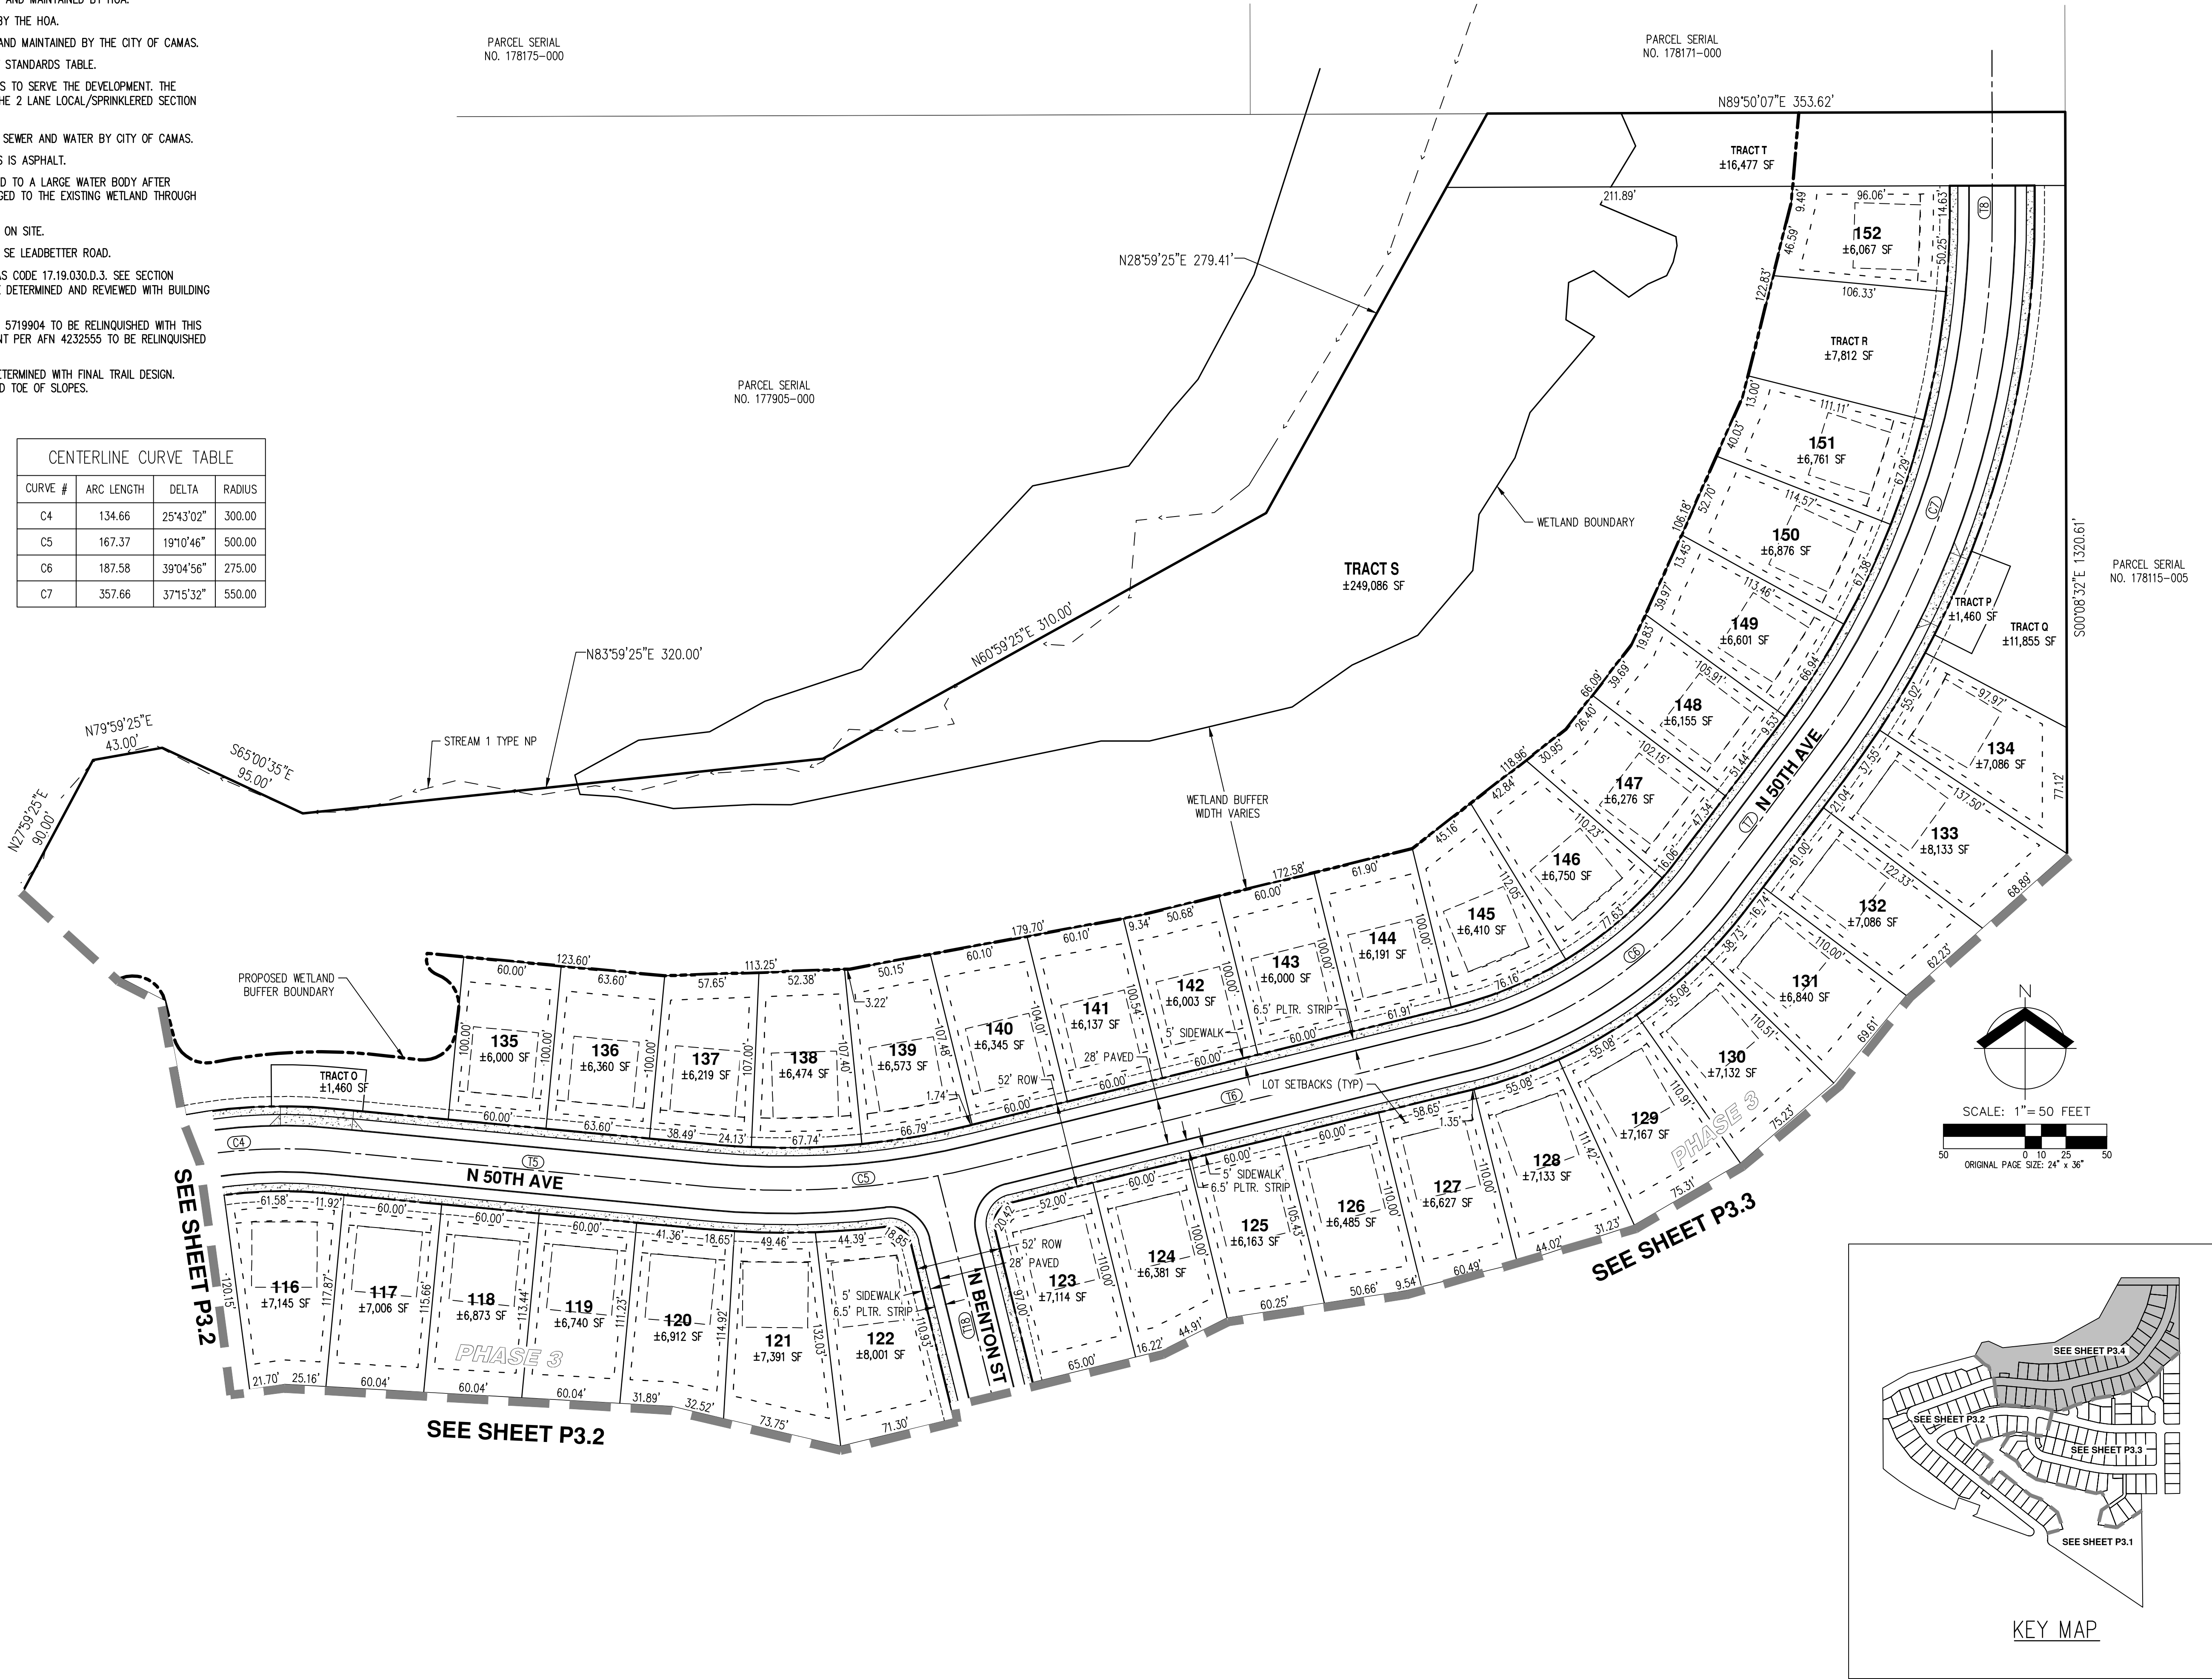
P3.4

PRELIMINARY PLAT - PHASE 3  
CJ DENS SUBDIVISION  
CJ DENS LACAMAS II LLC  
CAMAS, WASHINGTON

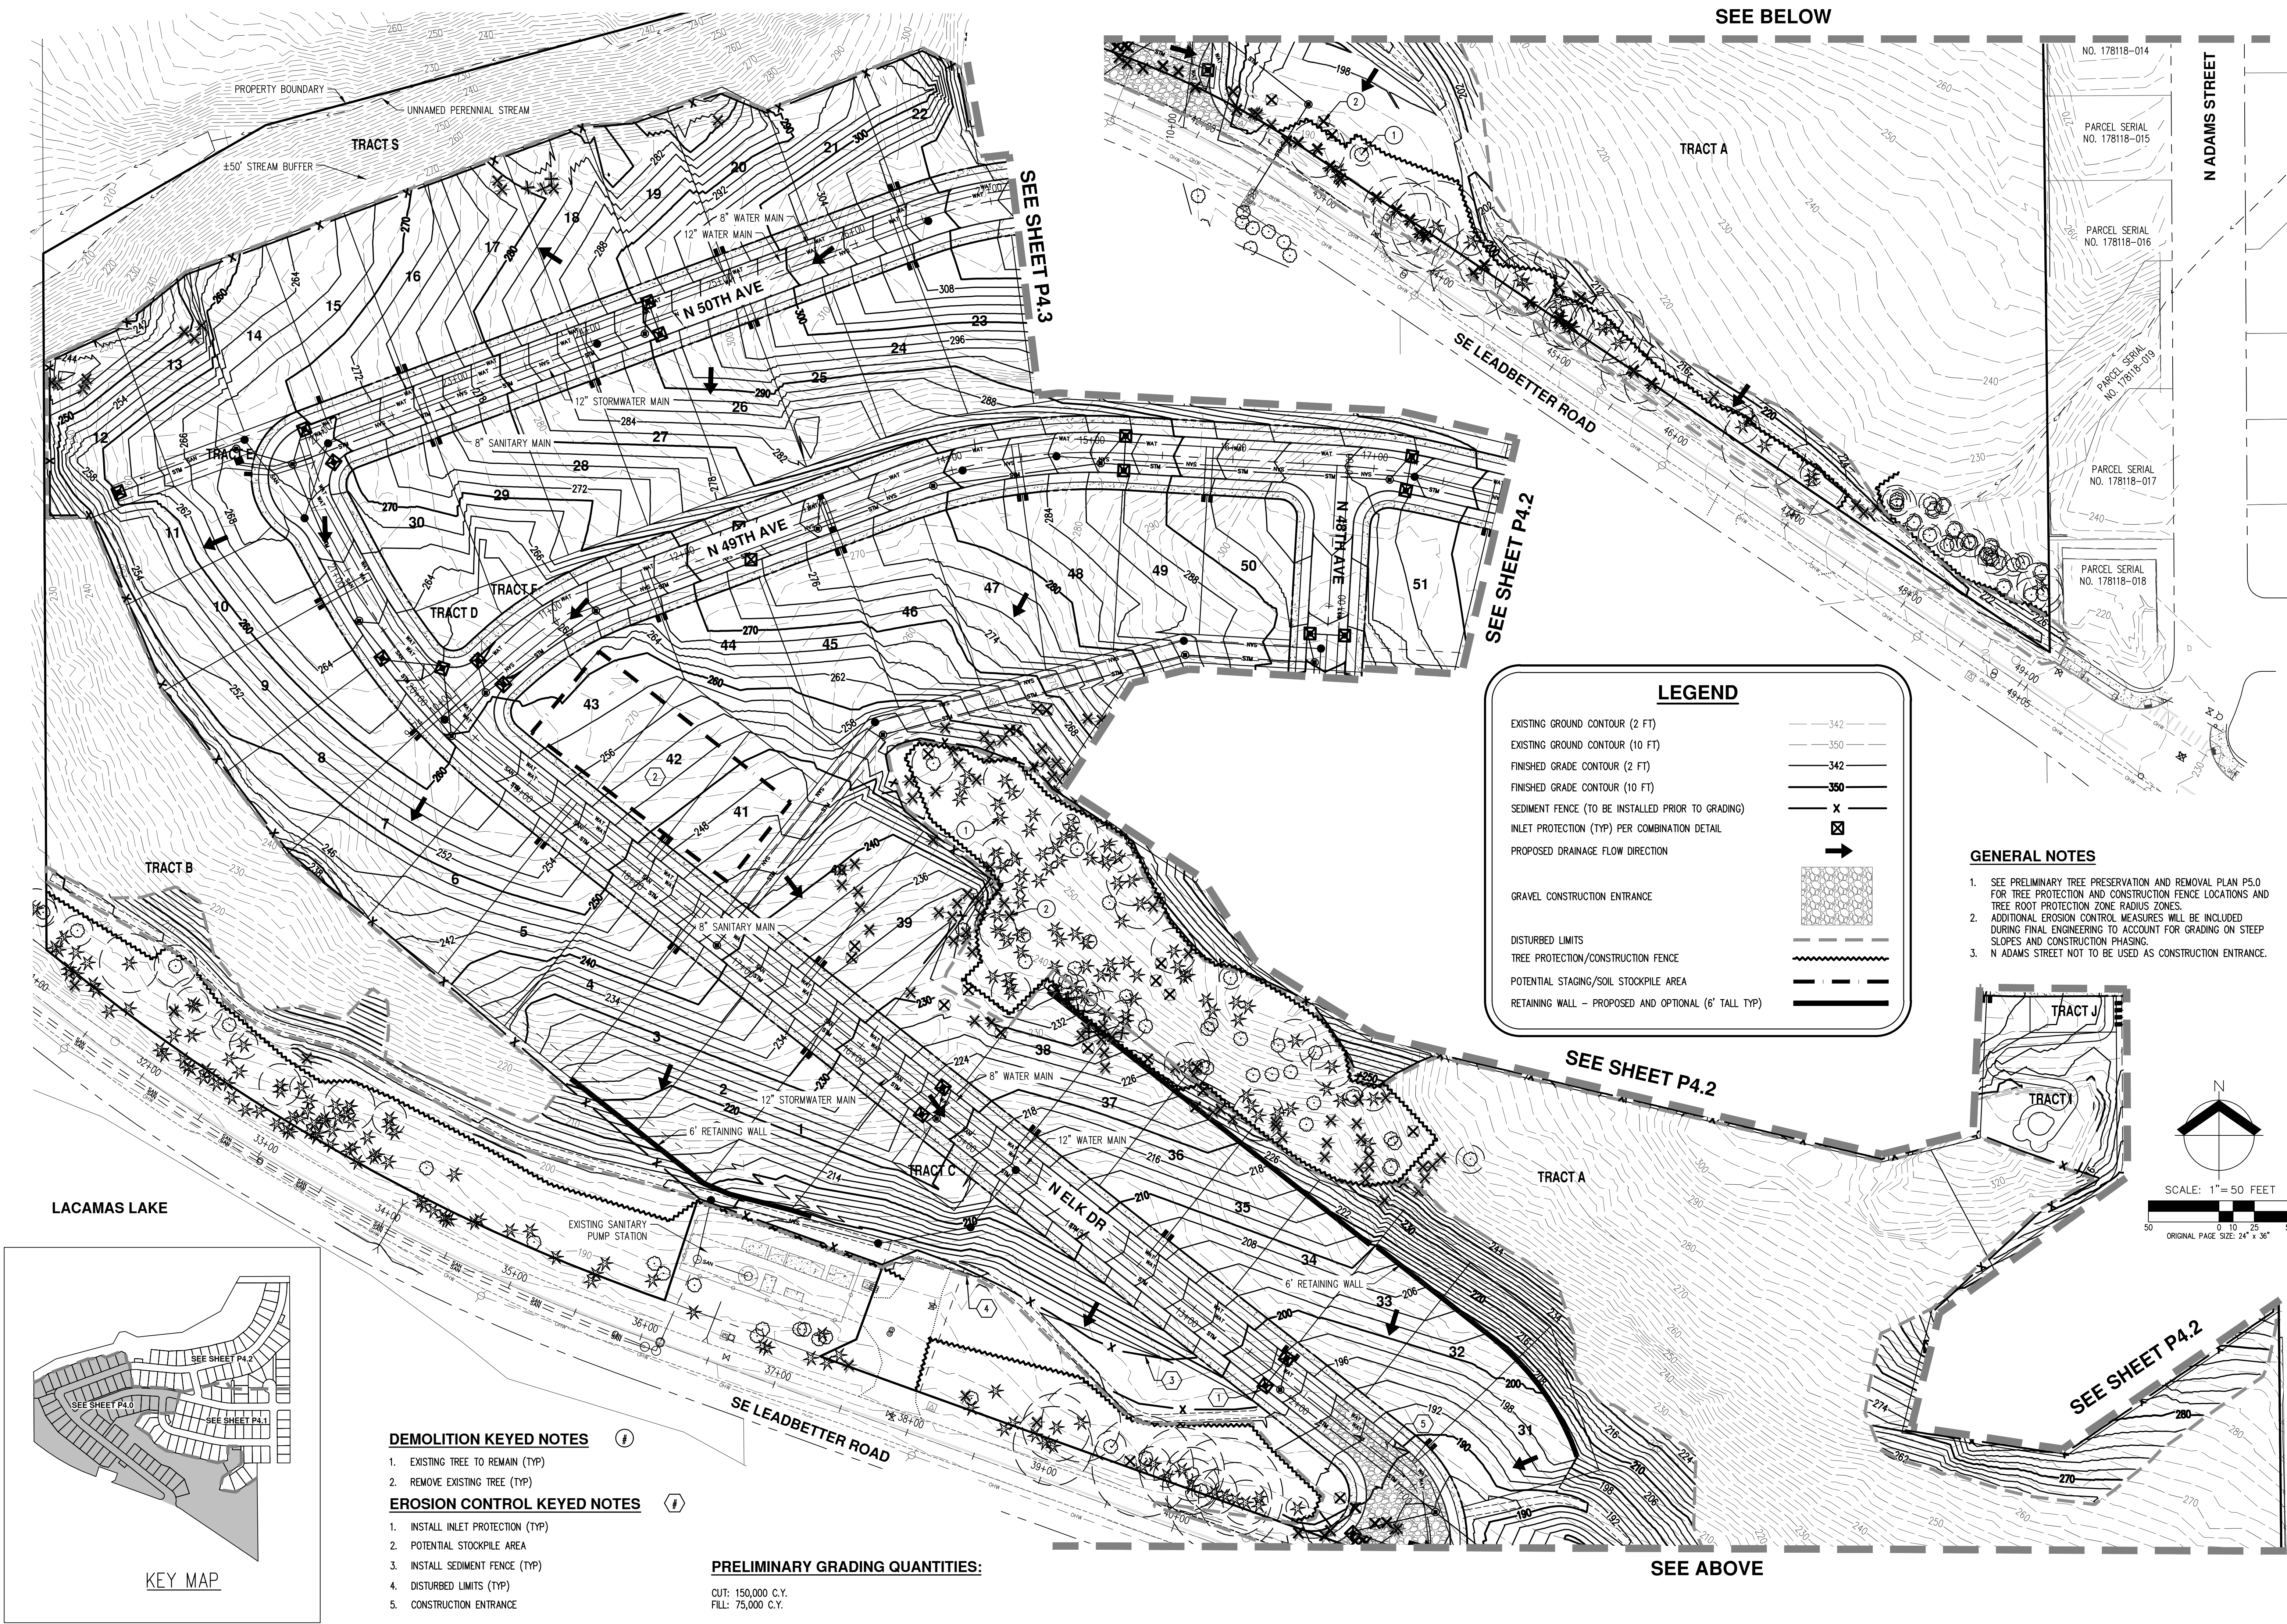
PRELIMINARY GRADING AND ESC PLAN - PHASE 1

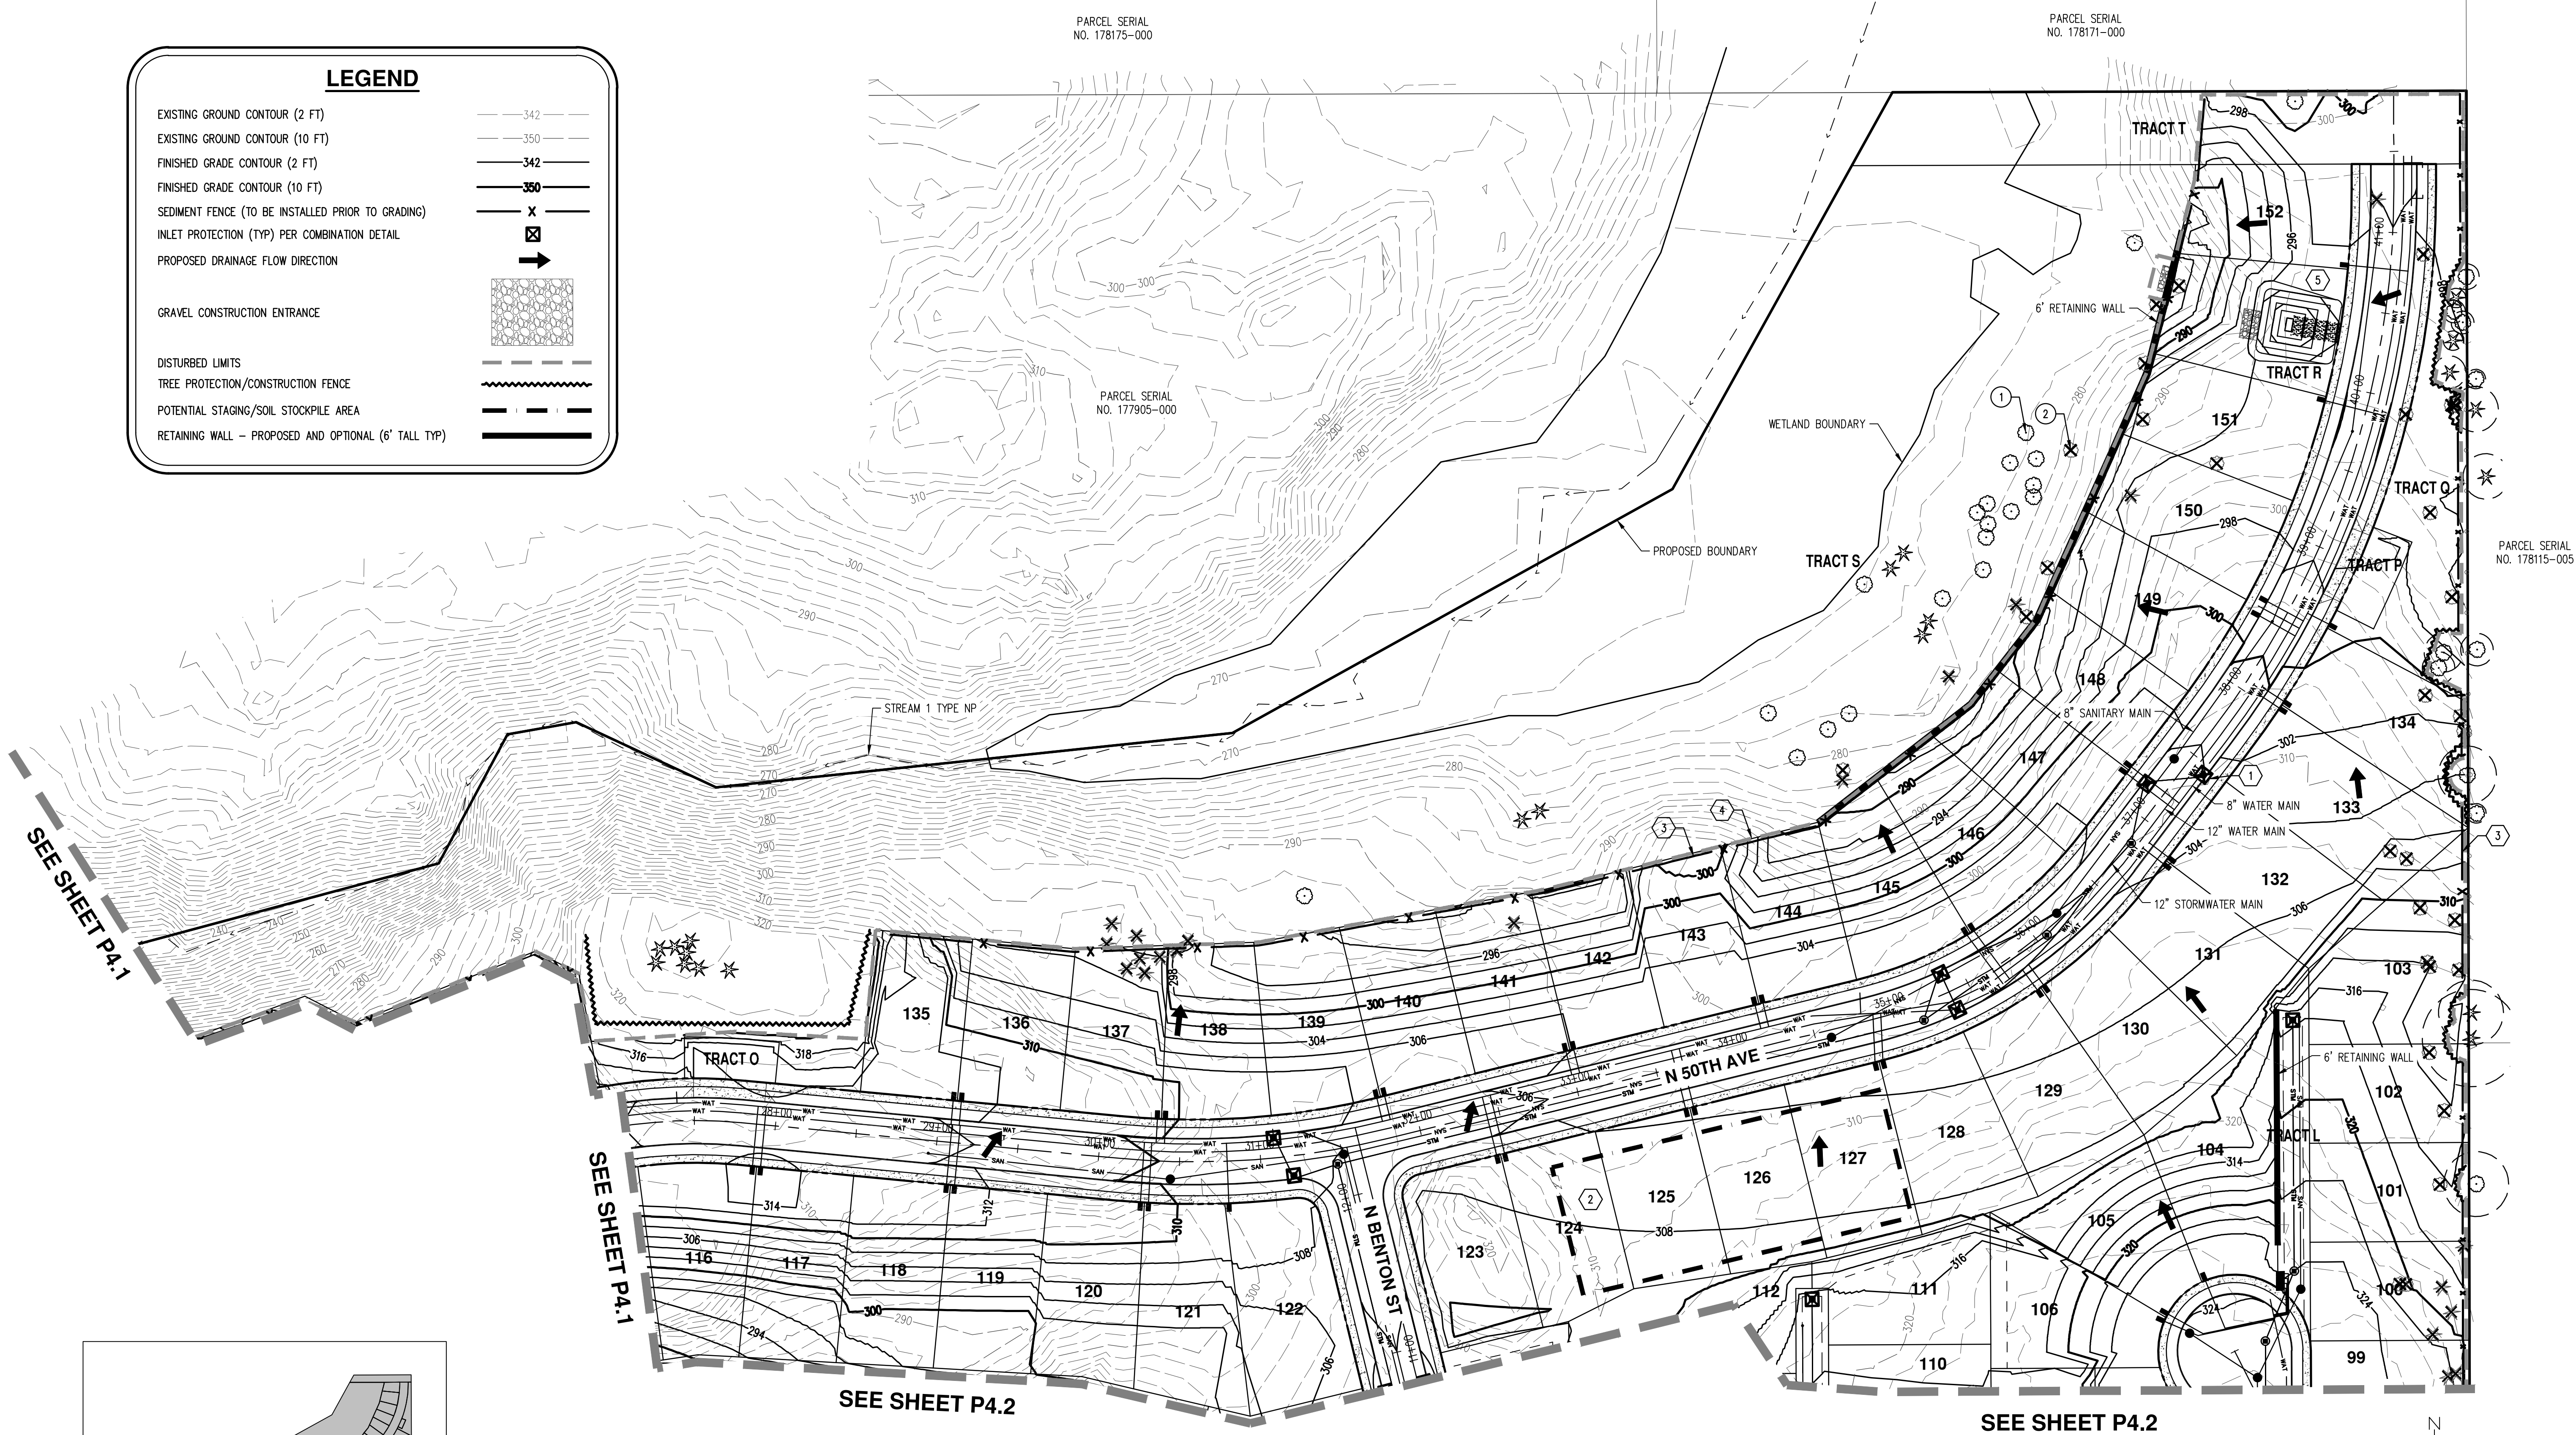
1. SEE PRELIMINARY TREE PRESERVATION AND REMOVAL PLAN P5.0 FOR TREE PROTECTION AND CONSTRUCTION FENCE LOCATIONS AND TREE ROOT PROTECTION ZONE RADIUS ZONES.
2. ADDITIONAL EROSION CONTROL MEASURES WILL BE INCLUDED DURING FINAL ENGINEERING TO ACCOUNT FOR GRADING ON STEEP SLOPES AND CONSTRUCTION PHASING.
3. N ADAMS STREET NOT TO BE USED AS CONSTRUCTION ENTRANCE.

1. INSTALL INLET PROTECTION (TYP)
2. POTENTIAL STOCKPILE AND ROCK CRUSHER AREA
3. INSTALL SEDIMENT FENCE (TYP)
4. DISTURBED LIMITS (TYP)
5. PERMANENT POND TO BE USED AS TEMPORARY SEDIMENT CONTROL POND DURING CONSTRUCTION.

PRELIMINARY GRADING AND ESC PLAN - PHASE 3  
CJ DENS SUBDIVISION  
CJ DENS LACAMAS II LLC  
CAMAS, WASHINGTON

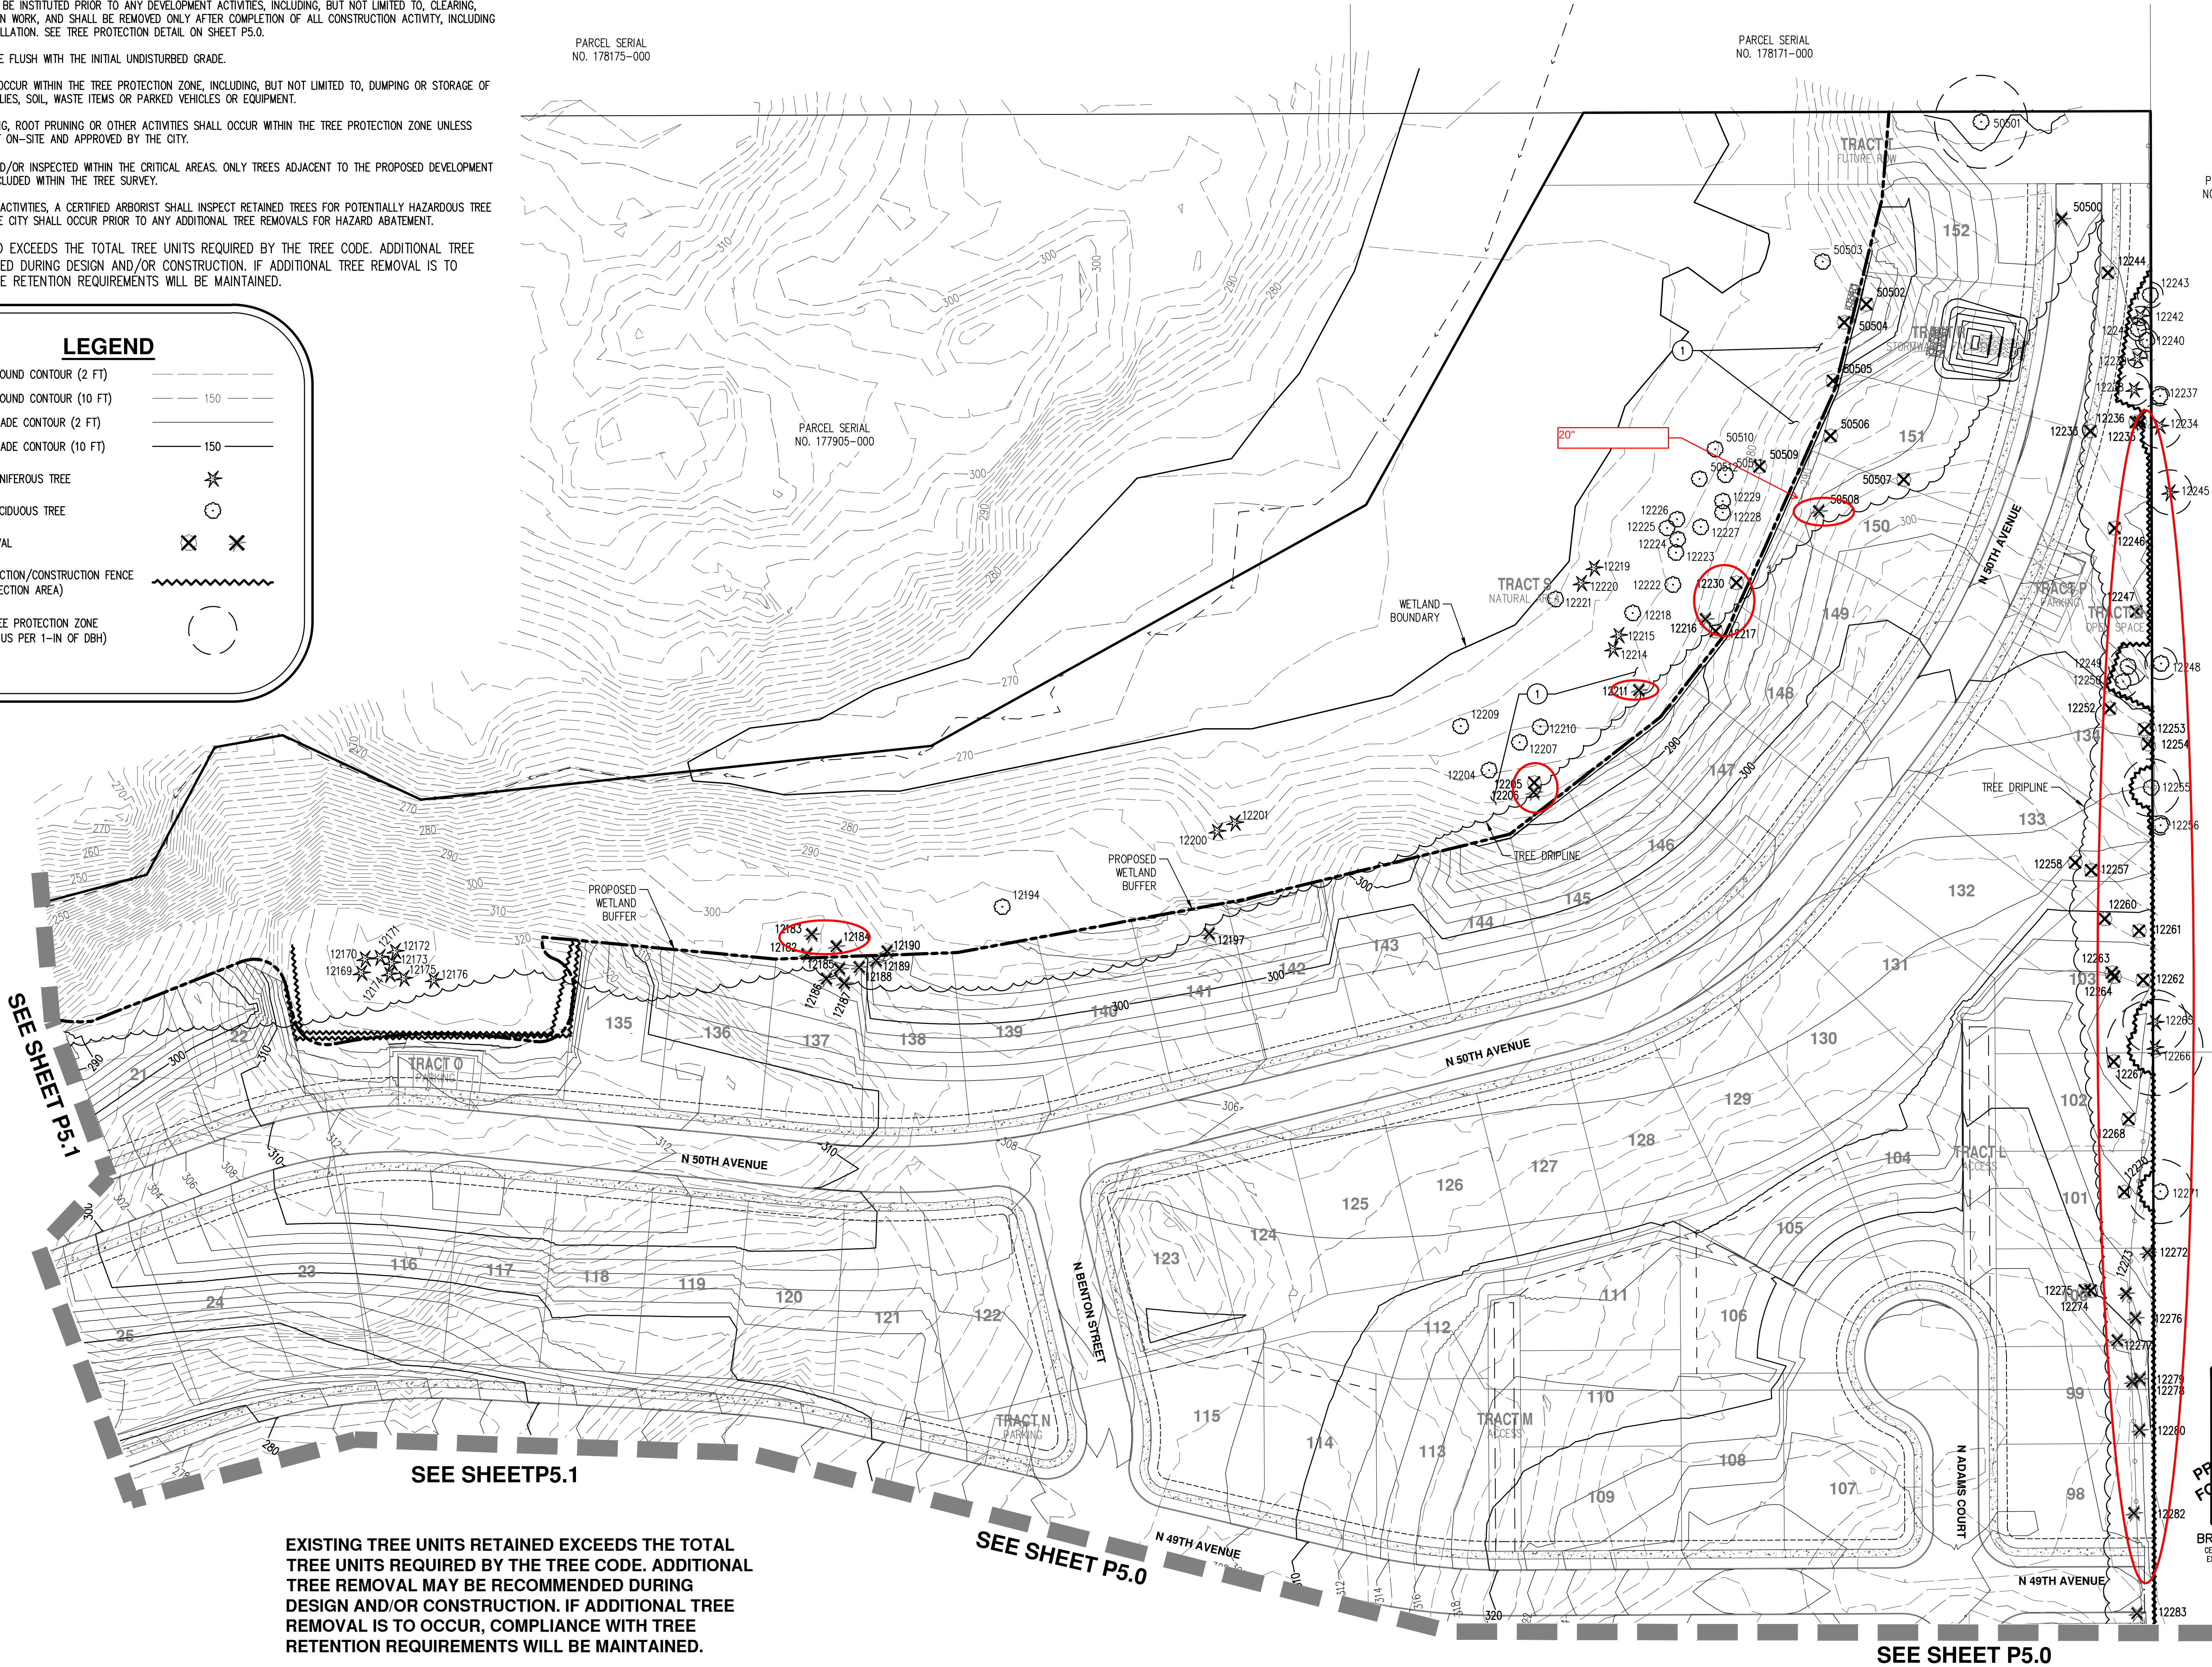
P5.2

TREE PROTECTION/CONSTRUCTION FENCE  
(TREE PROTECTION AREA)

OPTIMAL TREE PROTECTION ZONE  
(1-FT RADIUS PER 1-IN OF DBH)

EXISTING TREE UNITS RETAINED EXCEEDS THE TOTAL TREE UNITS REQUIRED BY THE TREE CODE. ADDITIONAL TREE REMOVAL MAY BE RECOMMENDED DURING DESIGN AND/OR CONSTRUCTION. IF ADDITIONAL TREE REMOVAL IS TO OCCUR, COMPLIANCE WITH TREE RETENTION REQUIREMENTS WILL BE MAINTAINED.

PRELIMINARY TREE PRESERVATION AND REMOVAL PLAN (NORTH)

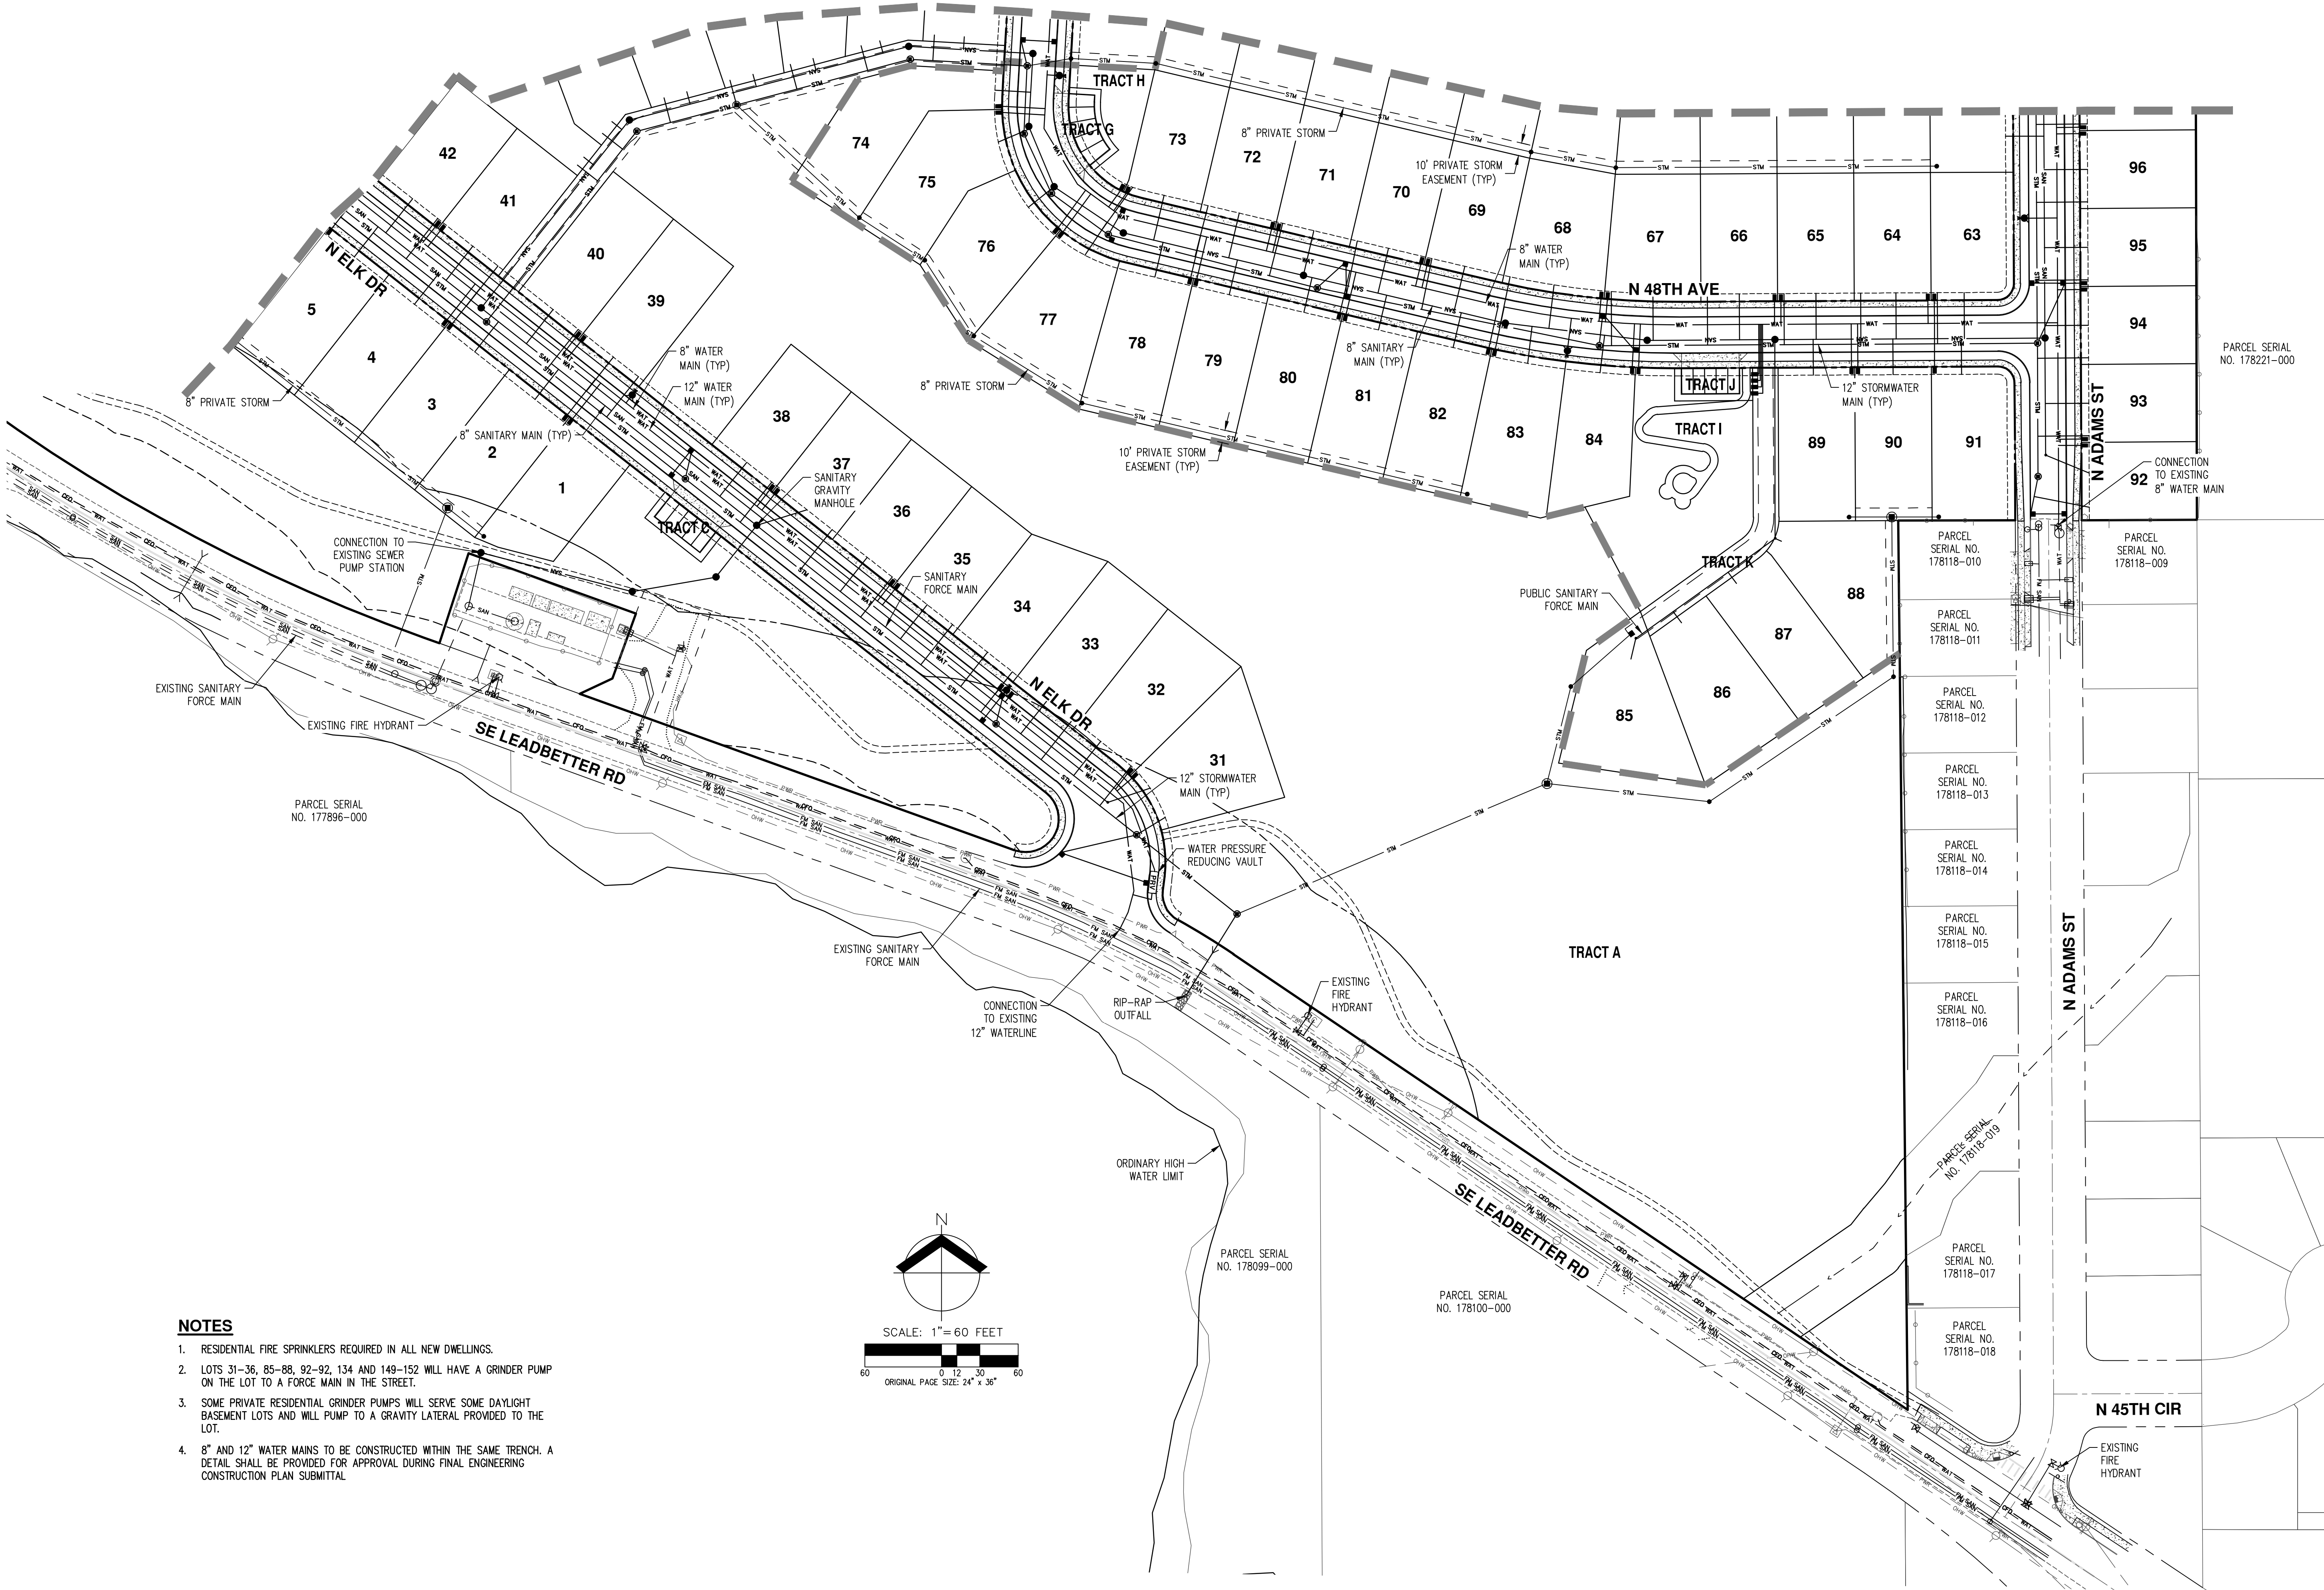
P6.0

1. RESIDENTIAL FIRE SPRINKLERS REQUIRED IN ALL NEW DWELLINGS.
2. LOTS 31-36, 85-88, 92-92, 134 AND 149-152 WILL HAVE A GRINDER PUMP ON THE LOT TO A FORCE MAIN IN THE STREET.
3. SOME PRIVATE RESIDENTIAL GRINDER PUMPS WILL SERVE SOME DAYLIGHT BASEMENT LOTS AND WILL PUMP TO A GRAVITY LATERAL PROVIDED TO THE LOT.
4. 8" AND 12" WATER MAINS TO BE CONSTRUCTED WITHIN THE SAME TRENCH. A DETAIL SHALL BE PROVIDED FOR APPROVAL DURING FINAL ENGINEERING CONSTRUCTION PLAN SUBMITTAL.

PRELIMINARY COMPOSITE UTILITY PLAN (SOUTH)  
CJ DENS SUBDIVISION  
CJ DENS LACAMAS II LLC  
CAMAS, WASHINGTON

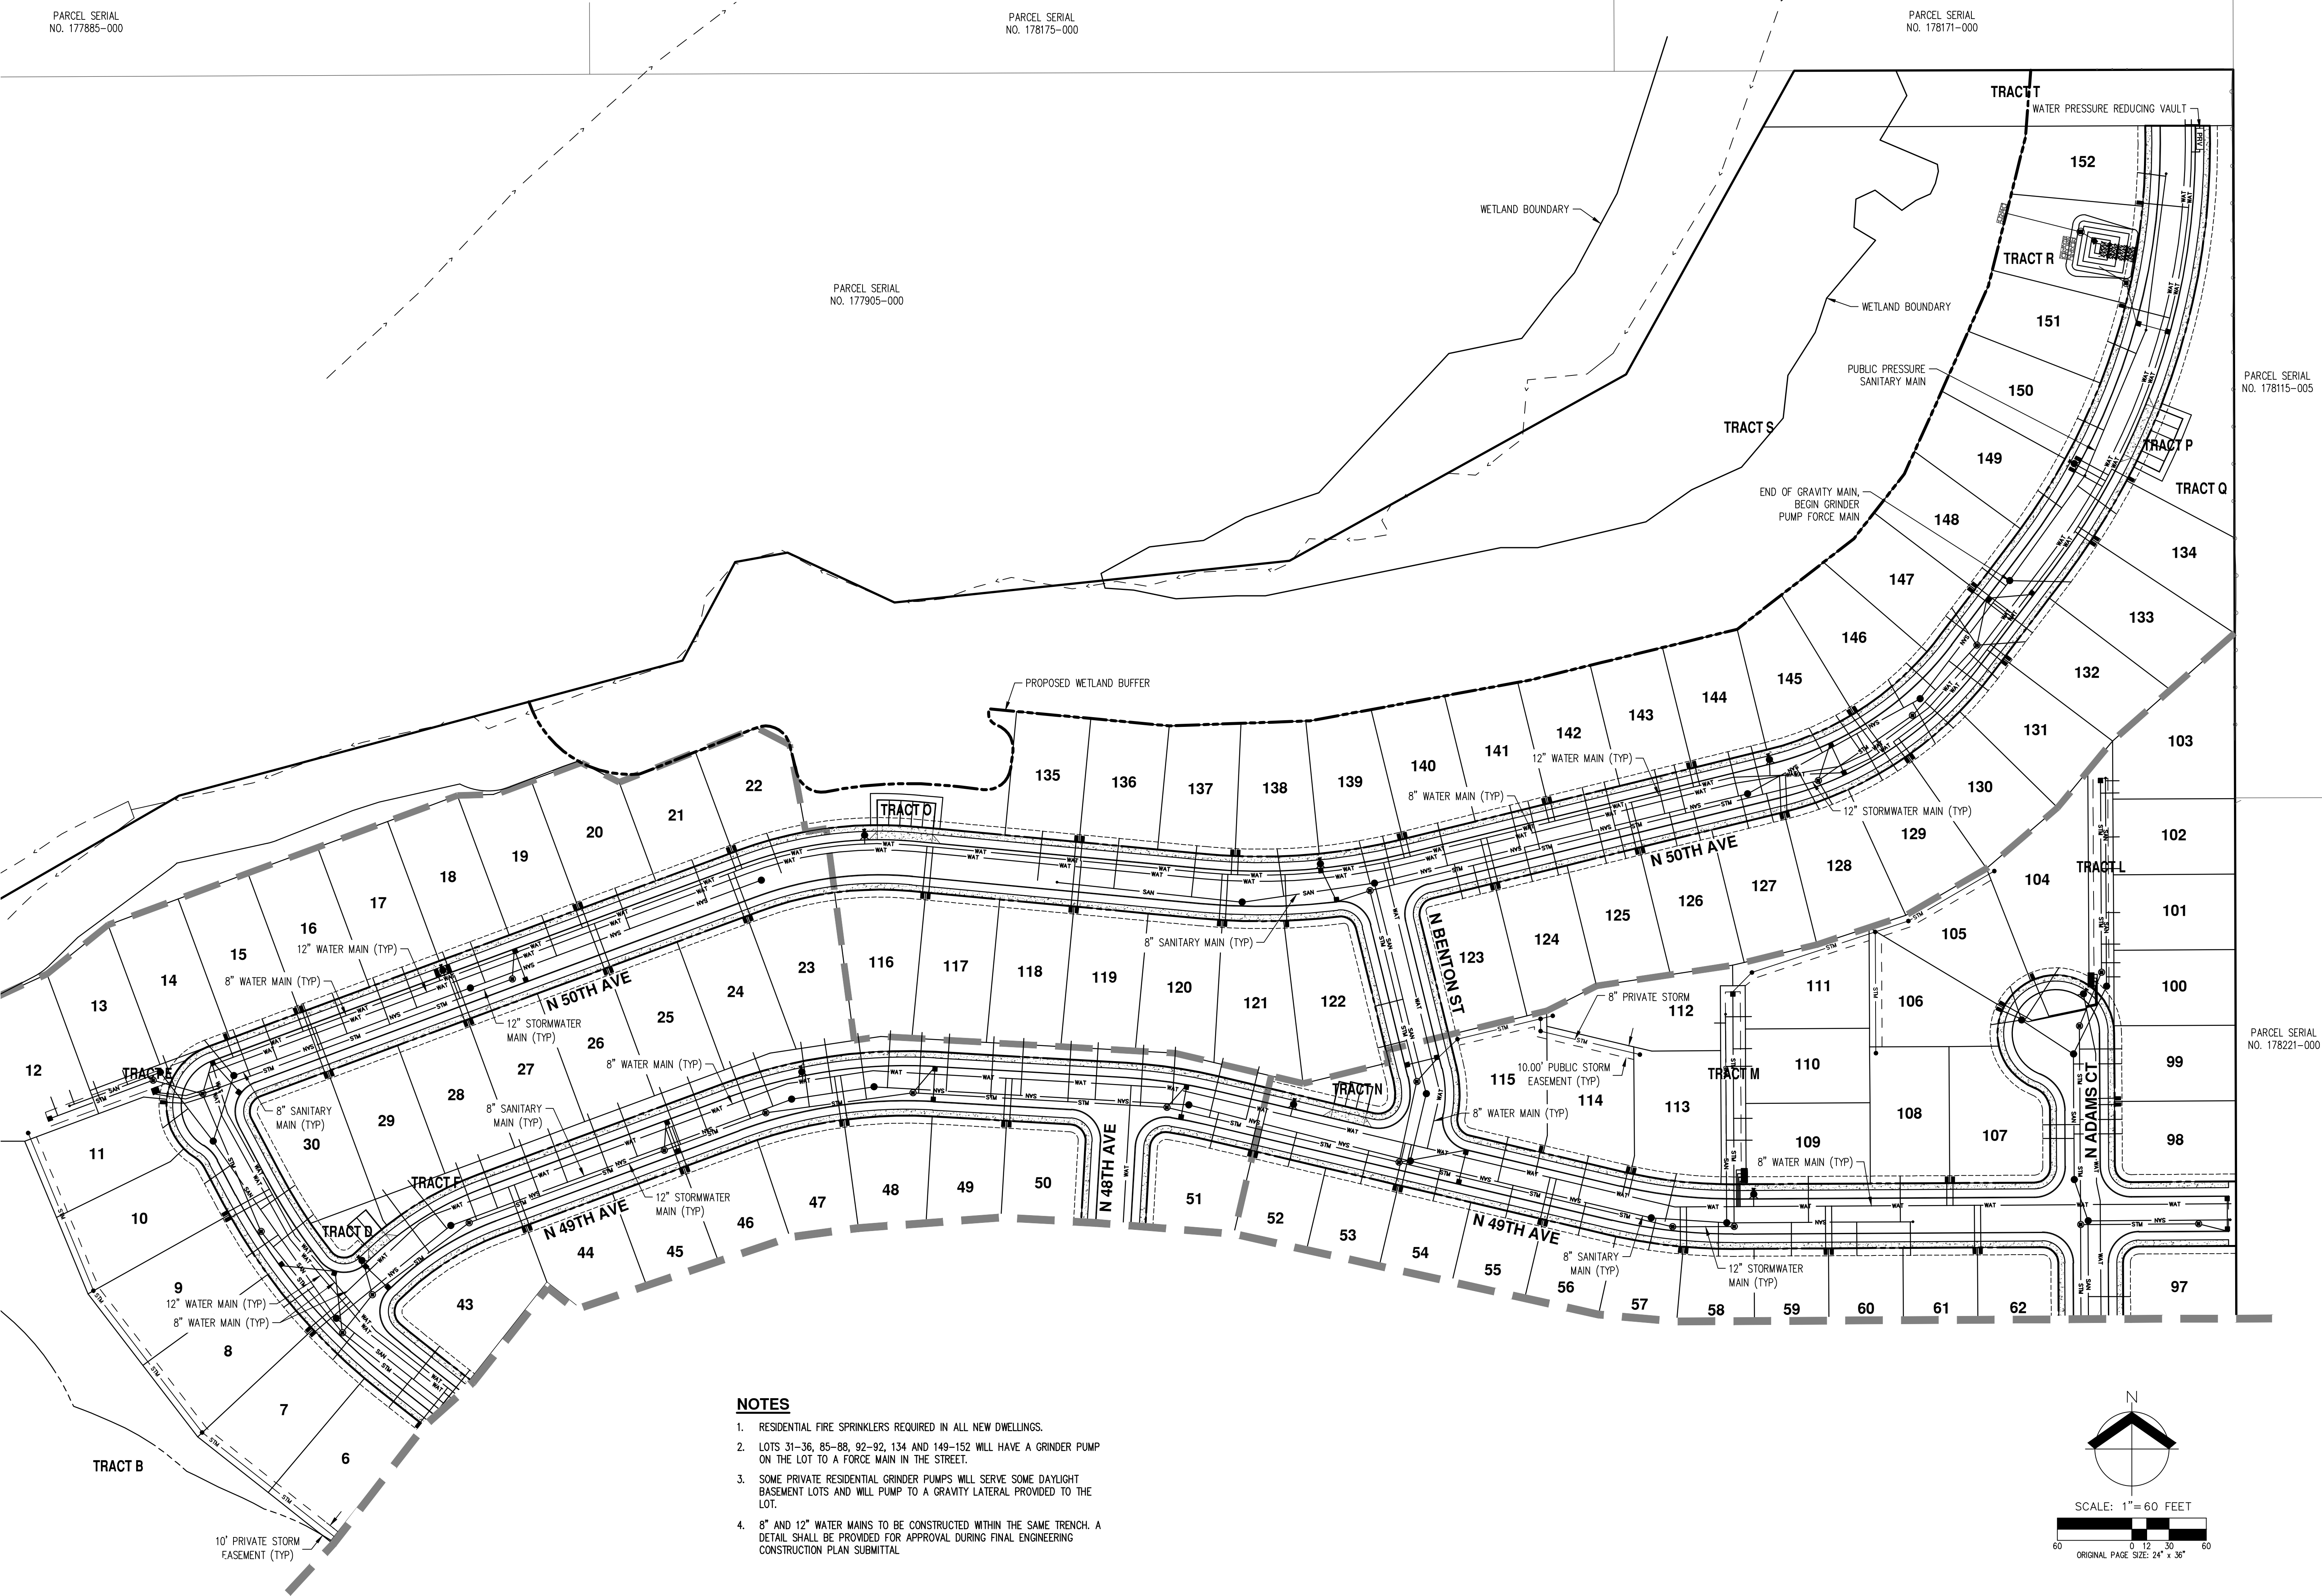
1. RESIDENTIAL FIRE SPRINKLERS REQUIRED IN ALL NEW DWELLINGS.
2. LOTS 31–36, 85–88, 92–92, 134 AND 149–152 WILL HAVE A GRINDER PUMP ON THE LOT TO A FORCE MAIN IN THE STREET.
3. SOME PRIVATE RESIDENTIAL GRINDER PUMPS WILL SERVE SOME DAYLIGHT BASEMENT LOTS AND WILL PUMP TO A GRAVITY LATERAL PROVIDED TO THE LOT.
4. 8" AND 12" WATER MAINS TO BE CONSTRUCTED WITHIN THE SAME TRENCH. A DETAIL SHALL BE PROVIDED FOR APPROVAL DURING FINAL ENGINEERING CONSTRUCTION PLAN SUBMITTAL.

PRELIMINARY COMPOSITE UTILITY PLAN (NORTH)  
CJ DENS SUBDIVISION  
CJ DENS LACAMAS II LLC  
CAMAS, WASHINGTON
