# CJ DENS EAST SUBDIVISION

## PRELIMINARY SUBDIVISION PLANS

CJ DENS SUBDIVISION  
CJ DENS LACAMAS II LLC  
CAMAS, WASHINGTON

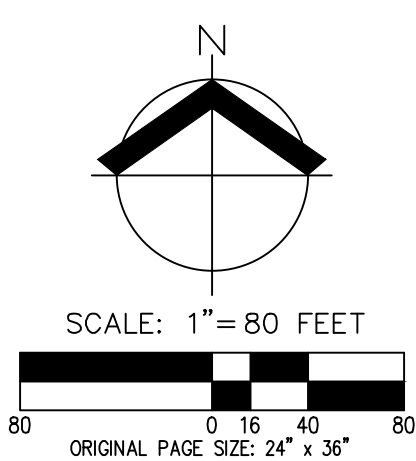
## P7.0

1. CONTOUR INTERVAL IS 2 FOOT.
2. TREES ARE NOT SHOWN.
3. STORMWATER DETENTION POND 1:1 ON TRACT R TO BE OWNED AND MAINTAINED BY THE HOA.
4. ACCORDING TO CLARK COUNTY GIS, THE SITE IS NOT WITHIN OR ADJACENT TO A 100-YEAR FLOODPLAIN.

5. THERE ARE NO KNOWN EXISTING ON-SITE STORMWATER FACILITIES.
6. NATIVE VEGETATION WITHIN TRACT A, TRACT B, TRACT S, AND THE CRITICAL AREAS WILL BE RETAINED AS MUCH AS POSSIBLE AND ENHANCED, AS NEEDED, PER THE WETLAND MITIGATION PLAN.

9. REAR YARD RUNOFF FOR LOTS 92-103 WILL BE COLLECTED AND DISPERSED INTO THE NEIGHBORING PROPERTY. ROOFS WILL DRAIN TO A STORMWATER LATERAL.

**PRELIMINARY STORMWATER PLAN**  
**CJ DENS SUBDIVISION**  
**CJ DENS LACAMAS II LLC**  
**CAMAS, WASHINGTON**

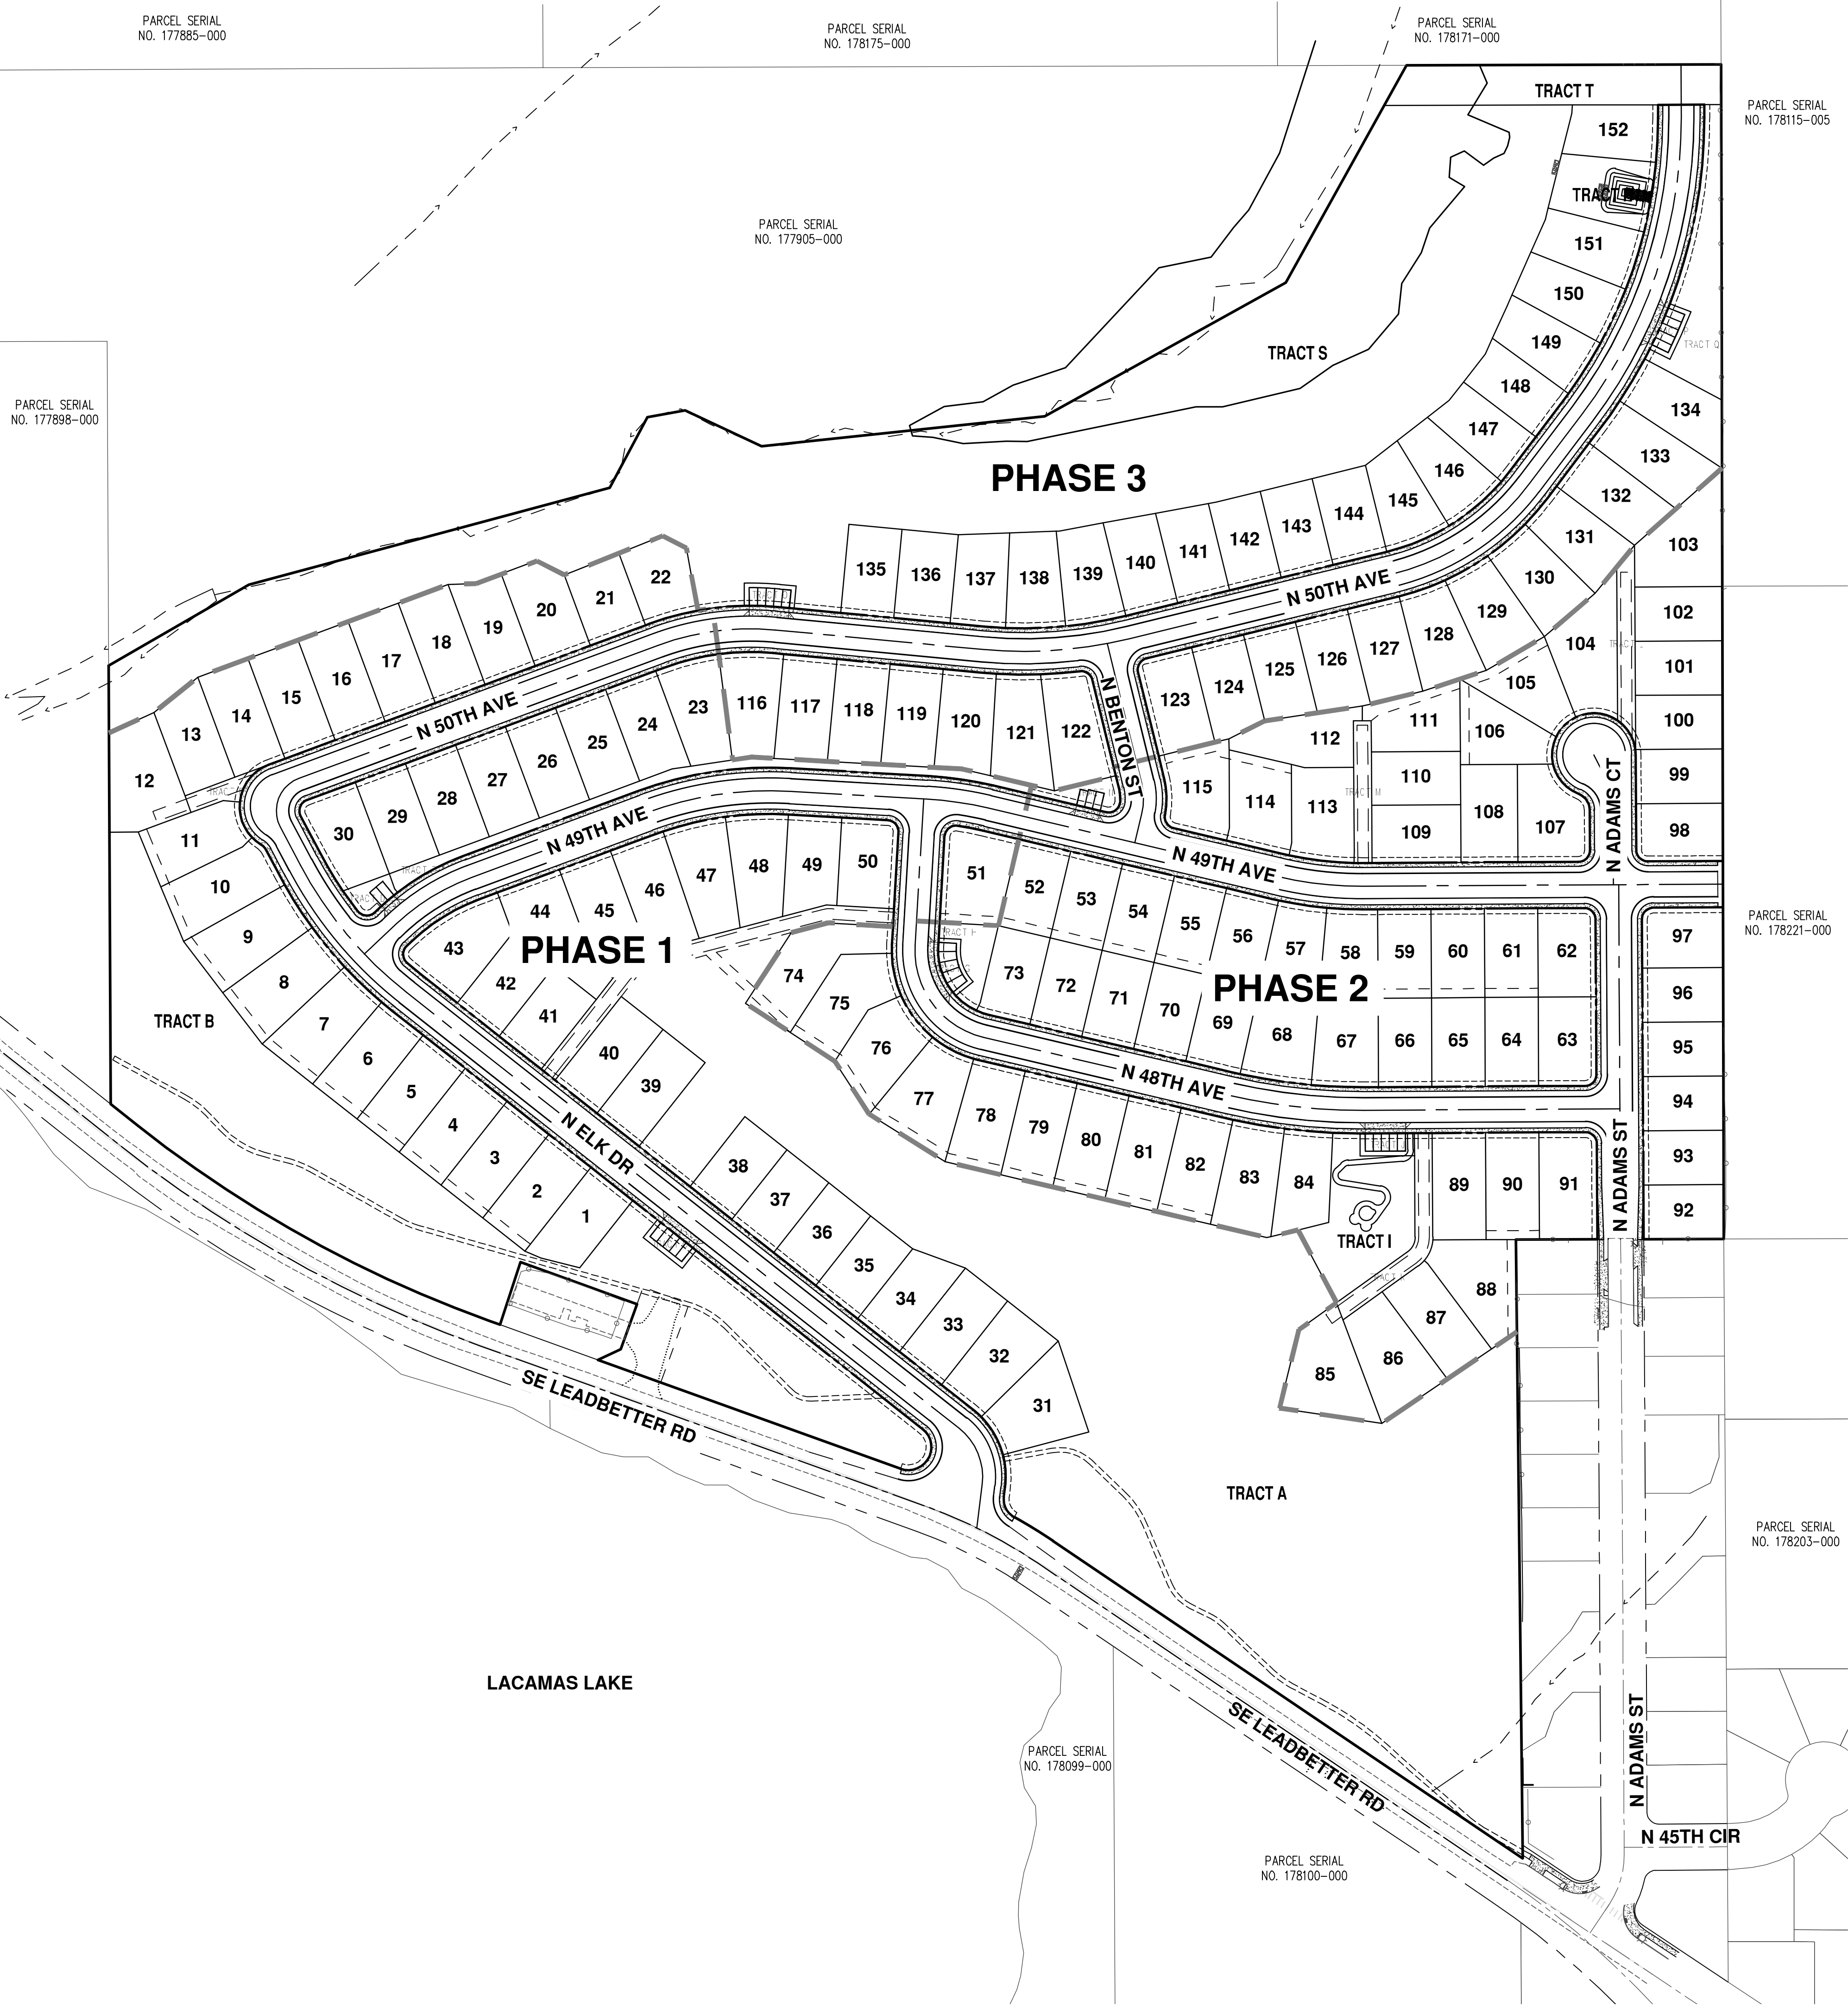
P8.0

PRELIMINARY STREET PLAN  
CJ DENS SUBDIVISION  
CJ DENS LACAMAS II LLC  
CAMAS, WASHINGTON

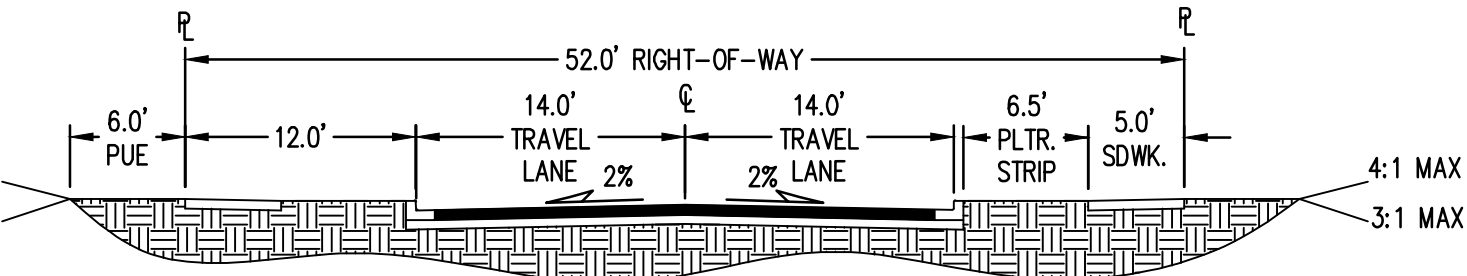
**2 LANE LOCAL ROAD (ST3)**  
N ELK DR, N 48TH AVE, N49TH AVE,  
N 50TH AVE, N BENTON ST, N ADAMS ST,  
N ADAMS CT

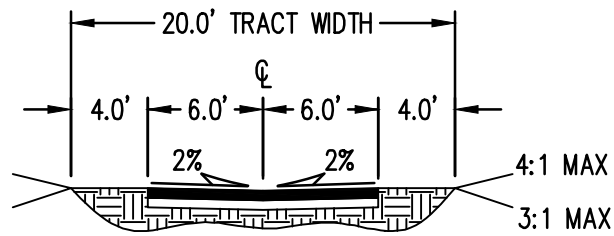
**PRIVATE ACCESS DRIVEWAY**

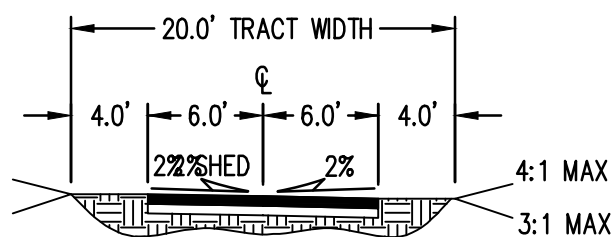
**UTILITY ACCESS ROAD**

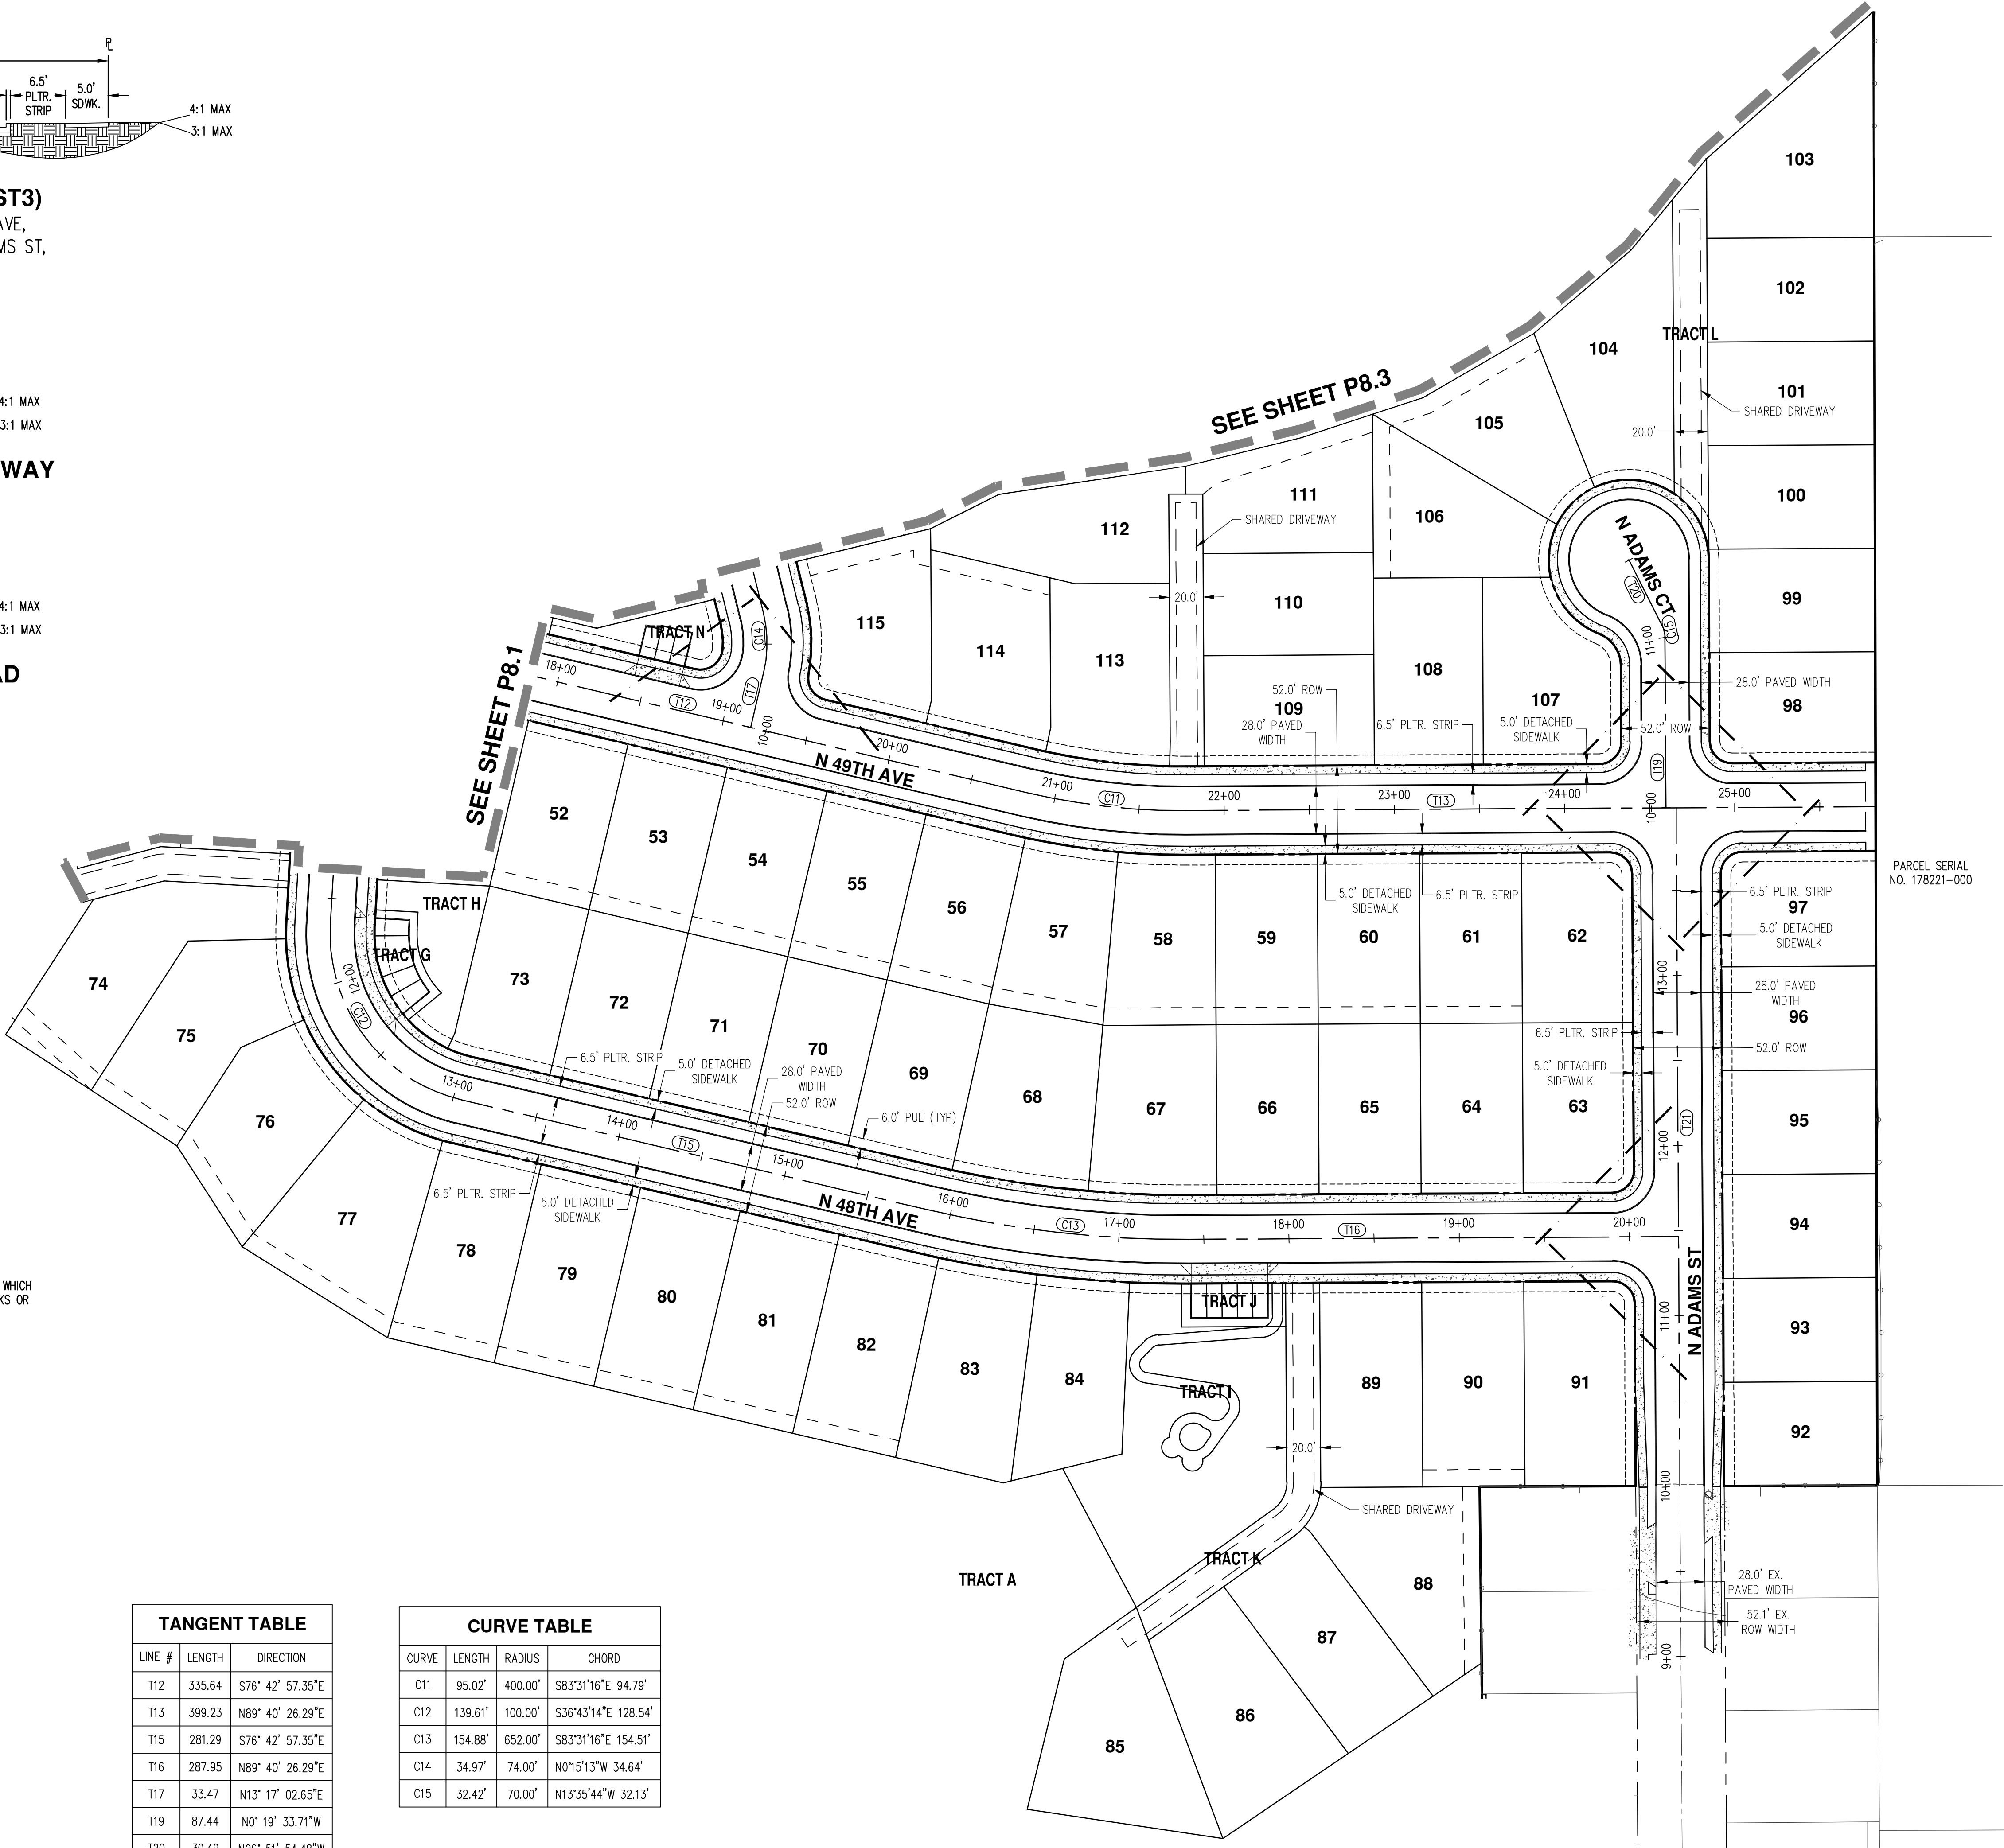
**PRELIMINARY STREET PLAN - PHASE 2**  
**CJ DENS SUBDIVISION**  
**CJ DENS LACAMAS II LLC**  
**CAMAS, WASHINGTON**

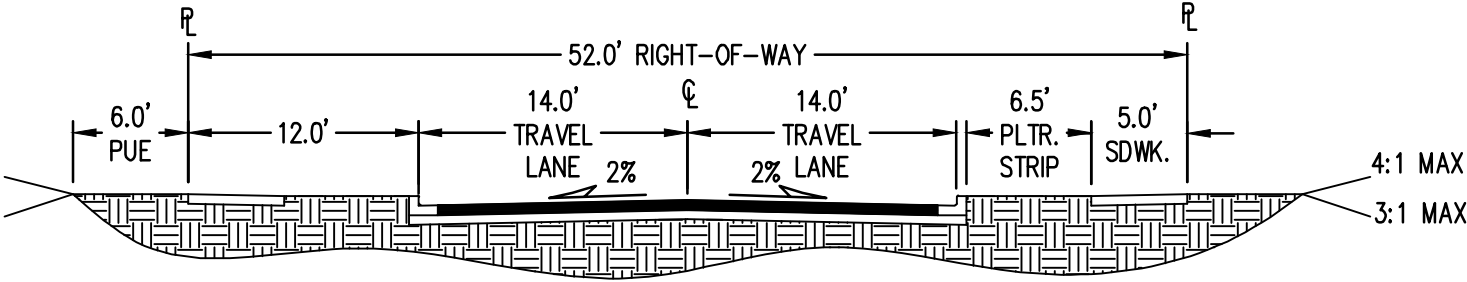
**2 LANE LOCAL ROAD (ST3)**  
N ELK DR, N 48TH AVE, N49TH AVE,  
N 50TH AVE, N BENTON ST, N ADAMS ST,  
N ADAMS CT

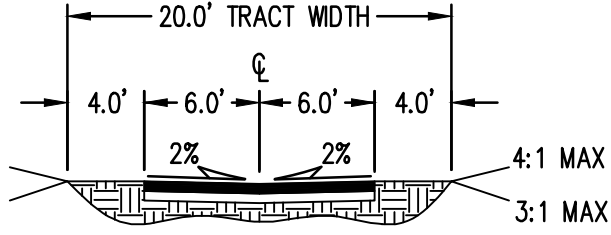
**PRIVATE ACCESS DRIVEWAY**

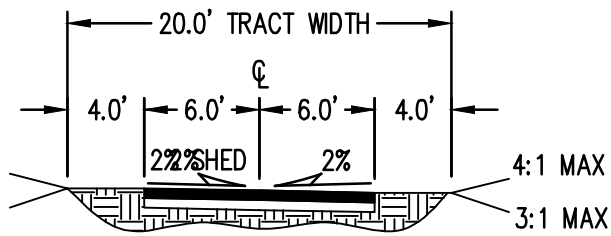
**UTILITY ACCESS ROAD**

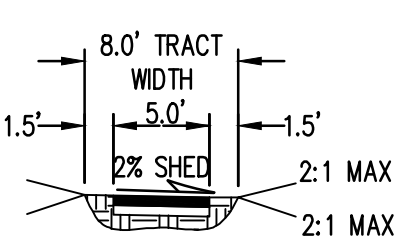
**PUBLIC PATH**

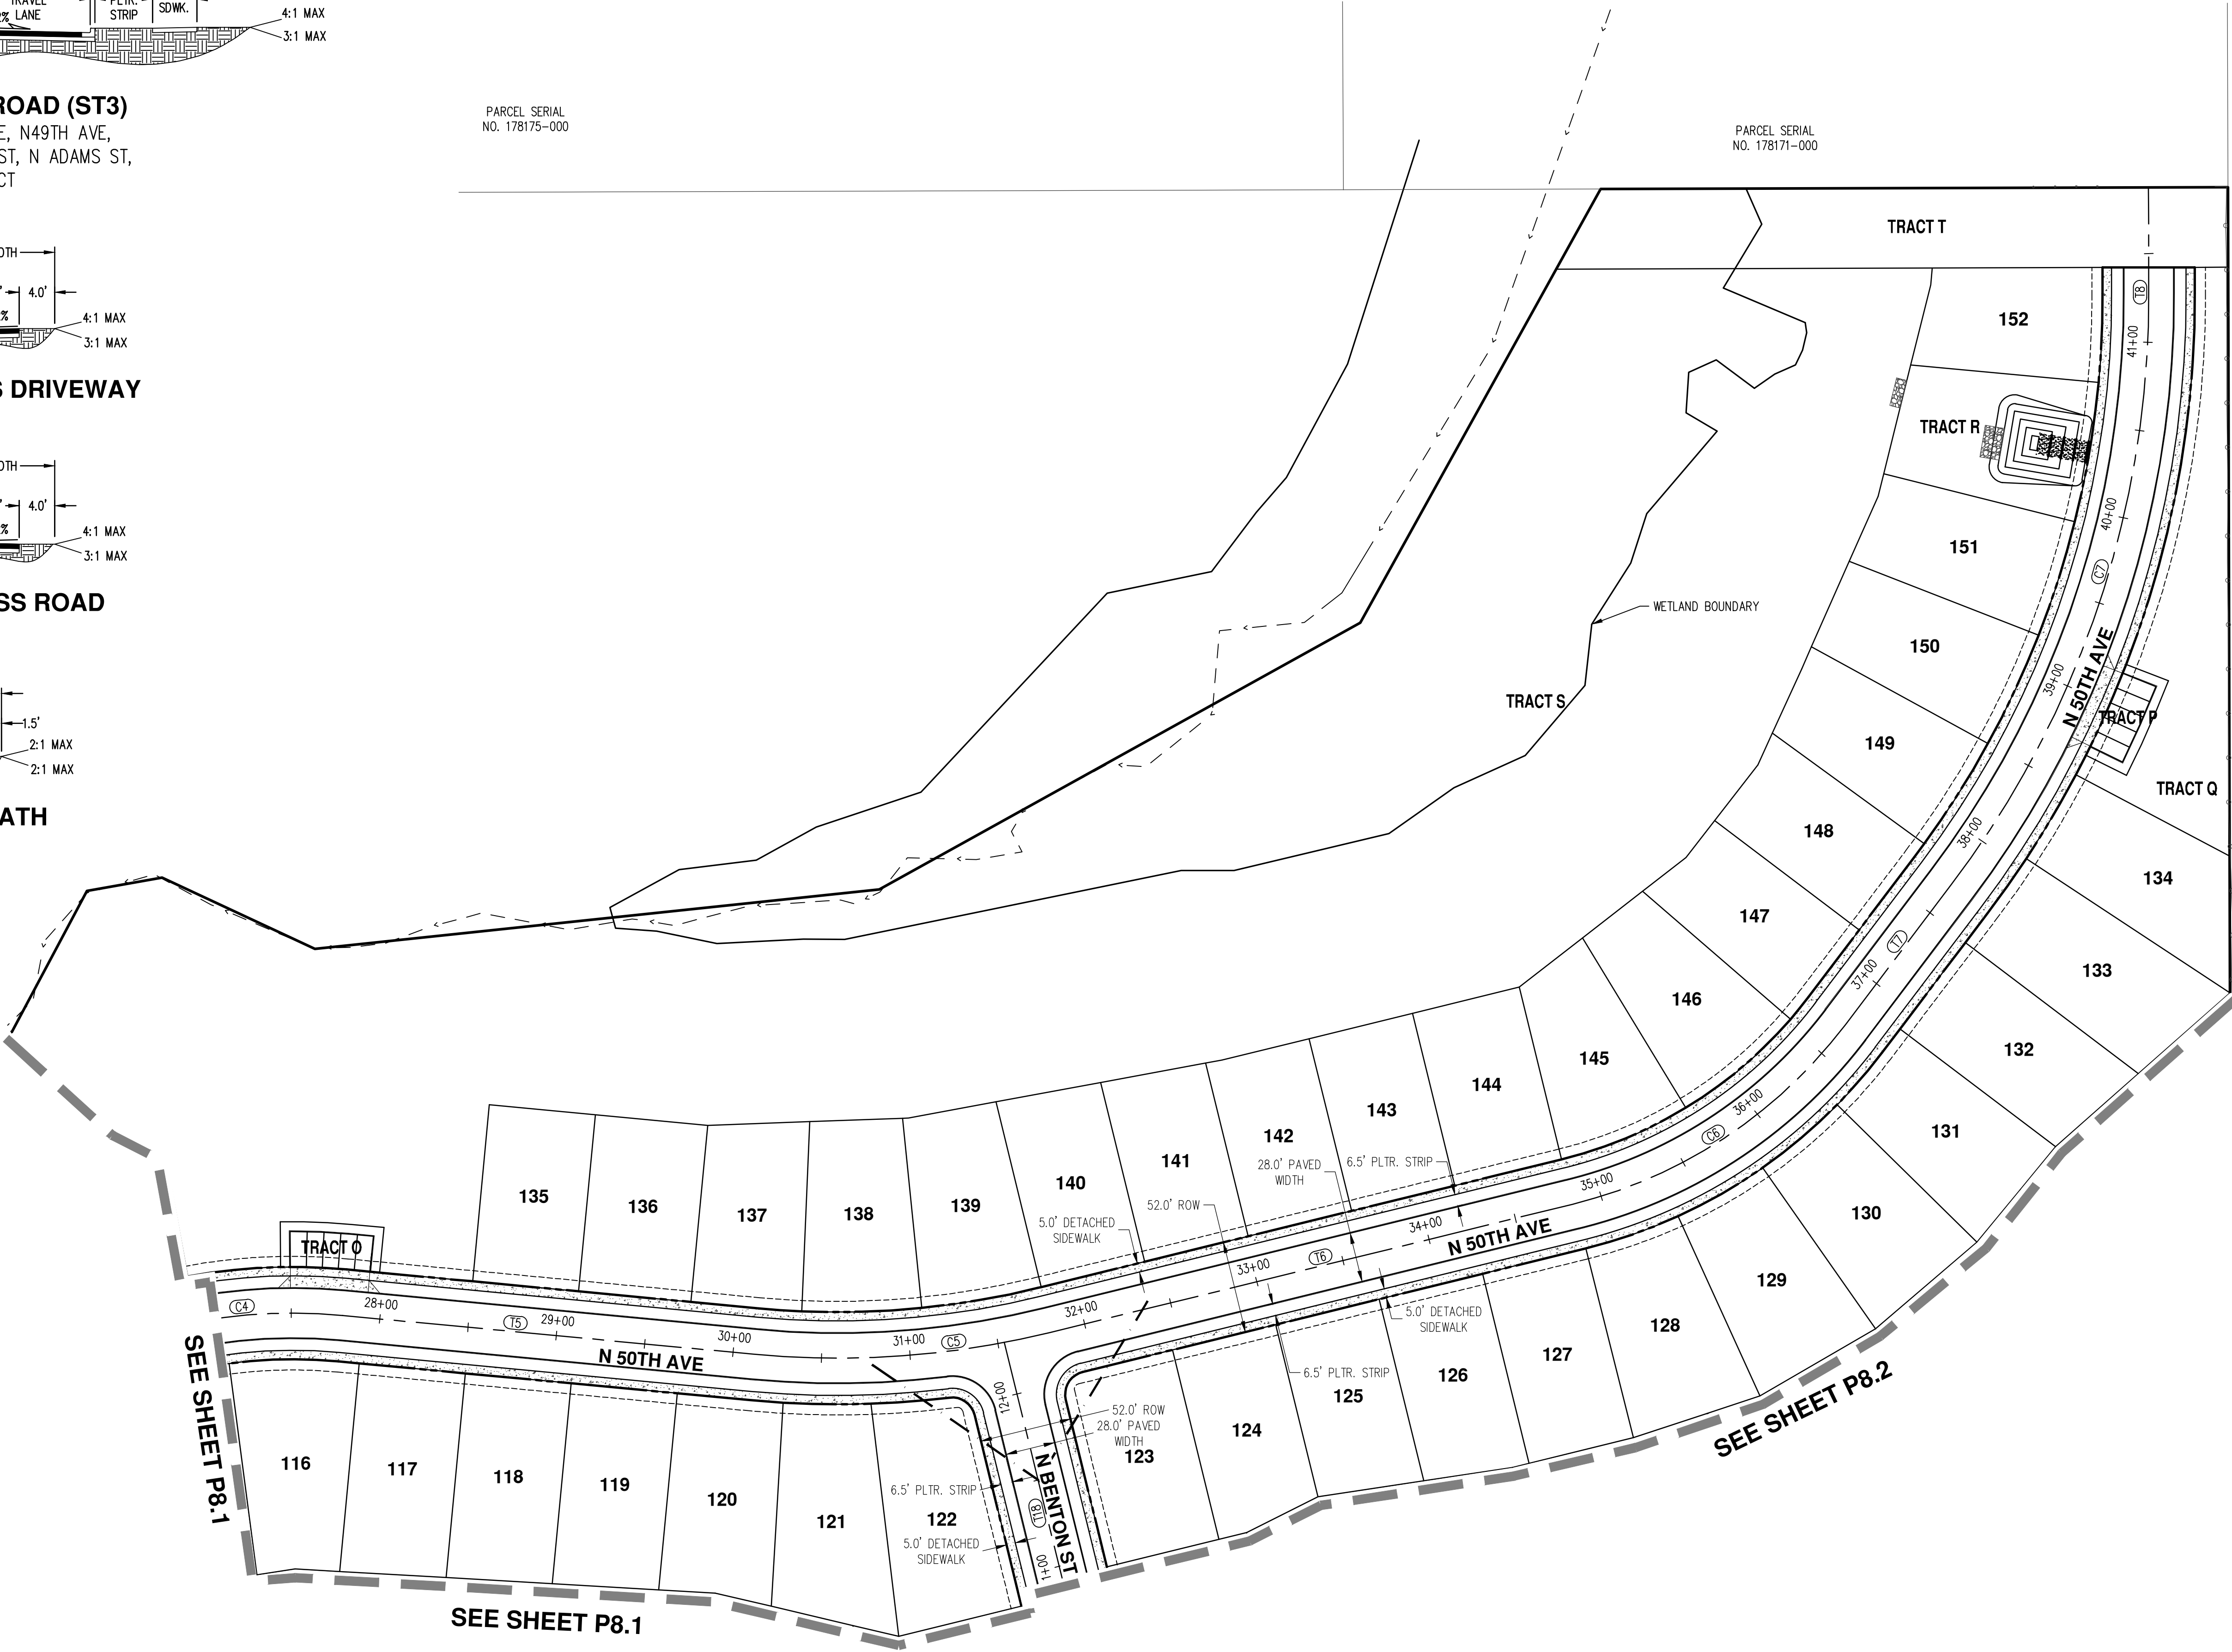
**P8.3**

**PRELIMINARY STREET PLAN - PHASE 3**  
**CJ DENS SUBDIVISION**  
**CJ DENS LACAMAS II LLC**  
**CAMAS, WASHINGTON**

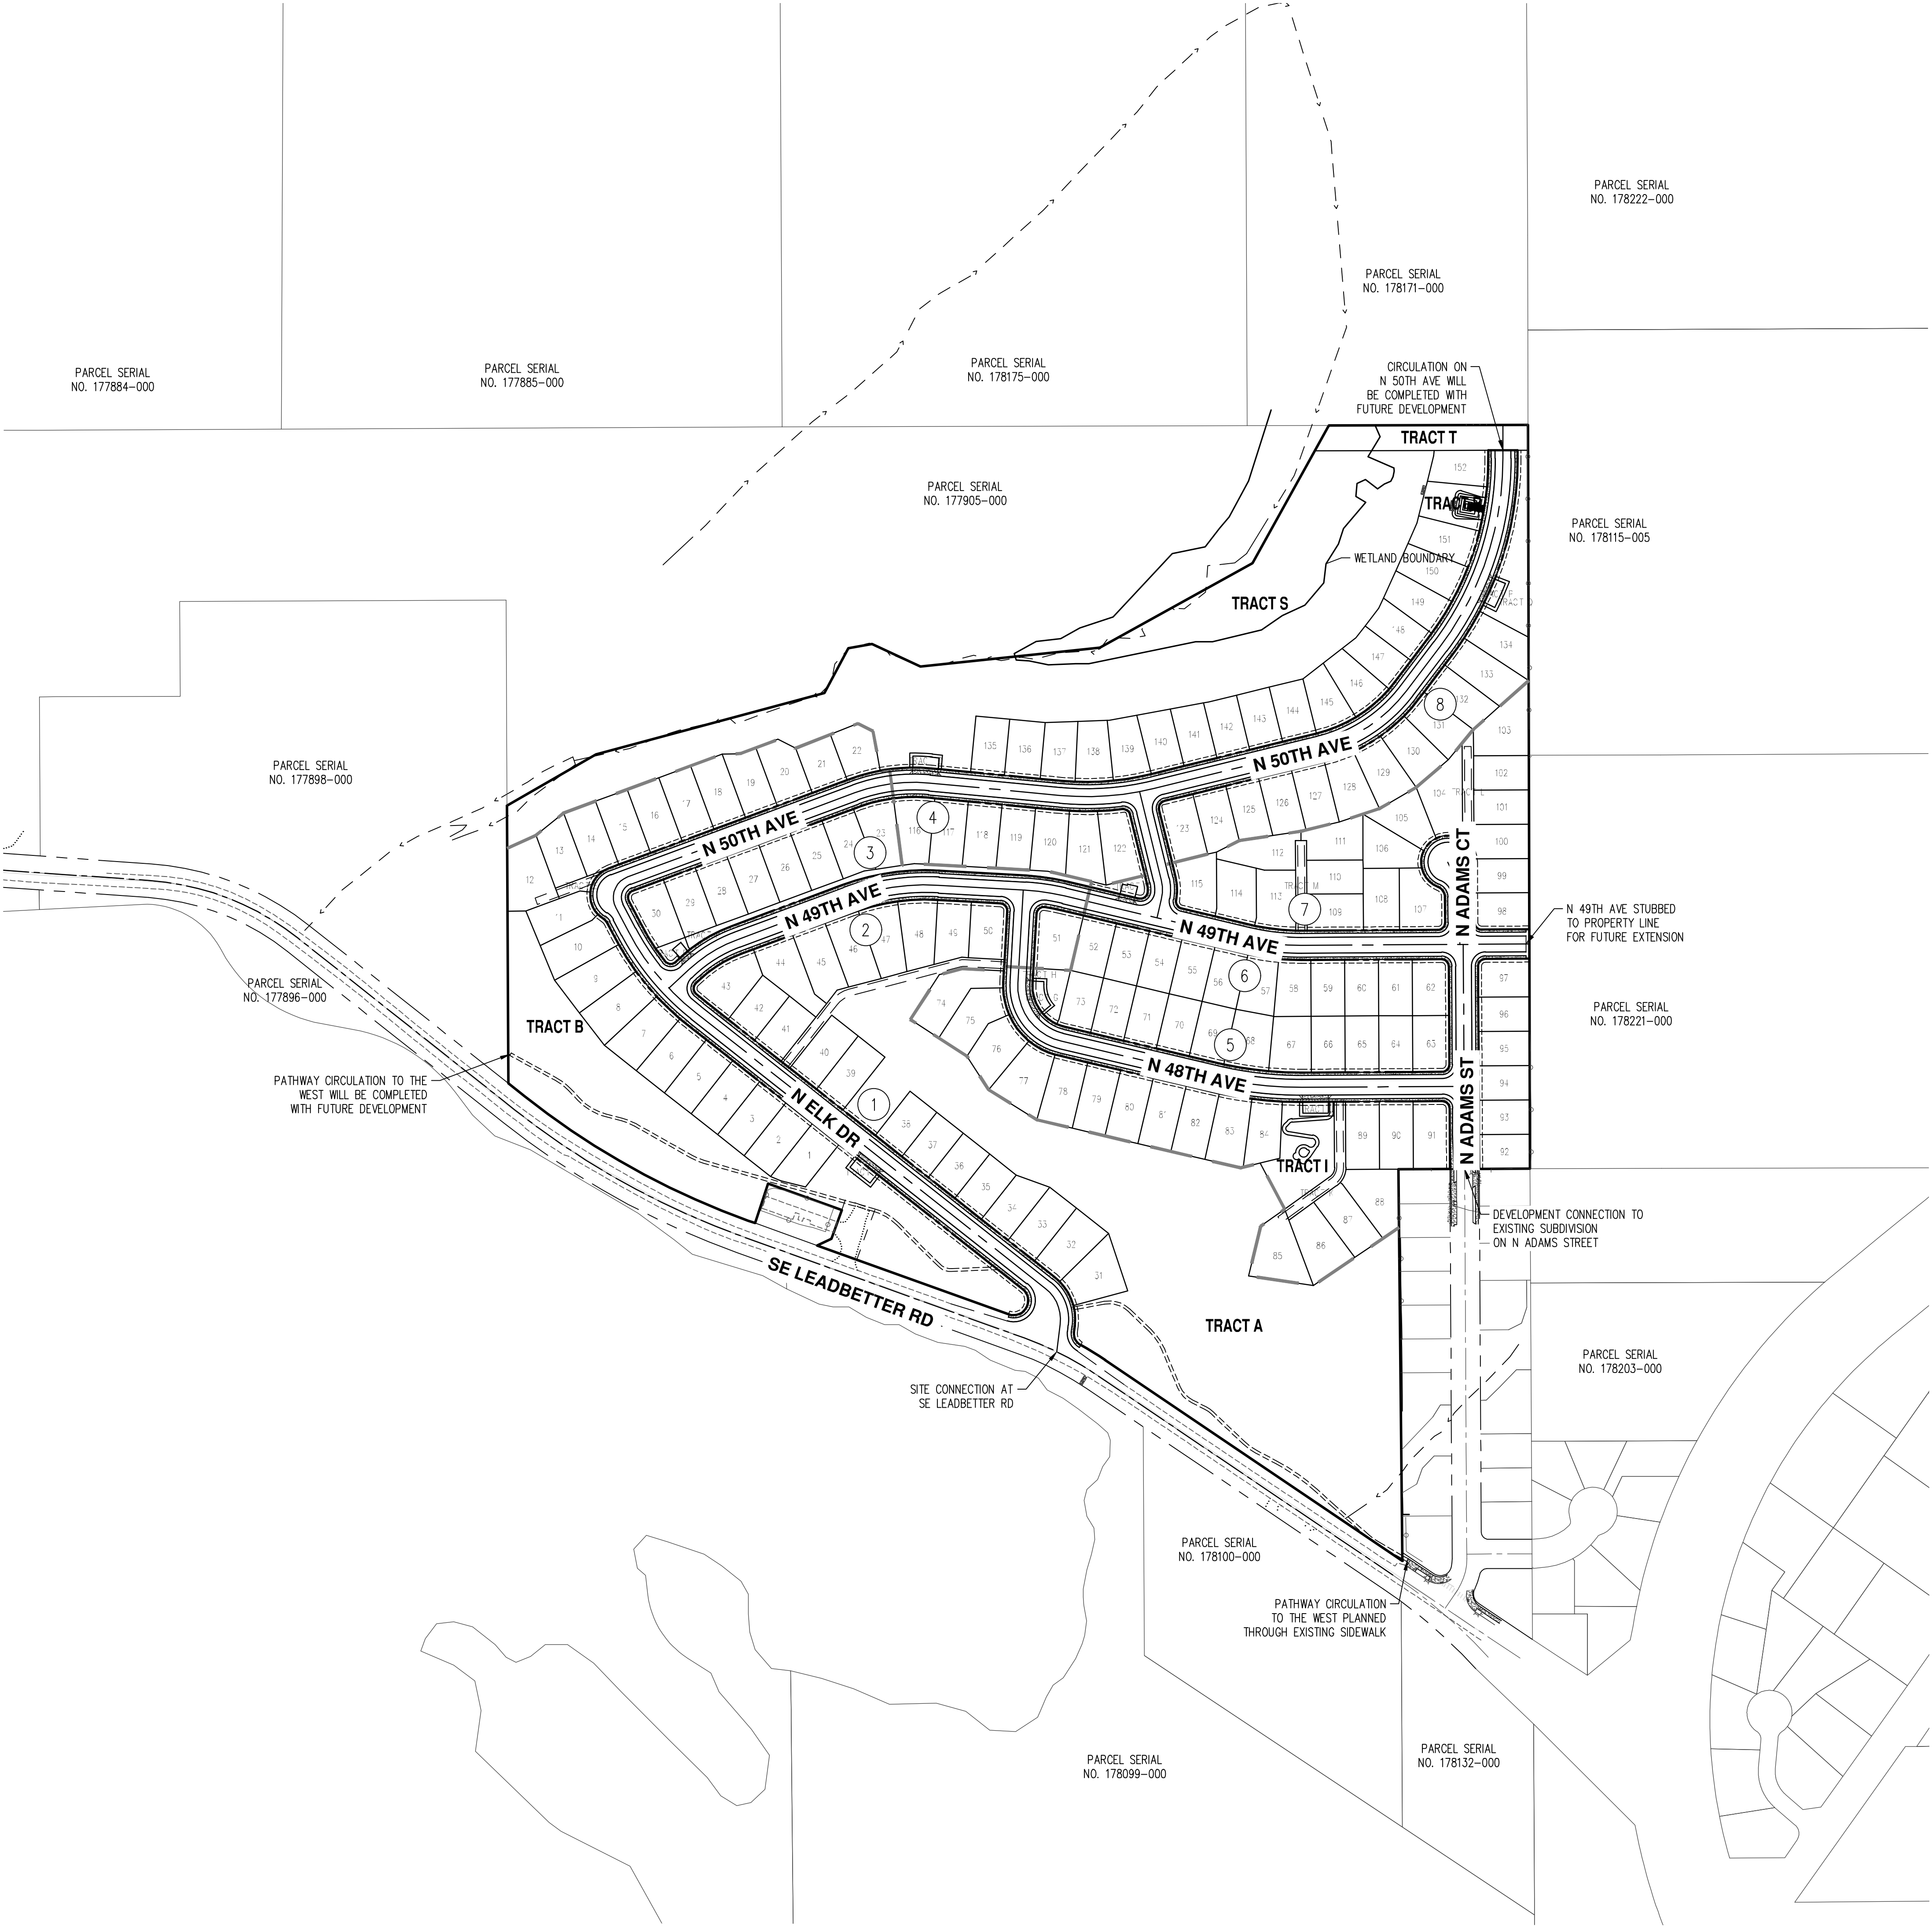
P9.0

- 1. 951.82' MEASURED ROW TO ROW SPACING
- 2. 582.83' MEASURED ROW TO ROW SPACING
- 3. 883.12' MEASURED ROW TO ROW SPACING
- 4. 911.65' MEASURED ROW TO ROW SPACING
- 5. 911.55' MEASURED ROW TO ROW SPACING
- 6. 729.84' MEASURED ROW TO ROW SPACING
- 7. 471.45' MEASURED ROW TO ROW SPACING
- 8. 999.29' MEASURED ROW TO ROW SPACING

PRELIMINARY CIRCULATION PLAN  
CJ DENS SUBDIVISION  
CJ DENS LACAMAS II LLC  
CAMAS, WASHINGTON

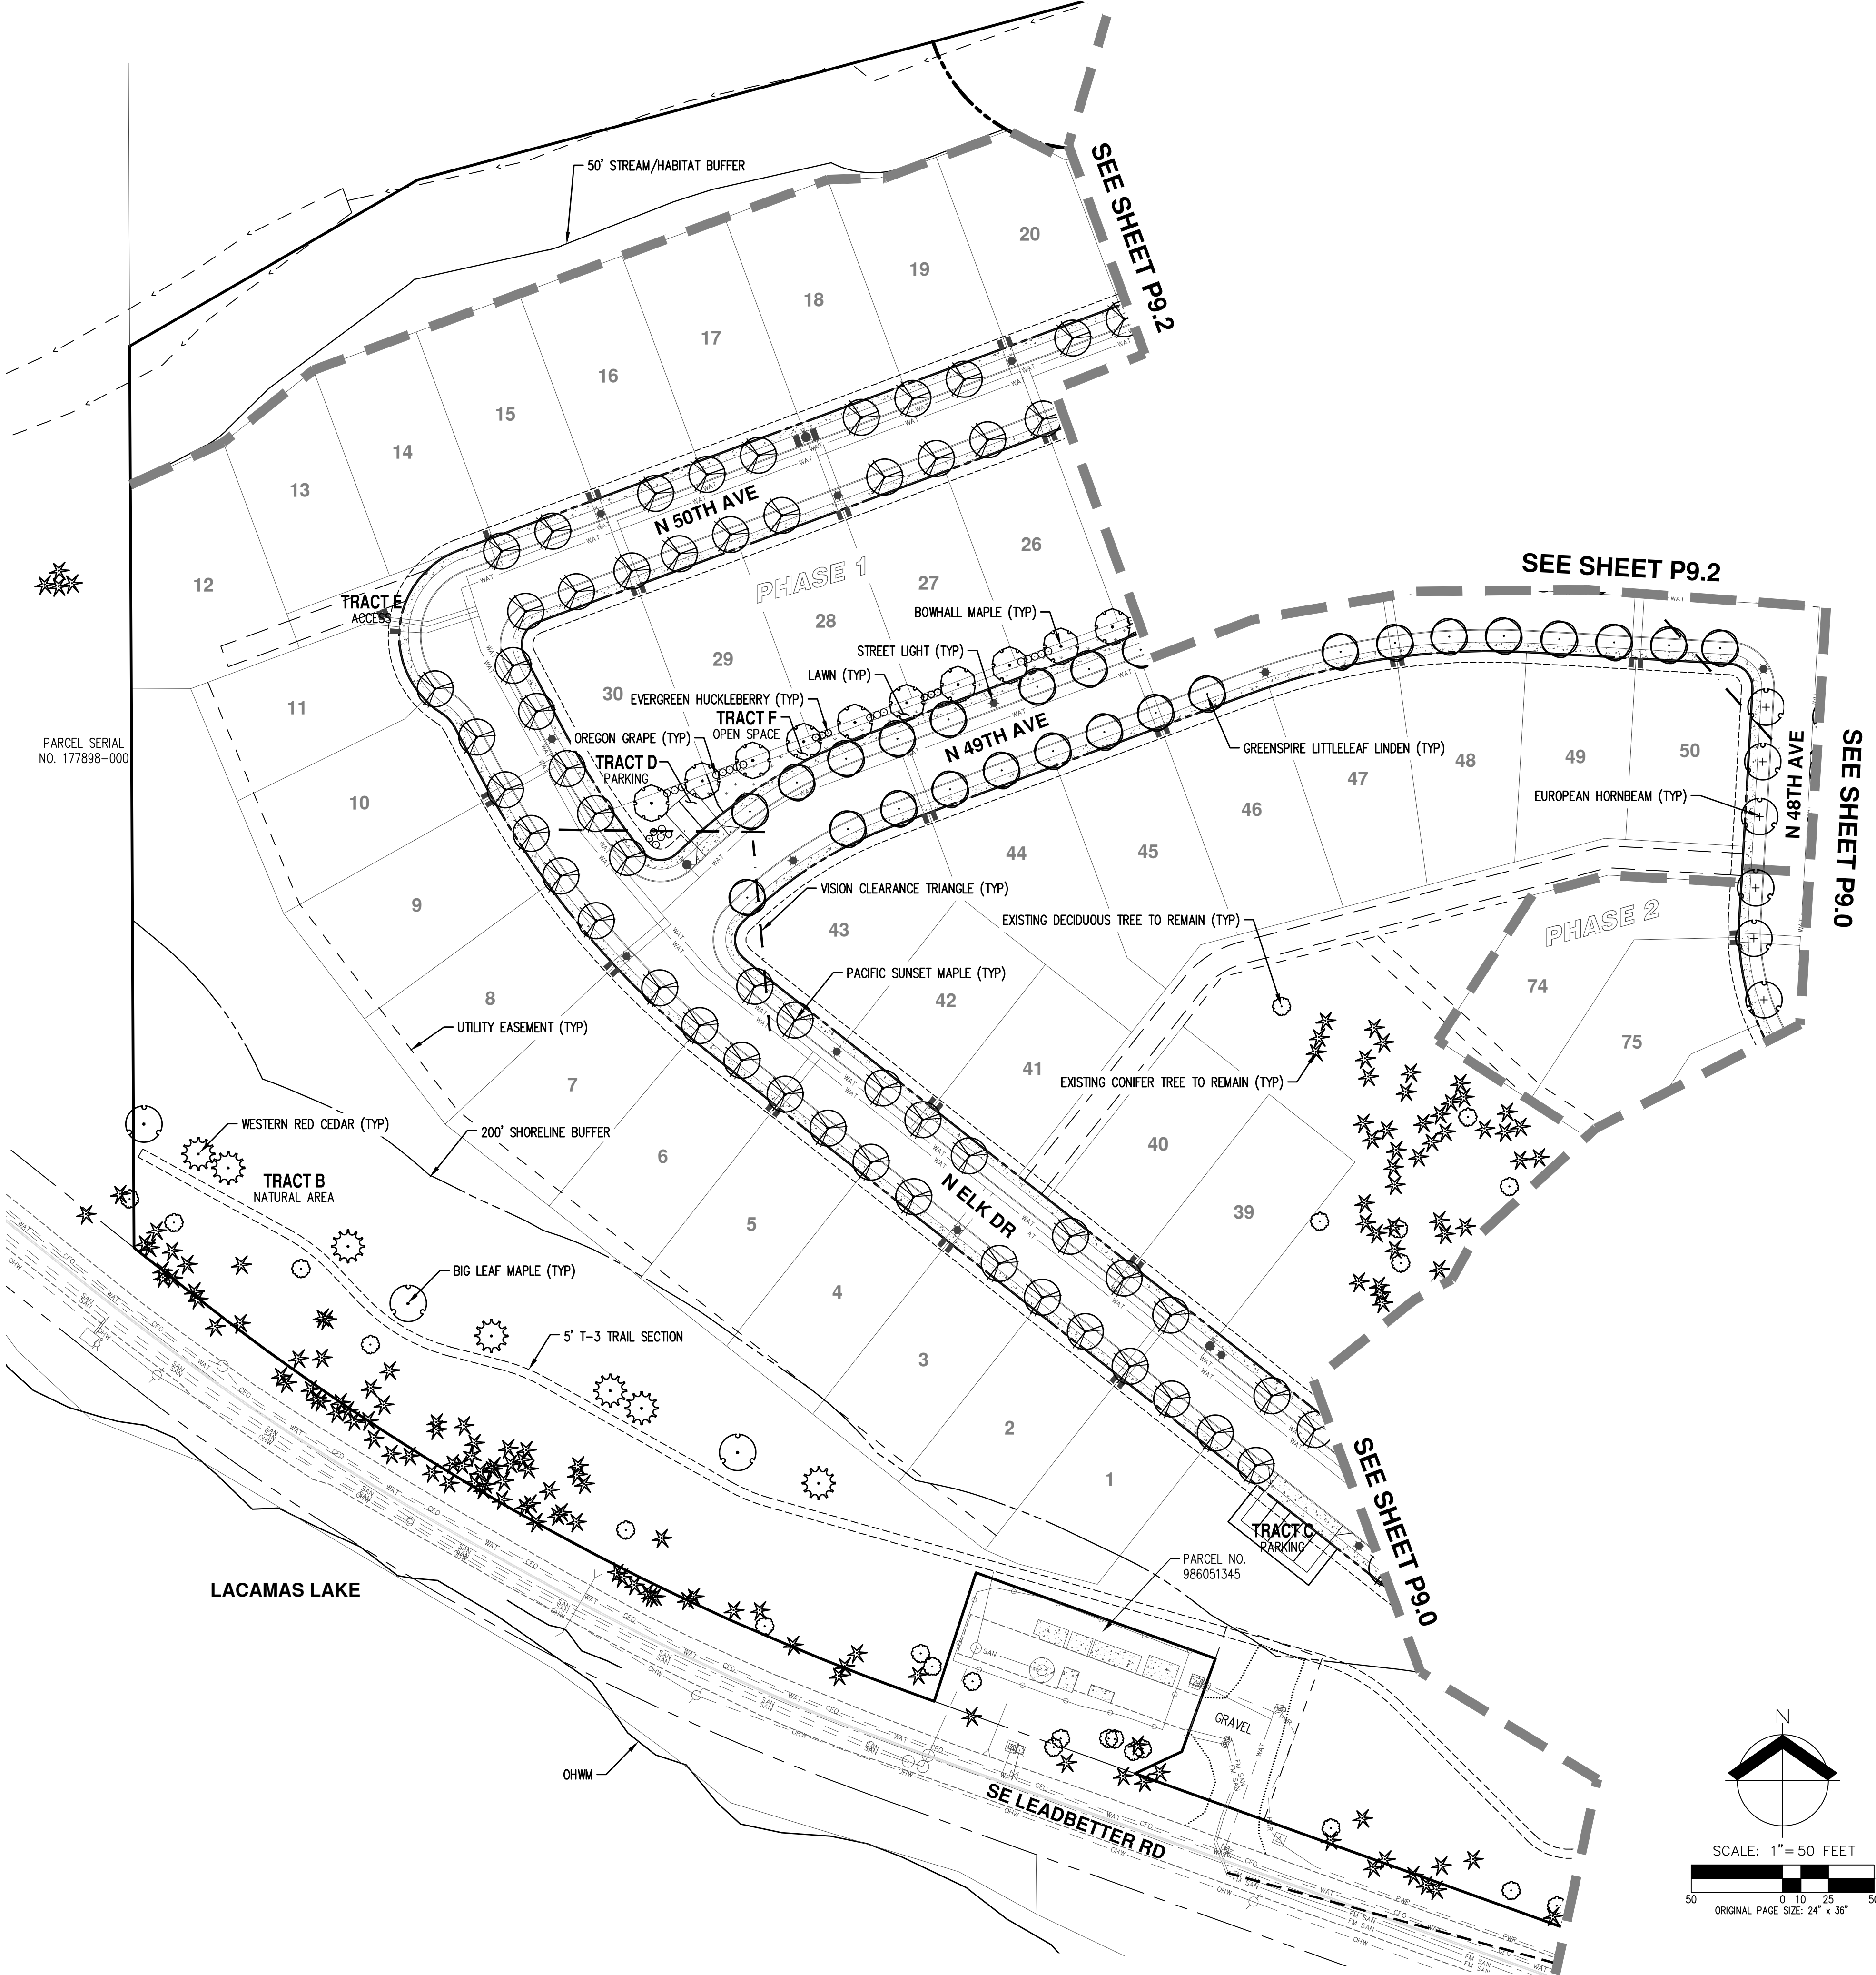
PRELIMINARY LANDSCAPE AND LIGHTING PLAN (WEST)  
CJ DENS SUBDIVISION  
CJ DENS LACAMAS II LLC  
CAMAS, WASHINGTON
