# CJ DENS EAST SUBDIVISION

## PRELIMINARY SUBDIVISION PLANS

CJ DENS SUBDIVISION  
CJ DENS LACAMAS II LLC  
CAMAS, WASHINGTON

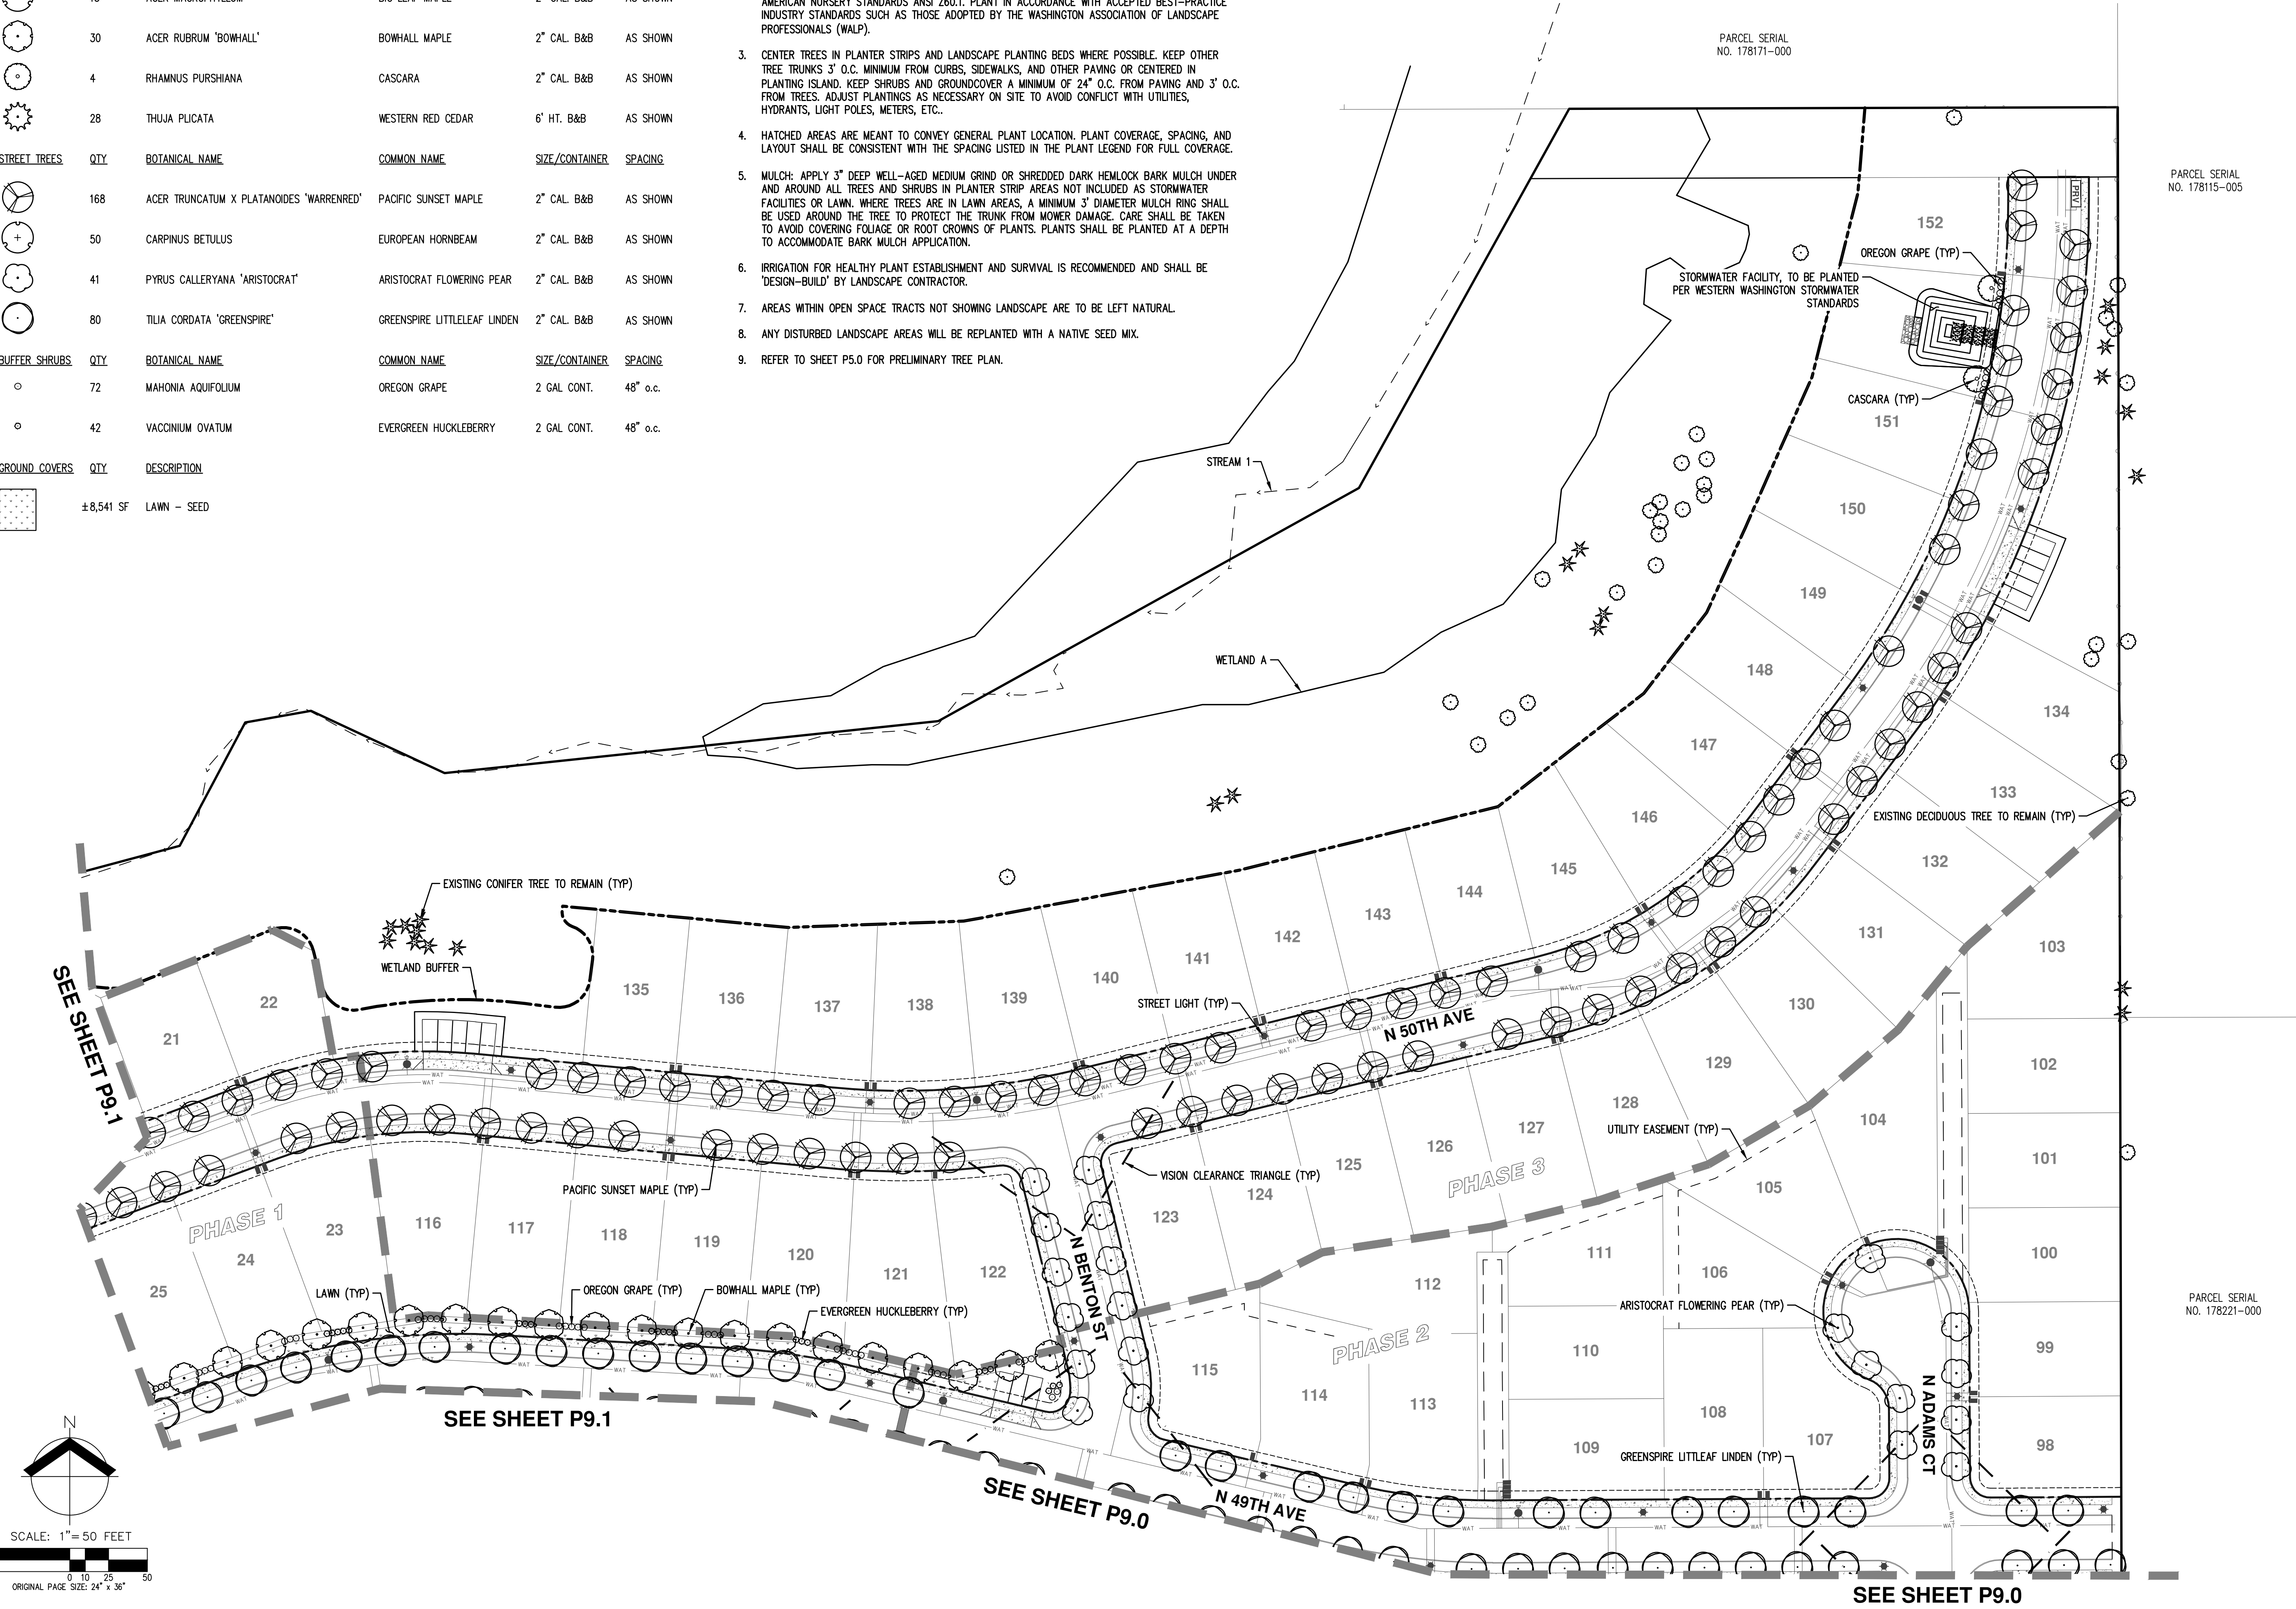
PRELIMINARY LANDSCAPE AND LIGHTING PLAN (NORTH)  
CJ DENS SUBDIVISION  
CJ DENS LACAMAS II LLC  
CAMAS, WASHINGTON
