## 8. Tree Report

# Camas Heights Subdivision Preliminary Tree Report

**Prepared For:** Ryan Selby  
Lennar Northwest, Inc.  
11807 NE 99<sup>th</sup> Street  
Vancouver, WA 98682

**Prepared By:** Bryce Hanson, Certified Arborist

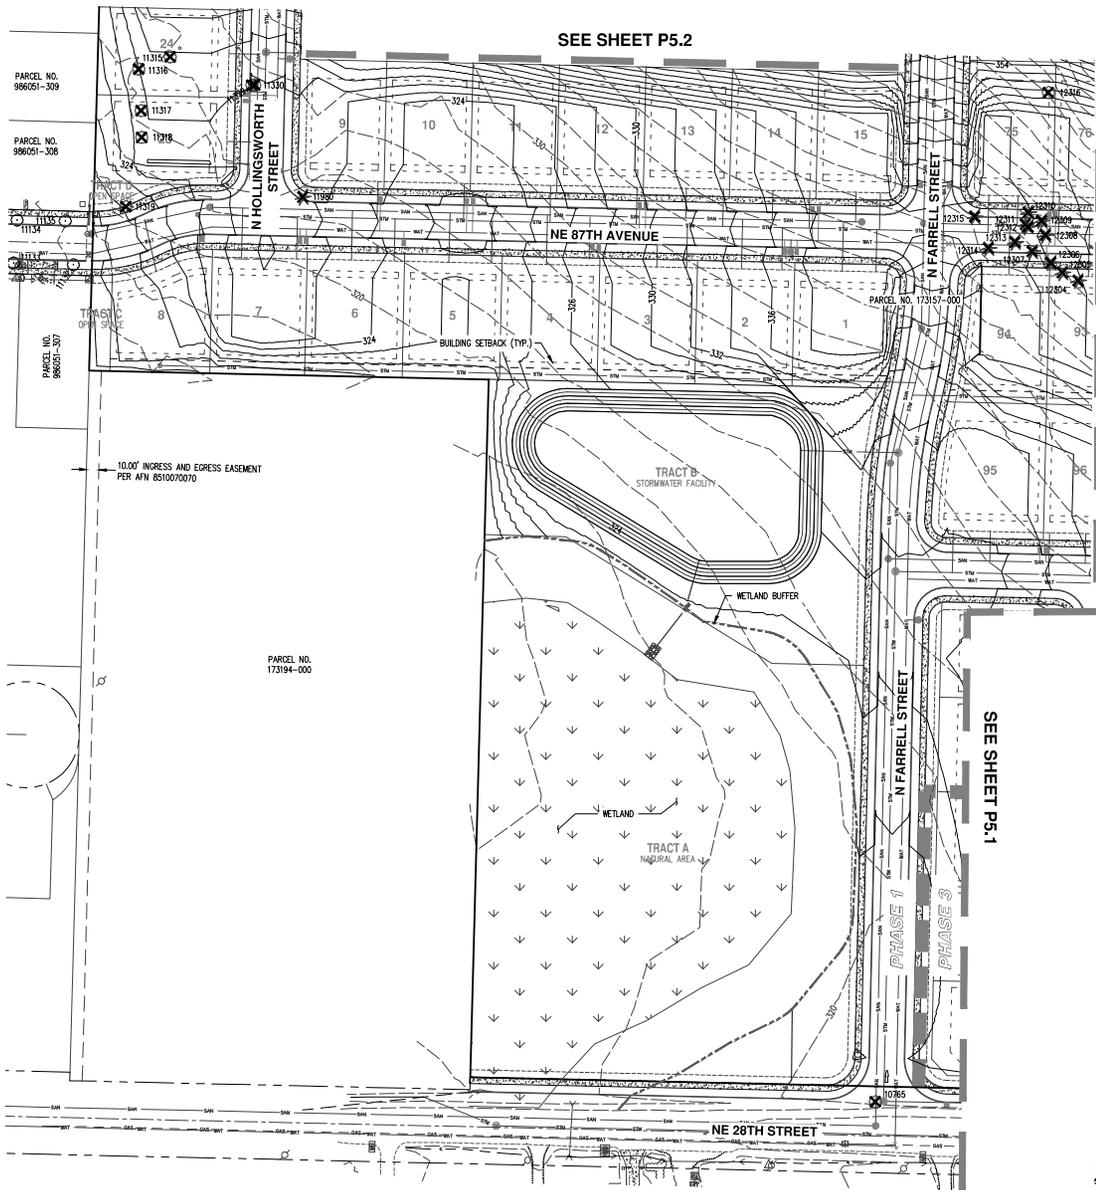
# **Appendix B: Tree Preservation and Removal Plan**

GROSS AREA: 37.27 AC  
 SITE AREA EXCLUDING TRACT A: 34.5 AC  
 TOTAL TREE UNITS REQUIRED (34.5 X 20): 690  
 EXISTING TREES RETAINED/(TREE UNITS): 2/(27)  
 PROPOSED SITE TREES/(TREE UNITS): 663/(663)

NOTE: SEE LANDSCAPING PLAN (P9.0) FOR PROPOSED TREE PLANTING PLAN

See the plans found in Appendix B.

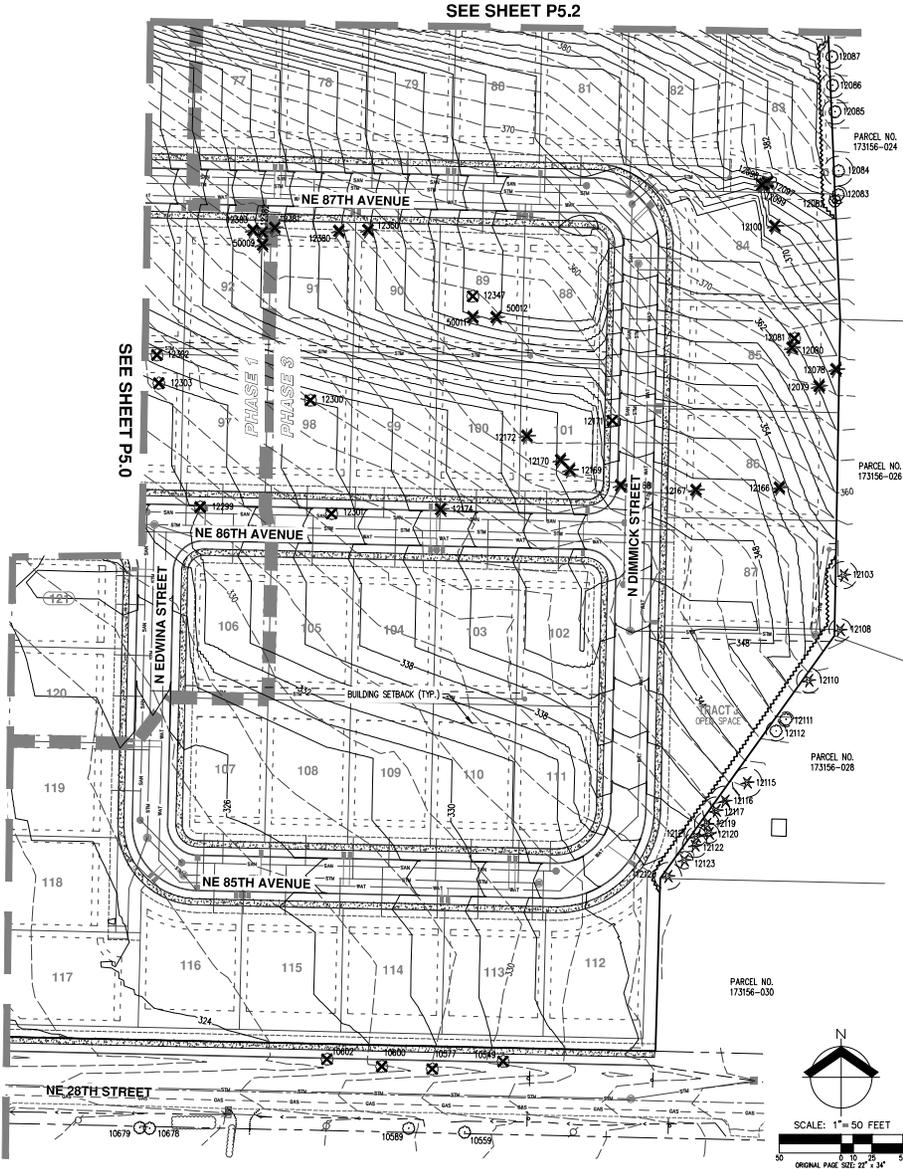
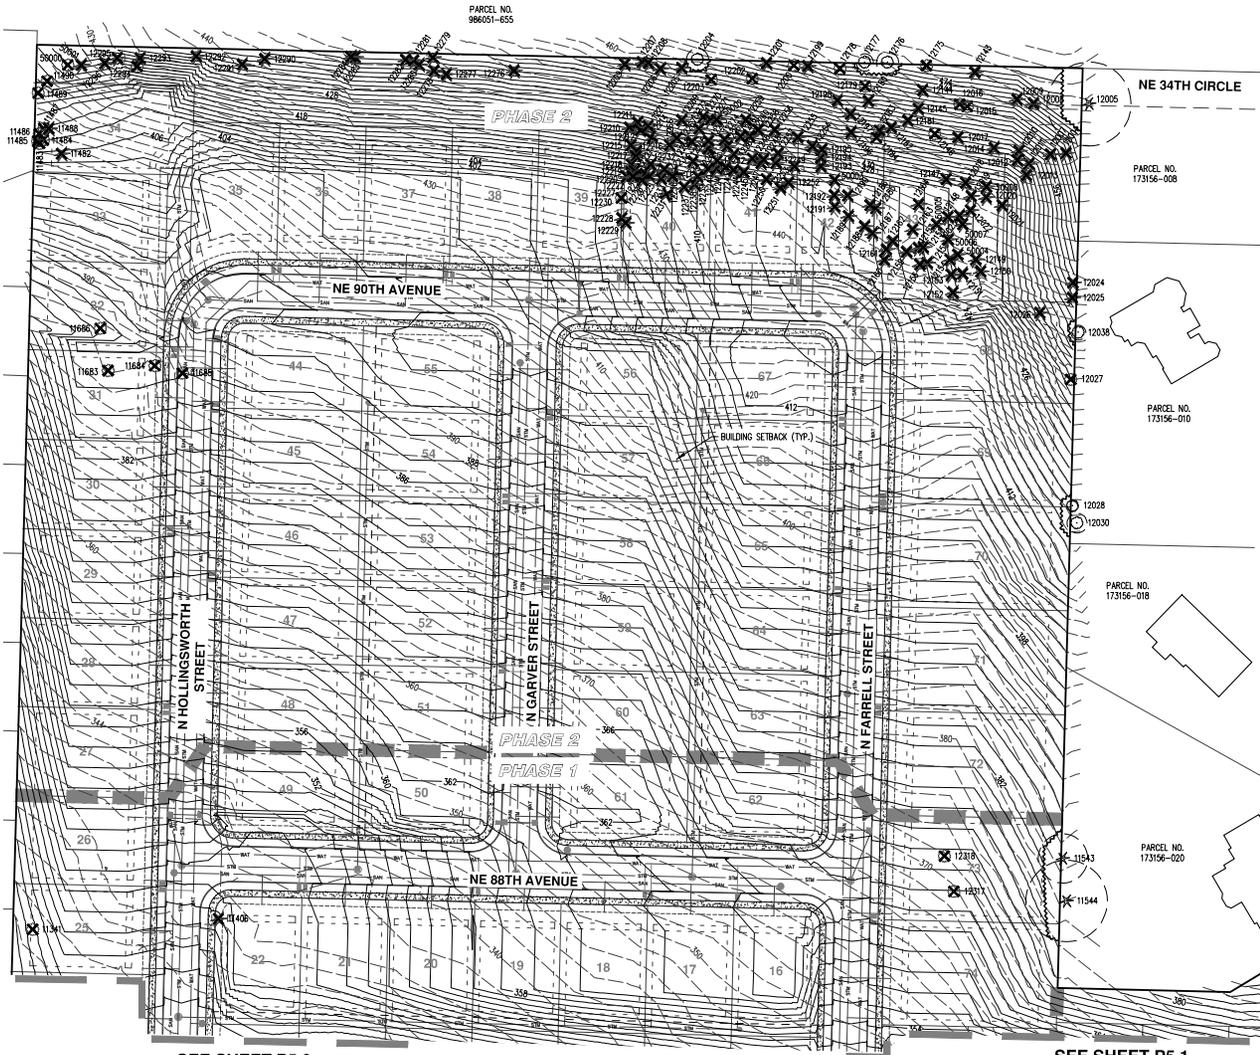
TREES SHOWN TO BE SAVED WILL BE EVALUATED BY THE PROJECT ARBORIST PRIOR TO, DURING, AND AFTER CONSTRUCTION. TREES ADVERSELY AFFECTED BY CONSTRUCTION AND/OR DETERMINED TO BE A SAFETY HAZARD WILL BE REMOVED.
