11. Stormwater Technical Information Report

Camas Heights Subdivision

Preliminary Stormwater Technical Information Report (TIR)

Date: October 2021

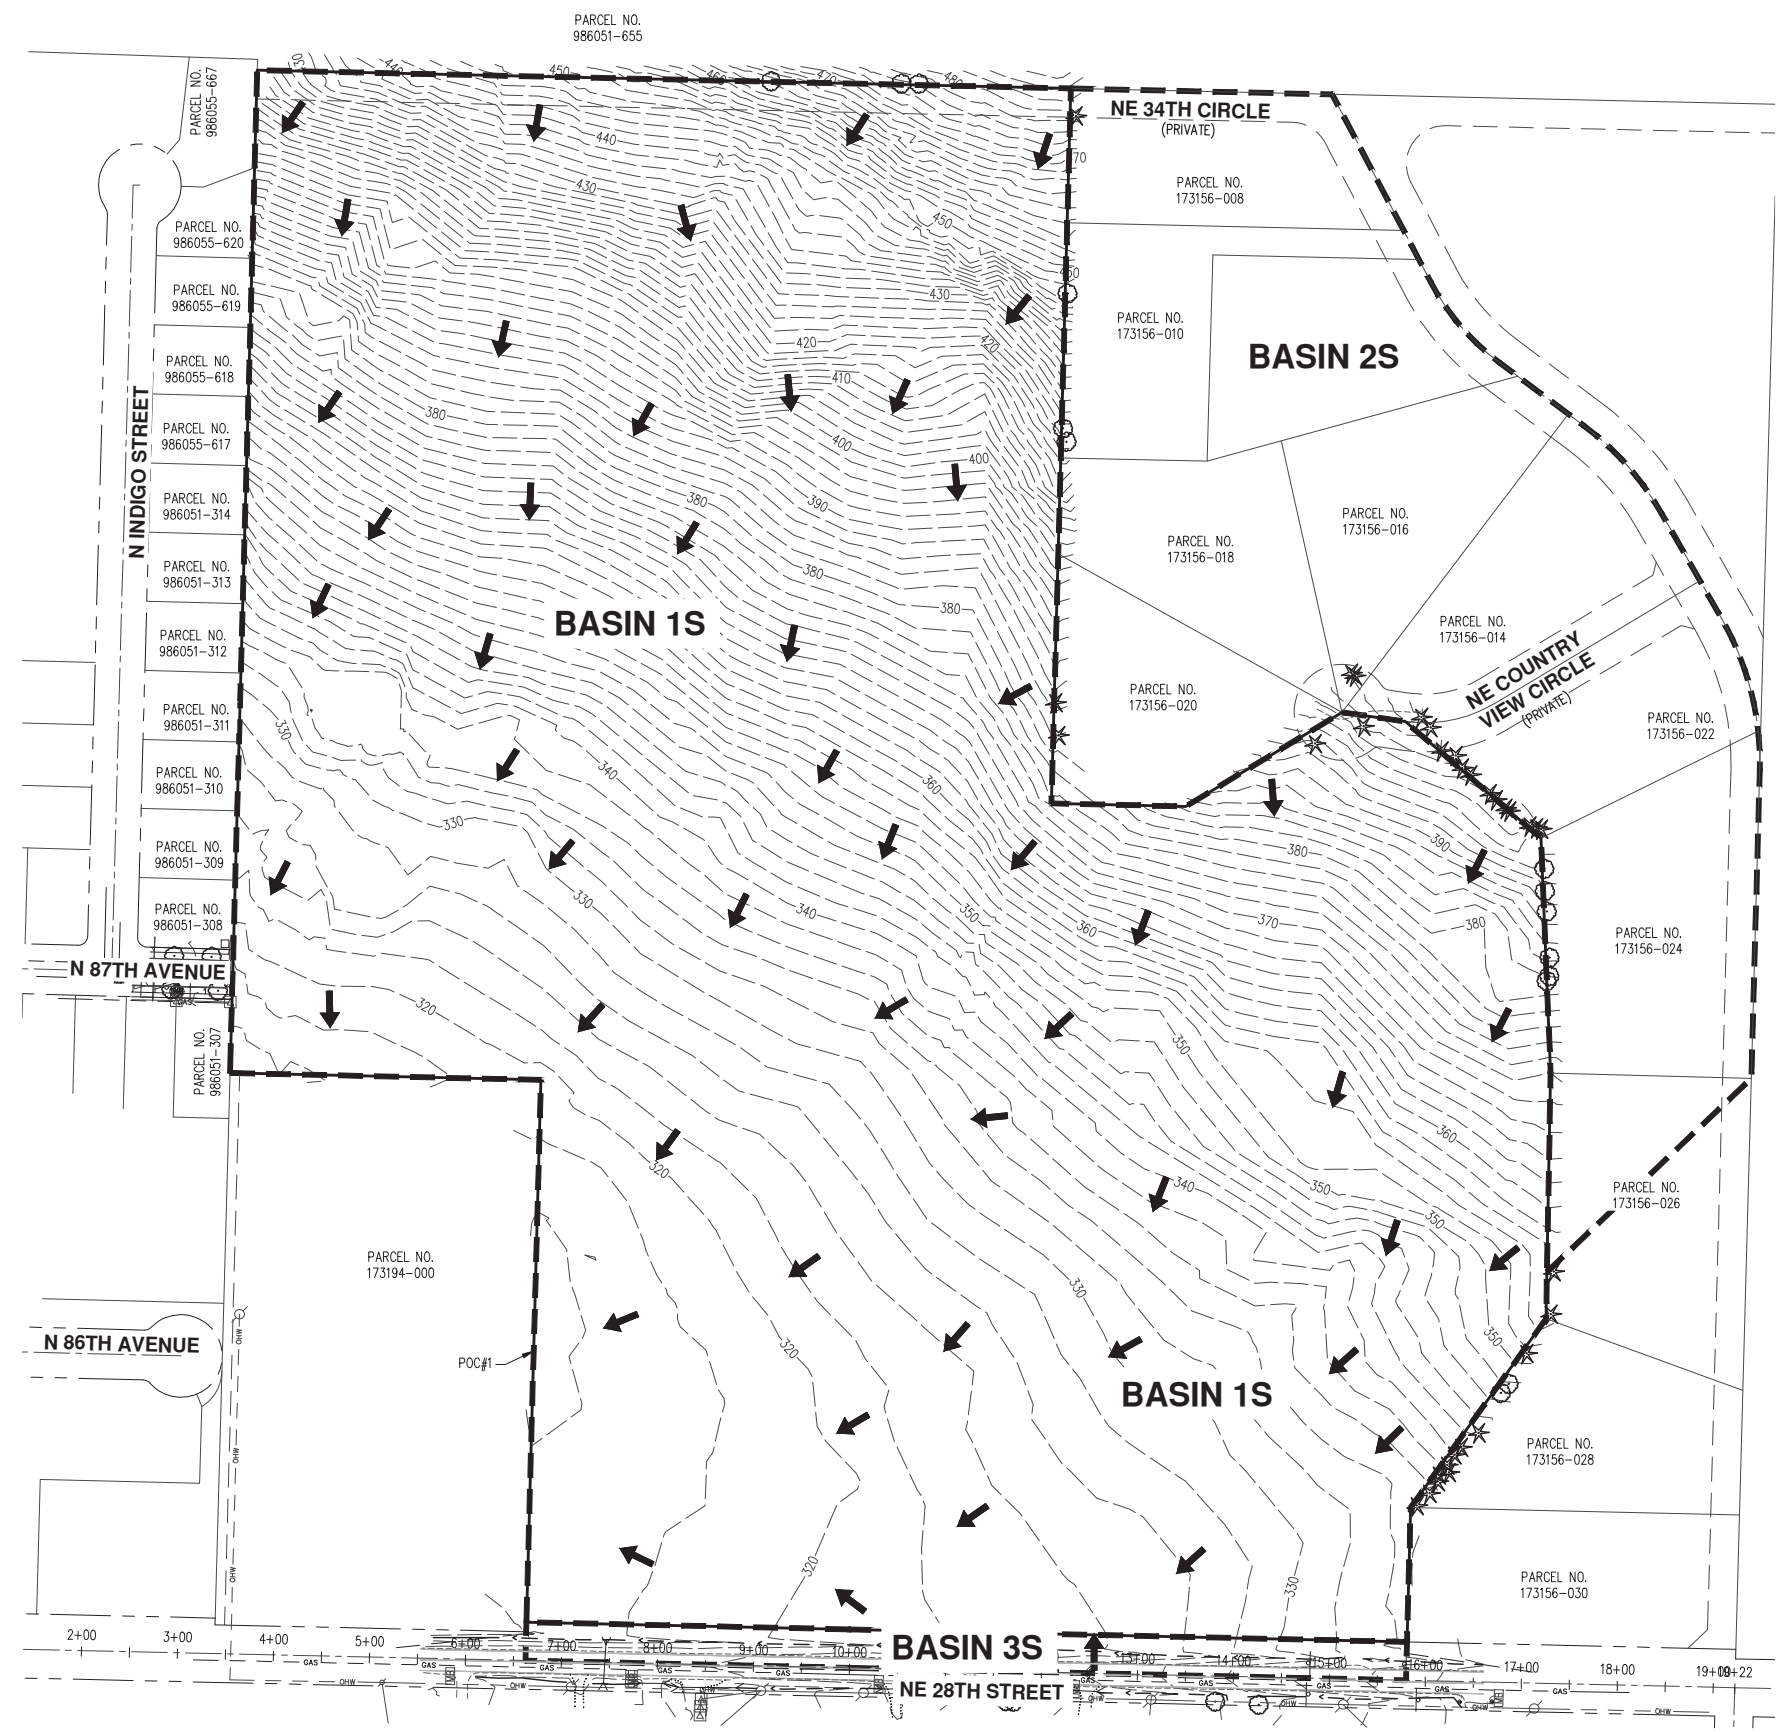
FIG. 1

1. BASIN 1S AND 2S FLOW THROUGH THE SITE TO POC#1.
2. BASIN 3S DIRECTLY DISCHARGES ALONG NE 28TH STREET.

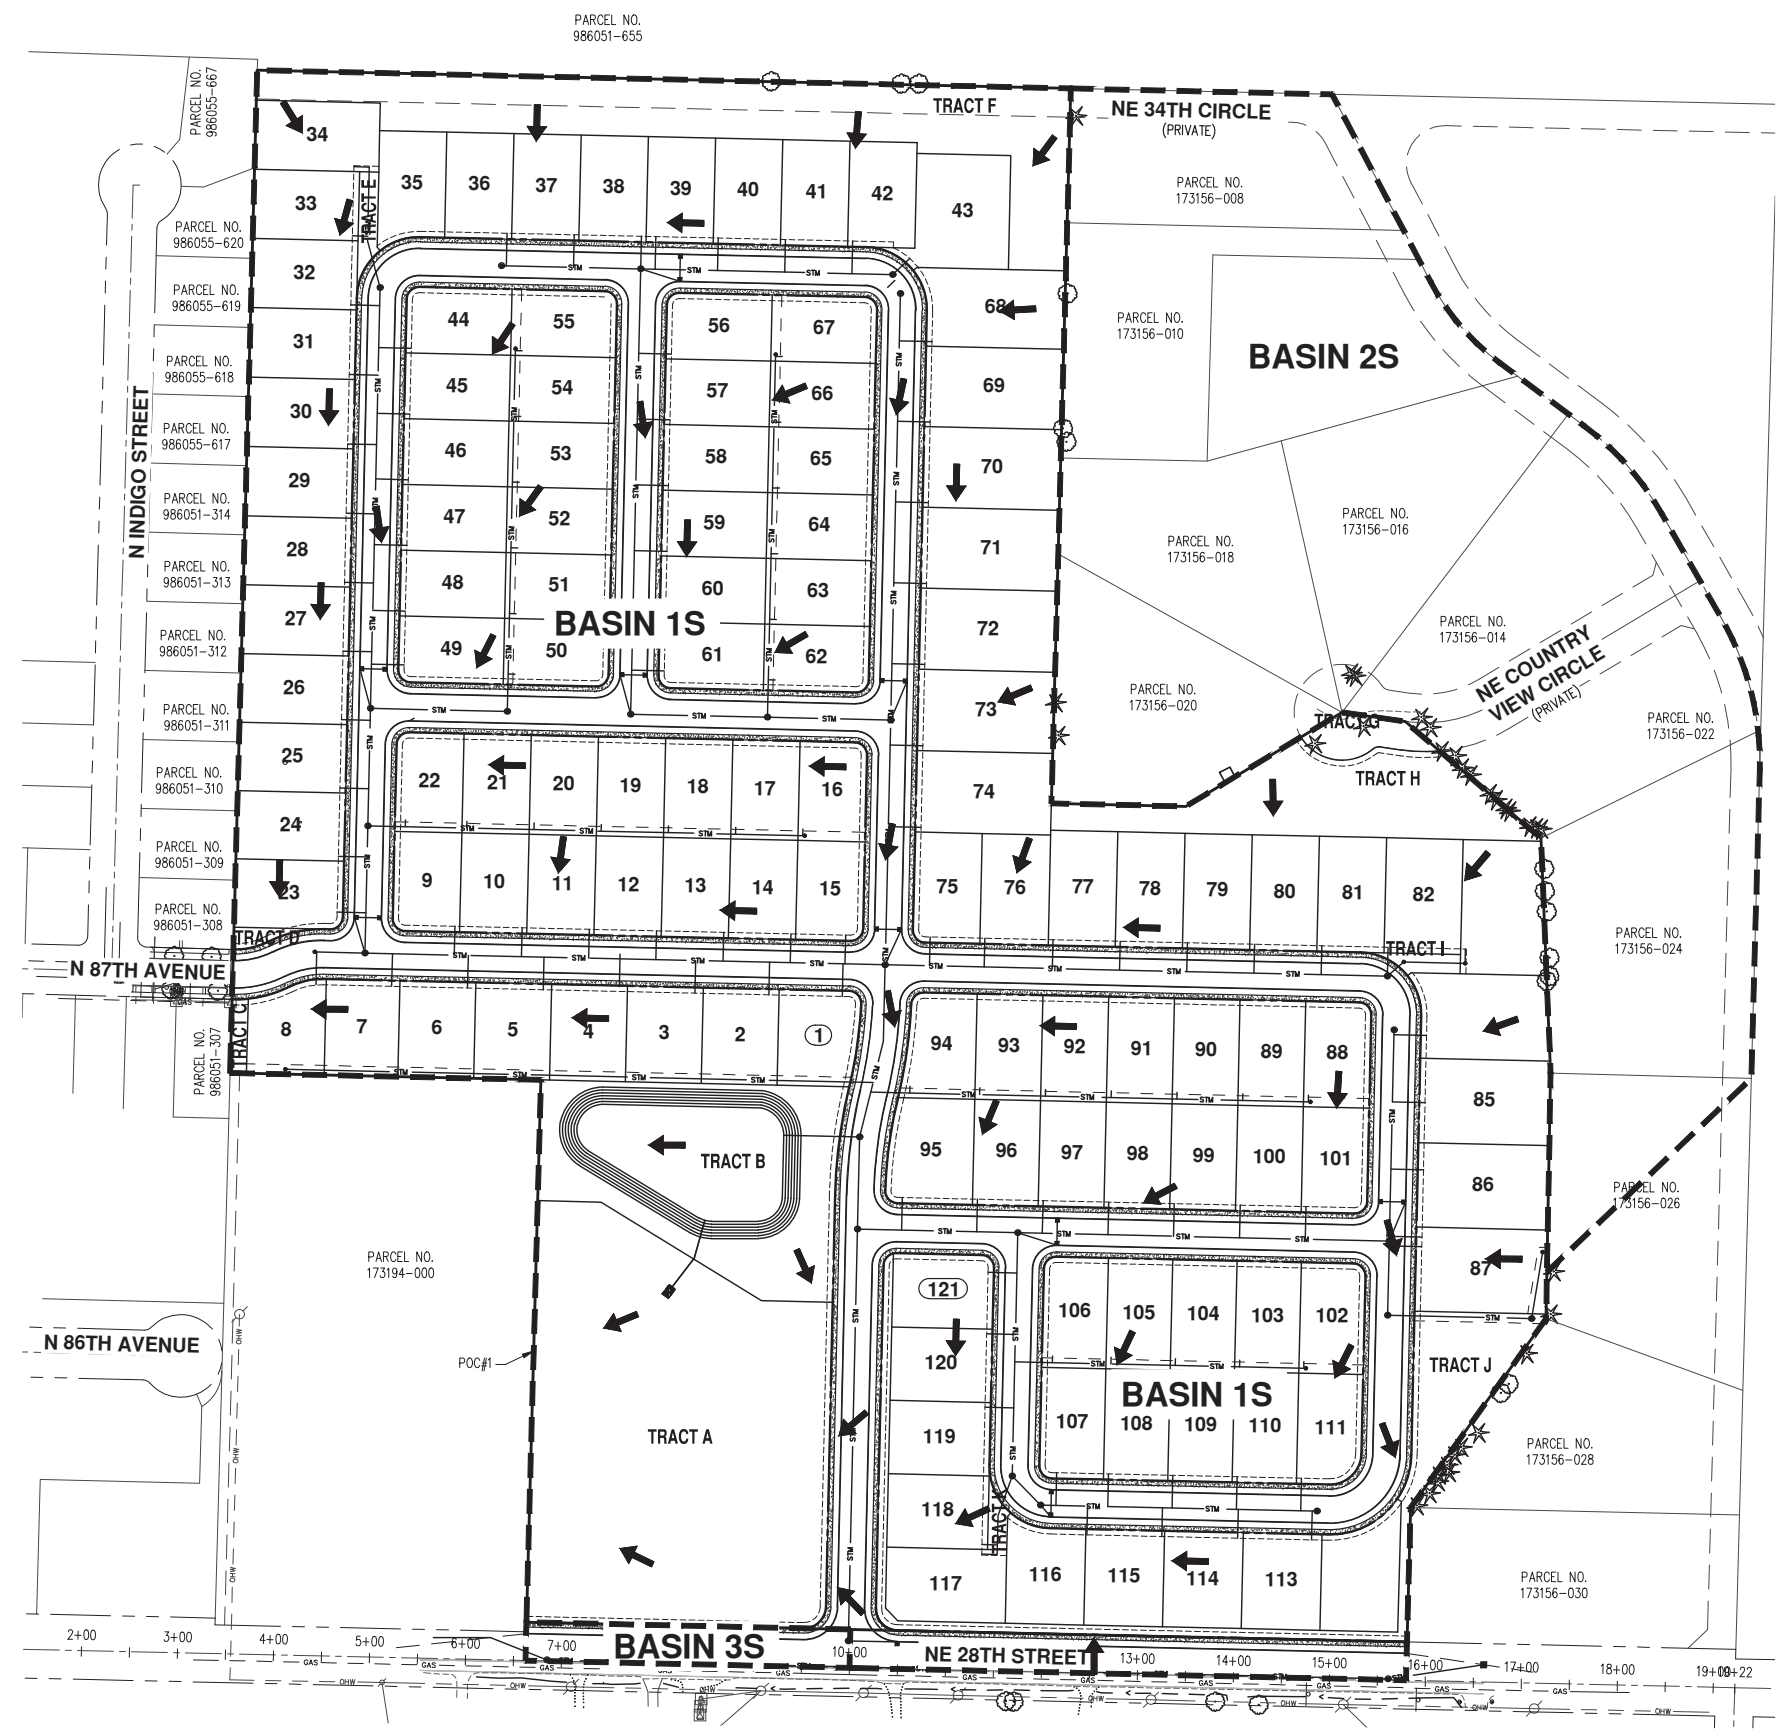
FIG. 2

1. BASIN 1S AND 2S TO BE DETAINED IN ON-SITE WETPOND LOCATED IN TRACT B.
2. BASIN 3S TO BE DIRECTLY DISCHARGED ALONG NE 28TH STREET.
