CITY OF CAMAS

STREET TREE SUCCESSION PLAN

MARCH 2023

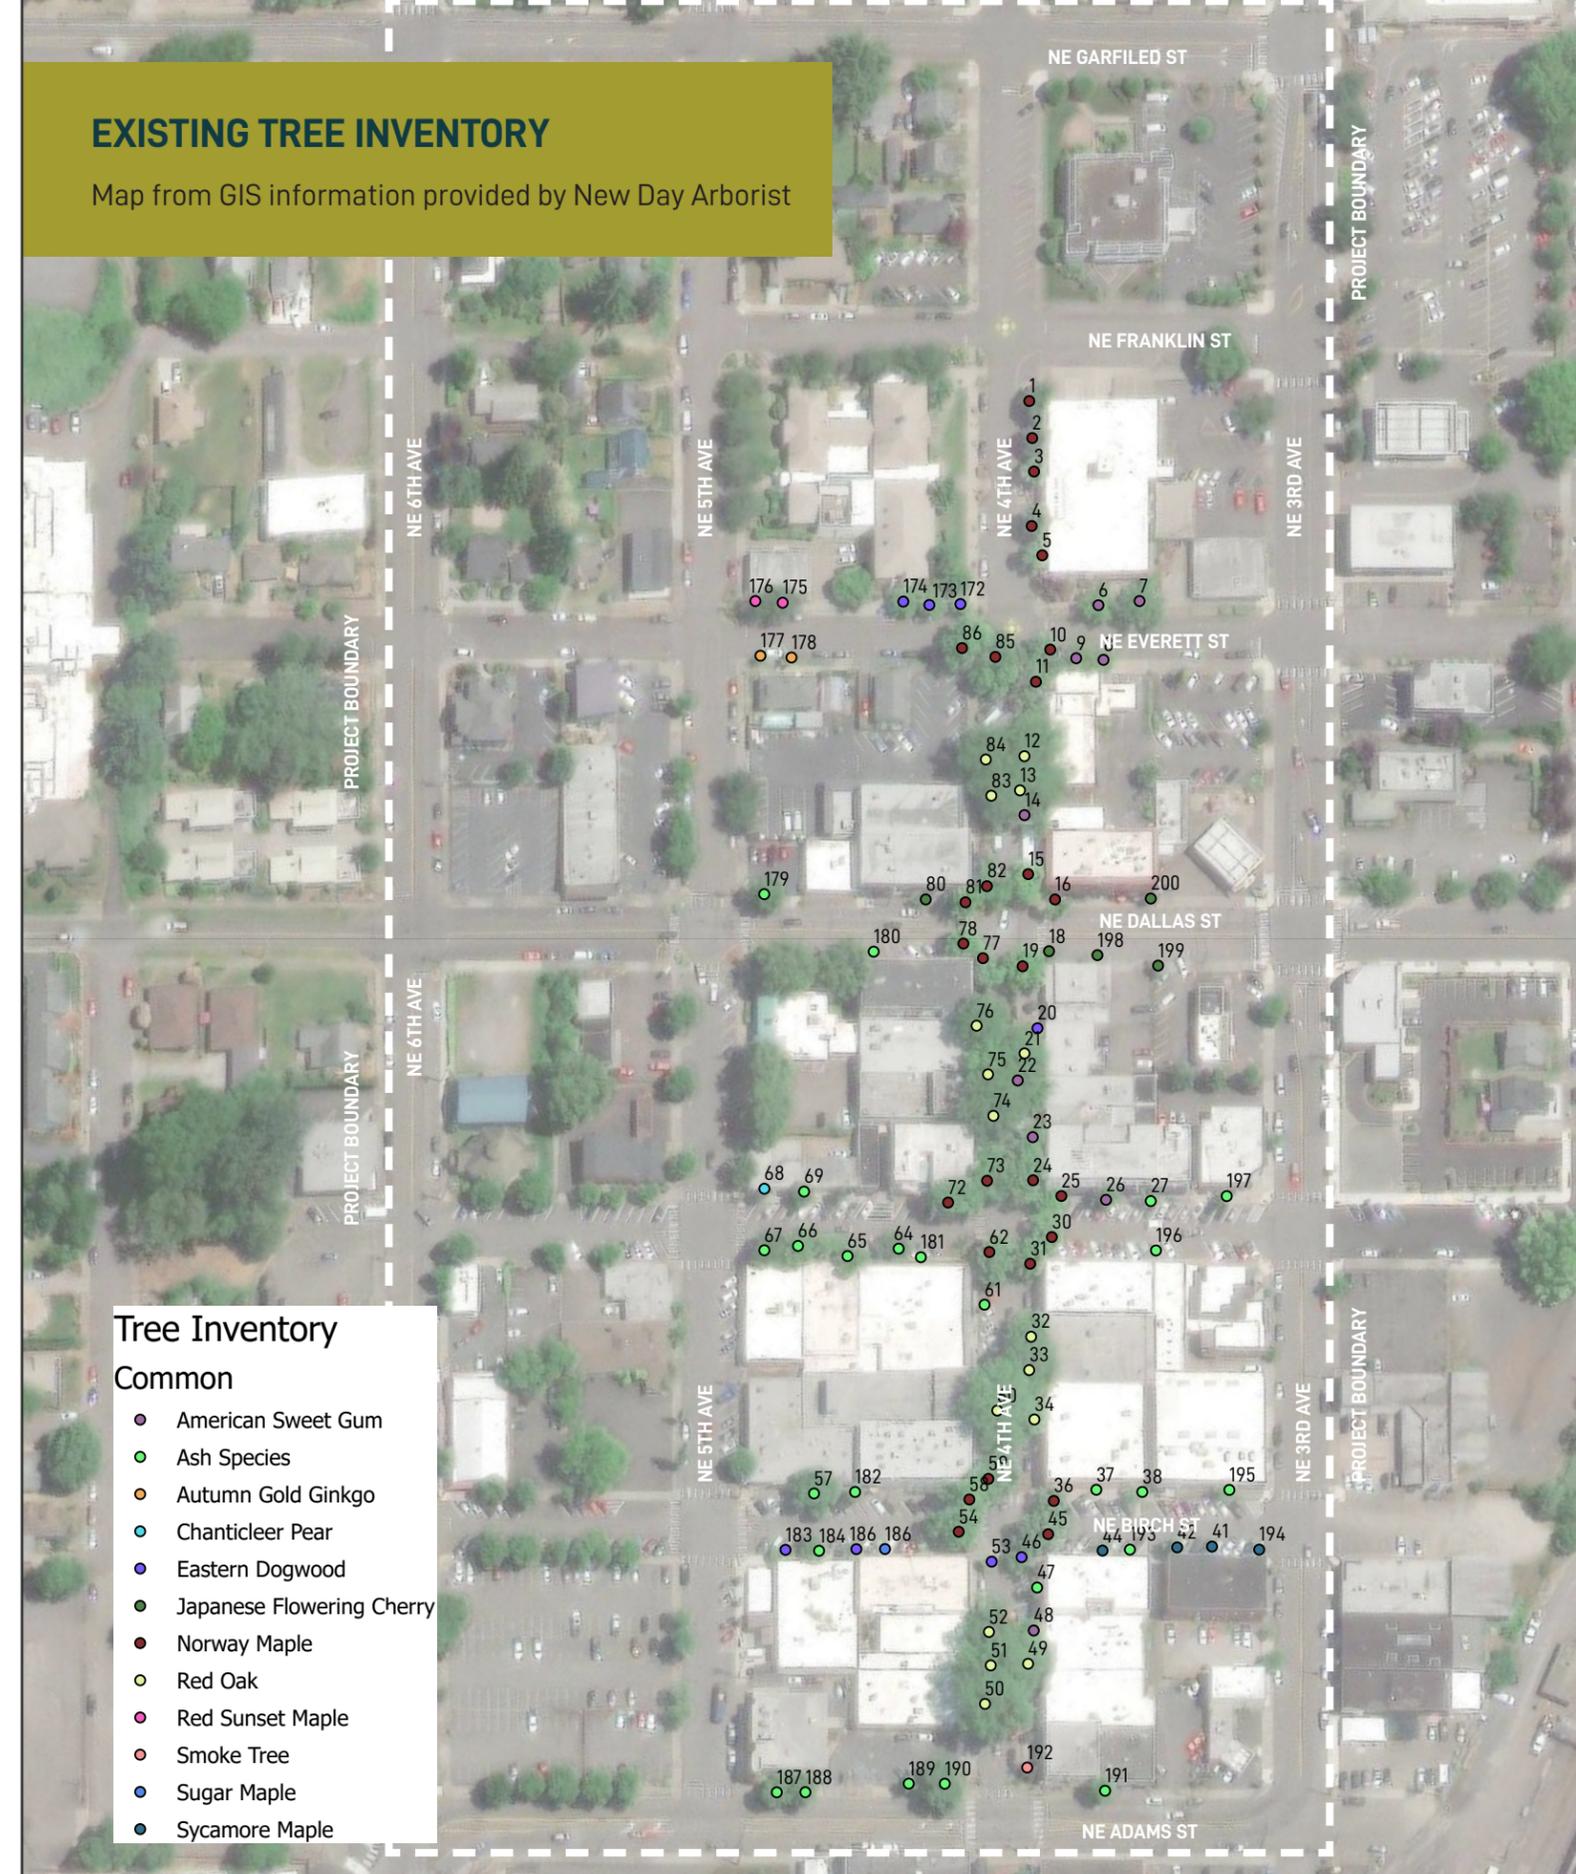
EXISTING TREE INVENTORY

Map from GIS information provided by New Day Arborist

The tree inventory noted a number of critical issues that helped inform this succession plan:

- Most species within the project area are Red Oaks (*Quercus rubra*) and Norway Maples.
- Most of the Norway Maple trees in the area are over-mature and showing signs of decline. The inventory recommends that the majority should be budgeted for removal and replacement.

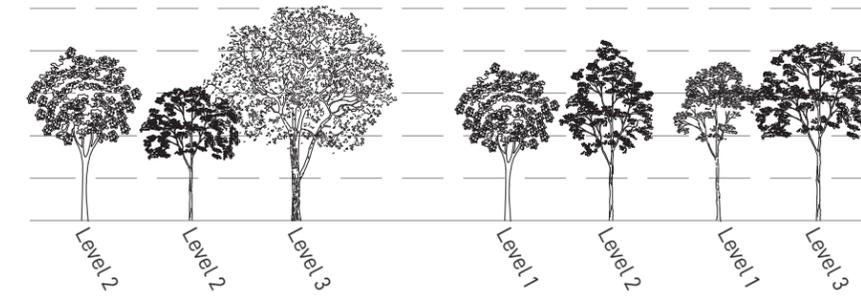
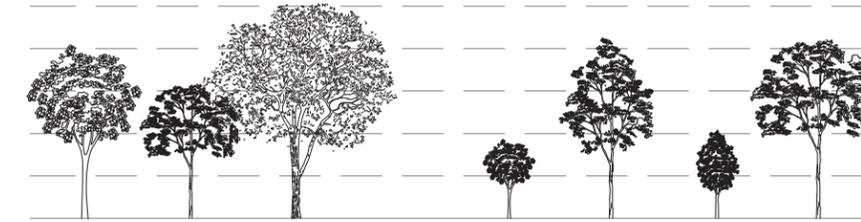
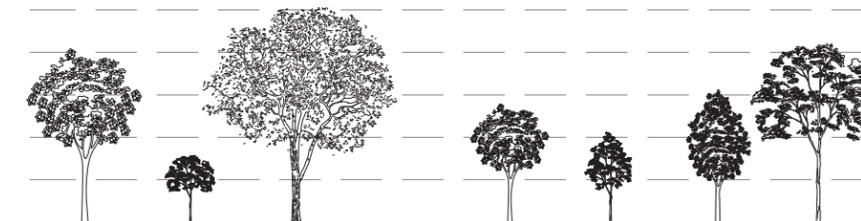
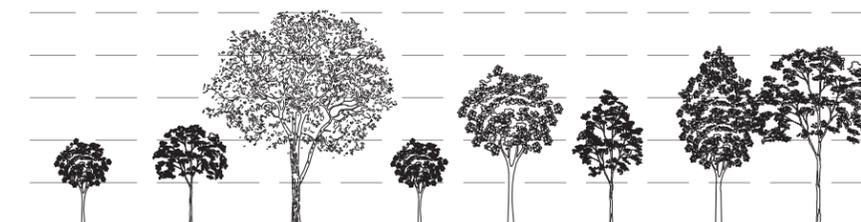
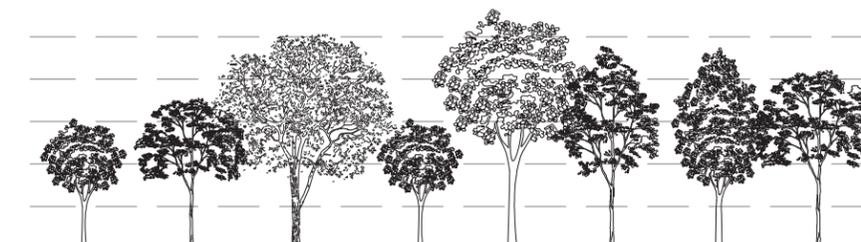
TREE SUCCESSION DIAGRAM

Existing Conditions:
Some diversity in species and age but many trees in moderate or poor health.

0-5 Years
Dead, hazardous, and high risk trees removed and replaced.

5-10 Years:
Level 2 trees replaced. All trees monitored for changes in health.

10+ Years:
Level 3 trees begin to decline in health and will need to be replaced.

Plant trees in gaps in the tree canopy.

Goal:
Healthy canopy with a diversity of tree species and ages.

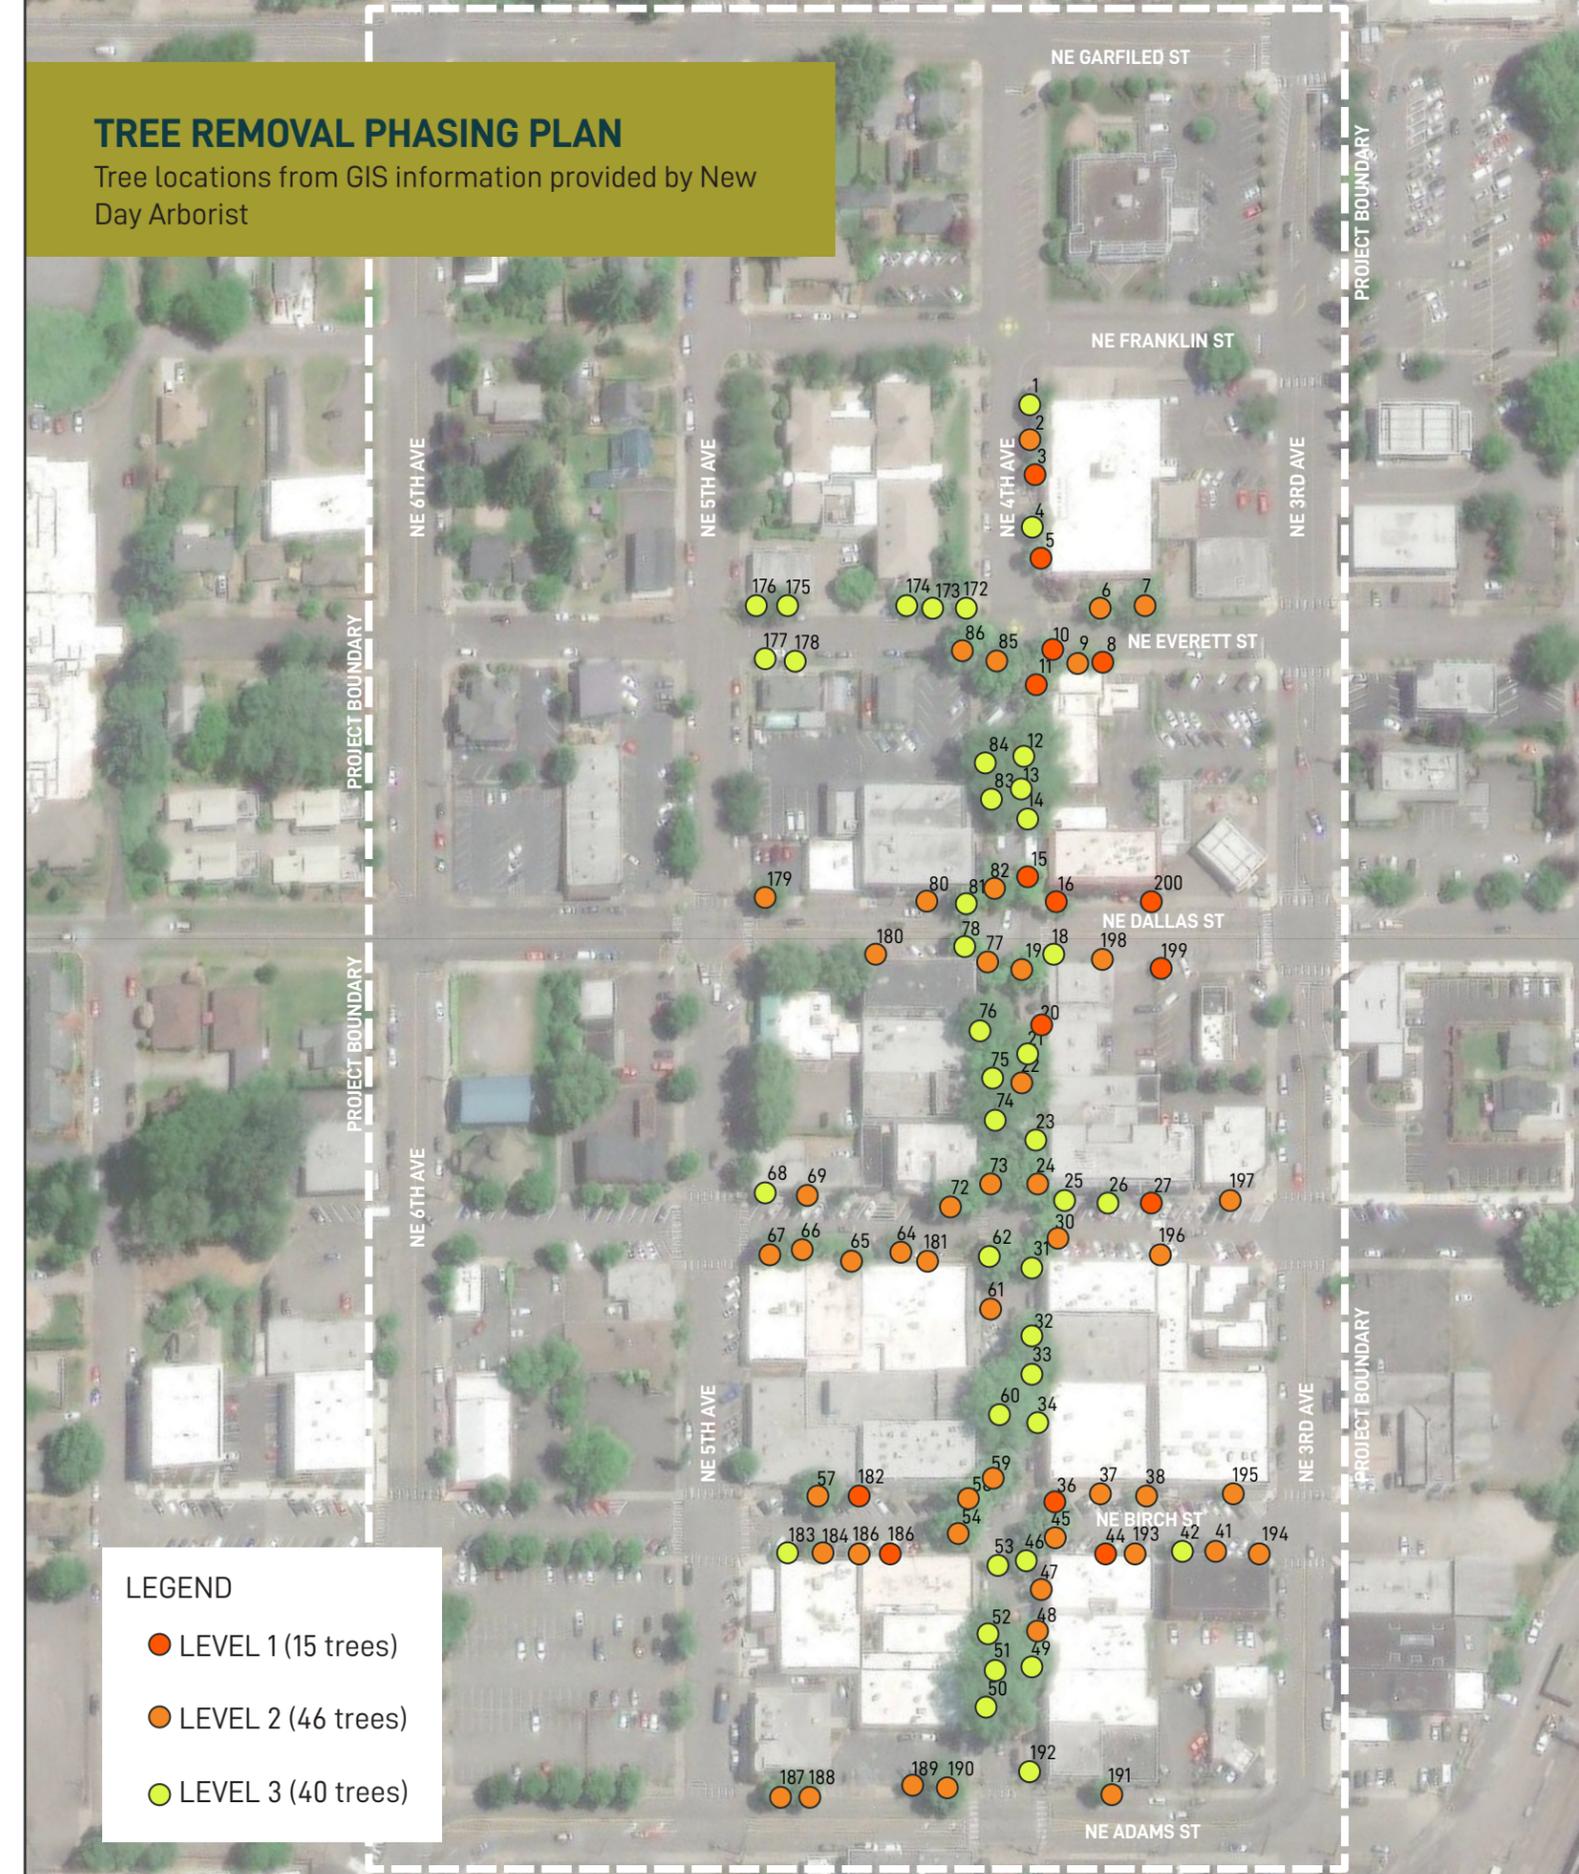
TREE REMOVAL PHASING PLAN

Tree locations from GIS information provided by New Day Arborist

Year 1	Trees to remove: 44, 10, 11 Additional maintenance: Deadwood removal on 8, 27	Tree 44 considered high risk and trees 10 and 11 considered moderate risk. Remove dead branches to decrease risk in remaining trees
Year 2	Trees to remove: 16, 20, 36 Additional maintenance: Remove any additional deadwood. Monitor canopy health for changes.	Remove and replace tree 16 so there is diversity in age between 15 and 16 at this corner. Decay in 36.
Year 3	Trees to remove: 3, 5, 182 Additional maintenance: Consider additional improvements in this area to increase planter size.	Group removal of 3 and 5 together to increase ability to improve infrastructure for additional soil volume.
Year 4	Trees to remove: 8, 15, 27, 186 Additional maintenance: Remove any additional deadwood. Monitor canopy health for changes.	Trees not currently identified as immediate risk. Monitor and remove earlier if conditions change.

- Remove high risk and hazardous trees first.
- Generally trees to be removed are phased spatially across the area to support age diversity.

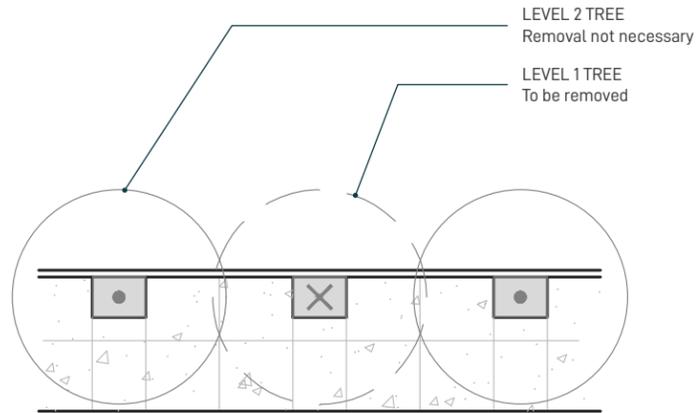
Existing Conditions:

Sidewalk with street trees. Tree wells are undersized and soil volume is too small. One tree is listed as Level 1 and ready for removal.

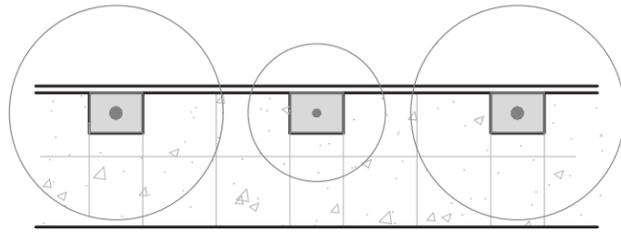
Option 1:

Remove and replace single Level 1 tree. No supplemental infrastructure improvement. Lowest cost in the short term. Option not recommended as it does not improve tree health long-term.

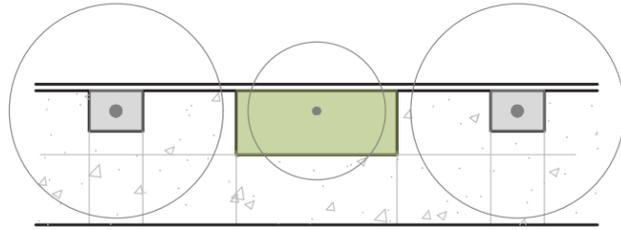
Option 2:

Remove and replace single Level 1 tree with supplemental infrastructure improvement to increase soil volume. Moderate cost in the short term. Some improvement in individual tree health however infrastructure is piecemeal.

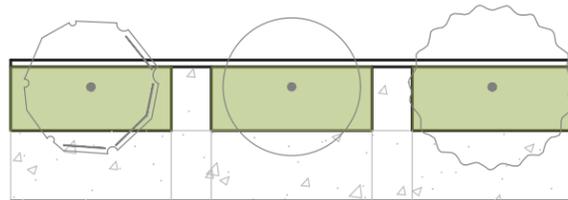
Option 3:

Remove and replace Level 1 tree and adjacent Level 2 trees. Higher upfront cost but cost savings over time. Improved soil volume increases long-term tree health and reduces maintenance costs.

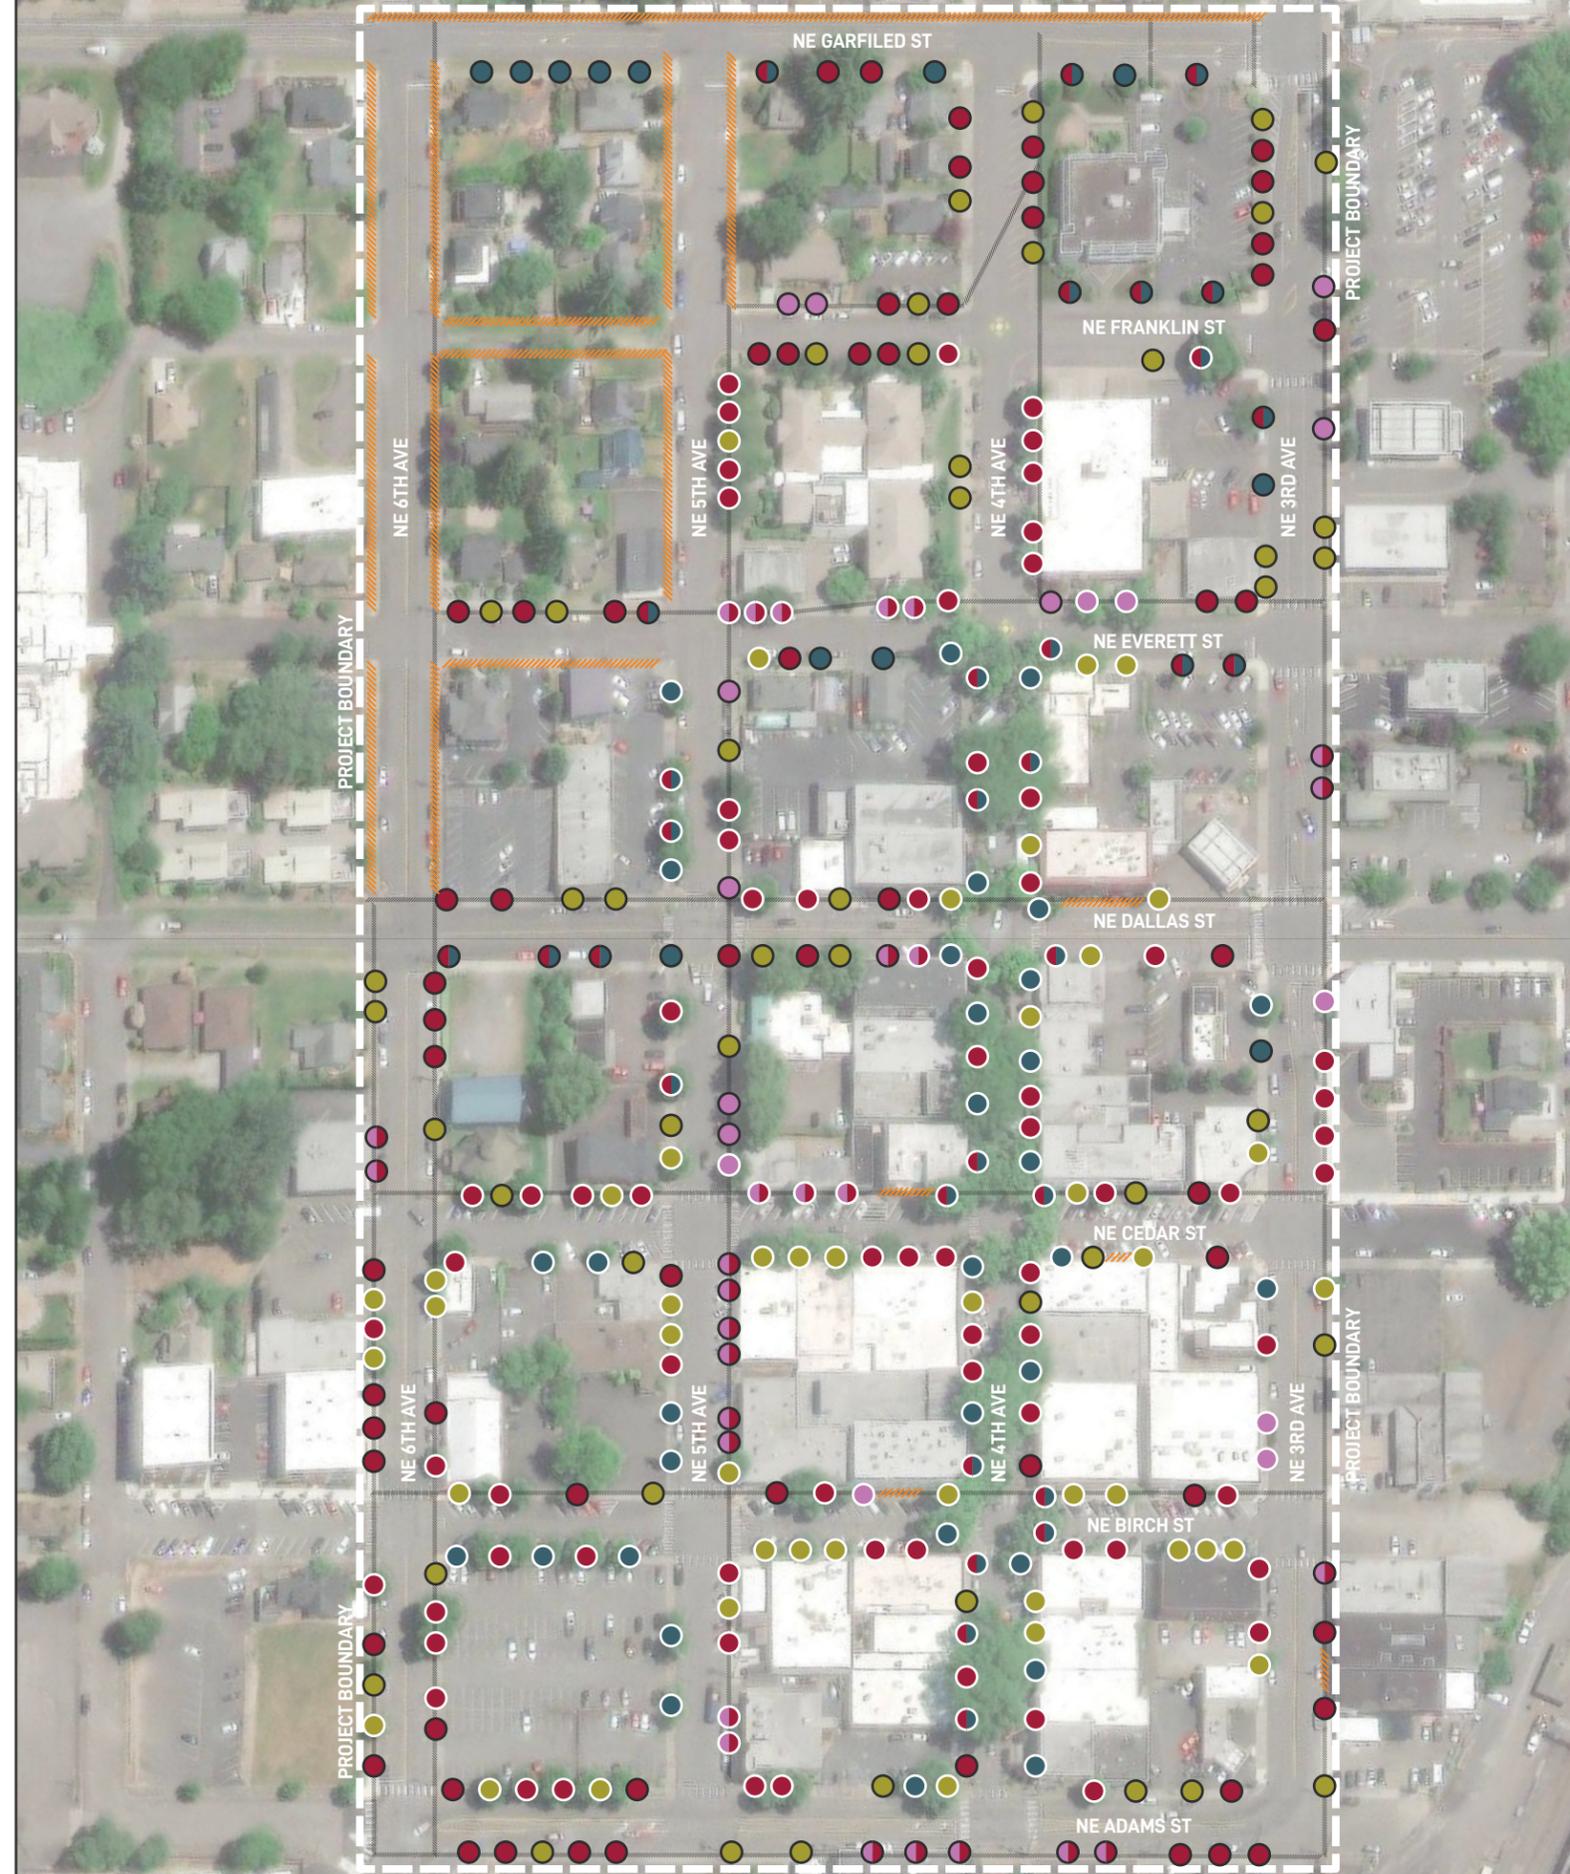
| ● Small or Ornamental Tree | ● Small tree recommended, Medium possible with infrastructure improvements | ○ Existing Tree Replacement | — Overhead Utility |
| ● Broadleaf Evergreen Tree | ● Medium tree recommended, Large possible with infrastructure improvements | ○ Gap or Infill Tree | ▨ Existing sidewalk too narrow to support street trees. Consider future improvements to widen sidewalk. |
| ● Medium Deciduous Tree | | | |
| ● Large Deciduous Tree | | | |

Recommended tree species for each location are broken into categories rather than specific species. Each category contains a few species that can be chosen from for the site based on availability, surrounding species diversity, and other considerations. All recommended species were selected for drought tolerance in anticipation of further climate change.

Trees recommended for under powerlines are marked with an * next to species name.

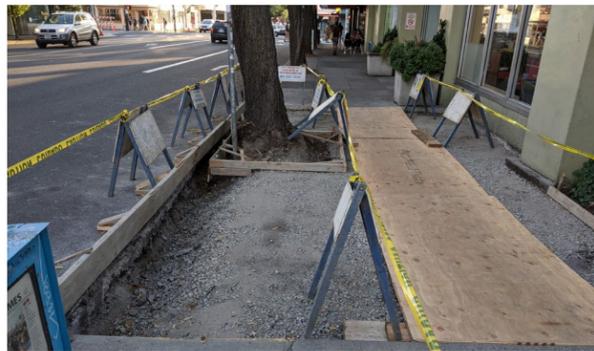
Increase Tree Well Size

As mentioned, one of the most beneficial factors in maximizing tree health is soil volume. Consider ways to enlarge this in the existing ROW space. When additional width is not available, tree wells can be made longer and still provide benefits to the tree.

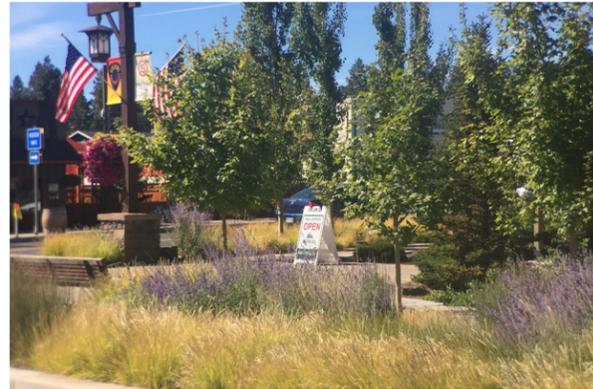
Co-Planting

Including ground cover plants in the tree well can help support a healthy canopy as well. Co-planting helps support healthy soil by increasing organic matter. It can also help reduce compaction by discouraging foot traffic over the tree well and can assist in taking up stormwater as well.

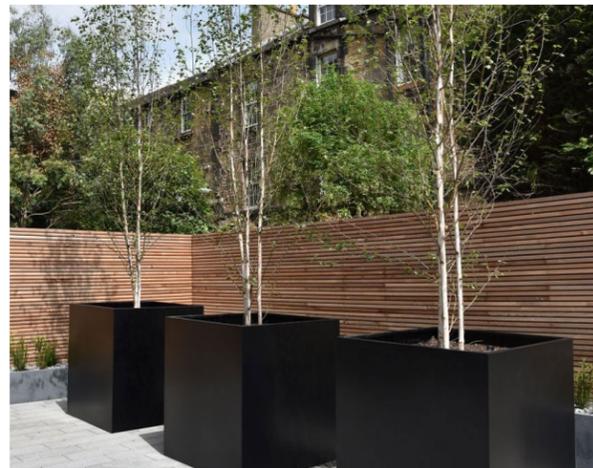
Raised Planter

Planter boxes can help provide additional soil volume by using vertical space when horizontal space is not available. Raised planters come in variety of styles and can be purchased off the shelf or customized designed for Camas.

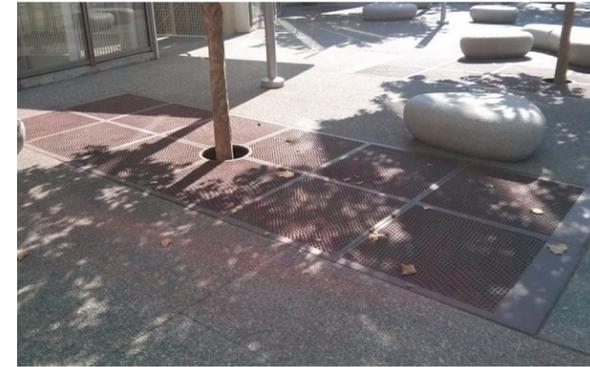
Tree Grates

Tree grates can be a useful tool when space is limited. Tree grates help to preserve pedestrian space while also providing soil below for the tree. However, tree grates are not always the best option for the tree as they can outgrow the size of the grate, thus damaging the overall tree health.

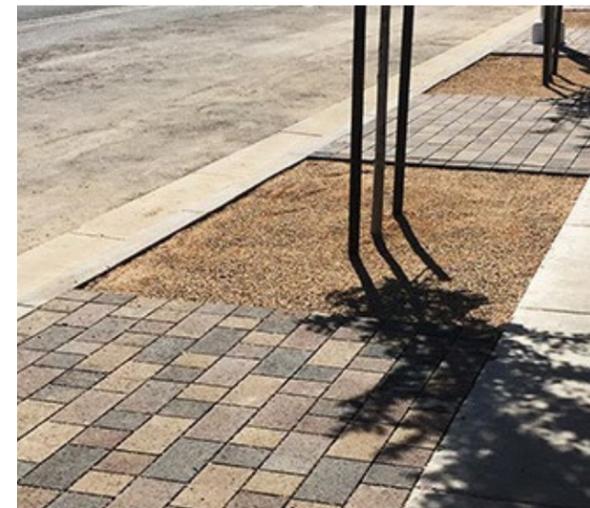
Permeable Pavers

Permeable pavers allow water to infiltrate into the soil below instead of running off. This also puts less pressure on the stormwater system and reduces irrigation needs for trees.

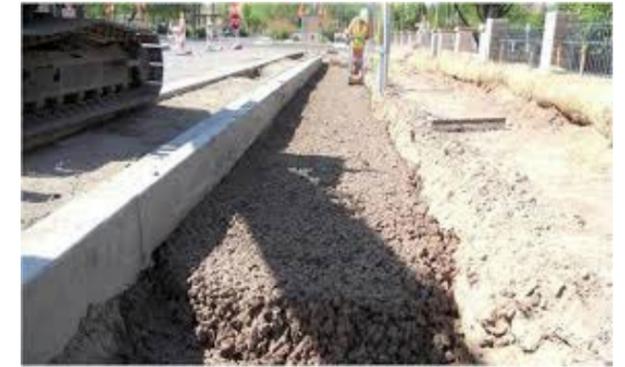
Structural Soils

Structural soils are a type of soil medium that can be compacted to support paving but still allow for root growth by urban trees. It is generally comprised of a certain percentage of soil and carefully graded crushed gravel.

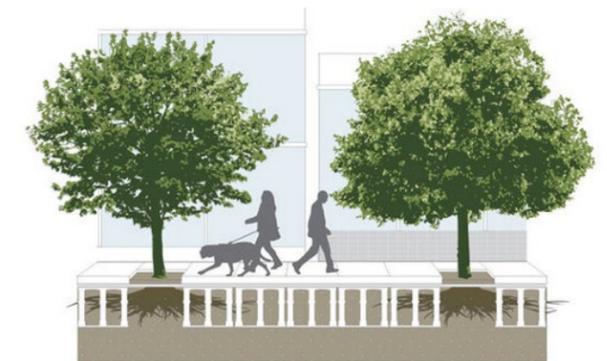
Structural Cells & Suspended Pavement

Suspended pavement systems allow for the weight of hardscape elements to be supported while providing a larger area of uncompacted soil for trees to use. Suspended pavement systems are typically modular, such as the Silva Cell system.

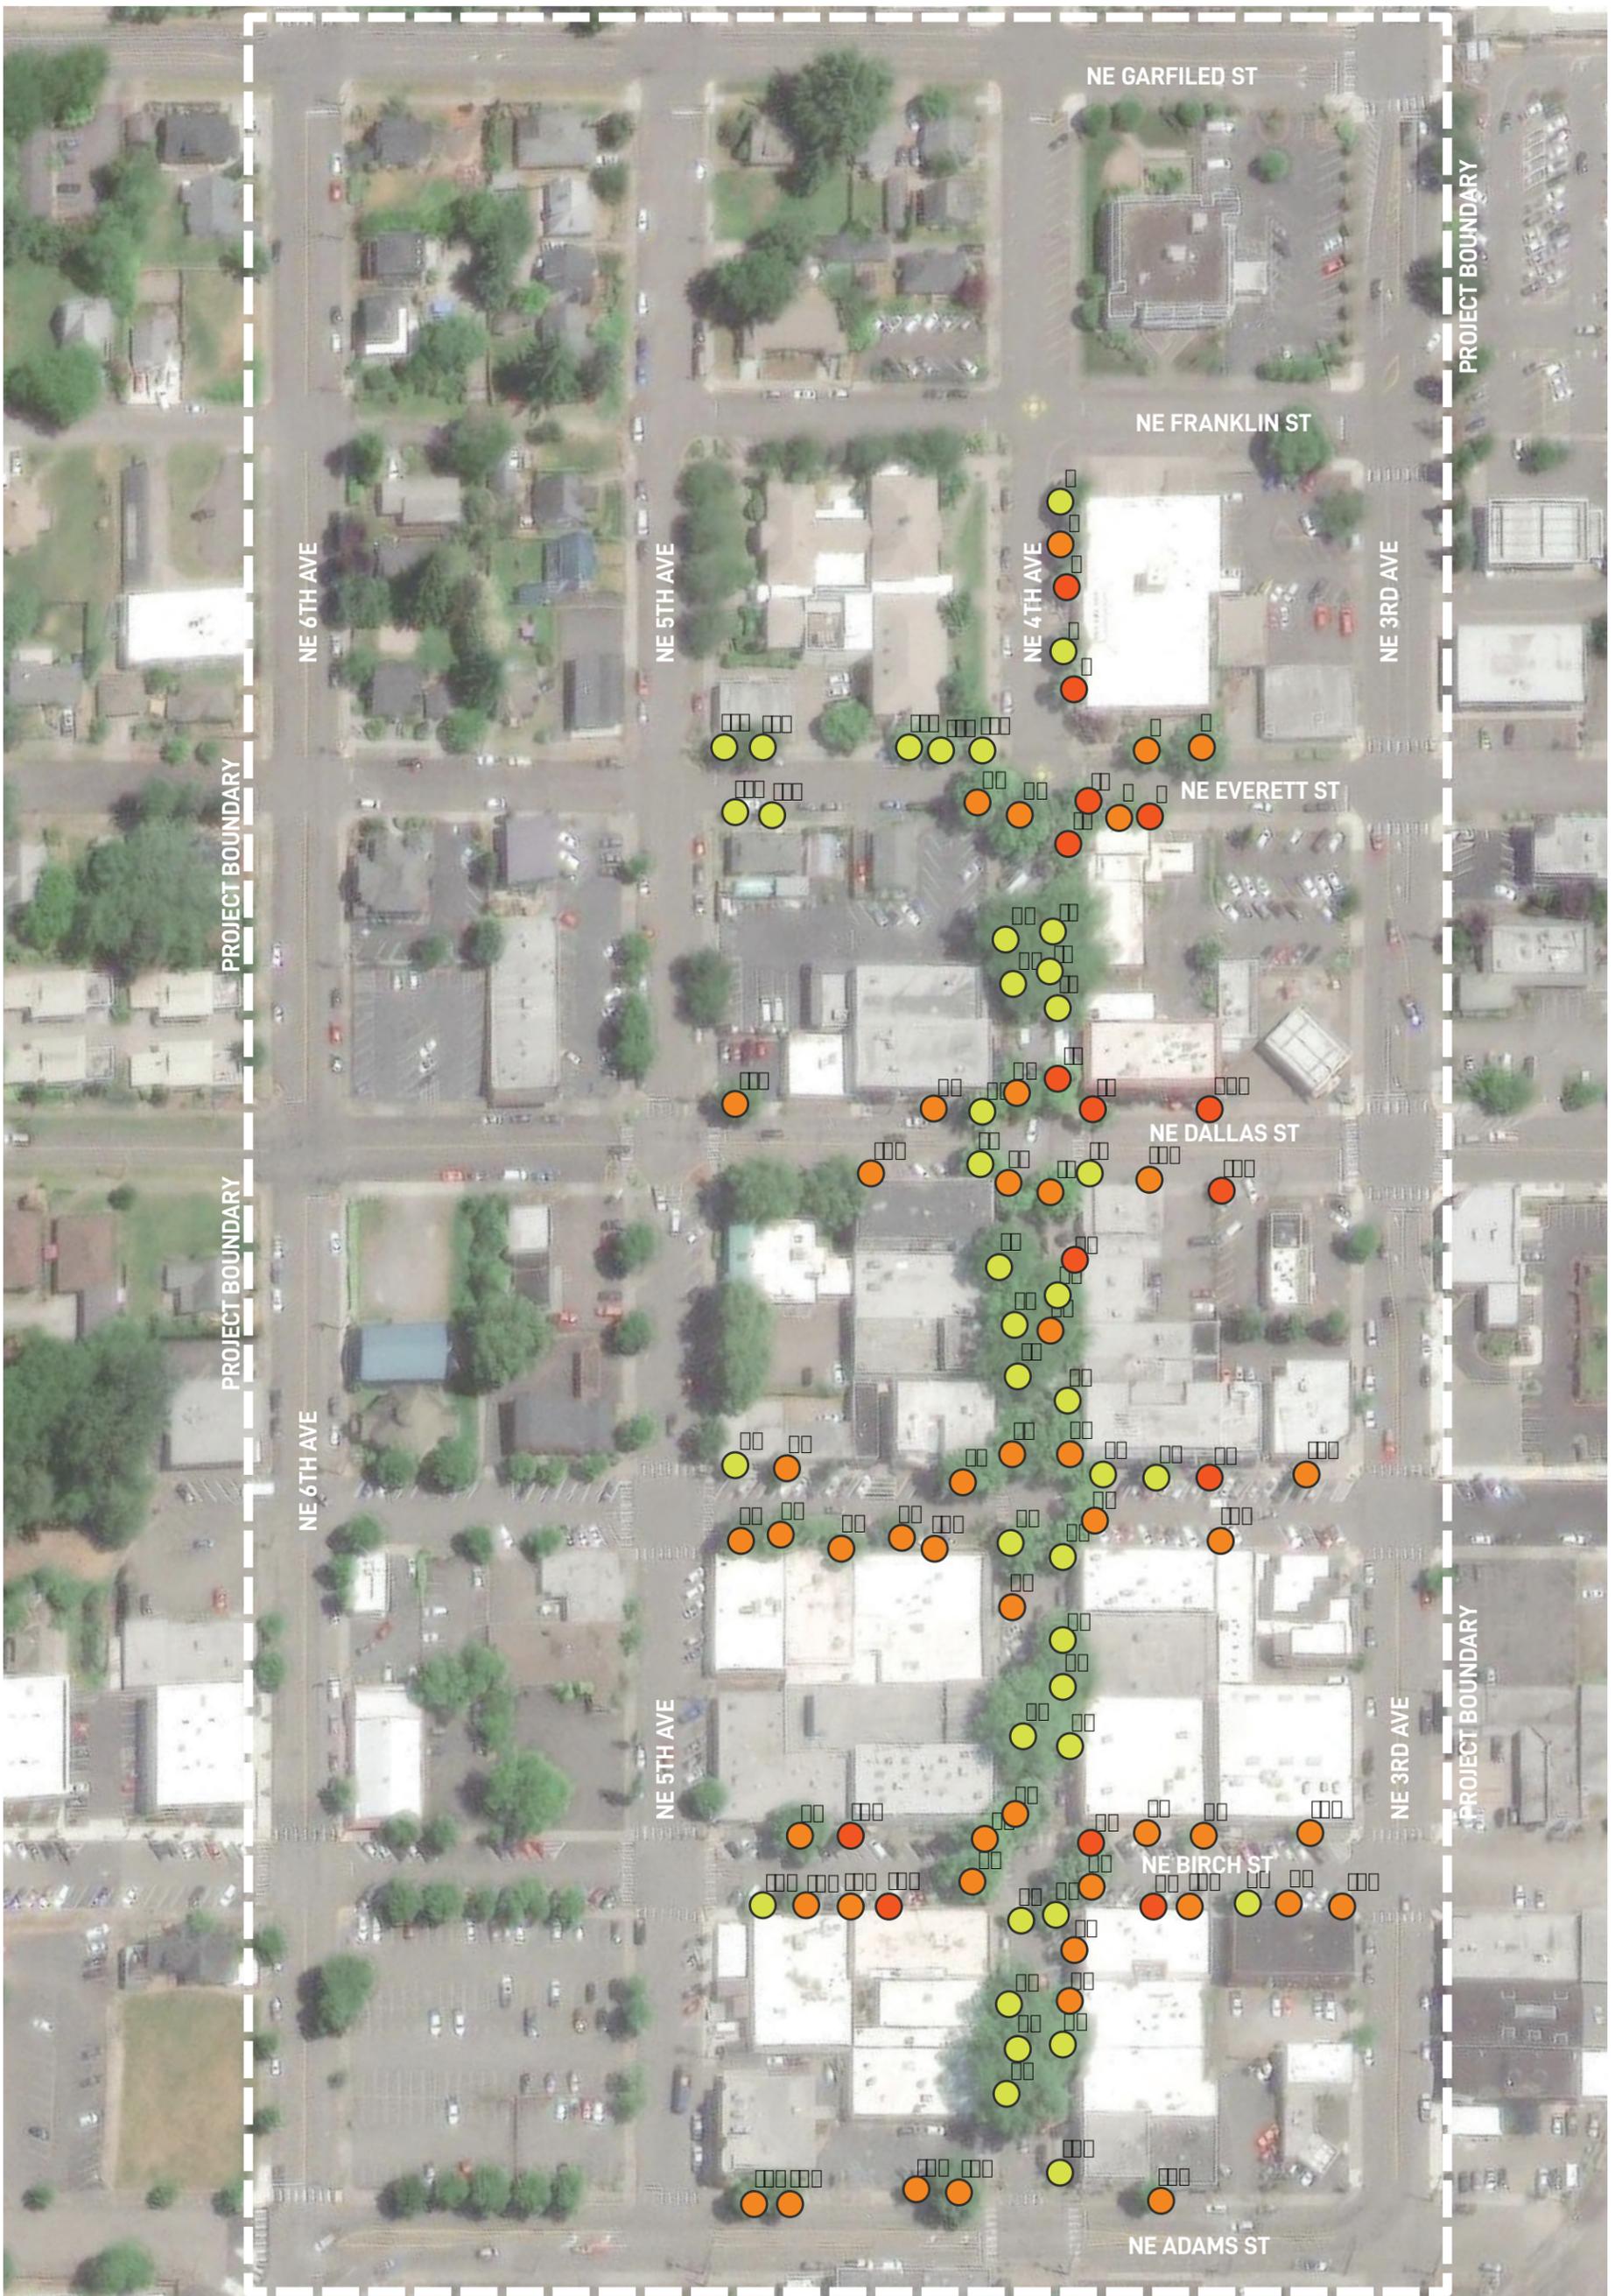
TREE REMOVAL PHASING PLAN

Tree locations from GIS information provided by New Day Arborist

- LEVEL 1 (15 trees)
- LEVEL 2 (46 trees)
- LEVEL 3 (40 trees)

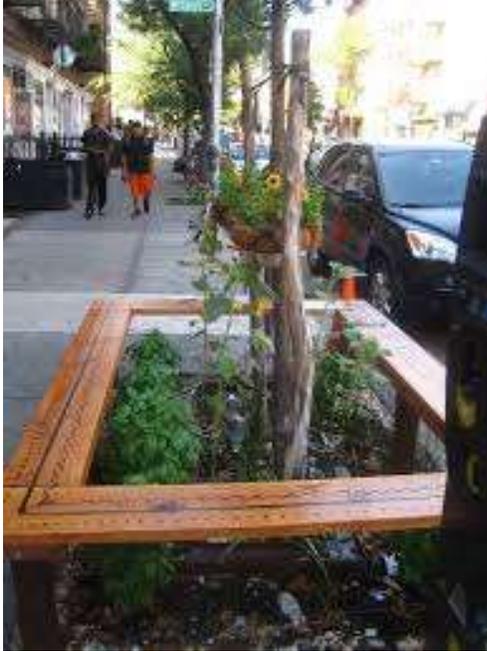
One idea for a more interesting planting space.

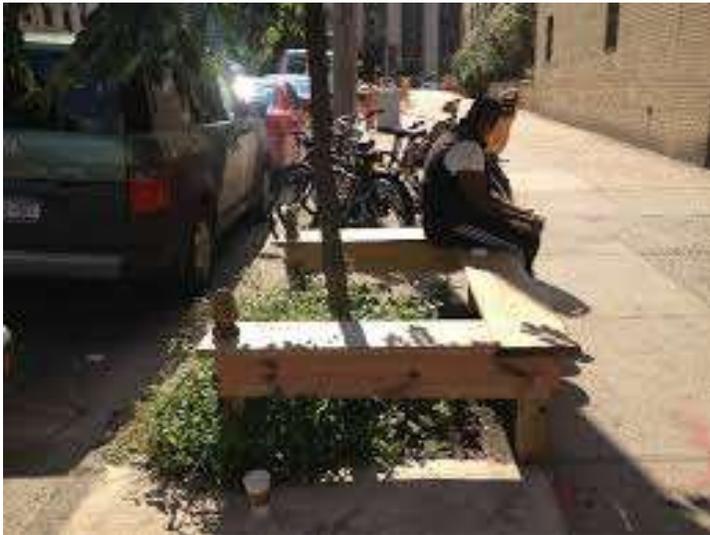
Creating larger openings for the trees, and adding a more “interactive” place for pedestrians.

This helps to reduce the amount of compacted soil around the tree. The planters should be as large as possible. Overall, my idea is fewer trees, but higher end species, quality, and more consideration to location through the downtown area.
