# Santa Cruz County Flood Control and Water Conservation District – Zone 5 Draft Storm Drain Master Plan Update 2023

**PREPARED FOR:**  
Santa Cruz County  
FCWCD Zone 5  
701 Ocean Street  
Santa Cruz, CA 95060

**PREPARED BY:**  
Schaaf & Wheeler  
870 Market Street, Suite 1278  
San Francisco, CA 94102

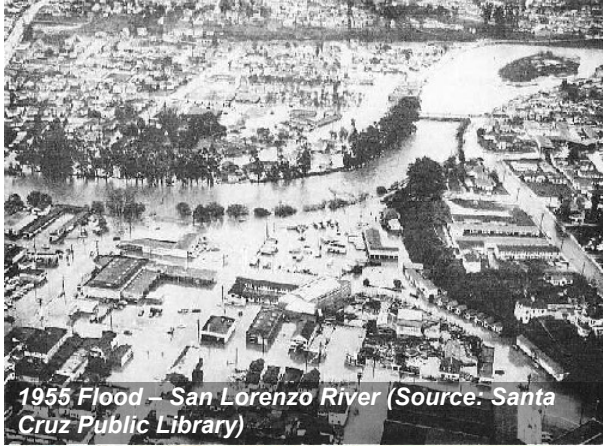
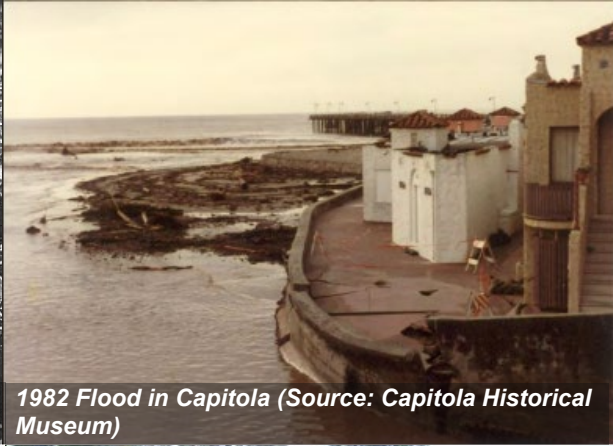
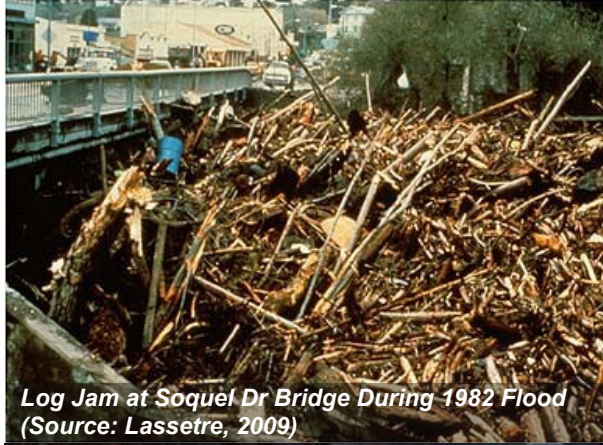
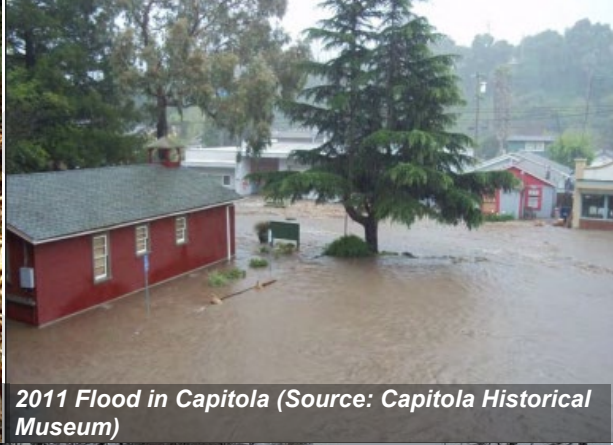
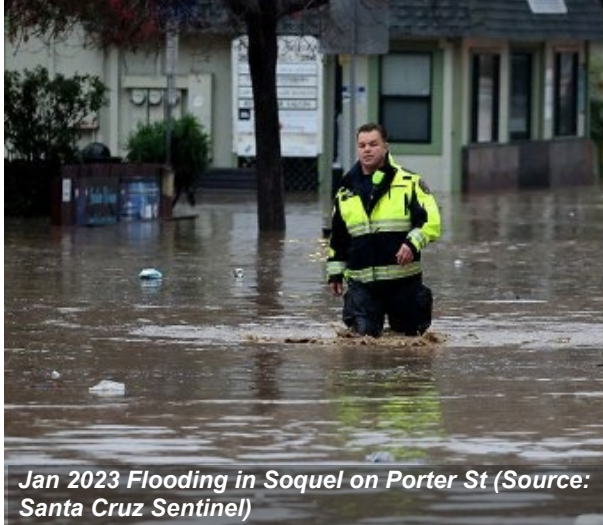
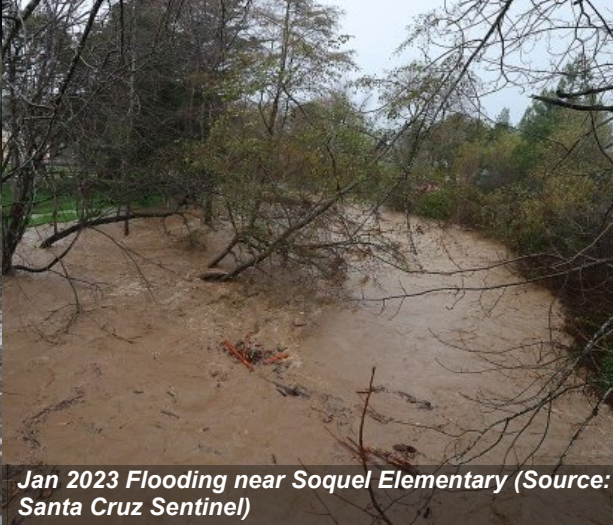
**Figure 2-5: Photos of Historical Flooding in Santa Cruz County and City of Capitola**

Photos of various flood events and damages are shown in Figure 2-5.

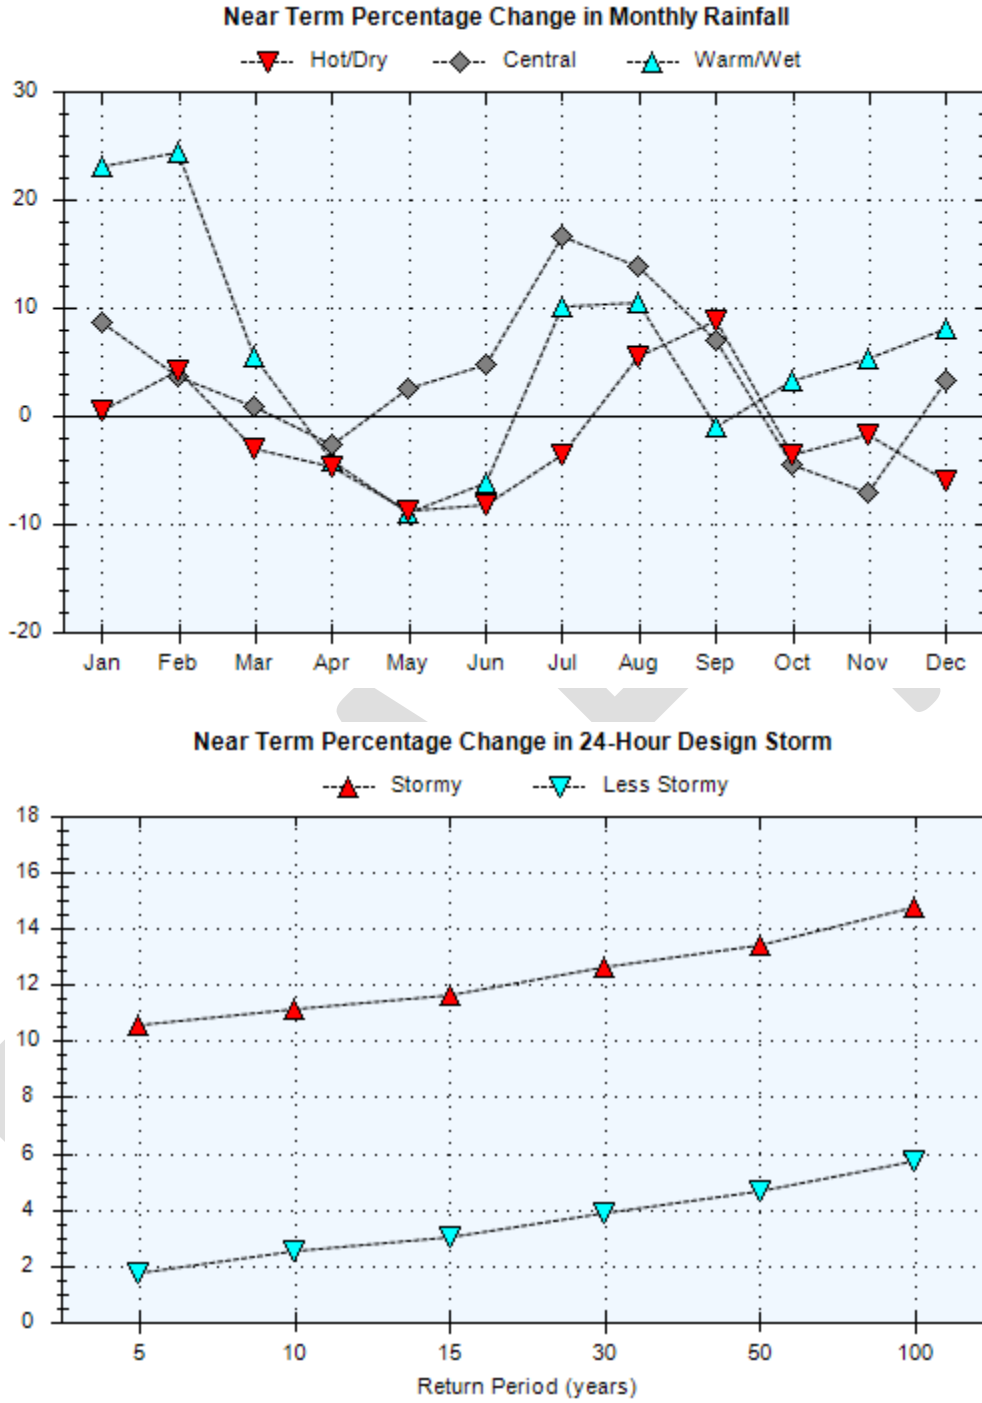
Figure 4-3: Near-Term Monthly Rainfall and 24-Hour Design Storm SWMM-CAT Predictions (95010 Zip Code)

The models also consider the potential impacts of climate change. This is accomplished by using EPA SWMM Climate Adjustment Tool (SWMM-CAT). The tool provides location-specific adjustment factors for Near-Term (2035) and Far-Term (2060) projects derived from global climate change model developed by the World Climate Research Program. The tool generates adjustment factors for several climate parameters. However, this analysis is primarily concerned with future changes in precipitation. Predictions generated by the tool are shown in Figure 4-3 and Figure 4-4 for near- and far-term cases, respectively.

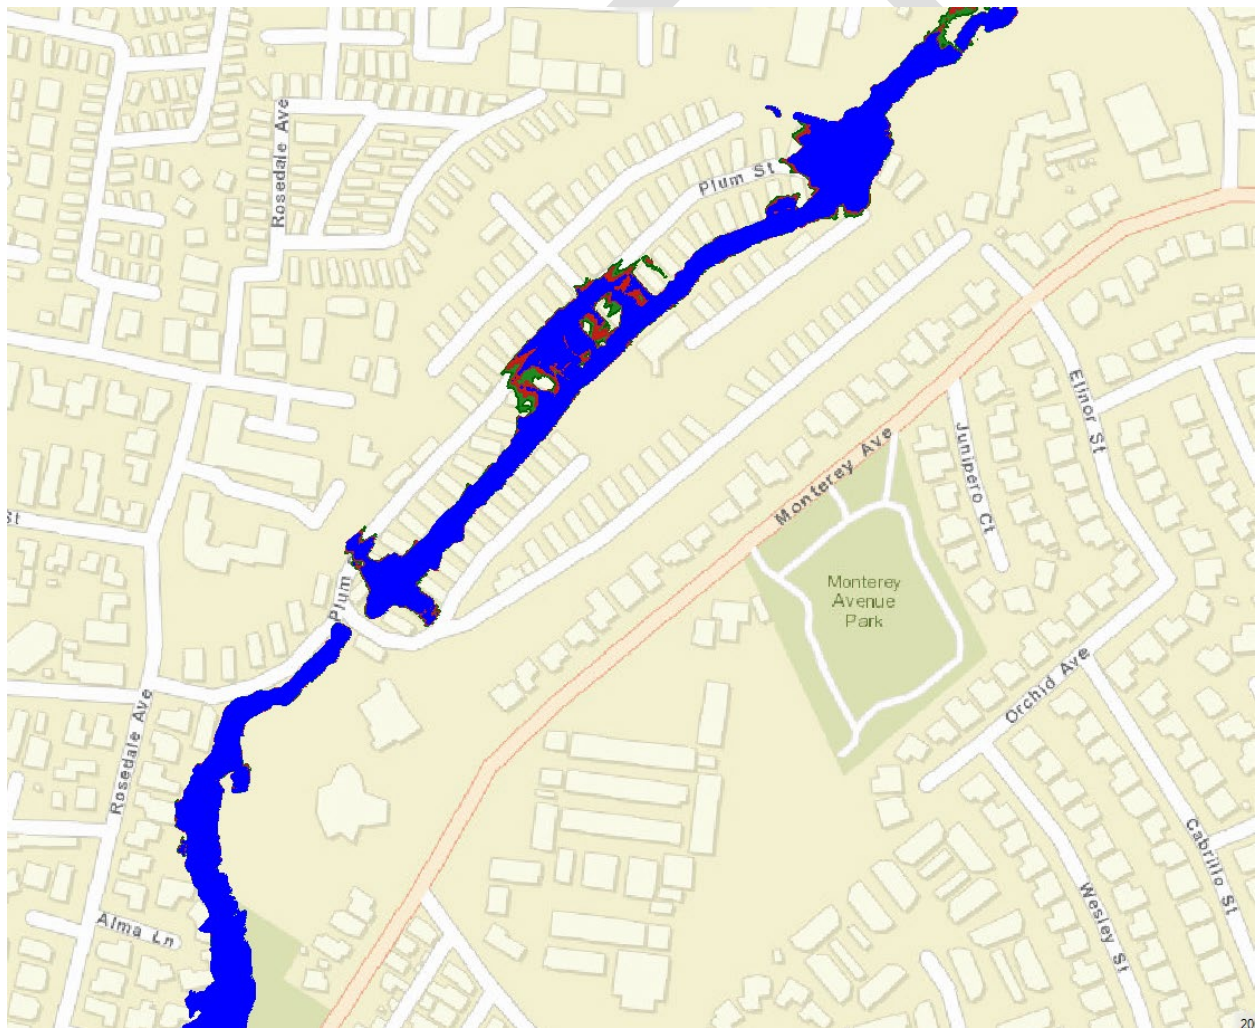
The HEC-RAS model has also been used to evaluate the 100-year event peak flow rate and climate change impacts on the channel for two scenarios. In the first scenario, the existing culverts remain in place and in the second, the proposed capacity improvements to the culverts are constructed.

**Figure 5-7: Noble 100-yr HEC-RAS (with Existing Culverts) Climate Change Model Inundation, Including Existing Condition (Blue), with 12% Increase in Runoff (Red), and with 25% Increase in Runoff (Green)**

The model results indicate that with the proposed CIP projects completed (Noble Upstream and Noble Downstream), there is some improvement in the 100-year floodplain. However, even with the CIPs in place, the channel itself lacks conveyance capacity to contain the 100-year peak flow rate. For both scenarios, increased precipitation depth and flow rate associated with climate change predictions does increase flooding outside of the channel and could impact some properties around Plum Street.

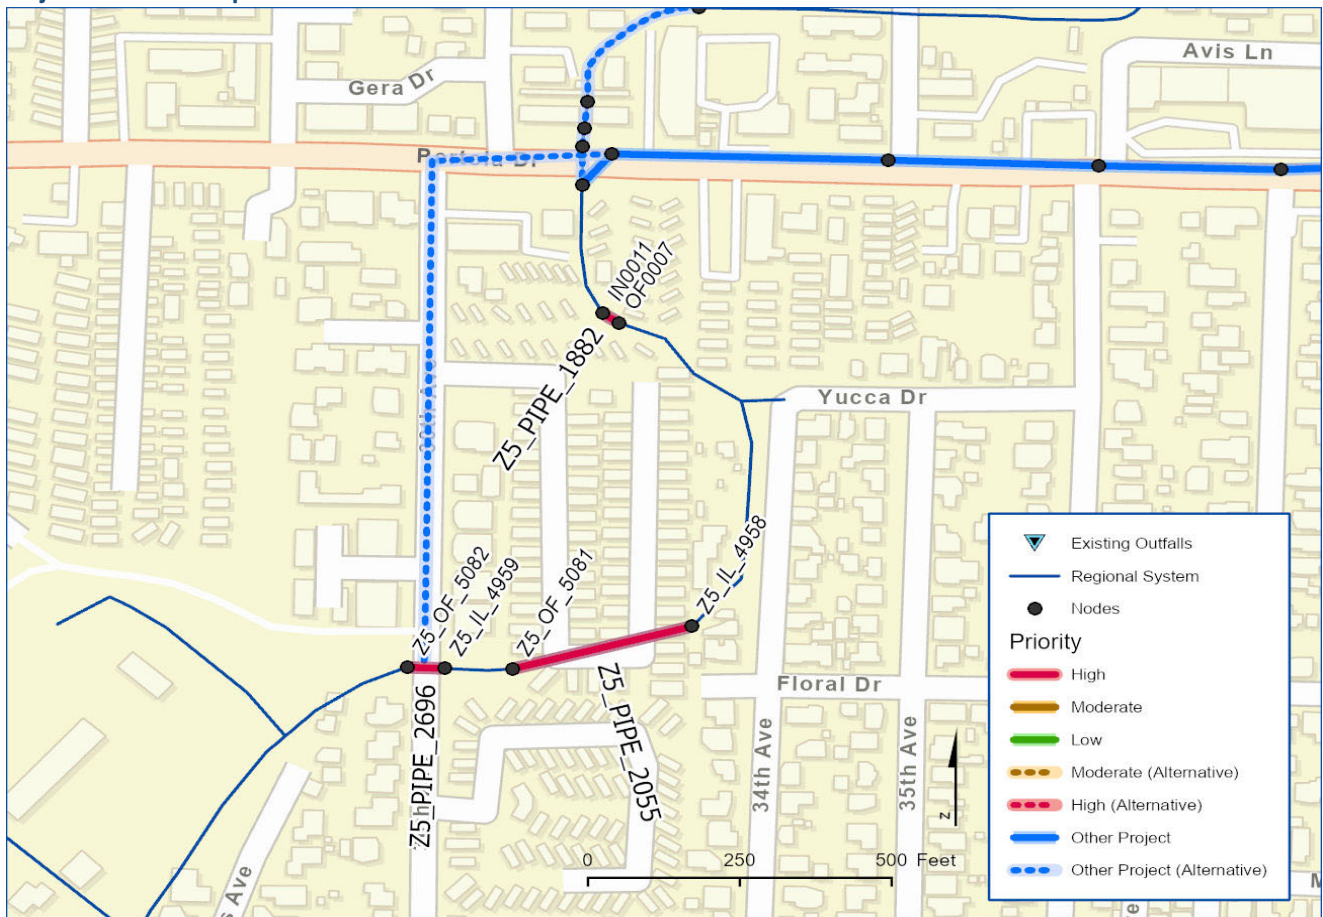
**J. Project Location Map:**

Ex. Size (in)	Replacement Pipe Size (in)	Parallel Pipe Diam (in)	Length (ft)
57 x 84	60 x 120	120	33
72	84	42	366

**I. Alternatives:** Install parallel pipe (see Project ID 2A for alternative project alignment within ROW)

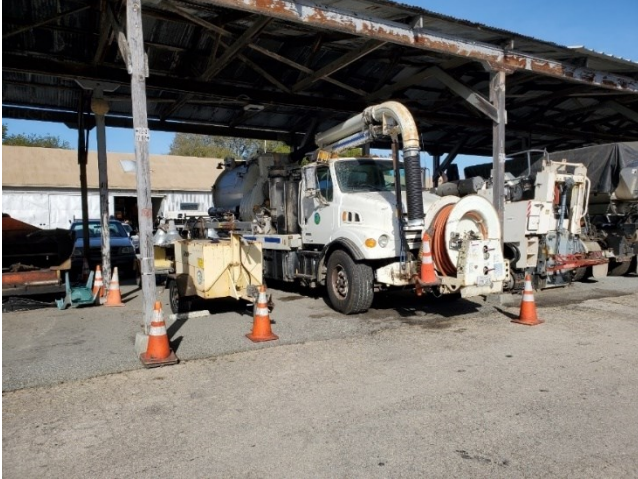
- Vactor Truck (**Figure 2**)
  - Used every day in the fall between August and October for NPDES work
  - Used ad-hoc other times of the year
  - One vactor truck is available for use

**Figure 2. Vector Truck at Brommer Yard**

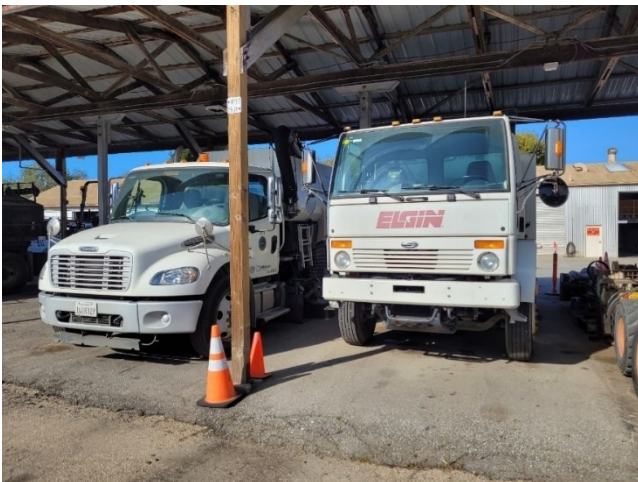
- Sweepers (**Figure 3**)
  - Two sweepers including a Vac Sweeper and Elgin Conveyor sweeper
  - Run multiple times per week following a pre-set route
  - Sweepers are run simultaneously at times
  - Takes about one month to sweep Zone 5
  - Sweeping quantities are calculated in Lucity
  - Average 2,500 miles of sweeping each year

**Figure 3. Sweepers at Brommer Yard**

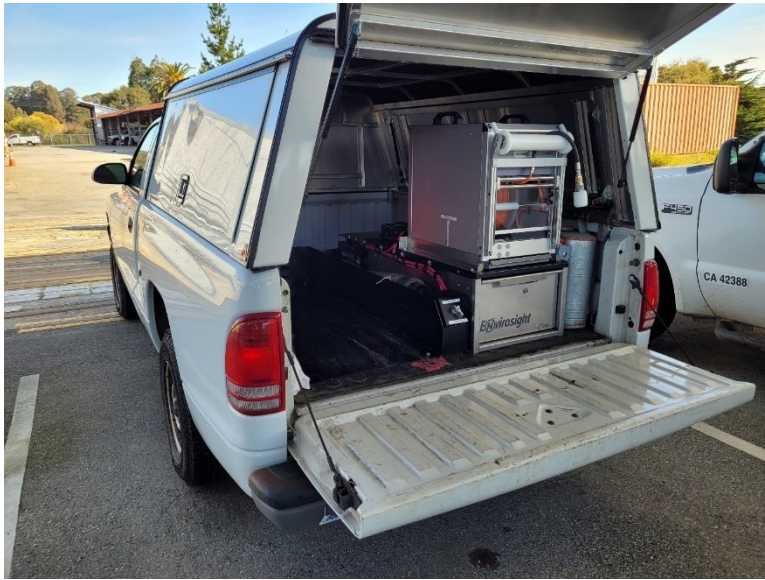
- CCTV camera truck (**Figure 4**)
  - New addition in 2021
  - 400 feet of cable
  - Superintendent and supervisors direct use of camera truck
  - No routine program in place, used to video specific neighborhood as part of a long-term study
  - Storm drain CCTV camera (**Figure 5**)

**Figure 4. CCTV Camera Truck Located at Brommer Yard**

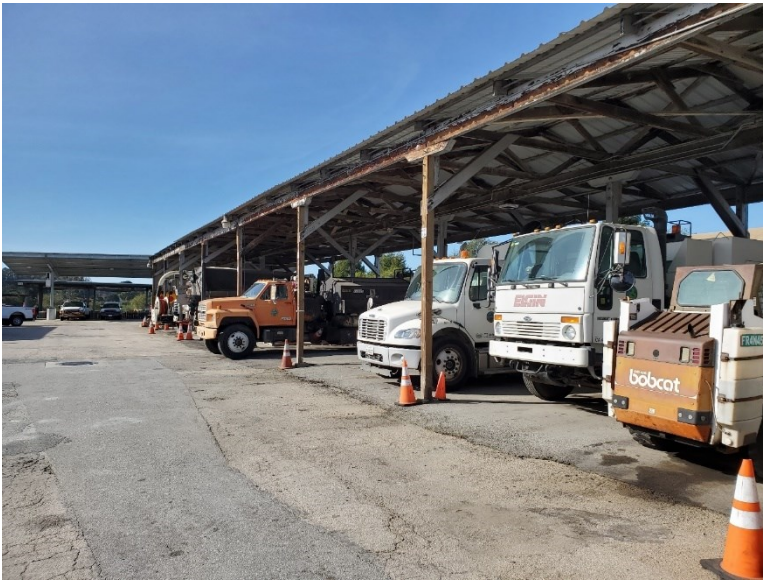
- Misc. equipment (**Figure 6**)
  - Backhoe, dump truck, excavators, loaders, and other equipment available to all County staff including O&M
  - Tablets (total tablet count not determined, each person assigned a tablet)
  - Android tablets run Lucity, Collector, and Survey123 – currently meeting the needs of field staff (**Figure 7**)
  - Various handheld equipment including a Ventis MX-4 handheld multi-gas detector (**Figure 8**)

**Figure 6. Miscellaneous Brommer Yard Equipment**

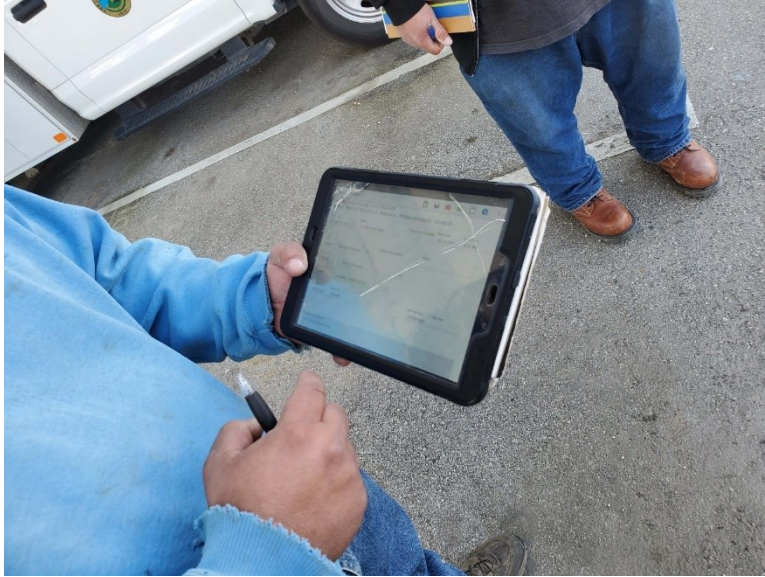
*Figure 7. Field Tablet Running Lucity*

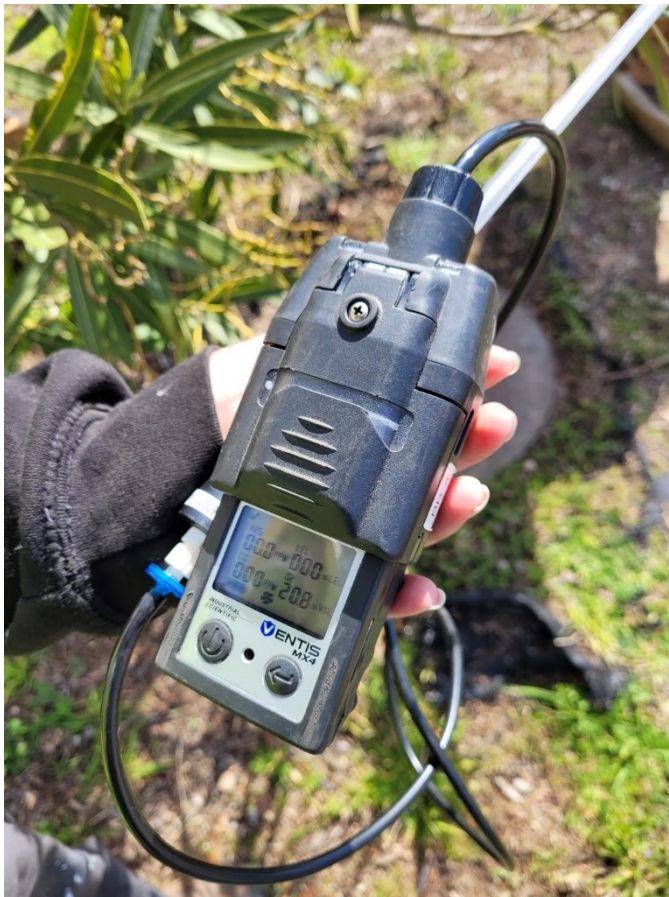
*Figure 8. Ventis MX-4 Handheld Multi-Gas Detector*

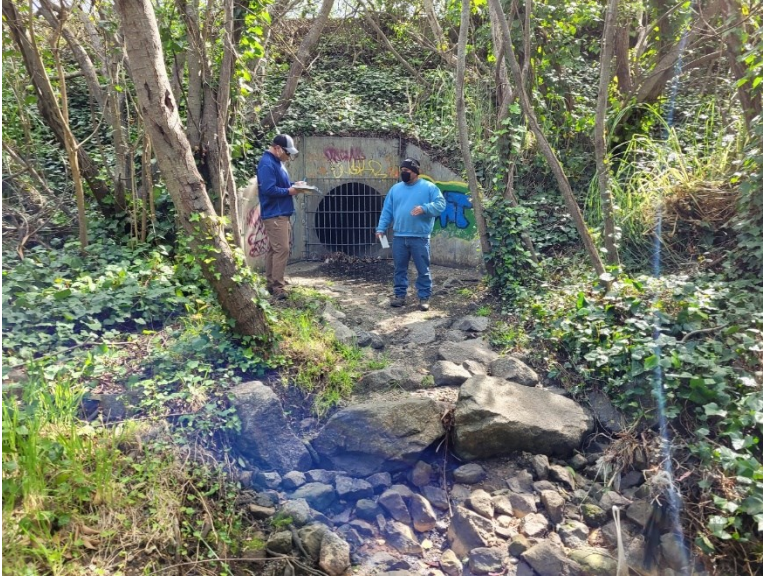
Simpkins Ditch (**Figure 9**) is one of the higher priority ditches that requires regular maintenance. The open ditch and adjoining structures and conduits are located behind the Simpkins Family Swim Center. This facility experiences debris and

garbage build-up behind an existing trash rack. Maintenance is required in the spring, summer, and fall. Storm events also trigger the need for maintenance.

**Figure 9. Simpkins Ditch and Outfall with Trash Rack**

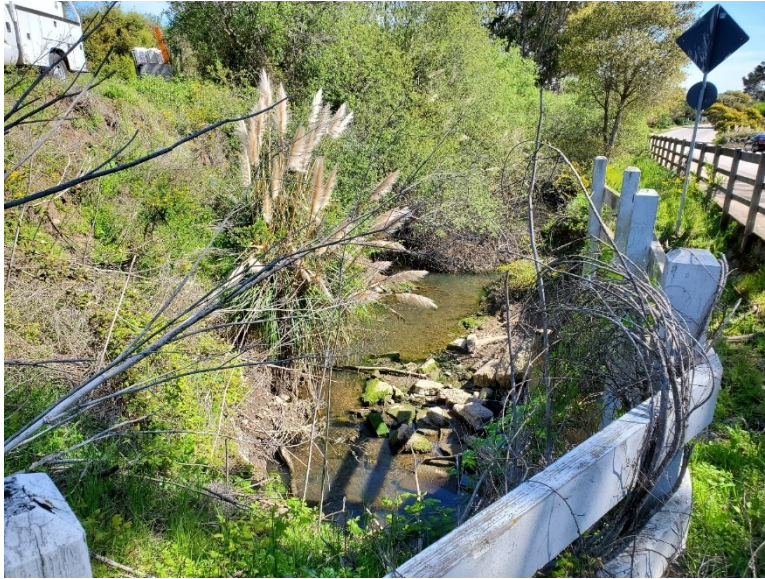
Rodeo Gulch (**Figure 10**) outfalls to Corcoran Lagoon, along Portola Drive and near Richmond Drive. This facility and adjoining structures and conduits require periodic maintenance. However, conducting maintenance is complicated because of existing regulatory permits from the California Department of Fish and Wildlife that limit the type of maintenance and time of year maintenance can be performed.

**Figure 10. Rodeo Gulch at Corcoran Lagoon Outfall**

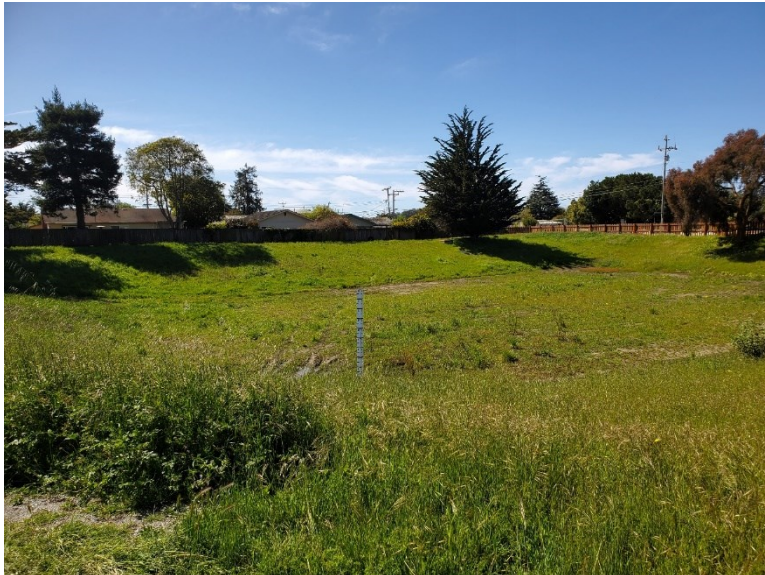
- 38th avenue detention basin - The 38th Avenue detention basin (**Figure 11**) is a unique storm drain asset that is within the Capitola City limits but is maintained by Zone 5. This basin includes a series of overflow channels, head gates, pumps, and sumps that help control water levels during large rain events. There are four (two large and two small) pumps that are monitored by the Sanitation Division. During 2020 and 2021, significant maintenance was performed at the 38th Avenue detention basin, including removal of 400 cubic yards of material, constructing a perimeter fence, installing plantings, replacing, and maintaining the pump system, and confirming the system was operational.

**Figure 11. 38th Avenue Detention Basin**

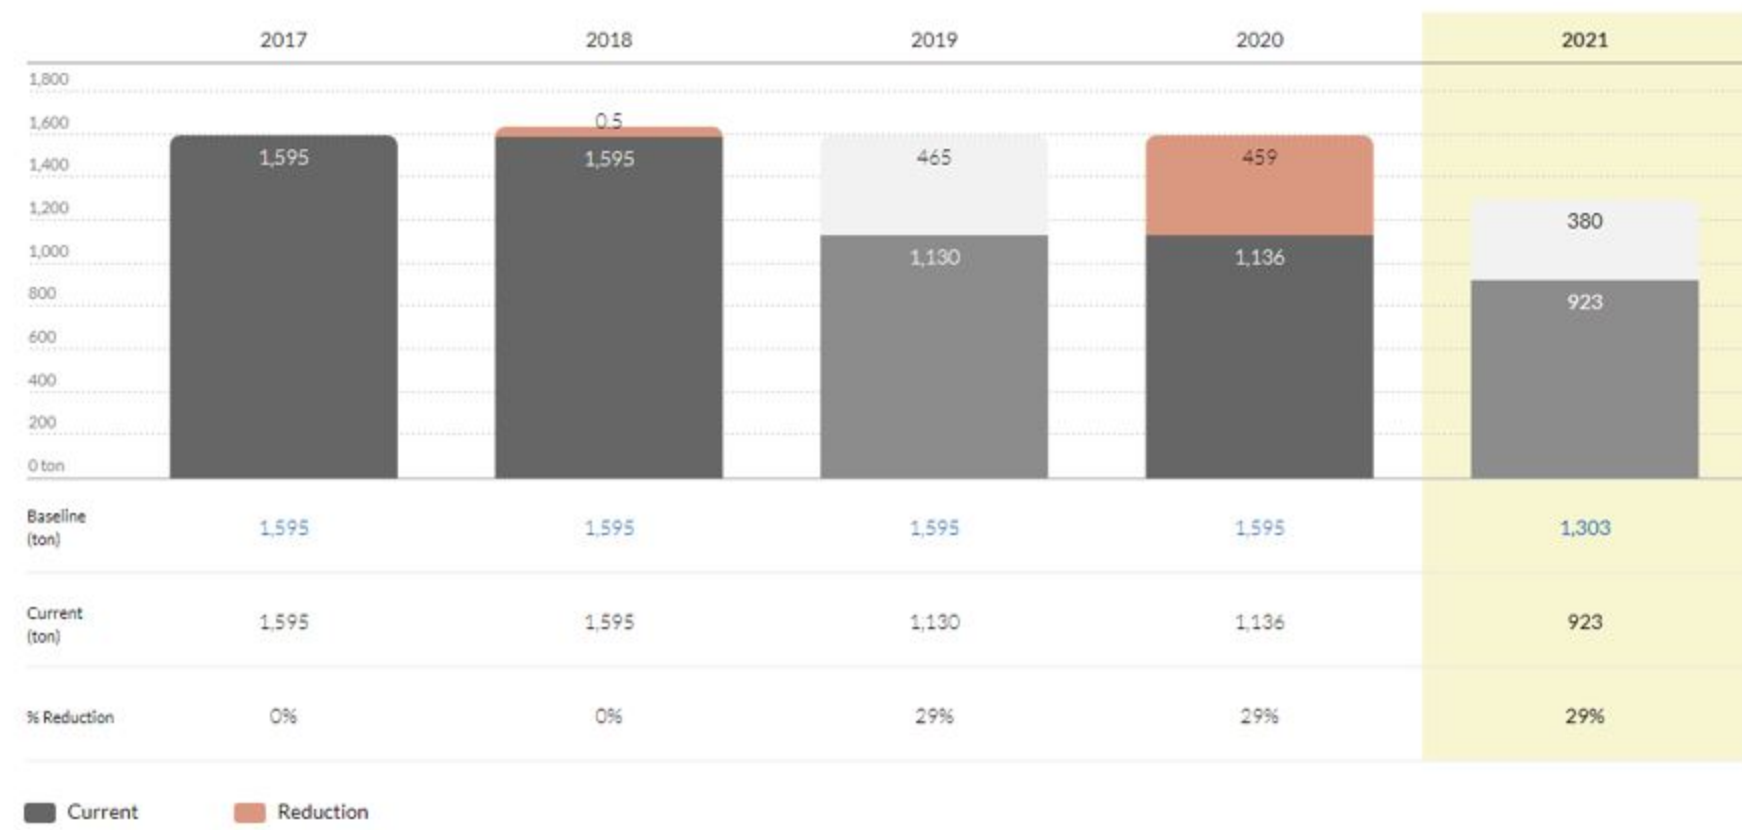
2017	2018	2019	2020	2021
Baseline (ton)	1,595	1,595	1,595	1,595	1,303
Current (ton)	1,595	1,595	1,130	1,136	923
% Reduction	0%	0%	29%	29%	29%
