Effingham County Public Works

Facilities Condition Assessment

Prepared for:
Effingham County
Department of Facilities

Prepared by;
Pond & Company

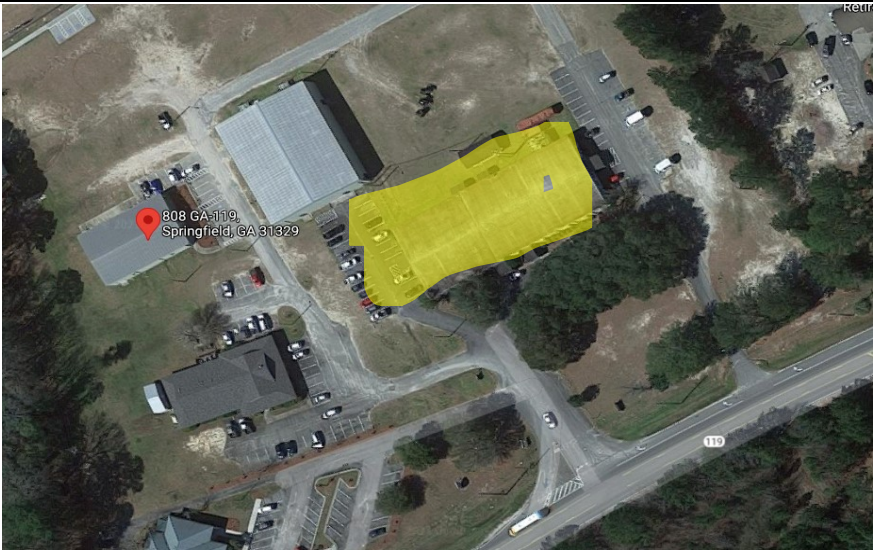
<p>Former school building that has been subdivided to multiple suites for use with the county. Renovations of building have happened multiple times with different levels of finish updates.</p>	
PRIORITY		INVENTORY		FCI / FCNI
NOTE - Links above to tabs in Facility Report for this Facility Only

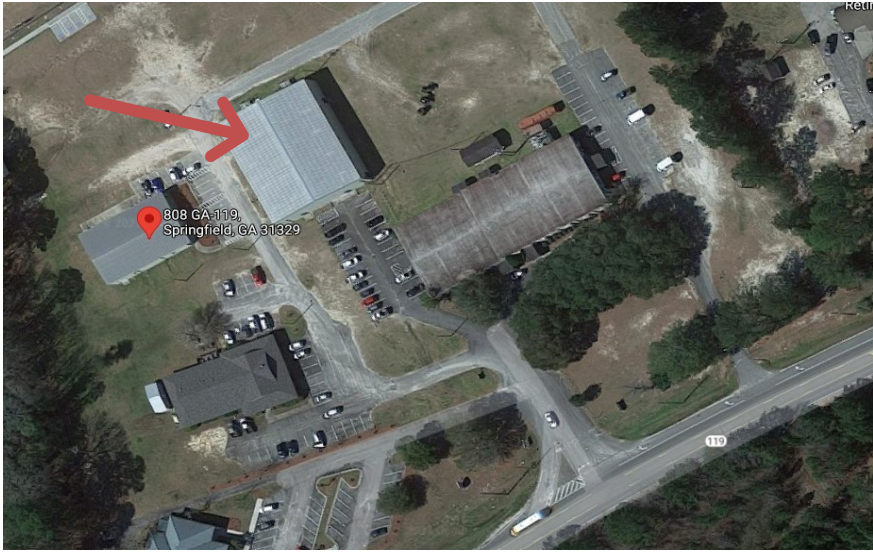
Gymnasium facility.	
PRIORITY		INVENTORY		FCI / FCNI
NOTE - Links above to tabs in Facility Report for this Facility Only

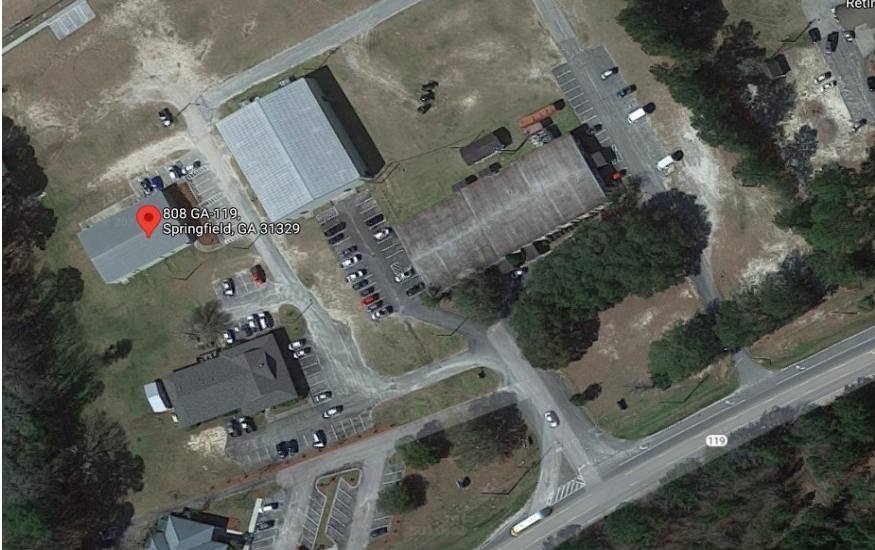
FACILITIES CONDITION ASSESSMENT				
BUILDING NAME	NUMBER	ADDRESS	BUILT	RENOVATED
Effingham County 119 Annex Office	3 / 768	768 GA Highway 19, Effingham GA	tbd	tbd
SQUARE FOOTAGE	PRIORITY	FCI	FCNI	
5,393	3.45	0.19	0.18	
IMAGE AND AERIAL			EXECUTIVE SUMMARY

<p>Former school complex building that has been updated to be auxiliary building for Parks and Recreation Department.</p>	
PRIORITY		INVENTORY		FCI / FCNI
NOTE - Links above to tabs in Facility Report for this Facility Only

Category	Priority	Commentary	Action	Picture
GENERAL	3	<i>Section Score</i>		
Overall	3	In general finish condition of building is in need of updating and repair. The structure of the building does not have any observed major deficiencies. The roofing, flashing, caulking and all finishes are at replacement level.	Recommend full interior renovation of building for all new finishes, fixtures and walls.	
SITE	3.67	<i>Section Score</i>		
Site	4	Site is relatively flat with mix of paved areas, landscaping, hardscaping and grass.		
Topography	4	Minor slope away from building to drainage areas.	Continued maintenance recommended.	
Storm Water	4	All water is surface drained to swales and roadside ditch system.	Continued maintenance recommended.	
Ingress/Egress	4	Asphalt paved entry area from main road to site.	Continued maintenance recommended.	
Paving	3	Asphalt paving. Majority of paving in usable condition. Areas noted areas where paving is in need of repairs.	Recommend a re-surface of all paved areas. Careful attention should be paid to drainage patterns and to keep flow positive.

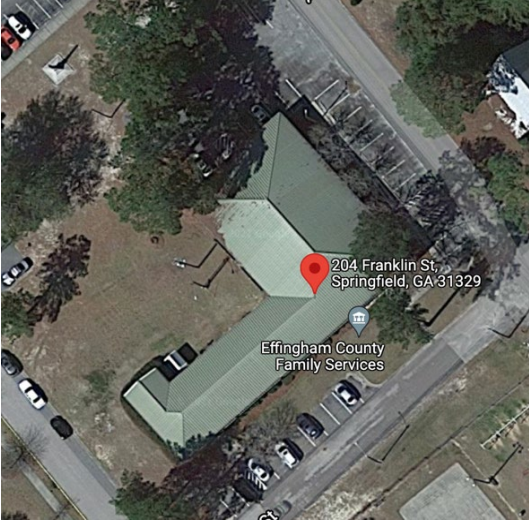
<p>DFCS office building located within the judicial complex.</p>	
PRIORITY		INVENTORY		FCI / FCNI
NOTE - Links above to tabs in Facility Report for this Facility Only

Category	Priority	Commentary	Action	Picture
GENERAL	3	<i>Section Score</i>		
Overall	3	In general finish condition of building is in need of updating and repair. The structure of the building does not have any observed major deficiencies. The roofing, flashing, caulking and all finishes are at replacement level.	Recommend full interior renovation of building for all new finishes, fixtures and walls.	
SITE	3.63	<i>Section Score</i>		
Site	4	Site is relatively flat with mix of paved areas, landscaping, hardscaping and grass.		
Topography	4	Minor slope away from building to drainage areas.	Continued maintenance recommended.	
Storm Water	4	All water is surface drained to swales and roadside ditch system.	Continued maintenance recommended.	
Ingress/Egress	4	Asphalt paved entry area from main road to site.	Continued maintenance recommended.	
Paving	3	Asphalt paving. Majority of paving in usable condition. Areas noted areas where paving is in need of repairs.	Recommend a re-surface of all paved areas. Careful attention should be paid to drainage patterns and to keep tied into existing systems and judicial complex drainage.

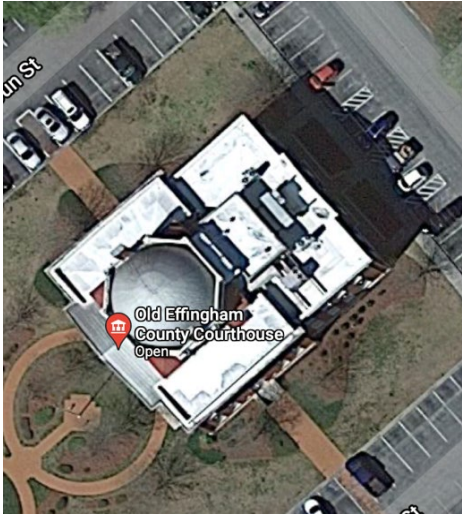
<p>Assessment of this facility is limited to roof FCA only. The roof portion surveyed is approximated based off drawings provided.</p>	
PRIORITY		INVENTORY		FCI / FCNI
NOTE - Links above to tabs in Facility Report for this Facility Only

Category	Priority	Commentary	Action	Picture
GENERAL	3.5	<i>Section Score</i>		
Overall	3.5	Assessment is limited to roof FCA only.	Recommend continued maintenance and repair of flashing at all penetrations, see below.	
BUILDING	3.25	<i>Section Score</i>		
Roof	3.5	TPO roof system over insulation. Roof original to renovated from facility from observation.	Recommend all flashings be maintained and or repaired. Noted areas where flashing sealants were not in optimal condition.	Photo
Roof Flashing	3	Typical flashing details at all penetrations.	Recommend all penetrations be monitored for proper sealing. Recommend all curb cuts be inspected to ensure insulation present for conditioned air.	
END OF REPORT

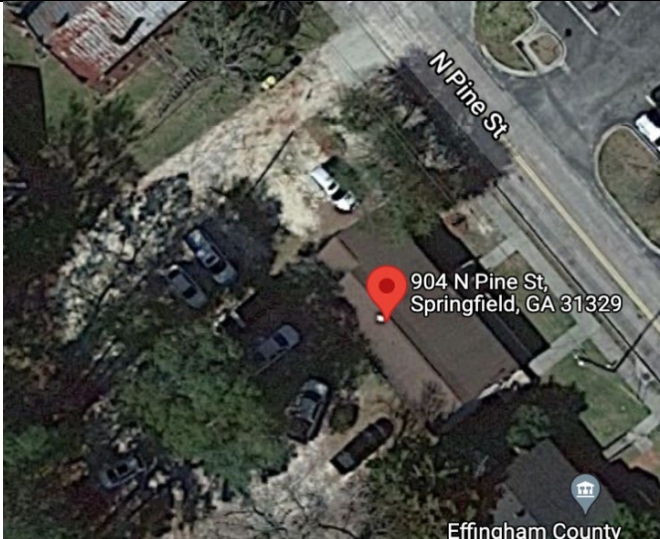
<p>Single story former residential house being utilized as office space for Effingham County</p>	
PRIORITY		INVENTORY		FCI / FCNI
NOTE - Links above to tabs in Facility Report for this Facility Only

Category	Priority	Commentary	Action	Picture
GENERAL	3	<i>Section Score</i>		
Overall	3	In general finish condition of building is in need of updating and repair. The structure of the building does not have any observed major deficiencies.	Recommend full interior renovation of building for all new finishes, fixtures and walls. Building is a residential construction and modifications should be limited to non structural items.	
SITE	3.88	<i>Section Score</i>		
Site	4	Site is relatively flat with mix of paved areas, landscaping, hardscaping and grass.		
Topography	4	Minor slope away from building to drainage areas.	Continued maintenance recommended.	
Storm Water	4	All water is surface drained to swales and roadside ditch system.	Continued maintenance recommended.	
Ingress/Egress	4	Gravel entry way off main road.	Continued maintenance recommended.	
Paving	4	No paving on site.		
Sidewalks	3	Concrete side walks stop short of road. Ramps at the front area are concrete.	Areas noted of cracking. Recommend repair all cracked and damaged areas. Recommend ramps and porch have new code compliant railings installed.

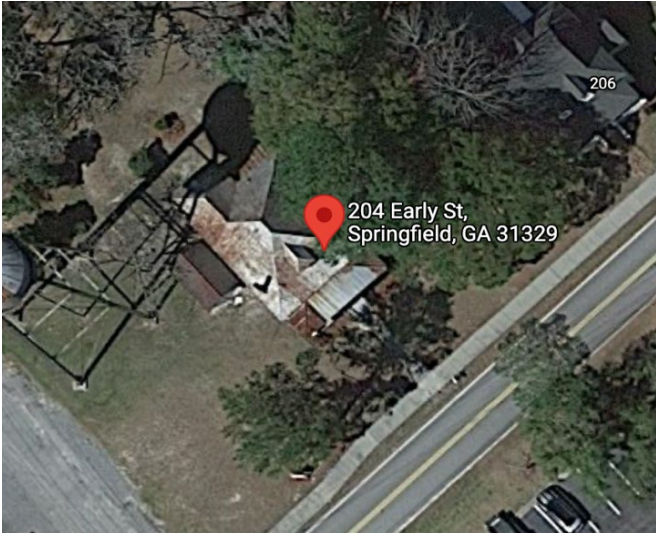
<p>Single story former residential house being utilized as office space for Effingham County</p>	
PRIORITY		INVENTORY		FCI / FCNI
NOTE - Links above to tabs in Facility Report for this Facility Only

Category	Priority	Commentary	Action	Picture
GENERAL	3	<i>Section Score</i>		
Overall	3	In general finish condition of building is in need of updating and repair. The structure of the building does not have any observed major deficiencies.	Recommend full interior renovation of building for all new finishes, fixtures and walls. Building is a residential construction and modifications should be limited to non structural items.	
SITE	3.88	<i>Section Score</i>		
Site	4	Site is relatively flat with mix of paved areas, landscaping, hardscaping and grass.		
Topography	4	Minor slope away from building to drainage areas.	Continued maintenance recommended.	
Storm Water	4	All water is surface drained to swales and roadside ditch system.	Continued maintenance recommended.	
Ingress/Egress	4	Gravel entry way to site.	Continued maintenance recommended.	
Paving	4	No paving on site.		
Sidewalks	3	Concrete side walks stop short of road.	Areas noted of cracking. Recommend repair all cracked and damaged areas.

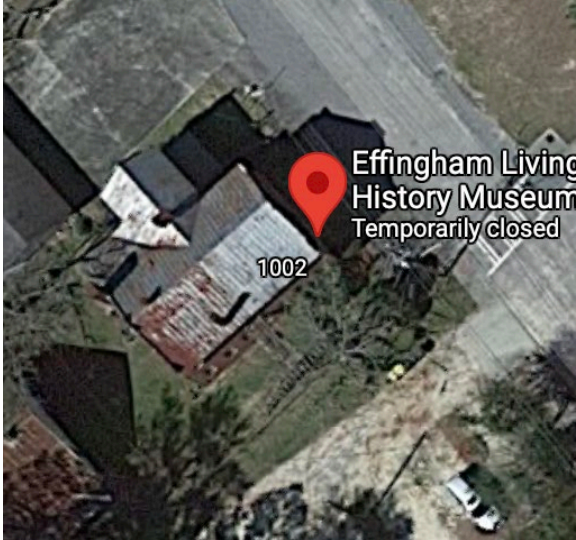
FACILITIES CONDITION ASSESSMENT				
BUILDING NAME	NUMBER	ADDRESS	BUILT	RENOVATED
Effingham County Old Jail Museum	8 / 1002	Effingham GA	tbd	tbd
SQUARE FOOTAGE	PRIORITY	FCI	FCNI	
3,684	3.38	0.20	0.19	
IMAGE AND AERIAL			EXECUTIVE SUMMARY

<p>Historic jail location that has been converted to a museum.</p>	
PRIORITY		INVENTORY		FCI / FCNI
NOTE - Links above to tabs in Facility Report for this Facility Only

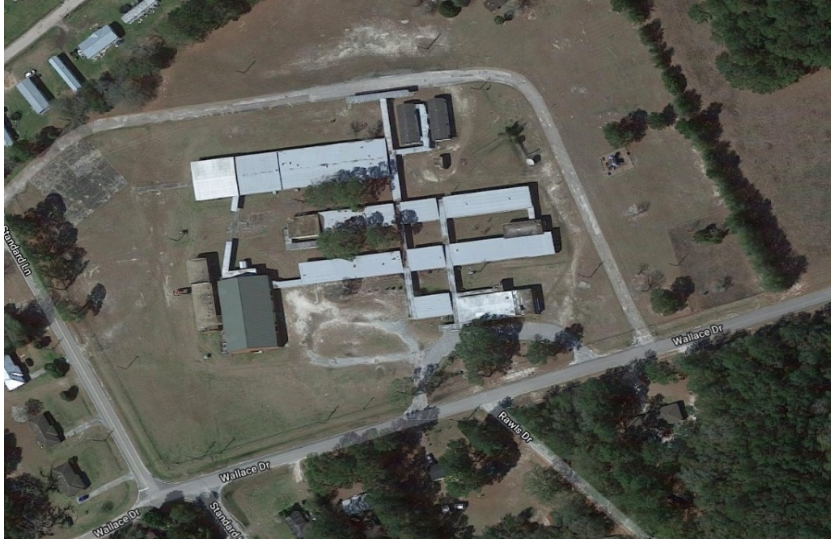
FACILITIES CONDITION ASSESSMENT				
BUILDING NAME	NUMBER	ADDRESS	BUILT	RENOVATED
Effingham County Central School	9 / 434	434 Wallace Drive, Effingham GA	tbd	tbd
SQUARE FOOTAGE	PRIORITY	FCI	FCNI	
59,326	2.02	0.39	0.38	
IMAGE AND AERIAL			EXECUTIVE SUMMARY

<p>Former school complex with multiple buildings that are built over many years. Complex includes former classroom buildings, cafeteria, gymnasium and accessory spaces.</p>	
PRIORITY		INVENTORY		FCI / FCNI
NOTE - Links above to tabs in Facility Report for this Facility Only

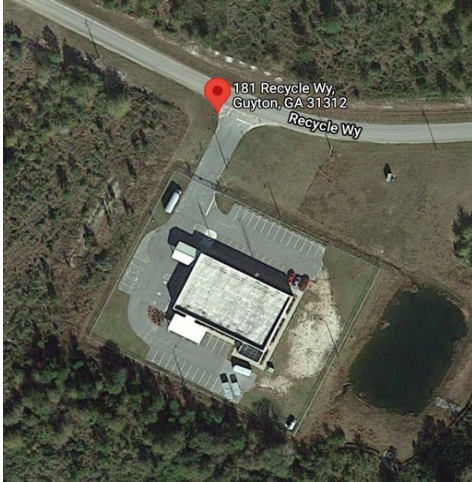
FACILITIES CONDITION ASSESSMENT				
BUILDING NAME	NUMBER	ADDRESS	BUILT	RENOVATED
Effingham County MACC	10 / 181	Effingham GA	tbd	tbd
SQUARE FOOTAGE	PRIORITY	FCI	FCNI	
9,542	4.09	0.03	0.02	
IMAGE AND AERIAL			EXECUTIVE SUMMARY

<p>Building for the coordination of emergency management for Effingham County</p>	
PRIORITY		INVENTORY		FCI / FCNI
NOTE - Links above to tabs in Facility Report for this Facility Only

Category	Priority	Commentary	Action	Picture
GENERAL	4.5	<i>Section Score</i>		
Overall	4.5	Building constructed for use as an emergency operations center. Load bearing CMU single story building.	Recommend continued maintenance of building to make sure building continues to function for designed purpose.	
SITE	4.25	<i>Section Score</i>		
Site	5	Site is relatively flat with mix of paved areas, landscaping, hardscaping and grass.		Photo
Topography	5	Minor slope away from building to drainage areas.	Continued maintenance recommended.	
Storm Water	4	All water is surface drained to swales and roadside ditch system.	Continued maintenance recommended.	
Ingress/Egress	4	Asphalt paved entry area from main road to site.	Continued maintenance recommended.	
Paving	4	Asphalt paving. Majority of paving in usable condition.	Continued maintenance recommended.	
Sidewalks	4	Concrete side walks.	Continued maintenance recommended.

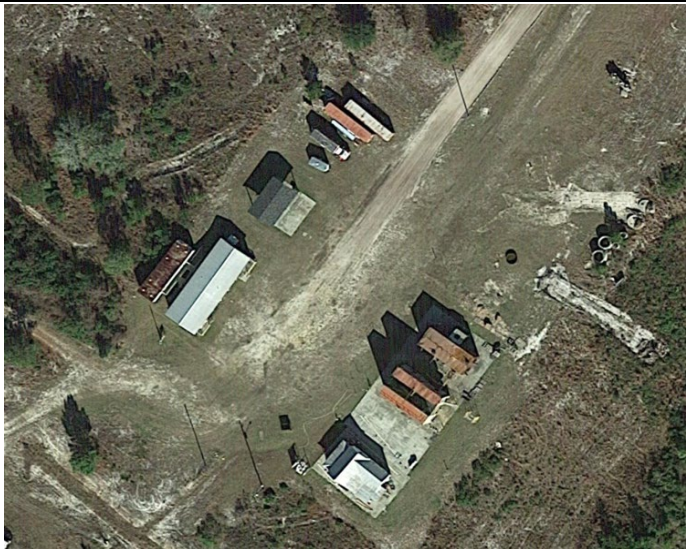
FACILITIES CONDITION ASSESSMENT				
BUILDING NAME	NUMBER	ADDRESS	BUILT	RENOVATED
Effingham County Fire Training	11 / 241	Effingham GA	tbd	tbd
SQUARE FOOTAGE	PRIORITY	FCI	FCNI	
4,500	3.57	0.22	0.21	
IMAGE AND AERIAL			EXECUTIVE SUMMARY

<p>Multiple buildings used for training of fire department. All structures are burned with live fires on a regular basis.</p>	
PRIORITY		INVENTORY		FCI / FCNI
NOTE - Links above to tabs in Facility Report for this Facility Only

Category	Priority	Commentary	Action	Picture
GENERAL	3	<i>Section Score</i>		
Overall	3	The multiple structures included: shipping containers, traditional wood frame house and auxillary structures. Due to nature of buildings use they are showing extreme signs of wear and tear.	Recommend a twice a year inspection of all structures for structural integrity. Due to nature of heat, water, and smoke the building will age more quickly than normal structures.	
SITE	3.86	<i>Section Score</i>		
Site	4	Site is relatively flat with mix of paved areas, landscaping, hardscaping and grass.		Photo
Topography	4	Minor slope away from building to drainage areas.	Continued maintenance recommended.	
Storm Water	4	All water is surface drained to swales and roadside ditch system.	Continued maintenance recommended.	
Ingress/Egress	4	Gravel and dirt road to facilities.	Continued maintenance recommended.	
Paving	3	Gravel and dirt parking area.	Continued maintenance recommended.

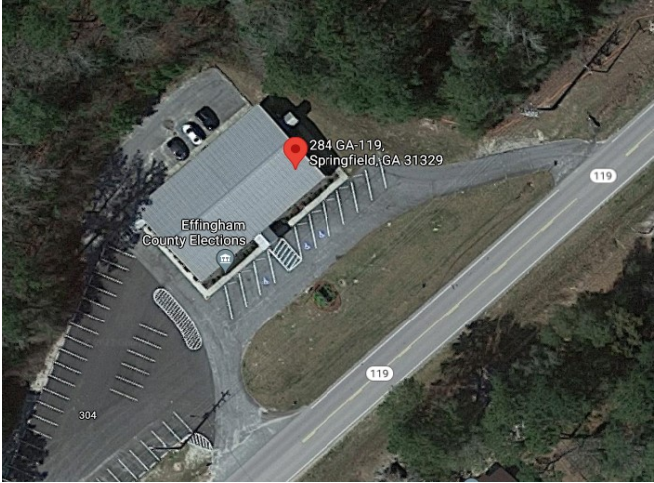
FACILITIES CONDITION ASSESSMENT				
BUILDING NAME	NUMBER	ADDRESS	BUILT	RENOVATED
Effingham County Elections UGA	12 / 284	284 Highway 119 S, Effingham GA	tbd	tbd
SQUARE FOOTAGE	PRIORITY	FCI	FCNI	
5,910	3.73	0.16	0.15	
IMAGE AND AERIAL			EXECUTIVE SUMMARY

Category	Priority	Commentary	Action	Picture
GENERAL	4	<i>Section Score</i>		
Overall	4	Overall building is a typical pre-engineered building that is in relatively good shape.	Recommend continued maintenance to keep the building in quality condition moving forward.	
SITE	3.78	<i>Section Score</i>		
Site	4	Site is relatively flat with mix of paved areas, landscaping, hardscaping and grass.		Photo
Topography	4	Minor slope away from building to drainage areas.	Continued maintenance recommended.	
Storm Water	4	All water is surface drained to swales and roadside ditch system.	Continued maintenance recommended.	
Ingress/Egress	4	Asphalt paved entry area from main road to site.	Continued maintenance recommended.	
Paving	4	Asphalt paving. Majority of paving in usable condition. Areas noted areas where paving is in need of repairs.	Continued maintenance recommended.	
Sidewalks	3	Concrete side walks.	Areas noted of cracking. Recommend repair all damaged areas.

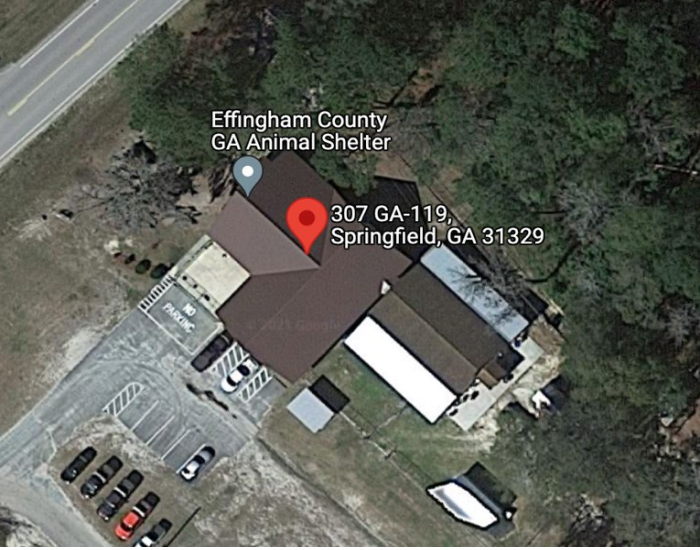
FACILITIES CONDITION ASSESSMENT				
BUILDING NAME	NUMBER	ADDRESS	BUILT	RENOVATED
Effingham County Animal Shelter	13 / 307	307 Highway 119, Springfield GA	tbd	tbd
SQUARE FOOTAGE	PRIORITY	FCI	FCNI	
5,721	3.32	0.31	0.30	
IMAGE AND AERIAL			EXECUTIVE SUMMARY

<p>Effingham County animal shelter. Used for staff and animals from the county.</p>	
PRIORITY		INVENTORY		FCI / FCNI
NOTE - Links above to tabs in Facility Report for this Facility Only

Category	Priority	Commentary	Action	Picture
GENERAL	3.5	<i>Section Score</i>		
Overall	3.5	Building is a traditional CMU structure with wood framed roof trusses.	Recommend update areas as noted below.	
SITE	4.00	<i>Section Score</i>		
Site	4	Site is relatively flat with mix of paved areas, landscaping, hardscaping and grass.		
Topography	4	Minor slope away from building to drainage areas.	Continued maintenance recommended.	
Storm Water	4	All water is surface drained to swales and roadside ditch system.	Continued maintenance recommended.	
Ingress/Egress	4	Asphalt paved entry area from main road to site.	Continued maintenance recommended.	
Paving	4	Asphalt paving. Majority of paving in usable condition. Areas noted areas where paving is in need of repairs.	Recommend a re-surface of all paved areas. Careful attention should be paid to drainage patterns and to keep flow positive.	
Sidewalks	4	Concrete side walks.	Continued maintenance recommended.

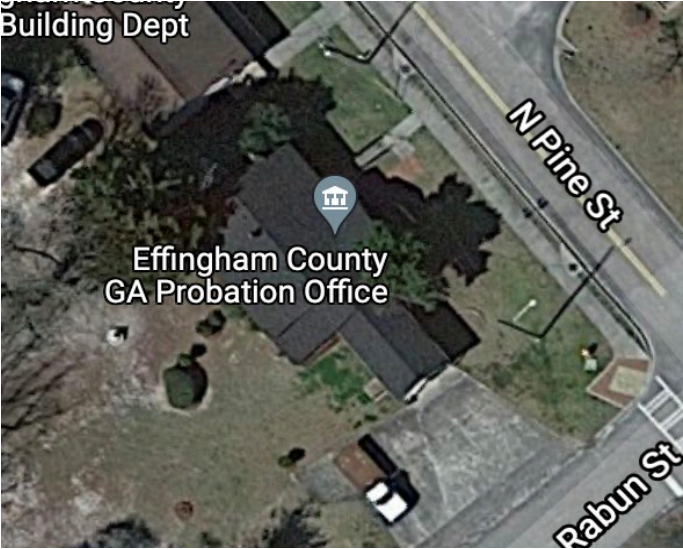
FACILITIES CONDITION ASSESSMENT				
BUILDING NAME	NUMBER	ADDRESS	BUILT	RENOVATED
Effingham County Probation Office	14 / 902	Effingham GA	tbd	tbd
SQUARE FOOTAGE	PRIORITY	FCI	FCNI	
1,676	2.91	0.60	0.59	
IMAGE AND AERIAL			EXECUTIVE SUMMARY

Former residential structure that has been converted by Effingham County for office use.	
PRIORITY		INVENTORY		FCI / FCNI
NOTE - Links above to tabs in Facility Report for this Facility Only

Category	Priority	Commentary	Action	Picture
GENERAL	3	<i>Section Score</i>		
Overall	3	In general finish condition of building is in need of updating and repair. The structure of the building does not have any observed major deficiencies.	Recommend full interior renovation of building for all new finishes, fixtures and walls. Building is a residential construction and modifications should be limited to non structural items.	
SITE	3.75	<i>Section Score</i>		
Site	4	Site is relatively flat with mix of paved areas, landscaping, hardscaping and grass.		Photo
Topography	4	Minor slope away from building to drainage areas.	Continued maintenance recommended.	
Storm Water	4	All water is surface drained to swales and roadside ditch system.	Continued maintenance recommended.	
Ingress/Egress	4	Asphalt paved entry area from main road to site. Concrete parking areas noted.	Continued maintenance recommended.	
Paving	4	No paving on site.

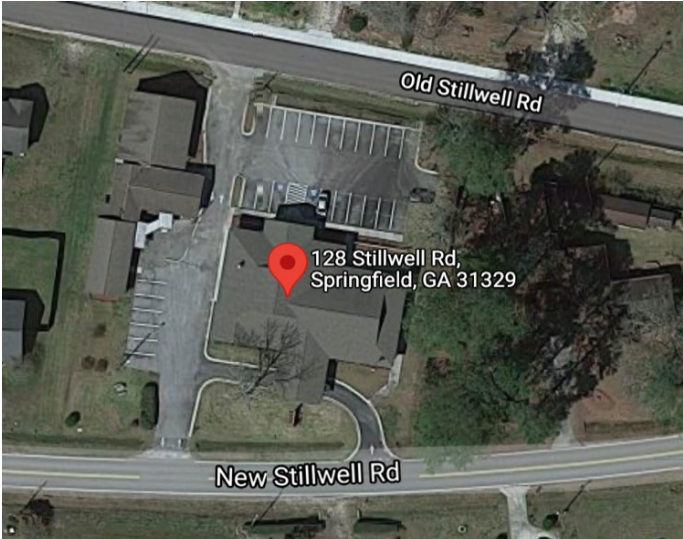
FACILITIES CONDITION ASSESSMENT				
BUILDING NAME	NUMBER	ADDRESS	BUILT	RENOVATED
Effingham County Senior Center	15 / 128	128 Stillwell Road Springfield GA	tbd	tbd
SQUARE FOOTAGE	PRIORITY	FCI	FCNI	
6,553	3.71	0.15	0.14	
IMAGE AND AERIAL			EXECUTIVE SUMMARY

<p>Free standing senior center facility for Effingham County. Facility includes meeting spaces, offices and space for senior center gatherings.</p>	
PRIORITY		INVENTORY		FCI / FCNI
NOTE - Links above to tabs in Facility Report for this Facility Only

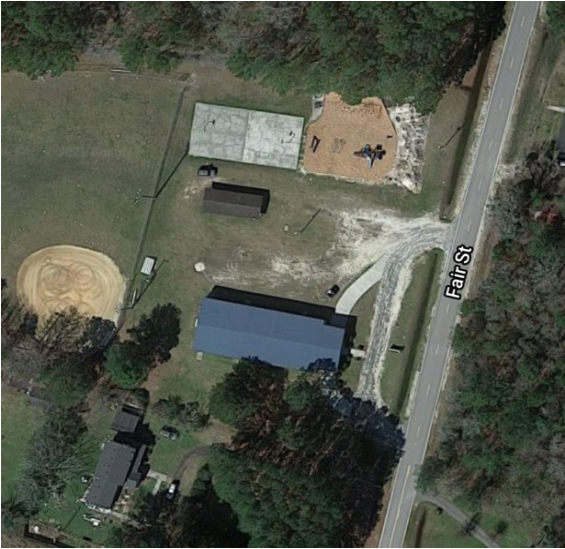
FACILITIES CONDITION ASSESSMENT				
BUILDING NAME	NUMBER	ADDRESS	BUILT	RENOVATED
Effingham County Cloy Community	16 / 545	Effingham GA	tbd	tbd
SQUARE FOOTAGE	PRIORITY	FCI	FCNI	
5,496	2.90	0.39	0.38	
STATION IMAGE AND AERIAL			EXECUTIVE SUMMARY

<p>Stand alone community center. Pre Engineered metal building with large meeting spaces.</p>	
PRIORITY		INVENTORY		FCI / FCNI
NOTE - Links above to tabs in Facility Report for this Facility Only
