# STAFF REPORT

July 20, 2022

1306 W. MOUNTAIN AVE, FINAL DESIGN REVIEW, REHABILITATION & ADDITION

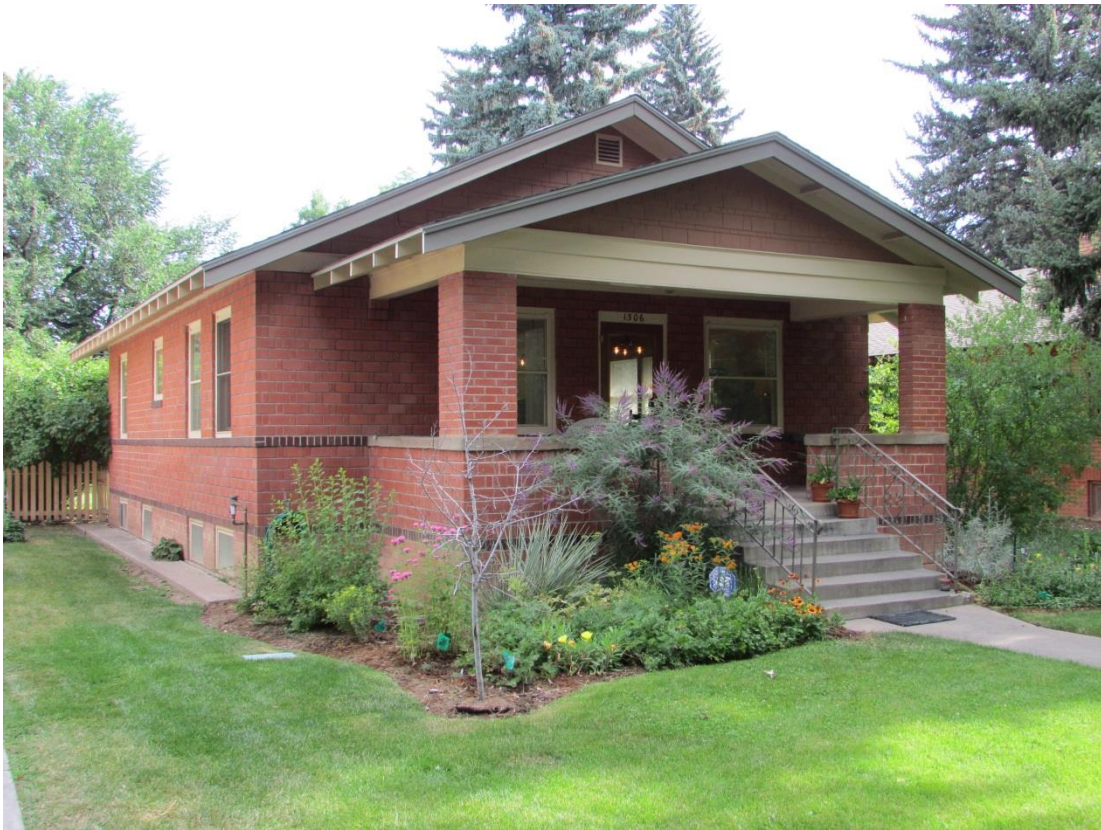
Front (South) and Side (West) Elevations, July 2014

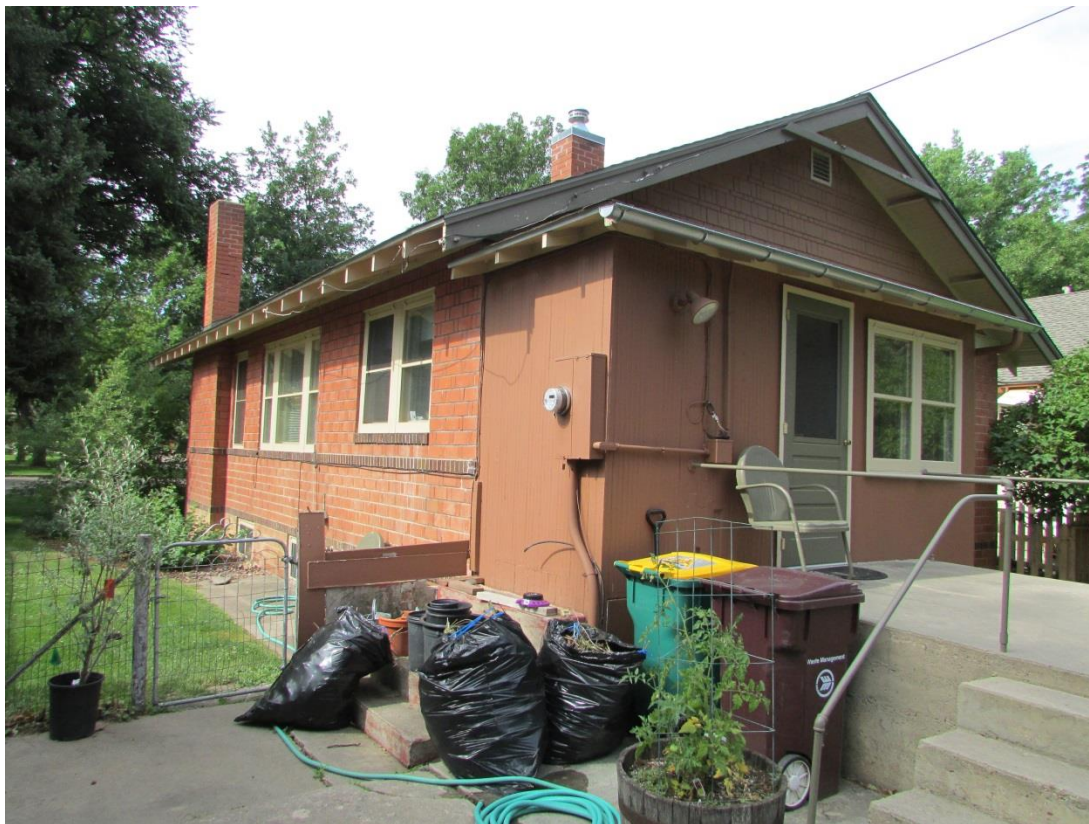
Side (East) and Rear (North) Elevations, July 2014

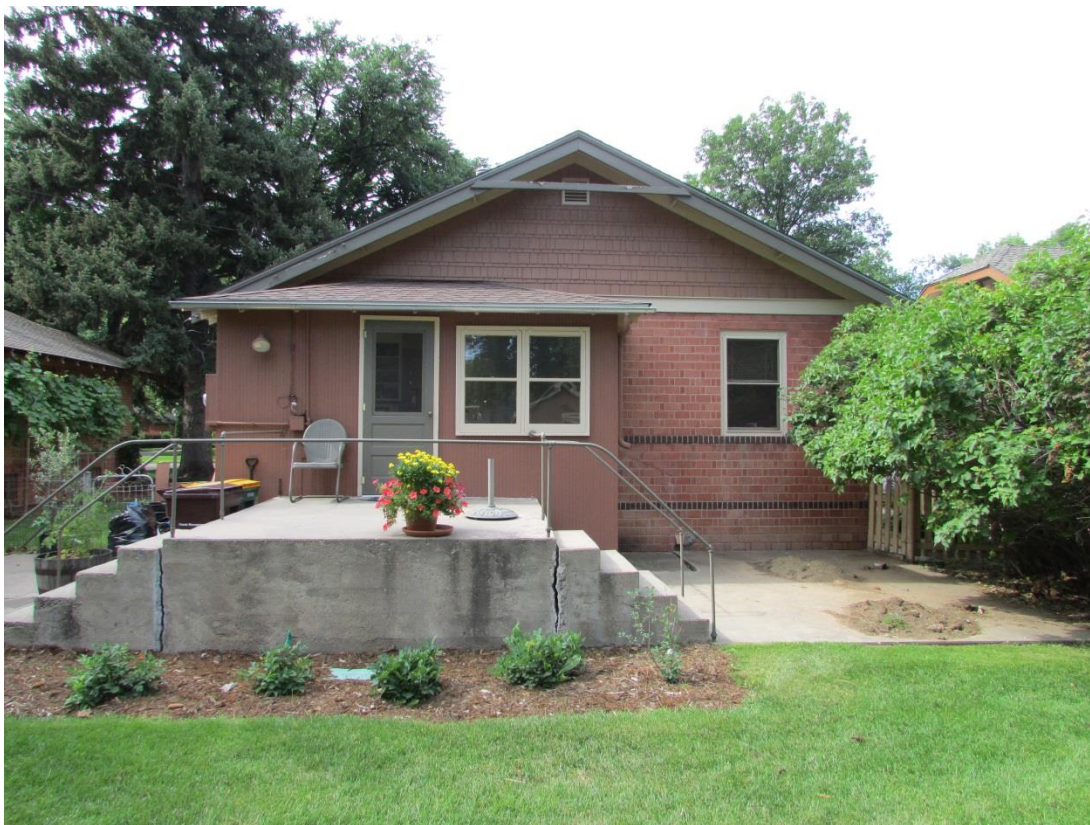
Rear (North) Elevation, July 2014

higher-placed and corbelled band runs around the house forming the bottom sill of the first-story windows and connects with the cement cap of the porch's wall structure. An undated addition to the kitchen on the rear (north) elevation sits on the northeast corner of the home and opens to a rear porch. The foundation is unexposed, but the base of the front and rear porches are constructed of cement.

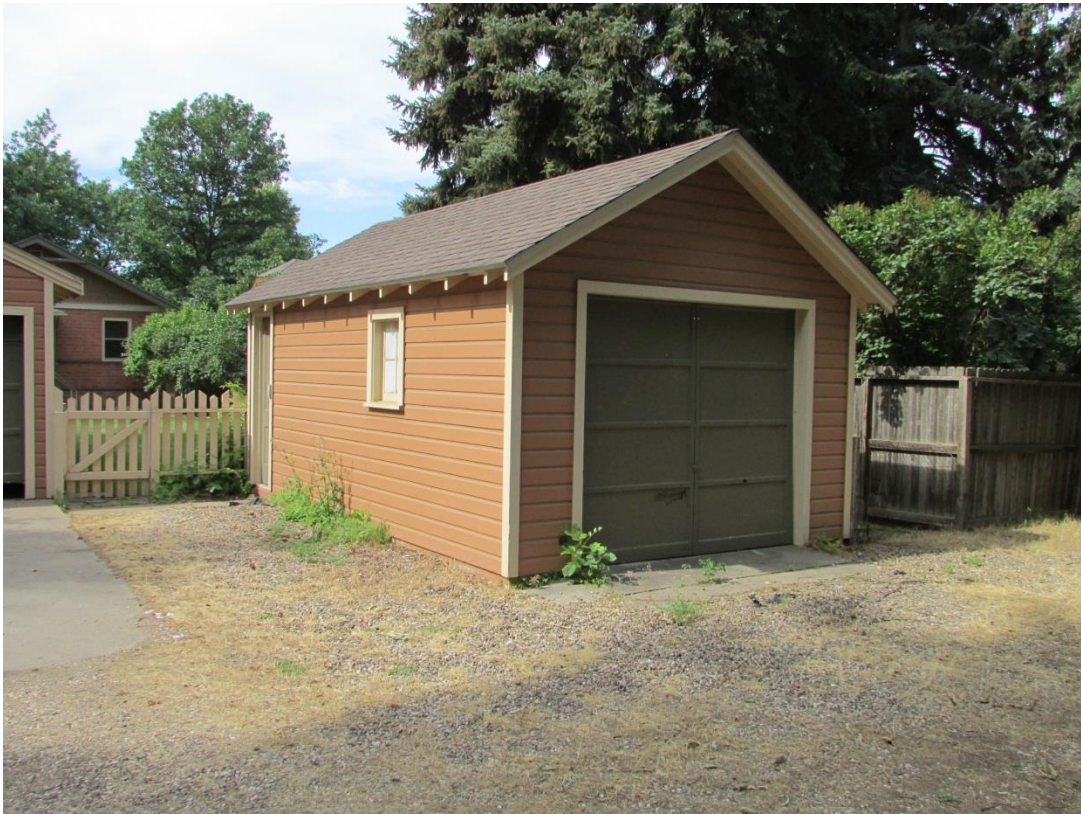
North and East Elevations, One-car Garage built 1942, July 2014

“frame one car garage” on the northwest corner of the lot; the estimated cost of labor and materials was \$200.00.<sup>5</sup> In 1947, Jackson re-shingled the home.<sup>6</sup> In October 1949, the Jacksons sold the Craftsman home to Gordon and Evelyn Heumesser. Gordon Heumesser was employed as a steward for the Elks Club, and Evelyn Heumesser worked as a bookkeeper.<sup>7</sup> The Heumessers remained here until 1963.<sup>8</sup> In November of that year, they sold their home to John H. Rust Jr., a machinist, and his wife Dorothy.<sup>9</sup> The Rusts financed their new home through the Fort Collins Federal Savings and Loan Association for \$12,800.00, and remained here for five years until selling it to Robert “Bob” and JoAnne Waldron in 1968.<sup>10</sup> The same year that the Waldrons purchased the home, they also paid \$1,000.00 to construct a 22’ x 26’ two-car detached garage on the property.<sup>11</sup> Bob Waldron, a World War II veteran, met his future wife, Joanne Bancroft in 1947, while both were working in downtown Fort Collins. The couple was married on February 22, 1948, and raised two daughters, Suzanne (Henderson) and Gwen (Feit). Bob worked at Paramount Laundry and then at Colorado State University Food Services, retiring from this position in 1972. JoAnne retired from Steele’s market in 1991, where she worked for 34 years. Bob Waldron passed away on December 6, 1999,<sup>12</sup> and JoAnne on September 11, 2002.

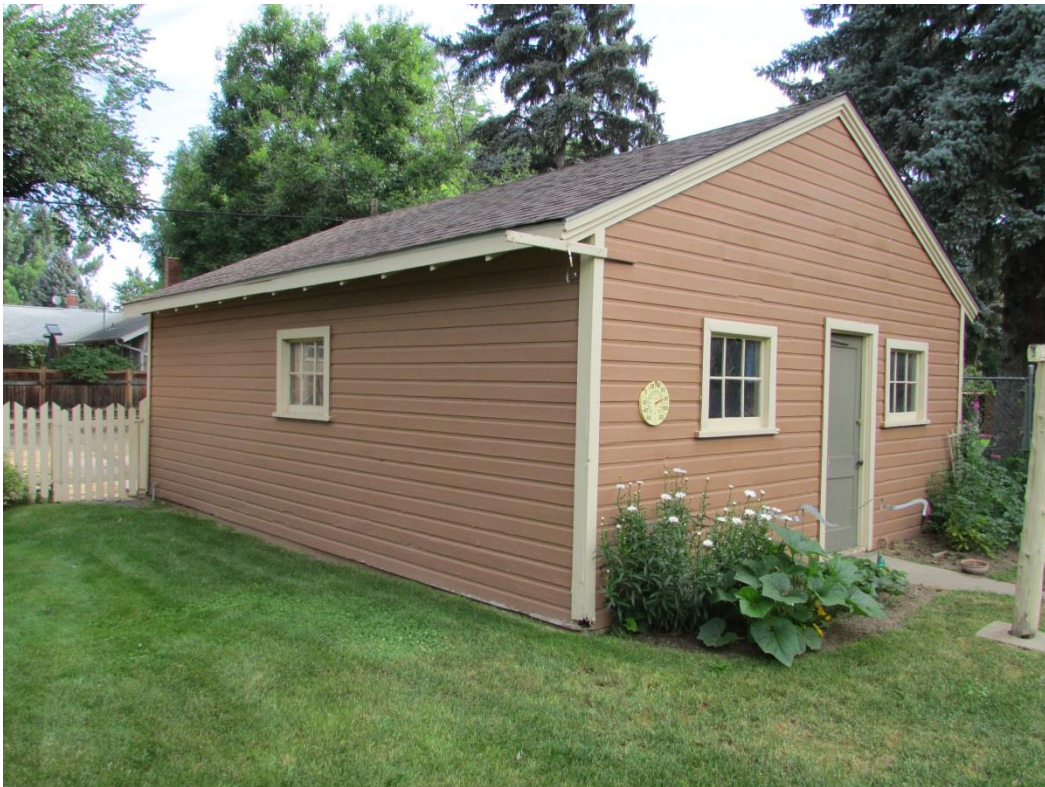
South and West Elevations, Two-car Garage built 1968, July 2014

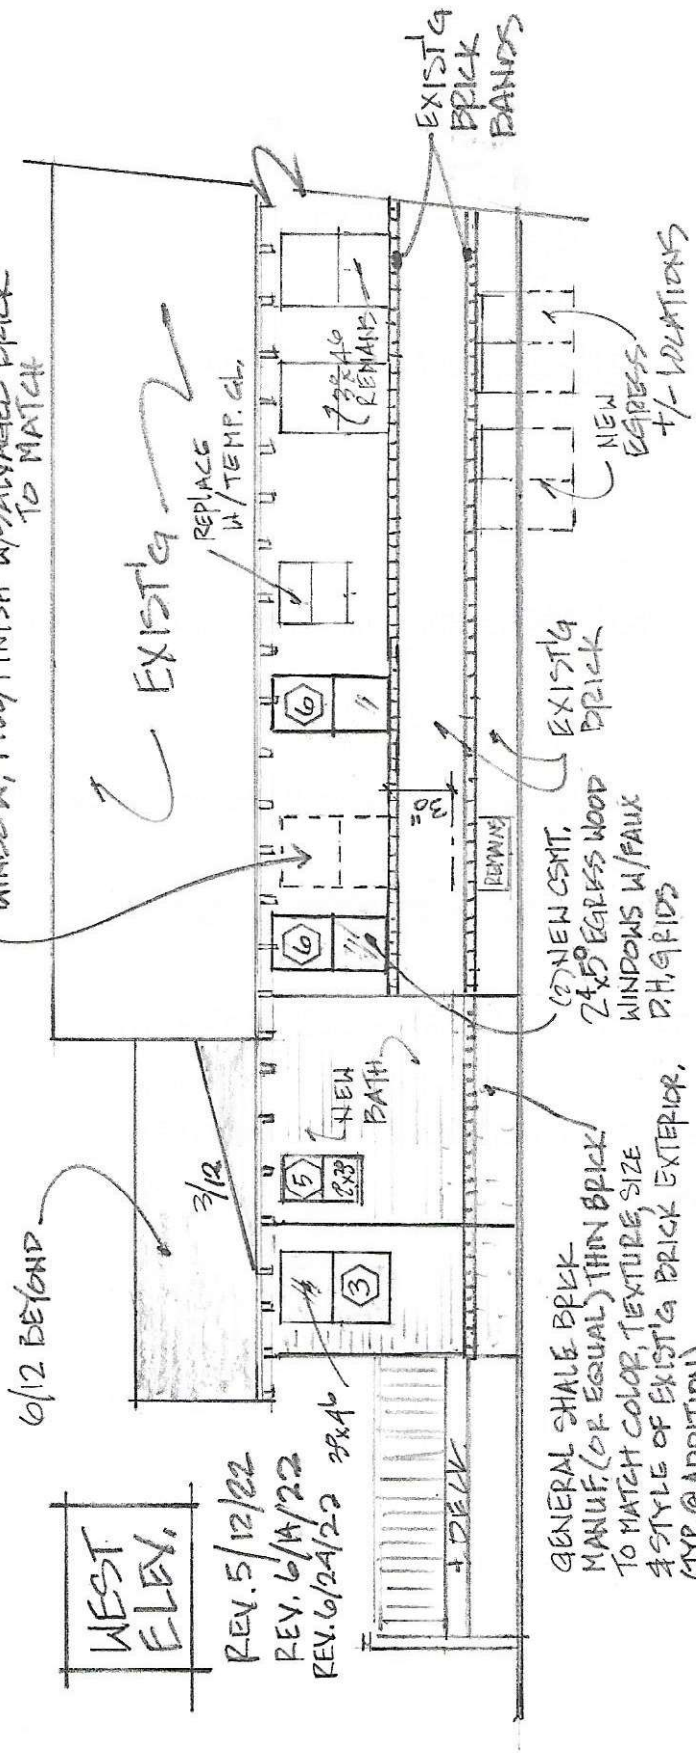
TYPICAL @ ADDITION:  
HARDBOARD (OR EQUAL) HORIZONTAL LAP  
SIDING W/ MAXIMUM 4" EXPOSURE, PAINTED.

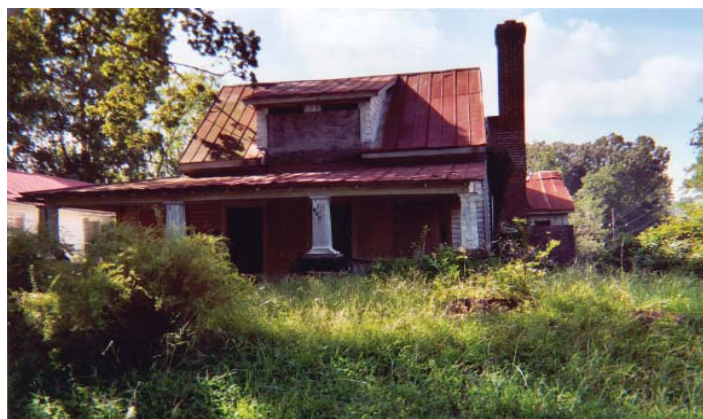
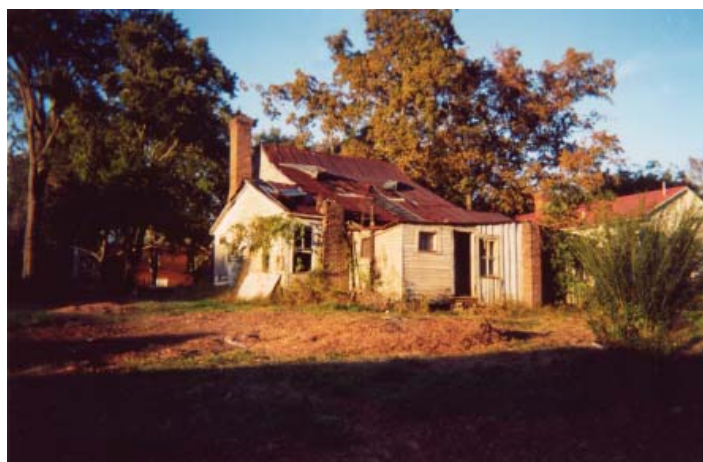
*Top and Above: This historic house had been altered numerous times in the past—including multiple additions to the rear of the building.*

**Application 1** (*Incompatible treatment*): This modest residence began as a two-story log house. Later, the main portion of the house was converted into a distinctive Bungalow-style residence. Over time, multiple additions were also made along the natural grade at the rear of the house. Prior to rehabilitation, these later additions were quite deteriorated.

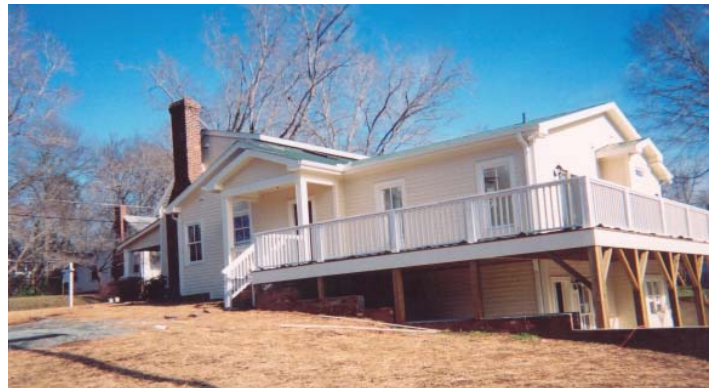
*The size of this new rear addition—incorporating two floors and an extended depth—combined with substantial changes to the site overwhelm the modest historic house.*

When the project began, the existing rear additions were determined to be beyond repair and were demolished. A replacement addition of a similar size to those removed would likely have met the Standards. However, the new addition constructed on the rear doubled the size of the structure as it existed before the rehabilitation. As built, the cladding, openings, and rooflines of the new addition were appropriate to the building's historic character. Yet this was not sufficient to overcome the effect of an addition substantially more massive than the additions that were demolished. With two full floors, a footprint that was much deeper than the previous additions, a new deck extending from the rear and side elevations, and significant grade changes at the rear, this work competes for attention with the historic structure to which it is attached and has seriously impacted the property's historic character.

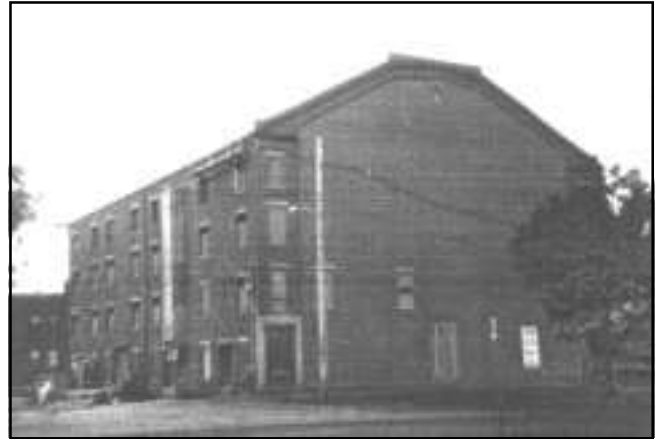
*Top: The historically important 1859 brick warehouse with largely solid end wall.*

**Application I** (*Incompatible new openings*): This freestanding brick warehouse was constructed in 1859 to store grain and dry goods. Although the largely solid end wall elevations were secondary, they were highly visible and contributed to the historic character of this building. During a conversion to offices, a series of new openings were inserted in the end walls to admit more light and take advantage of desirable views. The number and design of the new windows, which mimic the historic windows in size, proportion, detail and light configuration, fundamentally altered this building's historic character giving the building a significantly different look. The treatment did not meet the Standards.

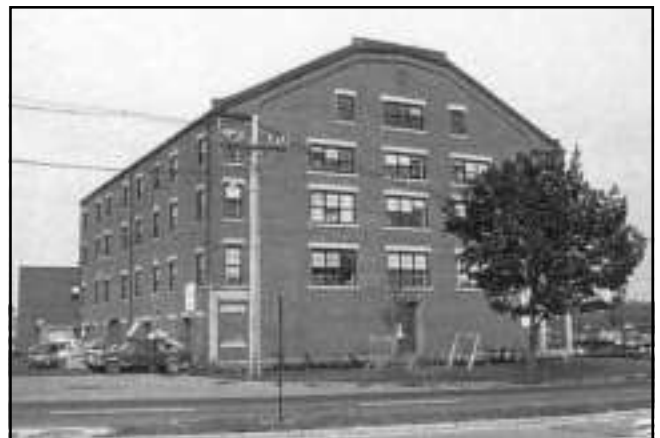
New windows could have been installed while maintaining the historic massiveness of the end wall. This would have required the introduction of only a few smaller windows.

*Bottom: The number and design of the windows added to the end wall make this an inappropriate treatment.*

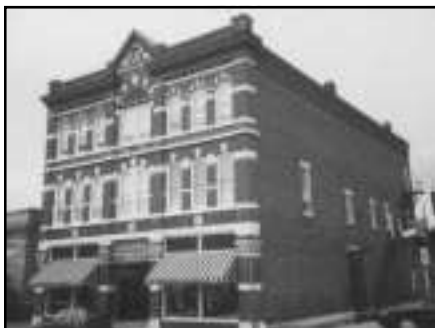
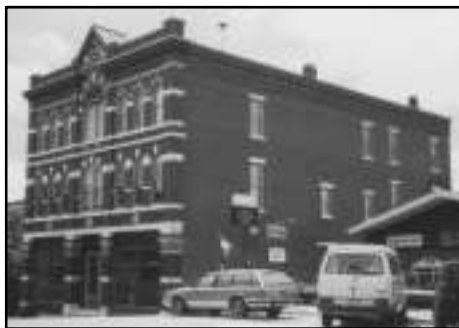
*Left: 1882 corner commercial building.*

*Right: The number and location of the new openings do not alter the historic character nor cause this elevation to compete with the facade.*

**Application 2** (*Compatible new openings*): This 1882 structure exemplifies the transition in commercial architecture after the Civil War from simple, domestically scaled buildings to structures distinguished as symbols of commercial prestige by their size and height, decoration, quality of architecture and prominence. When rehabilitating this building into bank offices, the owner proposed inserting new openings on the third floors of the secondary side elevation for added light and ventilation. The number and location of these new openings did not impact the character-defining features nor direct too much focus to the secondary elevation.

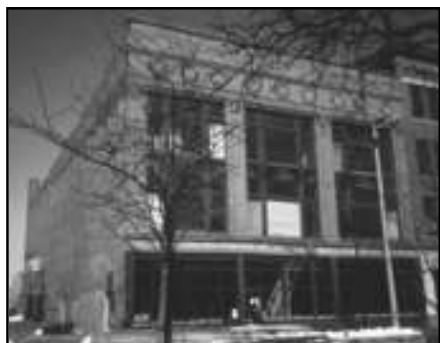
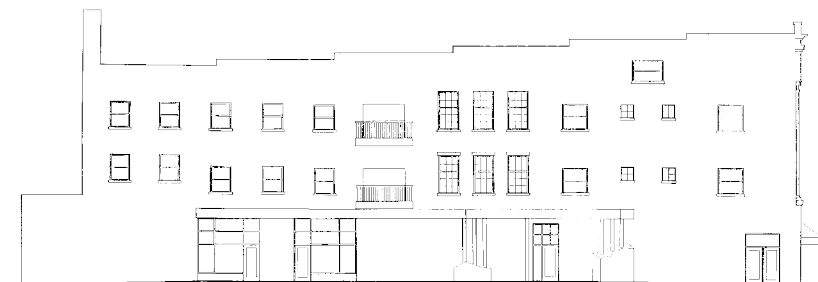
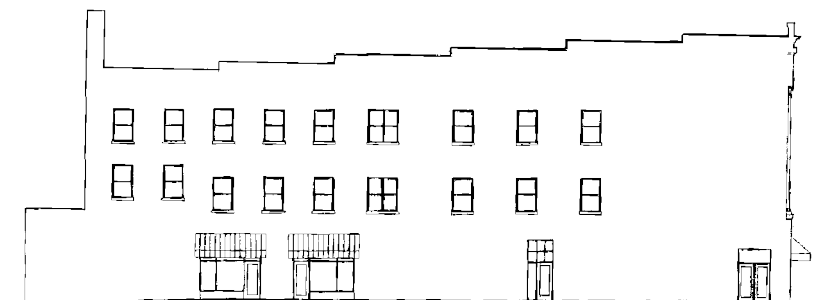
*Left: 19th century commercial building with exposed party wall. Above: Inappropriate treatment. Below: Appropriate solution.*

The revised elevation design eliminated the balconies and some of the new window openings, standardized the header heights, sash size and pane configuration. This compatible treatment meets the standards.

This 1897 commercial building with exposed party wall on the west was constructed to house a significant early twentieth century retail establishment. Four entry doorways were cut into the party wall when the building was altered in 1937 and 1992. When rehabilitating this building for mixed-use in 1999, with a restaurant and specialty shops on the first floor and residential apartments on the upper three stories, twenty-five new openings were proposed on the west elevation. These new openings with varying header heights included four different window sizes and pane configurations, and two projecting balconies. The number, placement, rhythm created by the variations in header heights and window sizes and proposed balconies make a strong architectural statement that is incompatible with the historic character of this large solid masonry wall.

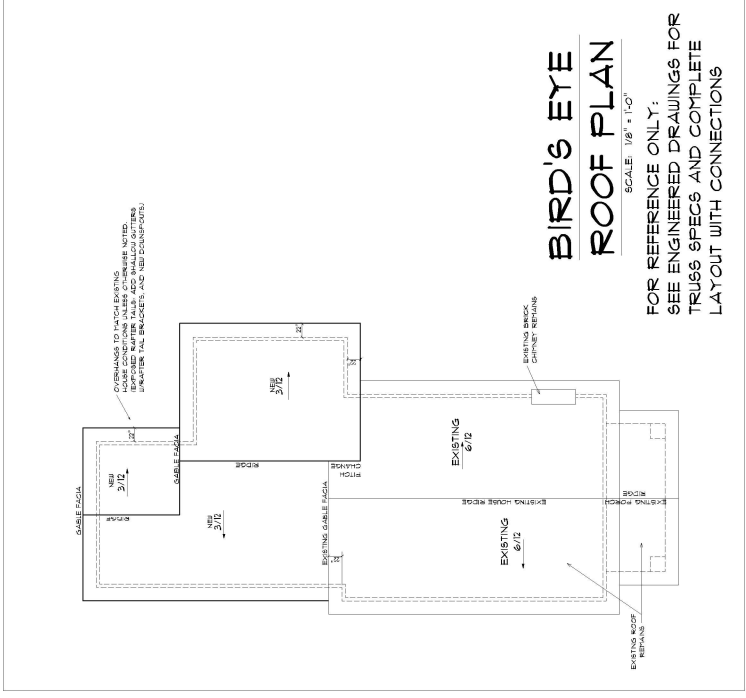
BIRD'S EYE  
ROOF PLAN

SCALE: 1/8" = 1'-0"  
FOR REFERENCE ONLY:  
SEE ENGINEER DRAWINGS FOR  
TRUSS SPECS AND COMPLETE  
LAYOUT WITH CONNECTIONS

- Removal of dormer on the east roof elevation based on the commission's recommendations.

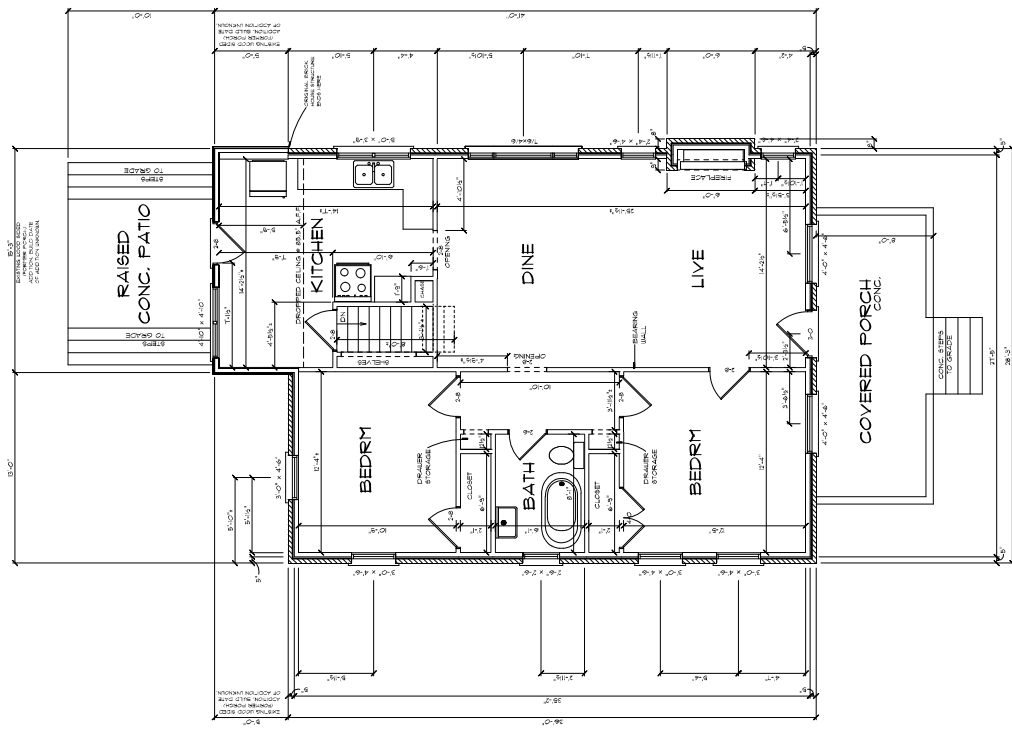
EXISTING (ONE-STORY,  
BRICK AND FRAME  
WITH BASEMENT)  
MAIN LEVEL: 11,000 S.F. | AN

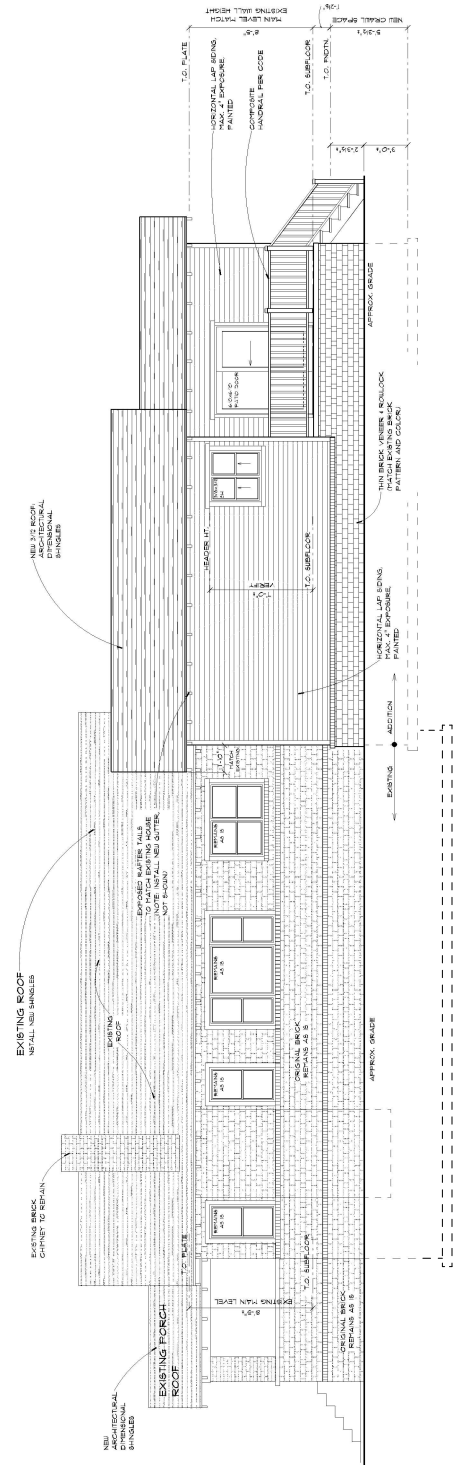
FRONT ELEVATION  
SOUTH  
SCALE: 1/4" = 1'-0"

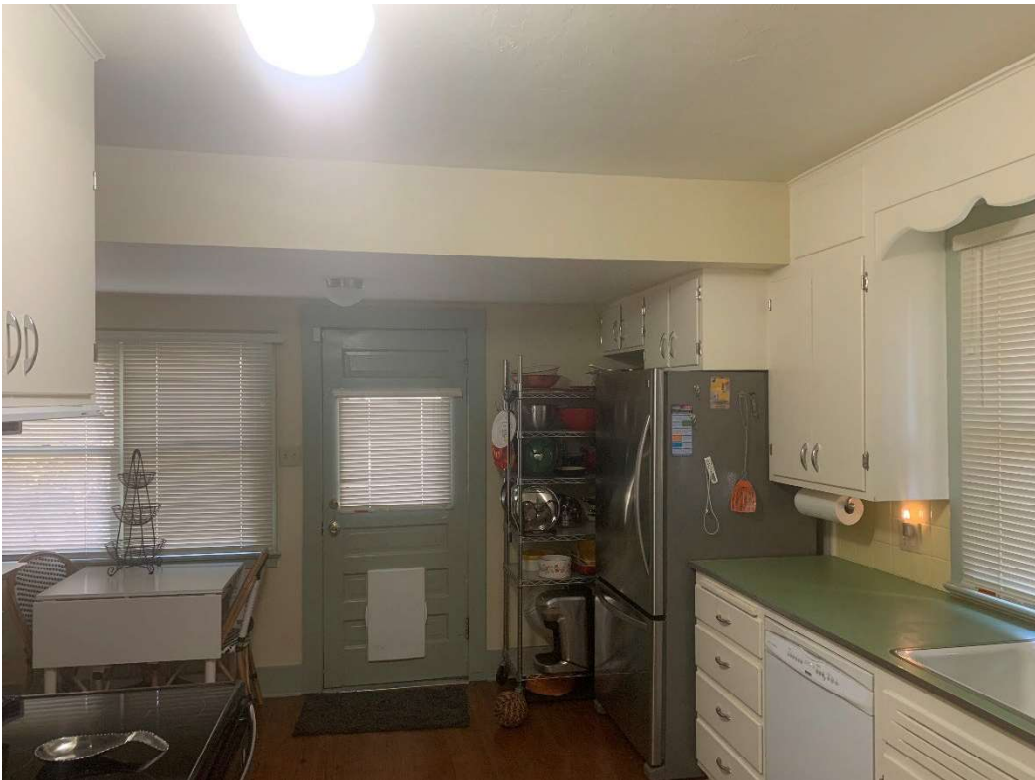
Northeast corner of historic house, looking north toward rear of house

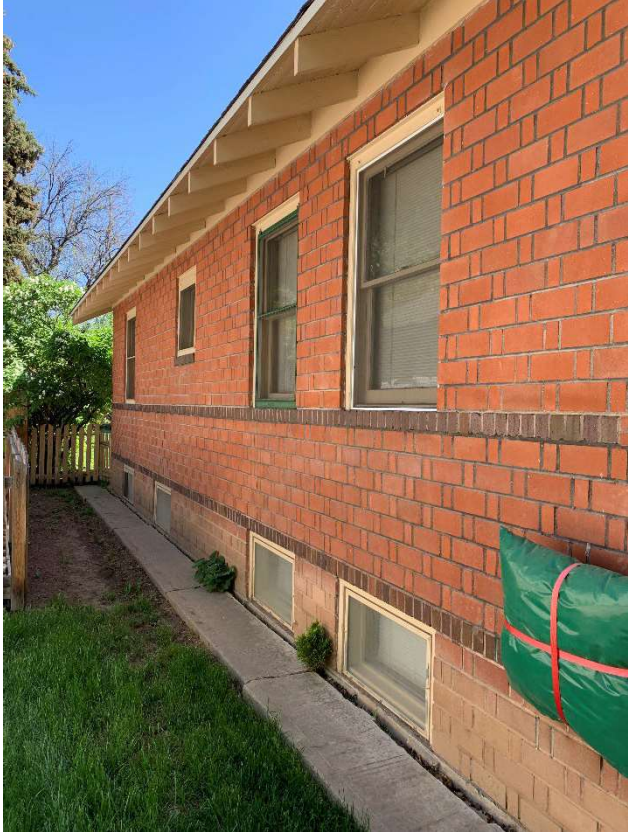
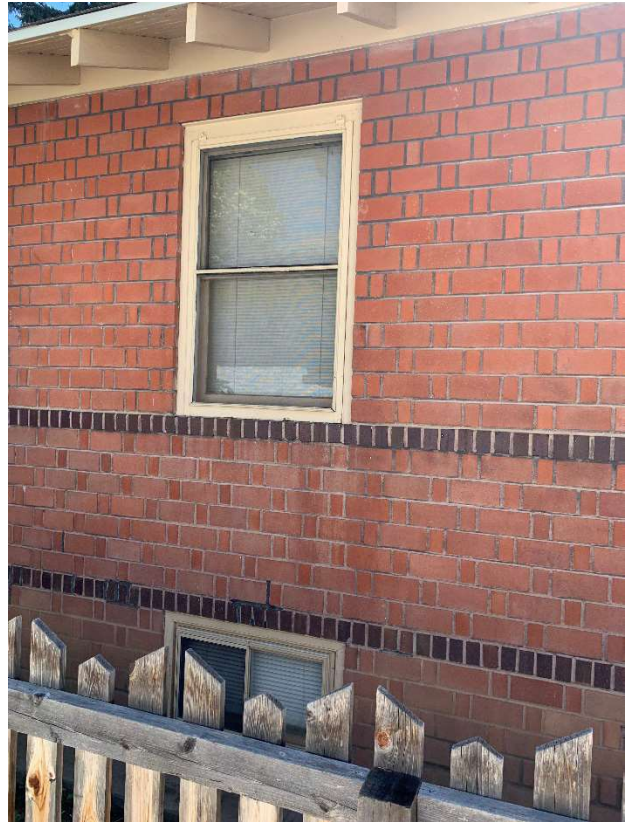
Left: photo of west elevation w details, looking north; Right: Photo of rear/northwest window

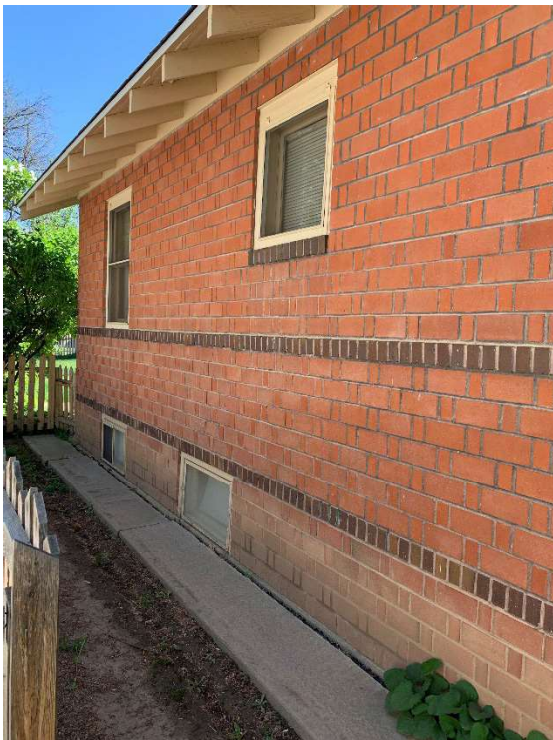
Rear bathroom & NW window on west elevation
