Rhumblin
Consultants

The property owners, Dr. Rainey and Mr. Moore request the approval of the Franklin County Planning and Zoning Board of Adjustment and Appeals to construct a low-elevation limerock stone revetment above the mean high water line and within the Critical Habitat Zone on their properties. In addition, the owners will include the planting of appropriate beach appropriate vegetation replacing the existing St. Augustine lawn within the remainder of the 50-foot habitat conservation zone to restore this area with native vegetation. These planting will improve the habitat quality of this areas as well as add additional erosion protection. The owners will plant *Spartina* (Sp) sprigs within the inter-tidal zone (see graphics to follow).

Proposed Solution:

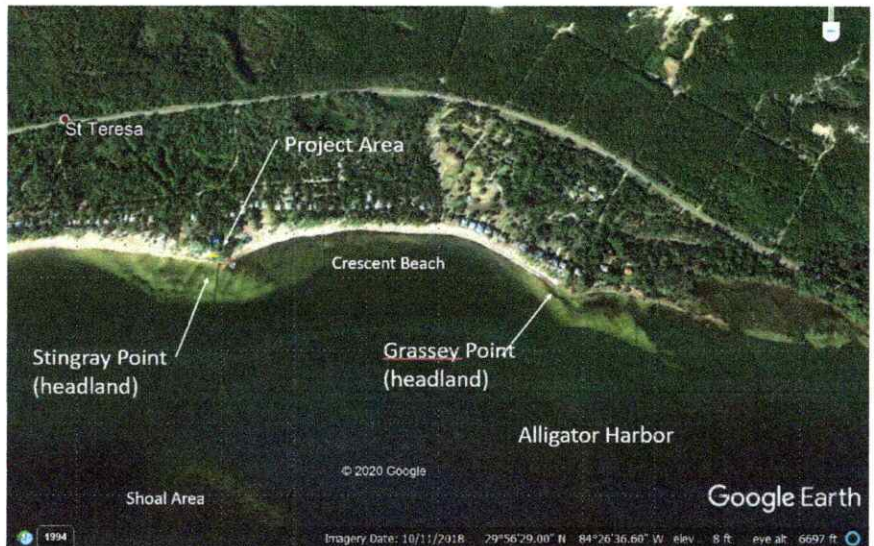
Figure 1 : Stingray point geomorpholgy

Stingray Point is a prominent geographical feature of the St. Teresa waterfront. This headland is offset by Grasseypoint to the east (Figure 1). These two points form the eastern and western bounds of the long crescent beach inside Alligator Harbor. Stingray Point is also the eastern headland bounded by Turkey Point which forms the crescent

beach of St. Teresa. As the headland, Stingray Point has anchored the two crescent shaped beaches for the recordable time frame.

Stingray Point is situated across the terminus of Alligator Point. Over the last few decades Alligator Point has continually extended and narrowed the opening between Stingray Point at the entrance of Alligator Harbor.

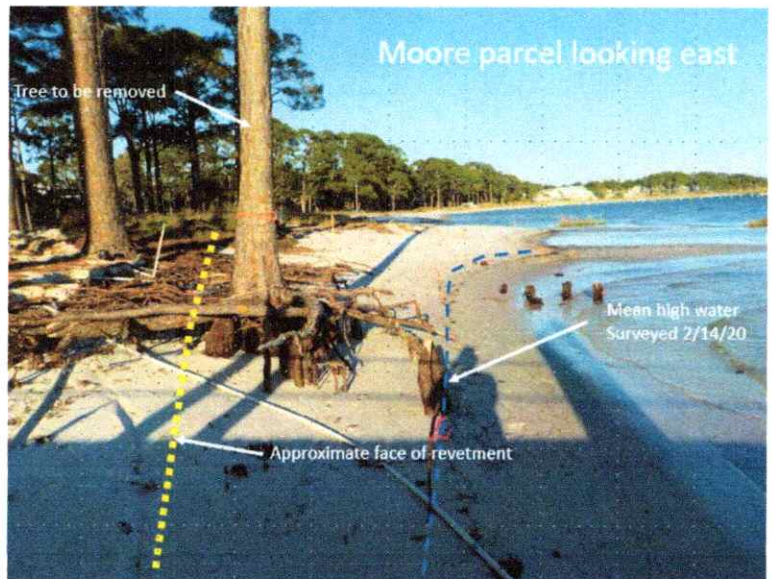
Figure 3 Proposed face of revetment and mean high water on Moore's Property

The construction of a stone structure set above the mean high water and on the waterside of the large, mature trees will increase the ability of this point to continue to act as a headland reduce the potential for erosion at this location as well as in the near reaches either side of this point. The proposed design includes a row of larger guard stone (approximately 3-foot diameter stone) set to hold smaller (3-inch diameter cobbles) which will be placed within and among the root system pines (Figure 3). The smaller rock would then be covered with the larger guard stone. In areas where there are no tree roots the large stone will extend the full depth of the revetment, about 10'. The height of the stone revetment would be approximately one foot above the existing scarp or about 5' (see plan and profile sketches provided).
