Rhumblin Consultants PLLC

The property owners, Dr. Rainey and Mr. Moore request the approval of the Franklin County Planning and Zoning Board of Adjustment and Appeals to construct a low-elevation limerock stone revetment above the mean high water line and within the Critical Habitat Zone on their properties. In addition, the owners will include the planting of appropriate beach appropriate vegetation replacing the existing St. Augustine lawn within the remainder of the 50-foot habitat conservation zone to restore this area with native vegetation. These planting will improve the habitat quality of this areas as well as add additional erosion protection. The owners will plant *Spartina* (Sp) sprigs within the inter-tidal zone (see graphics to follow).

The construction of a stone structure set above the mean high water and on the waterside of the large, mature trees will increase the ability of this point to continue to act as a headland reduce the potential for erosion at this location as well as in the near reaches either side of this point (Figure 3). The proposed design includes a row of larger guard stone (approximately 3-foot diameter stone) set to hold smaller (3-inch diamet

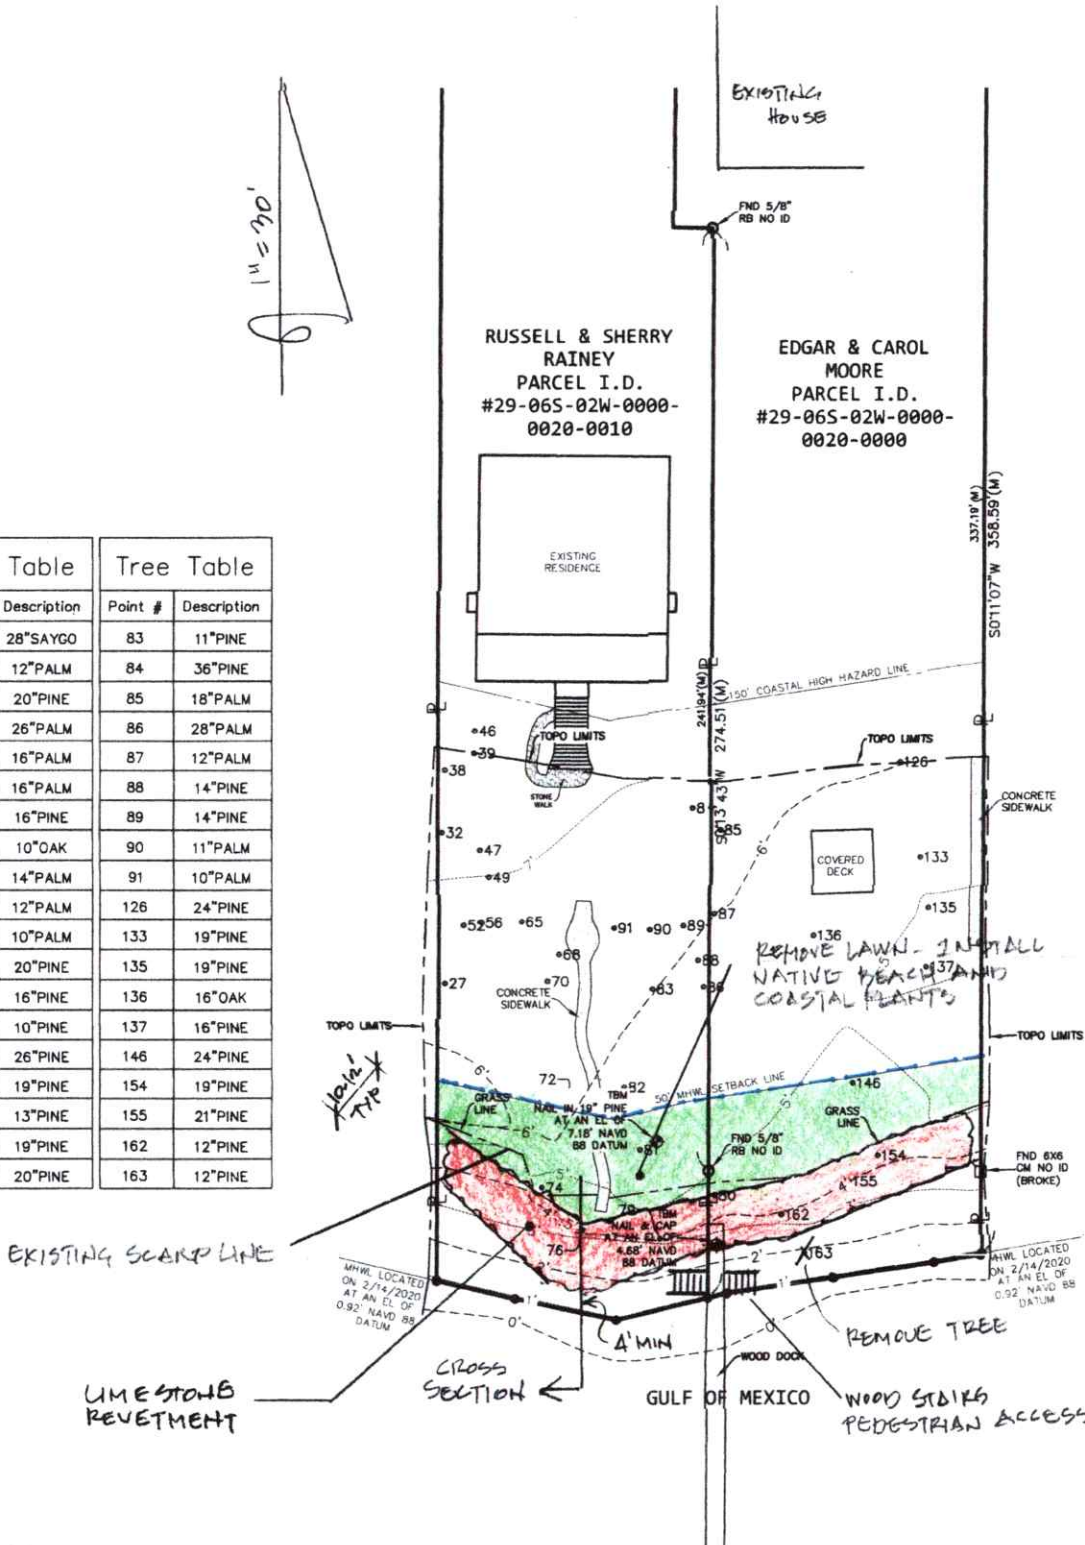
Tree Table		Tree Table	
Point #	Description	Point #	Description
27	28" SAYGO	83	11" PINE
32	12" PALM	84	36" PINE
38	20" PINE	85	18" PALM
39	26" PALM	86	28" PALM
46	16" PALM	87	12" PALM
47	16" PALM	88	14" PINE
49	16" PINE	89	14" PINE
52	10" OAK	90	11" PALM
56	14" PALM	91	10" PALM
65	12" PALM	126	24" PINE
68	10" PALM	133	19" PINE
70	20" PINE	135	19" PINE
72	16" PINE	136	16" OAK
74	10" PINE	137	16" PINE
76	26" PINE	146	24" PINE
79	19" PINE	154	19" PINE
80	13" PINE	155	21" PINE
81	19" PINE	162	12" PINE
82	20" PINE	163	12" PINE

Notes:

1. Survey conducted 2/14/20 by Edwin Brown and Associates
2. Construction to be conducted on both lots by the same contractor at the same time
3. No sand will be removed from the beach
4. Minimal sand will be provided for fill behind the revetment and will be compatible with the local sands

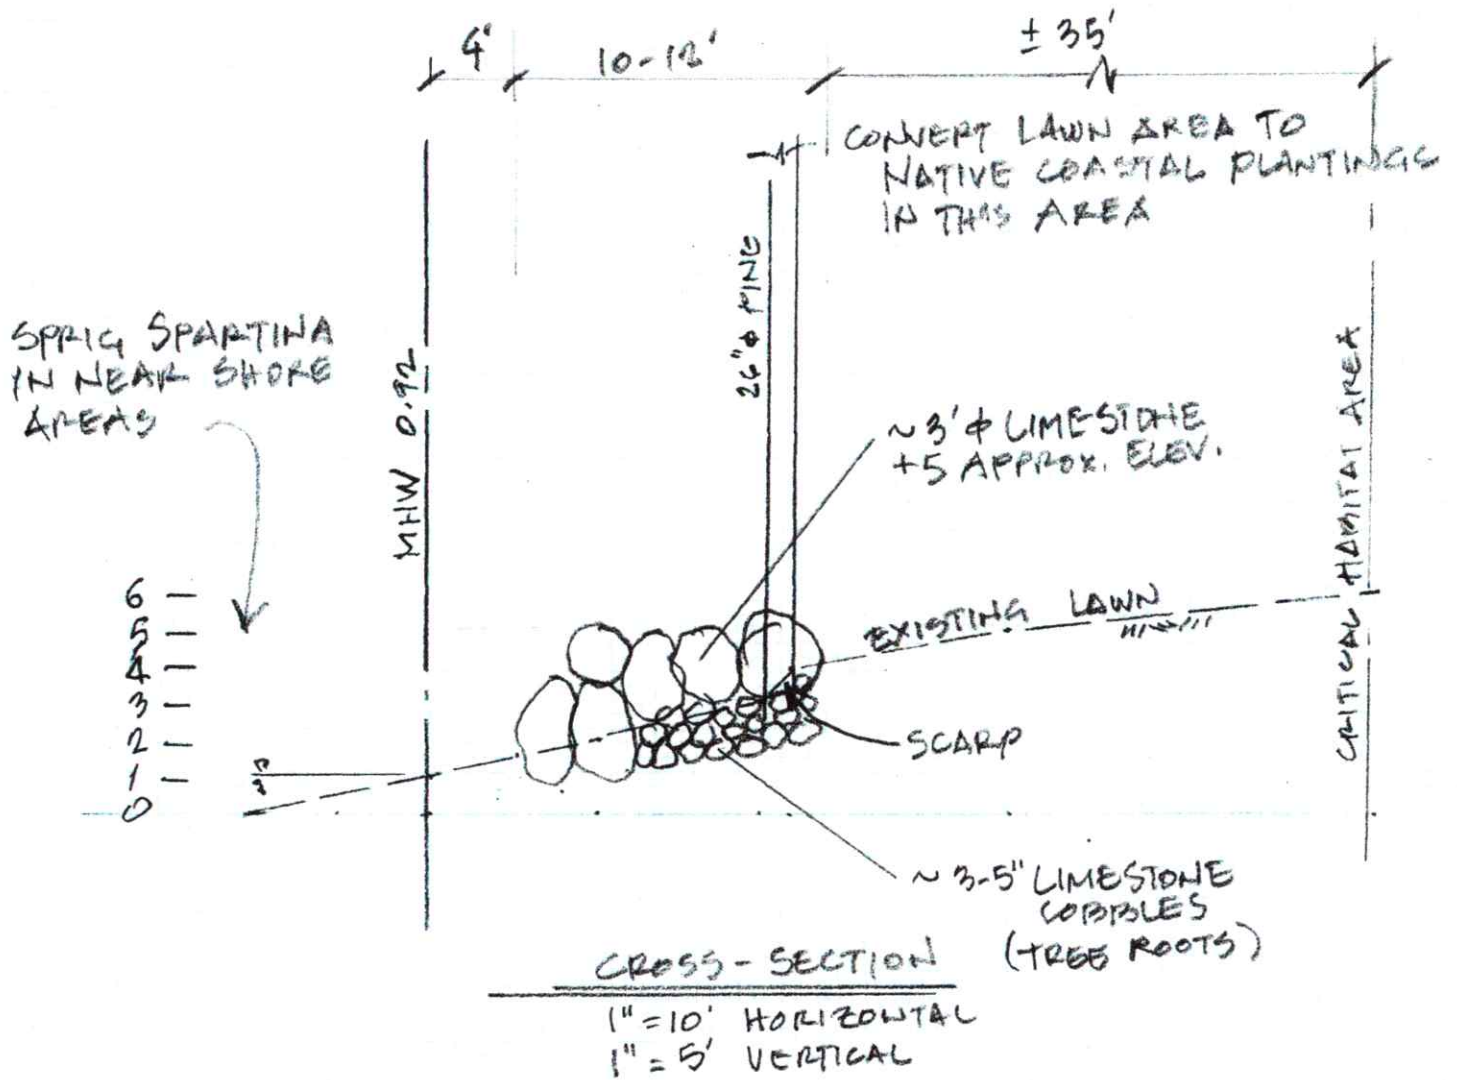
NOTES.

PROFILE FROM SURVEYED DATA

COBBLES TO BE USED AROUND TREE ROOTS.

BOULDERS TO BE FULL DEPTH EVERYWHERE ELSE

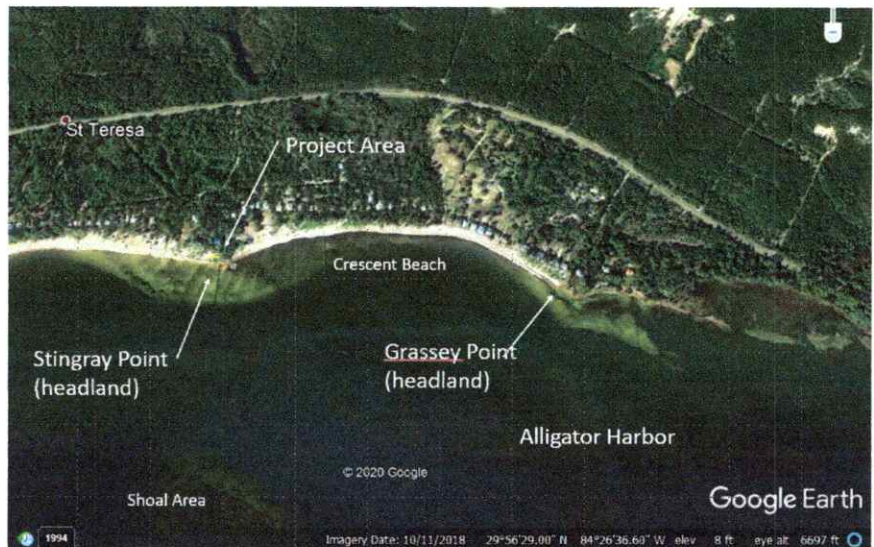
Figure 1 : Stingray point geomorpholgy

Stingray Point is a prominent geographical feature of the St. Teresa waterfront. This headland is offset by Grassey Point to the east (Figure 1). These two points form the eastern and western bounds of the long crescent beach inside Alligator Harbor. Stingray Point is also the eastern headland bounded by Turkey Point which forms the crescent

The result is the documented increased erosion of Stingray Point causing a loss of trees and submerged aquatic vegetation in the inter-tidal zone which has created a scarp above the mean high water mark at the tree line.

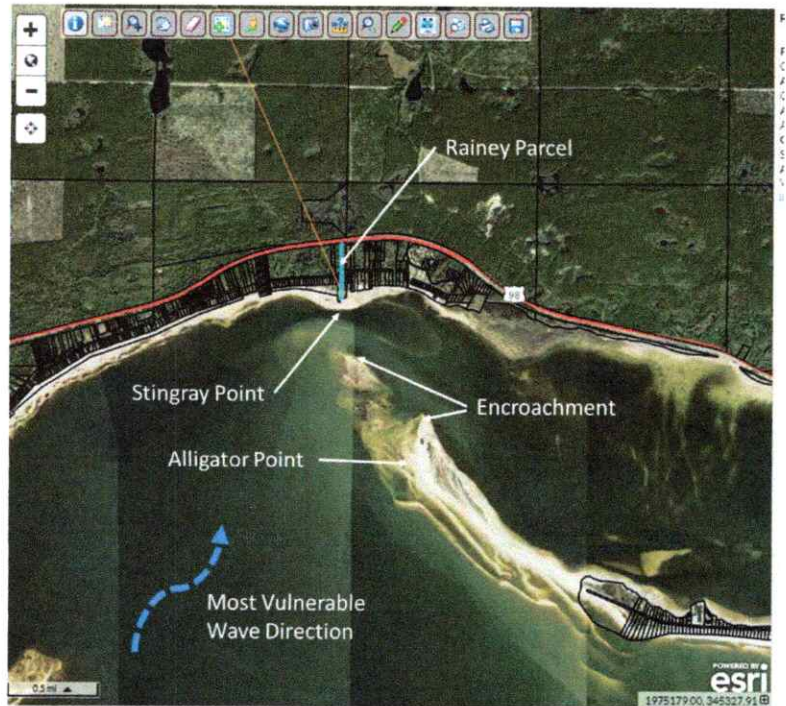
Figure 2 Coastal impacts at Stingray Point

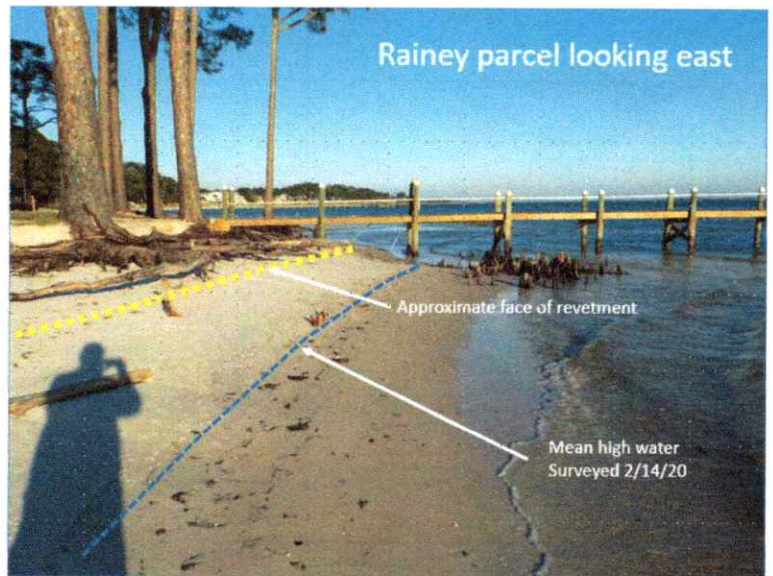
Figure 3 Proposed face of revetment and mean high water line
