REPORT OF INSPECTION PROCEDURES AND RESULTS
FOR
DETERMINING QUALIFICATIONS
OF A
TAX INCREMENT FINANCING DISTRICT

OSB PLANT
REDEVELOPMENT TIF DISTRICT

CITY OF GRAND RAPIDS, MINNESOTA

November 7, 2022

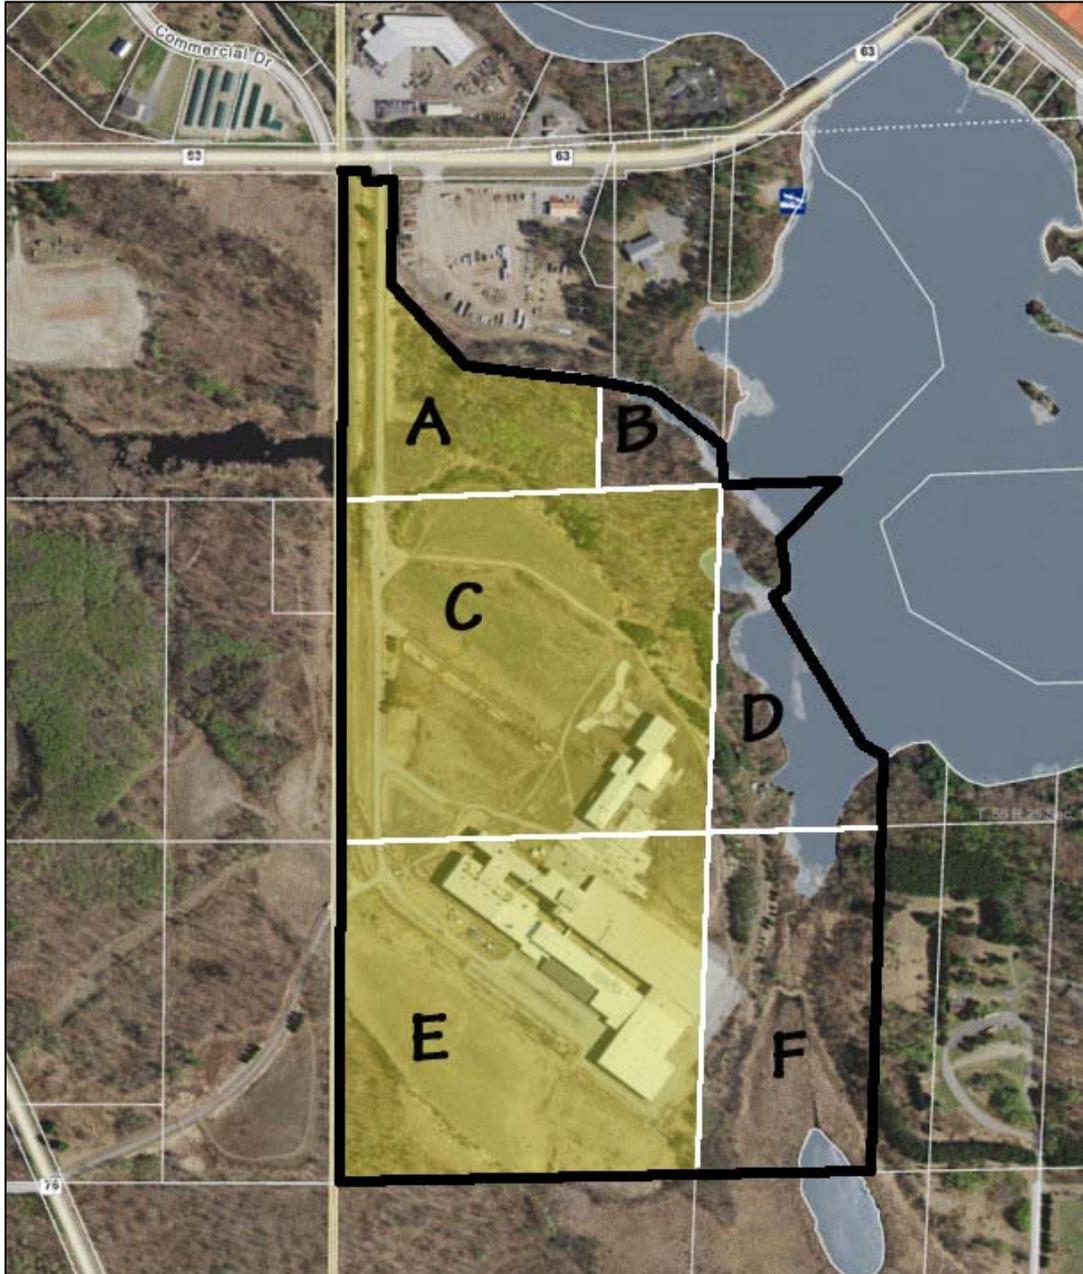
Diagram 2 – Coverage Diagram

Shaded area depicts a parcel more than 15 percent occupied by buildings, streets, utilities, paved or gravel parking lots or other similar structures

The proposed TIF District met the coverage test under *Minnesota Statutes, Section 469.174, Subdivision 10(e)*, which resulted in parcels consisting of 73.9 percent of the area of the proposed TIF District being occupied by buildings, streets, utilities, paved or gravel parking lots, or other similar structures (Diagram 2). This exceeds the 70 percent area coverage requirement for the proposed TIF District under *Minnesota Statutes, Section 469.174, Subdivision (a) (1)*.

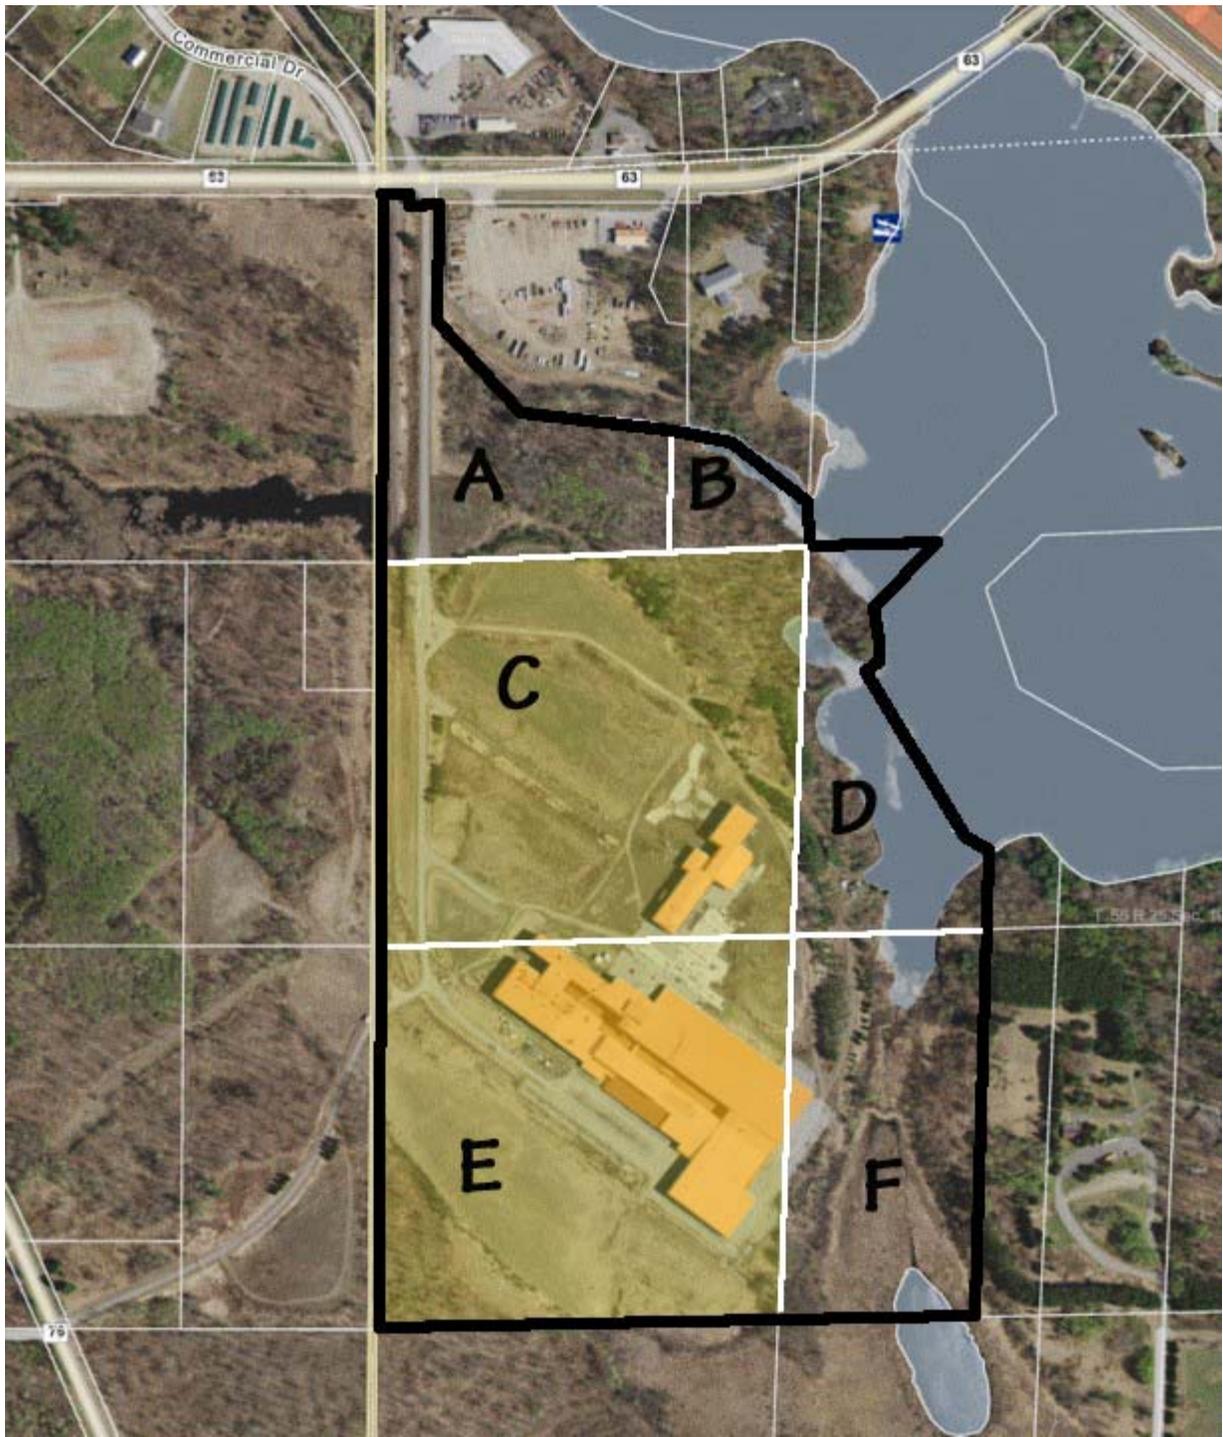
Diagram 3 – Substandard Buildings

Shaded yellow area depicts parcels with buildings.
Shaded orange area depicts substandard buildings.

The parcels with substandard buildings are reasonably distributed compared to all parcels that contain buildings.
