9 Preservation Briefs

Technical Preservation Services
National Park Service
U.S. Department of the Interior

The Repair of Historic Wooden Windows

John H. Myers

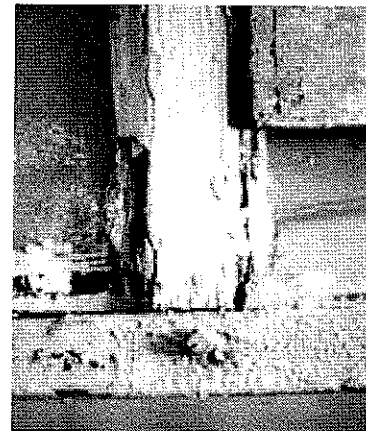
This historic double-hung window has many layers of paint, some cracked and missing putty, slight separation at the joints, broken sash cords, and one cracked pane. Photo: NPS files.
