2023 CWSRF PROJECT PLAN

The City of Grosse Pointe Woods

AEW Project No. 0160-0462

ANDERSON, ECKSTEIN & WESTRICK, INC.

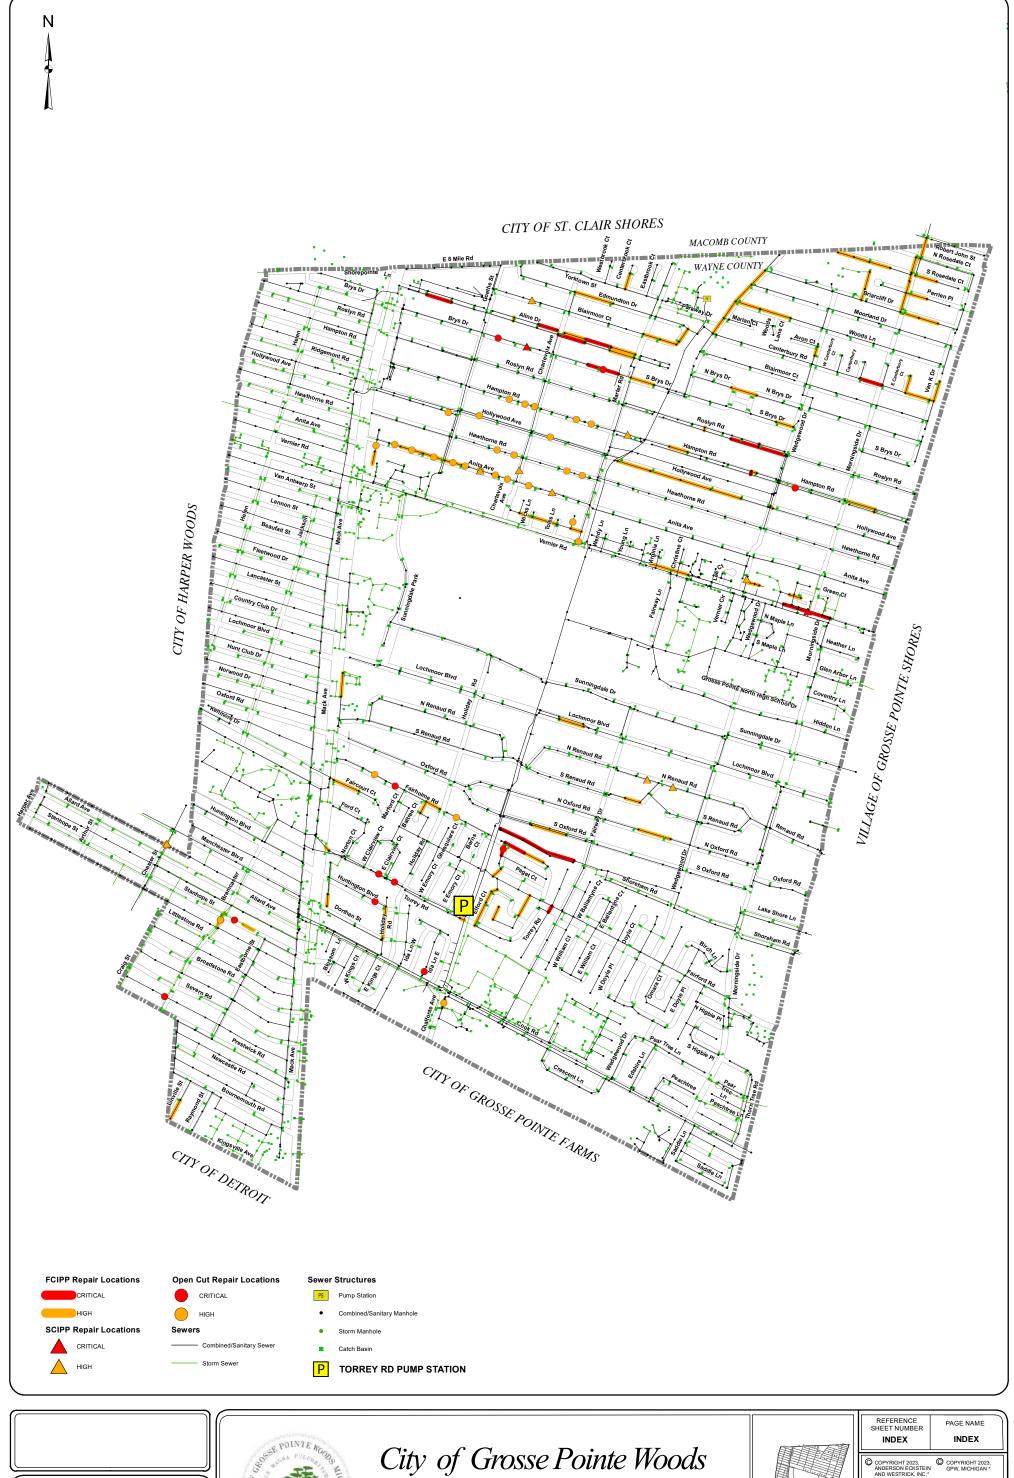
Appendix A

Map of Service Area with Proposed Projects Locations

A table summarizing the results of the NASSCO PACP sewer video inspection is included in Appendix G. A map of the proposed sewer projects with areas of Grade 4 or 5 defects is included in Appendix A.
