Adame Roofing
810 S Norwood
Pueblo, Co 81001

Overview

Inspection report for 50 N Lake Rd, Cuchara Colorado

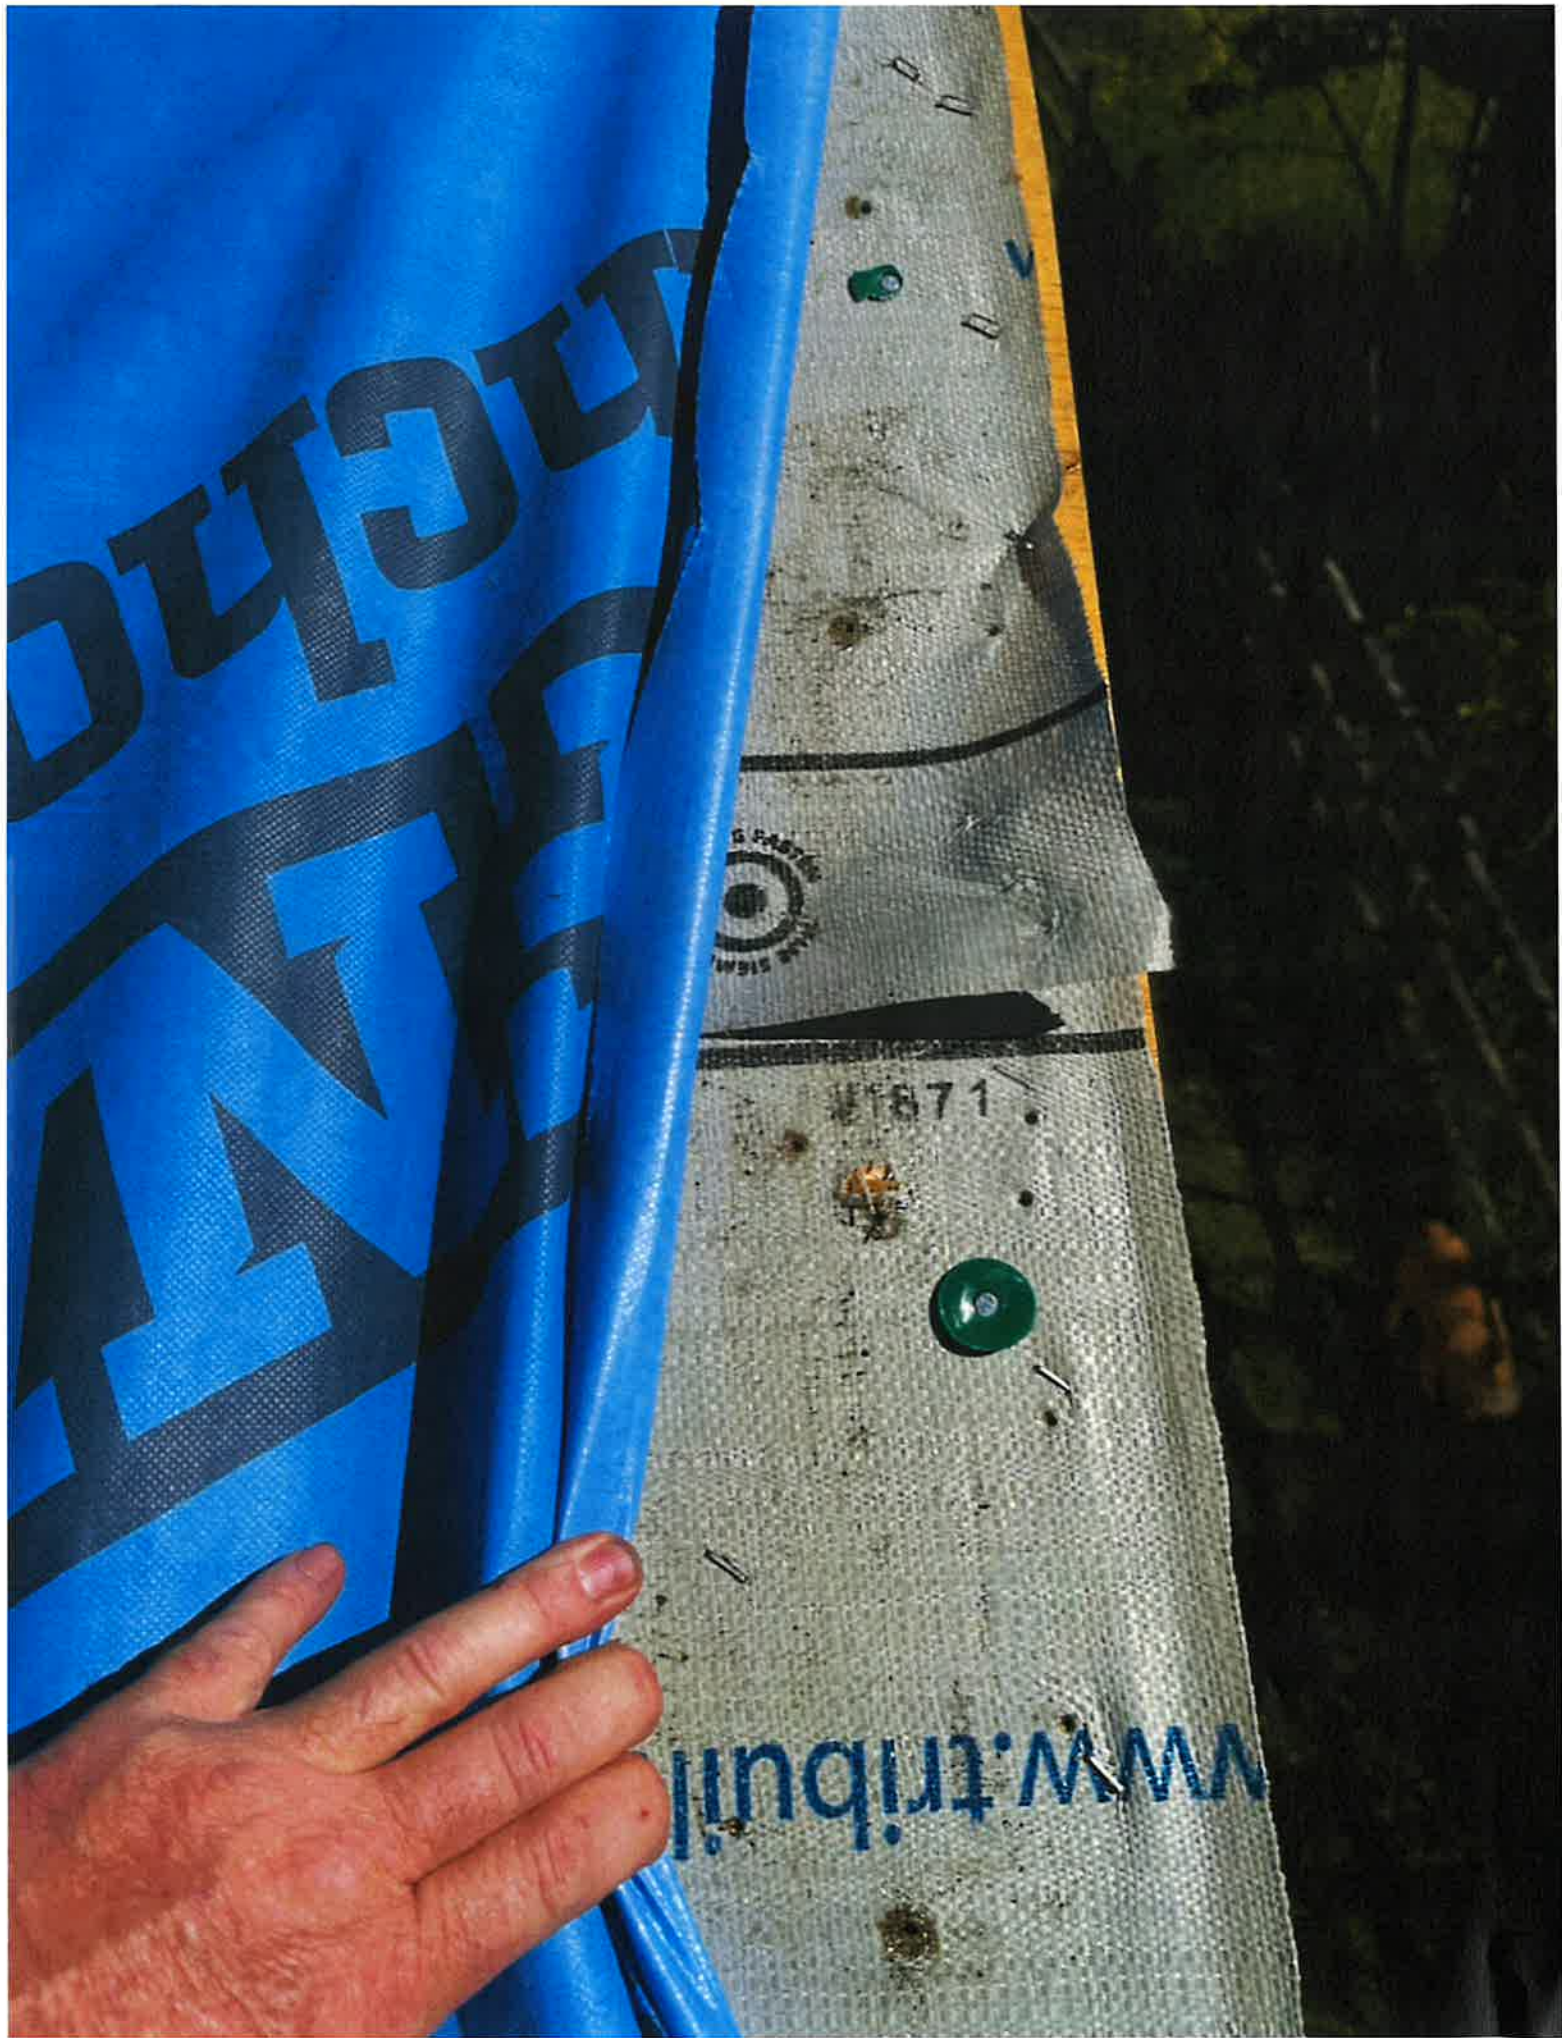
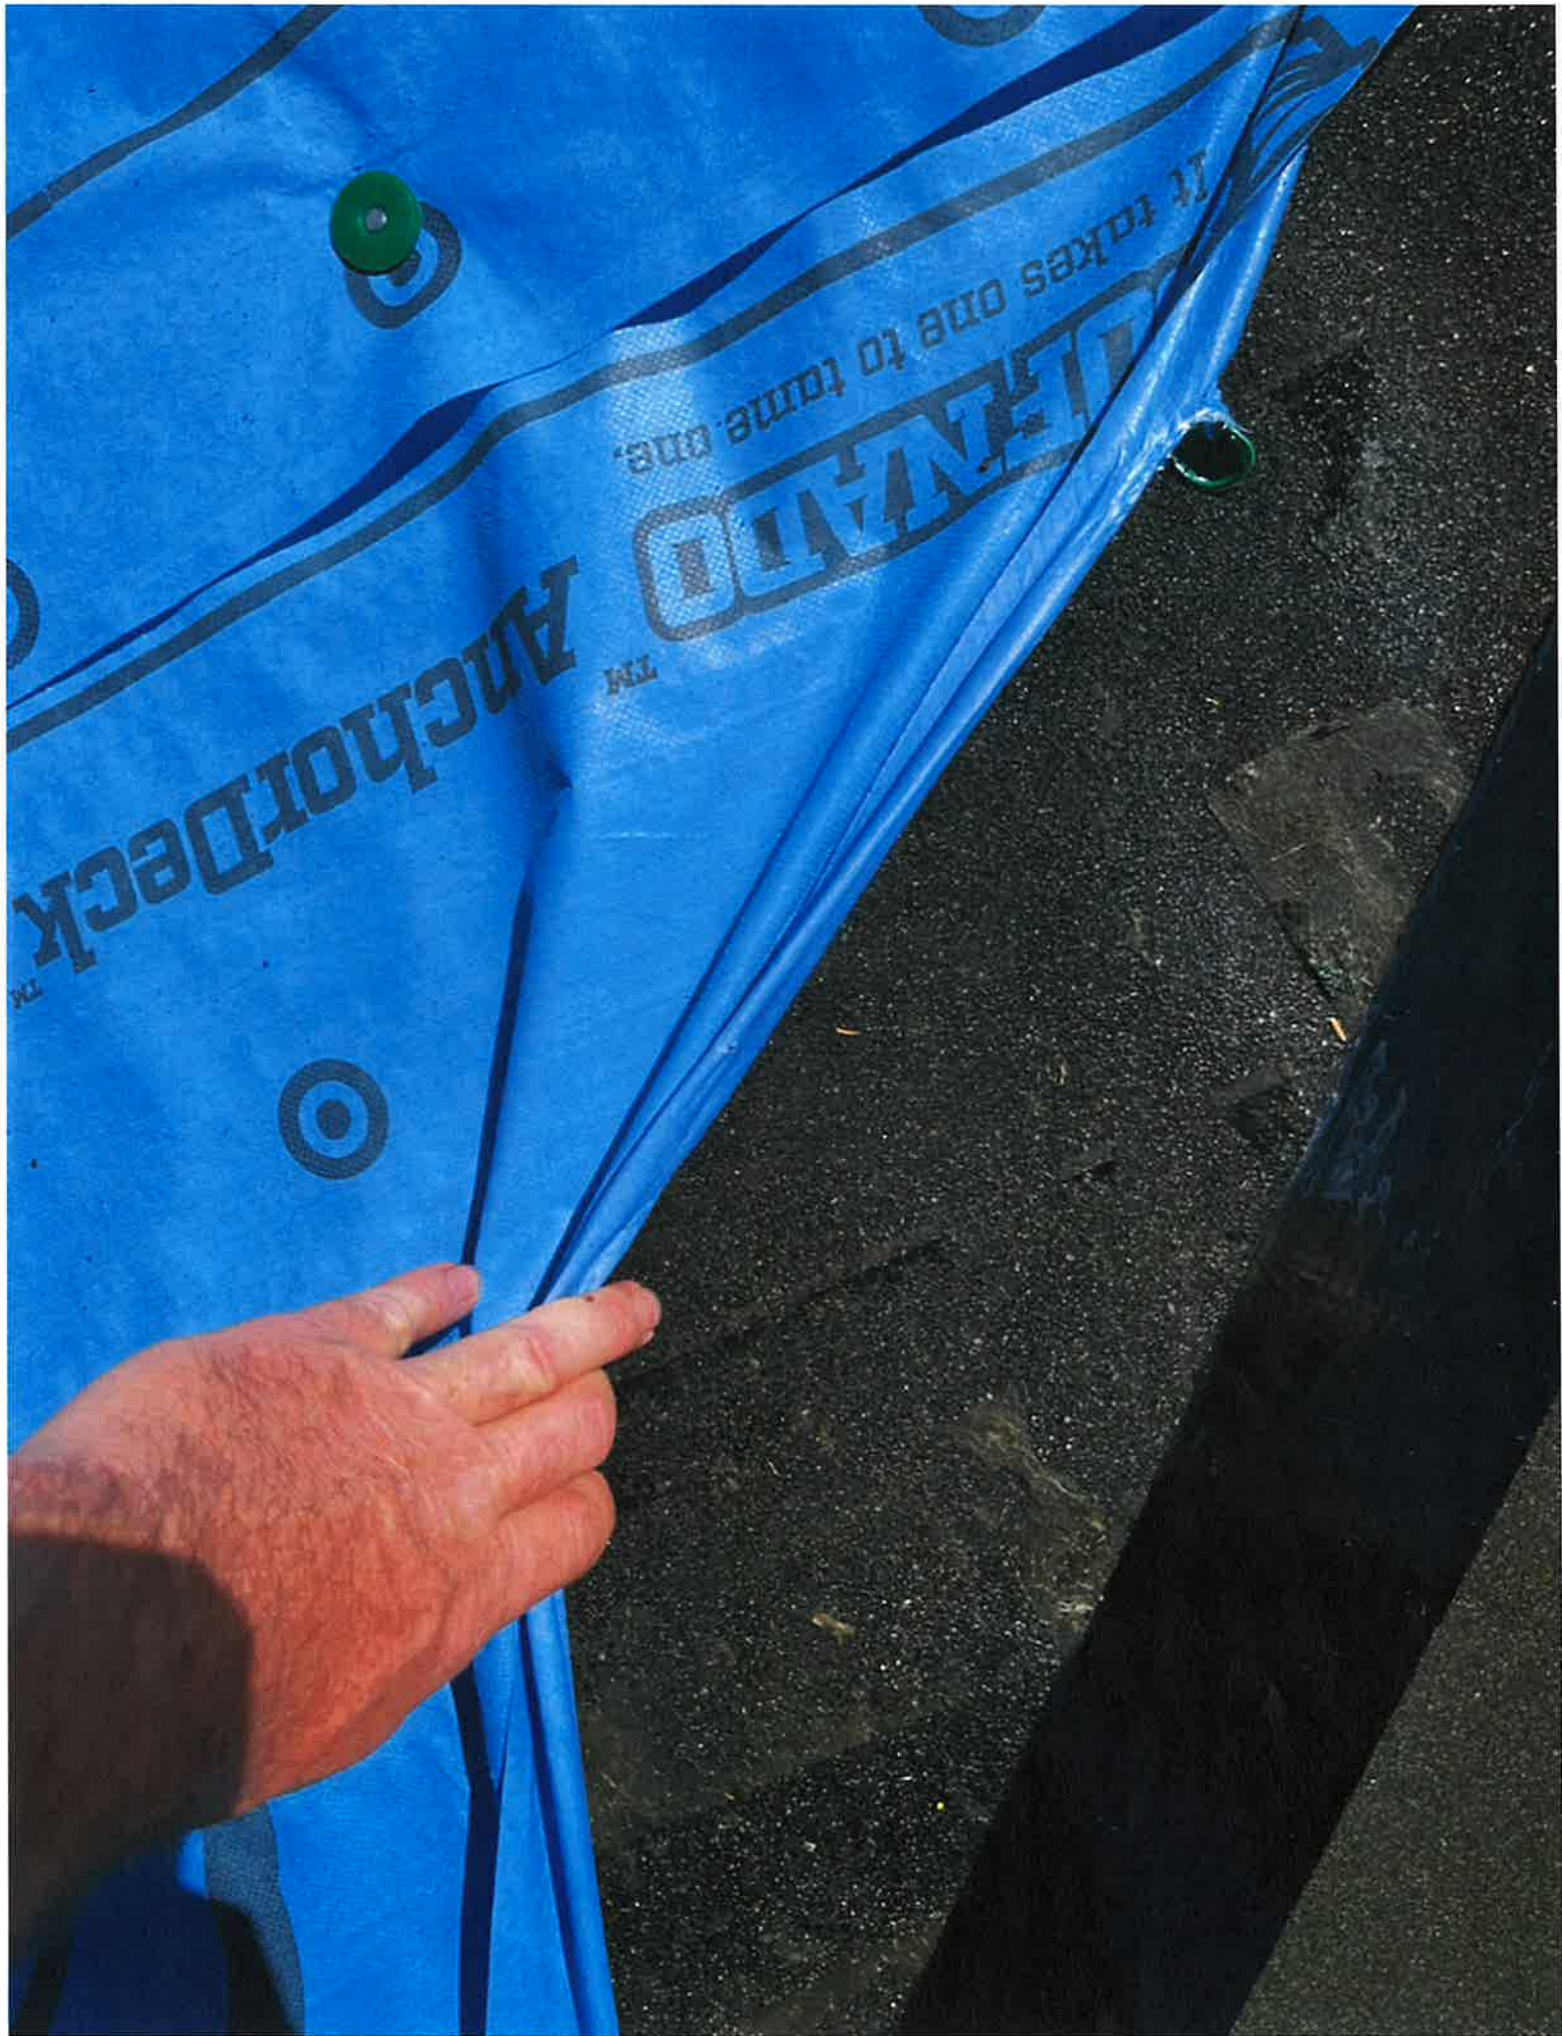
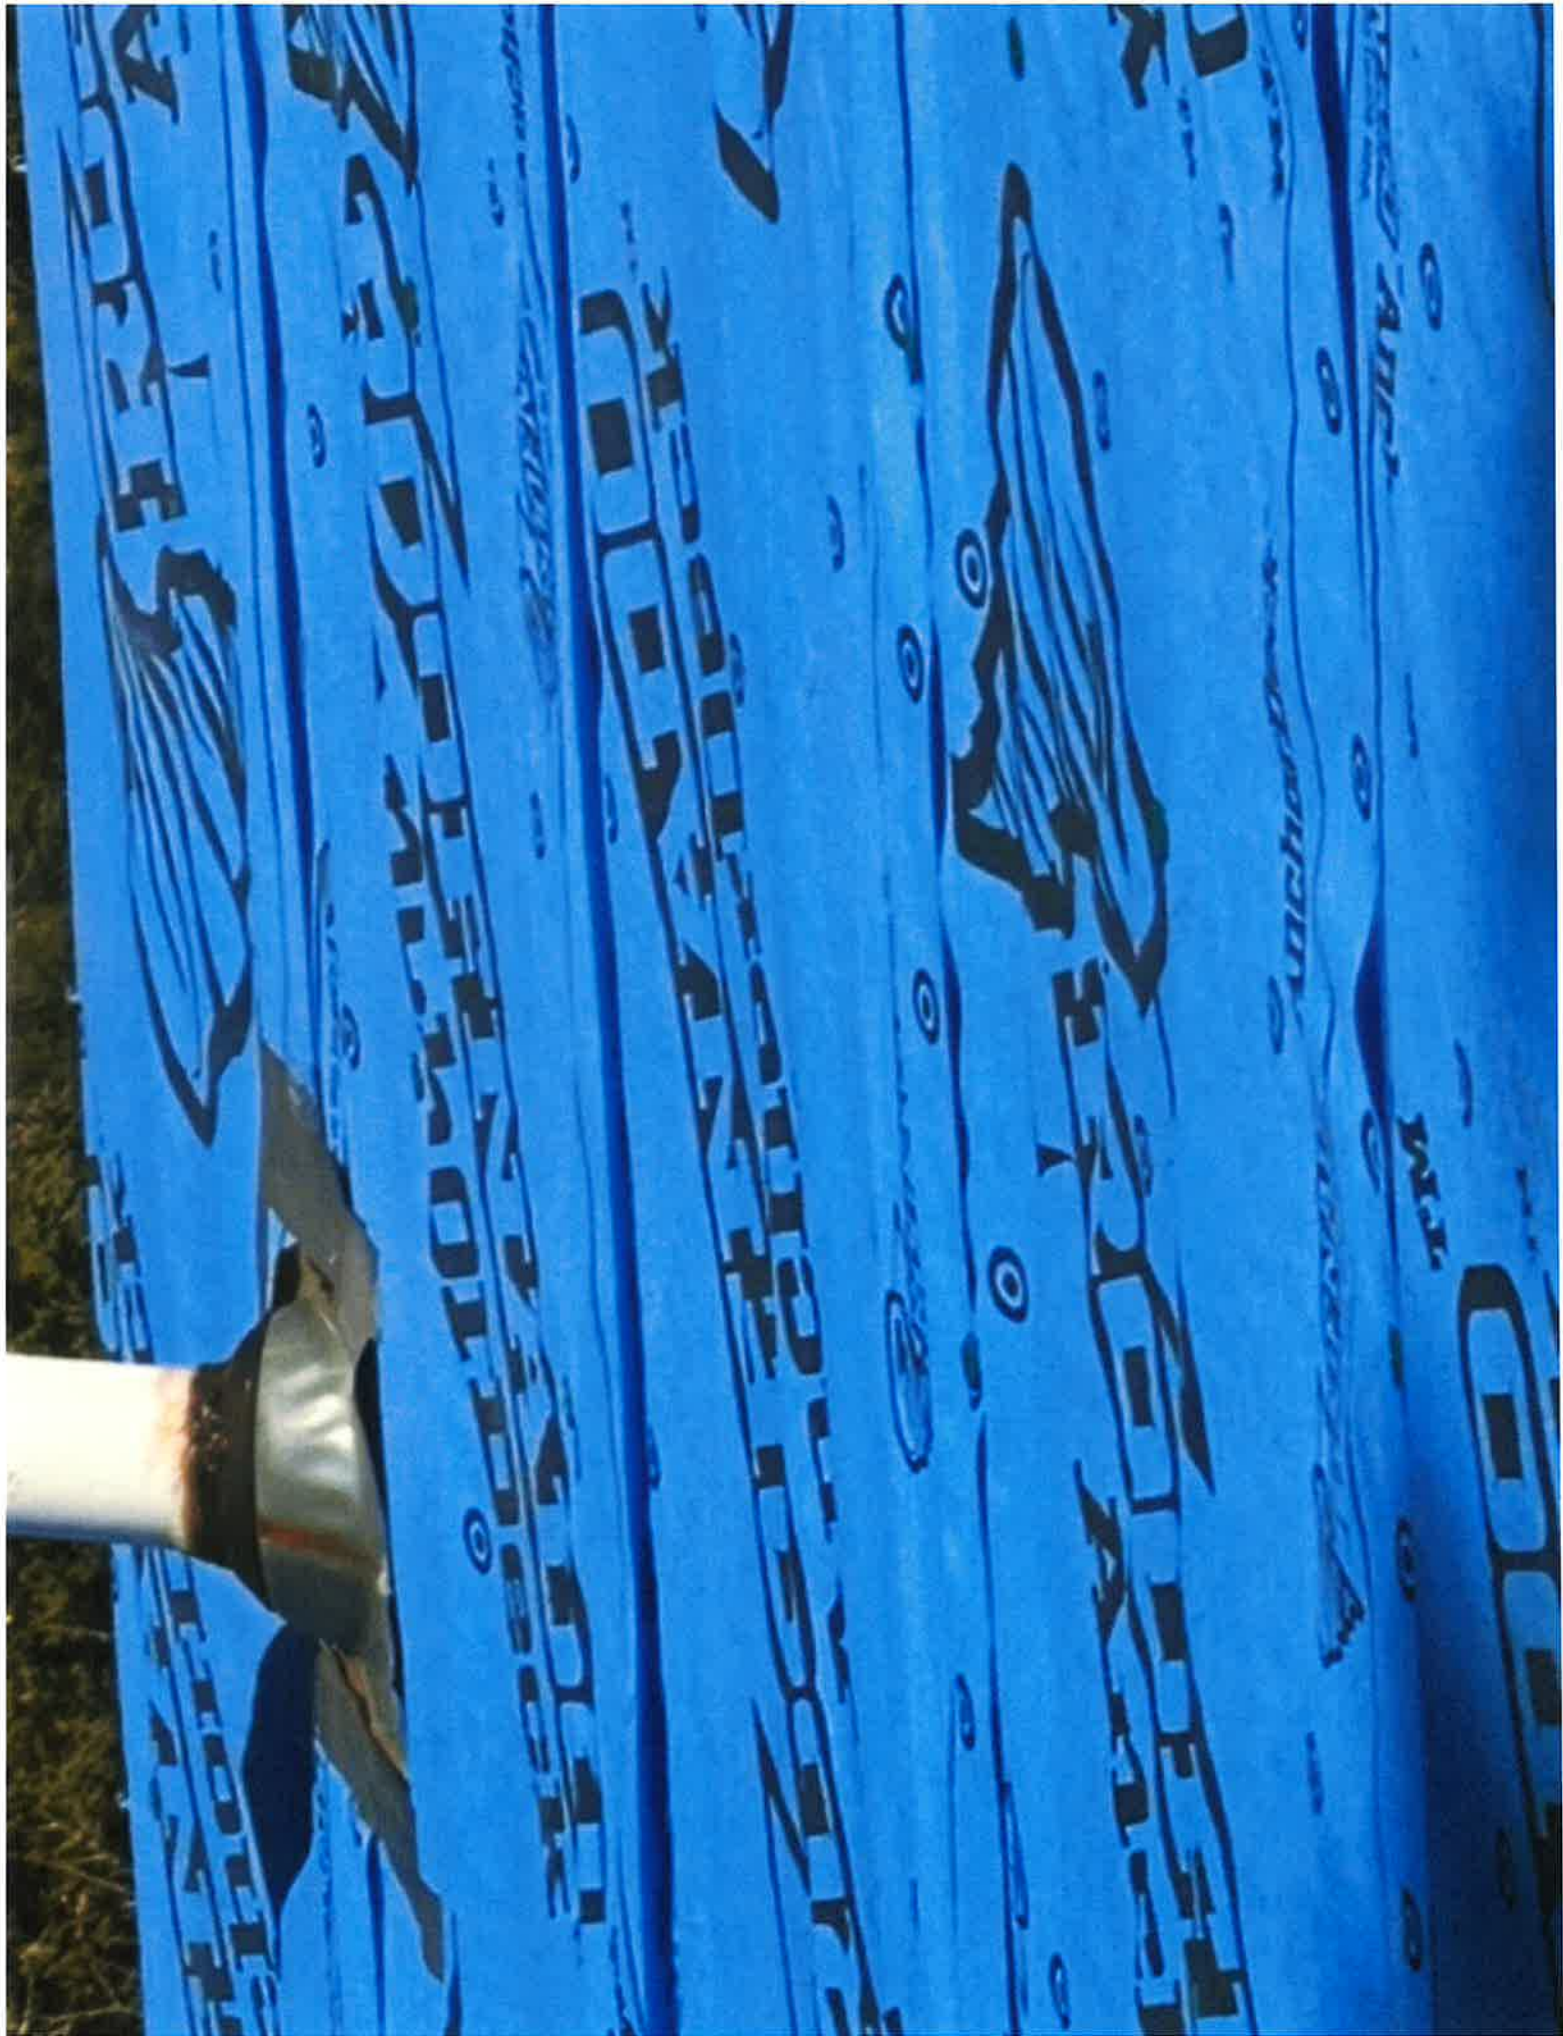
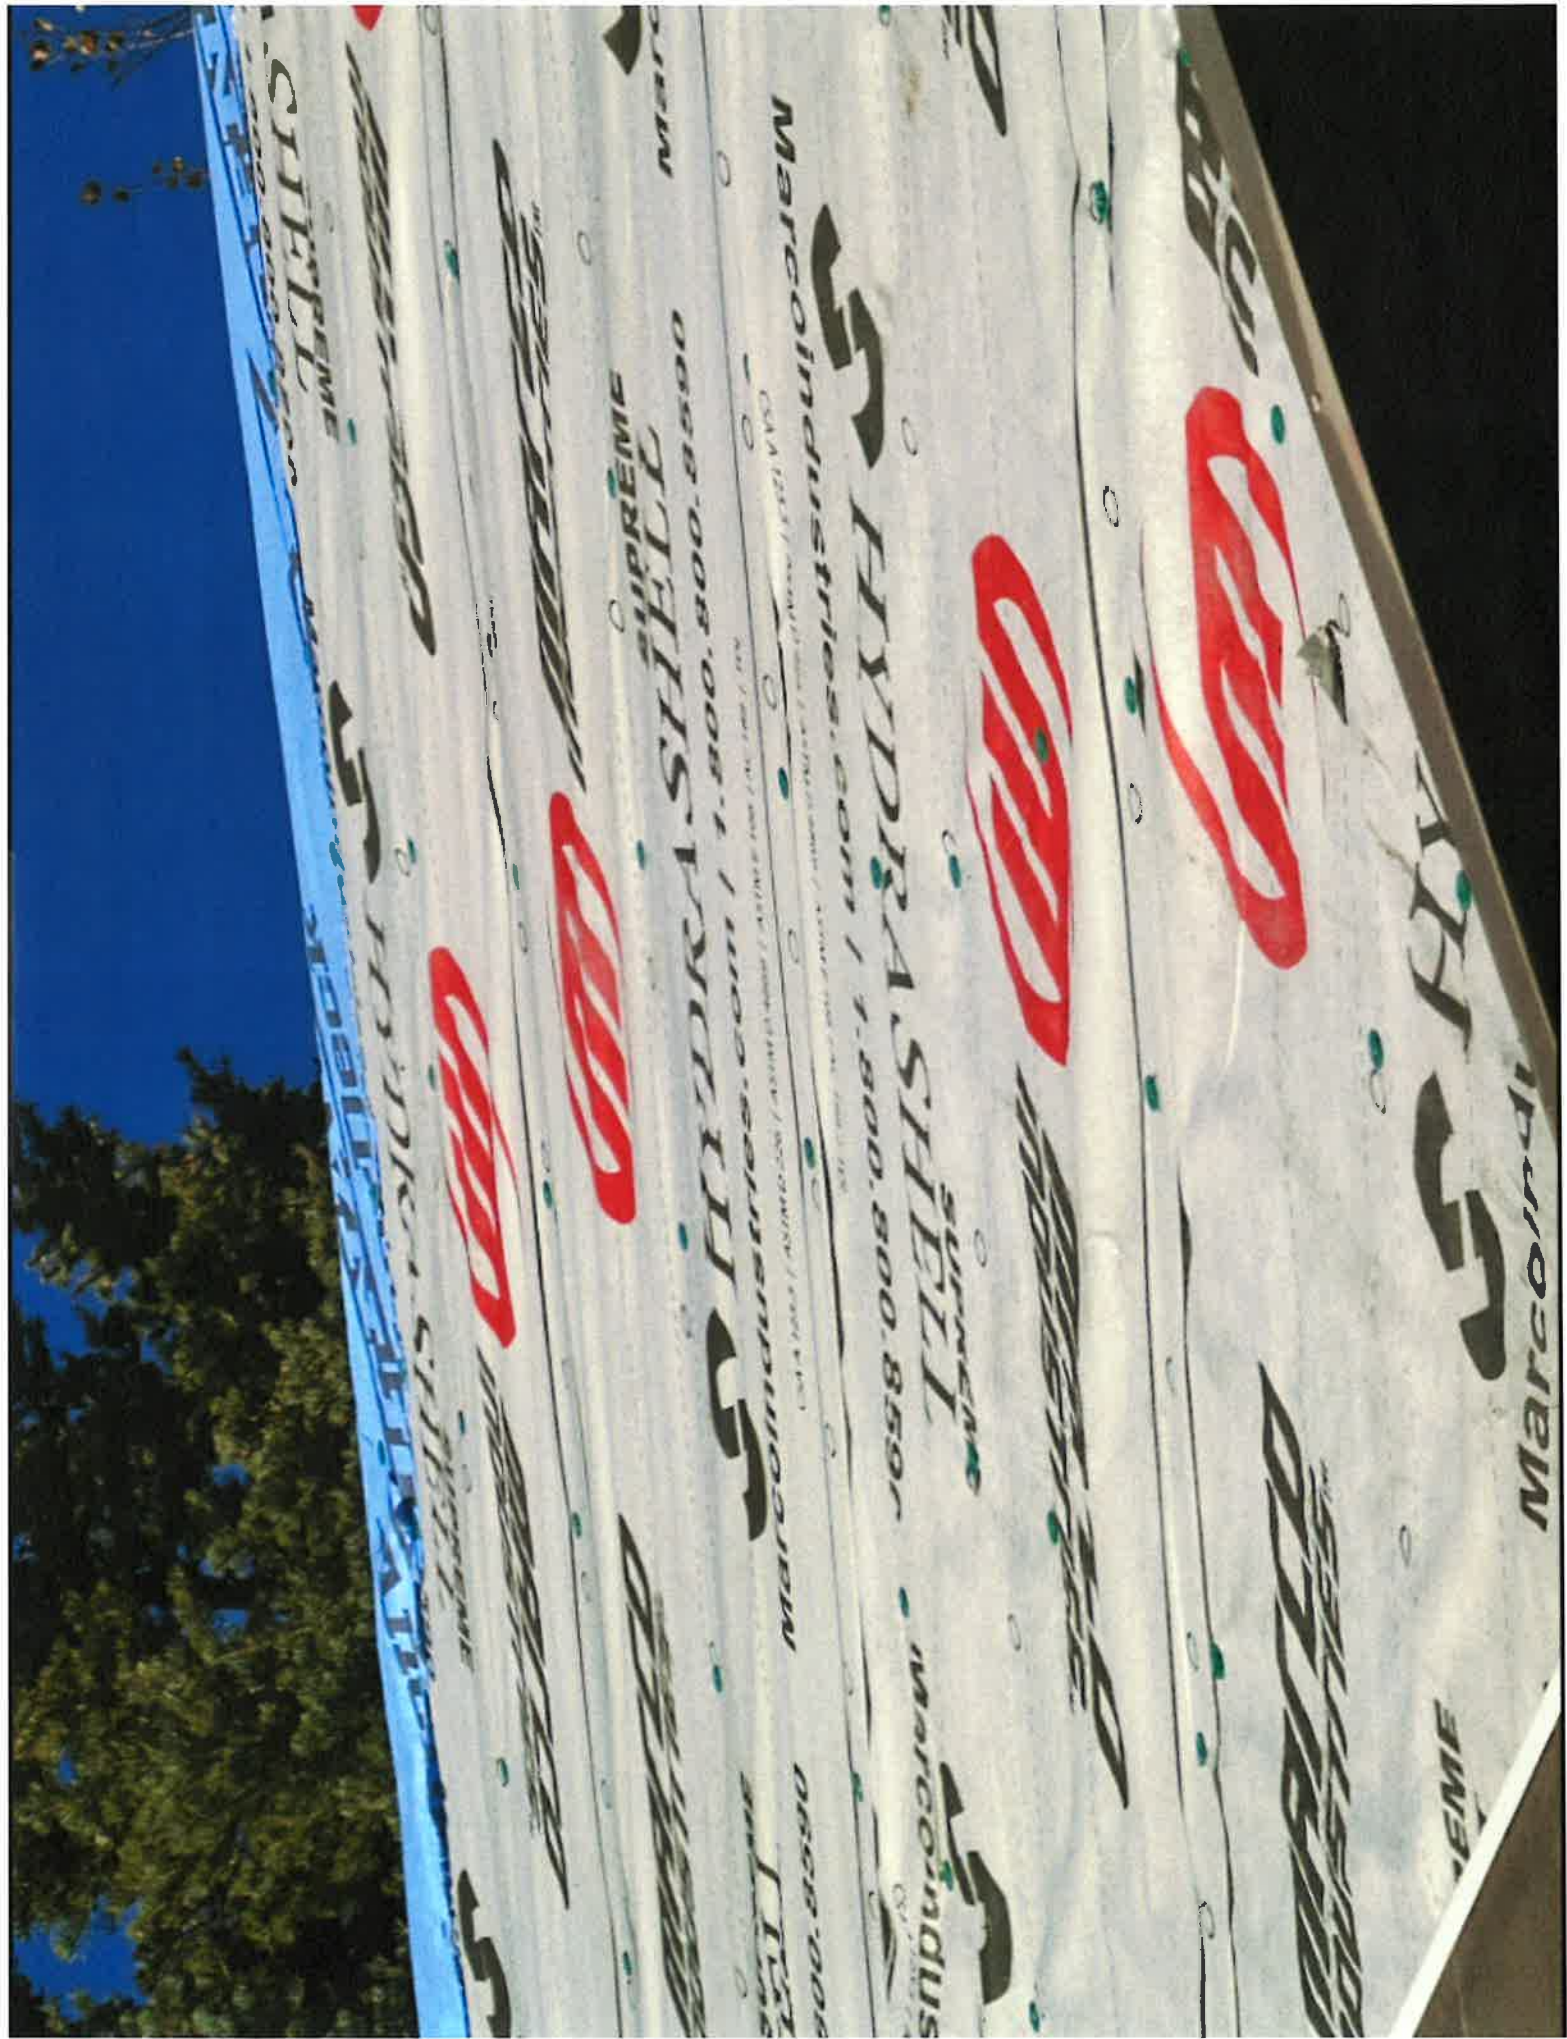
1. Granulated ice and water was underneath the synthetic felt. The ice and water underlayment seemed to be from the original shingle roof. This underlayment is not suitable for a metal roof per material specs since it has been known to melt due to high temperature. Two different brands of synthetic were used on top of the ice and water. There was new ice and water on eaves but it was still the improper kind.
2. Duct tape was used around skylight instead of ice and water
3. Panels were different sizes and not reaching the ridge vent line evenly. Due to this a longer ridge would have had to have been used.
4. Panels were showing bumps where clips were installed. This issue is both a cosmetic and functional problem. If clips were not fastened correctly this could have voided wind warranties and caused issues in the future.

It was recommended to the homeowner to remove existing panels and underlayment and start with a new deck and new metal system. None of the material on the roof would be salvageable.
