## **Supplemental Information Requested by County**

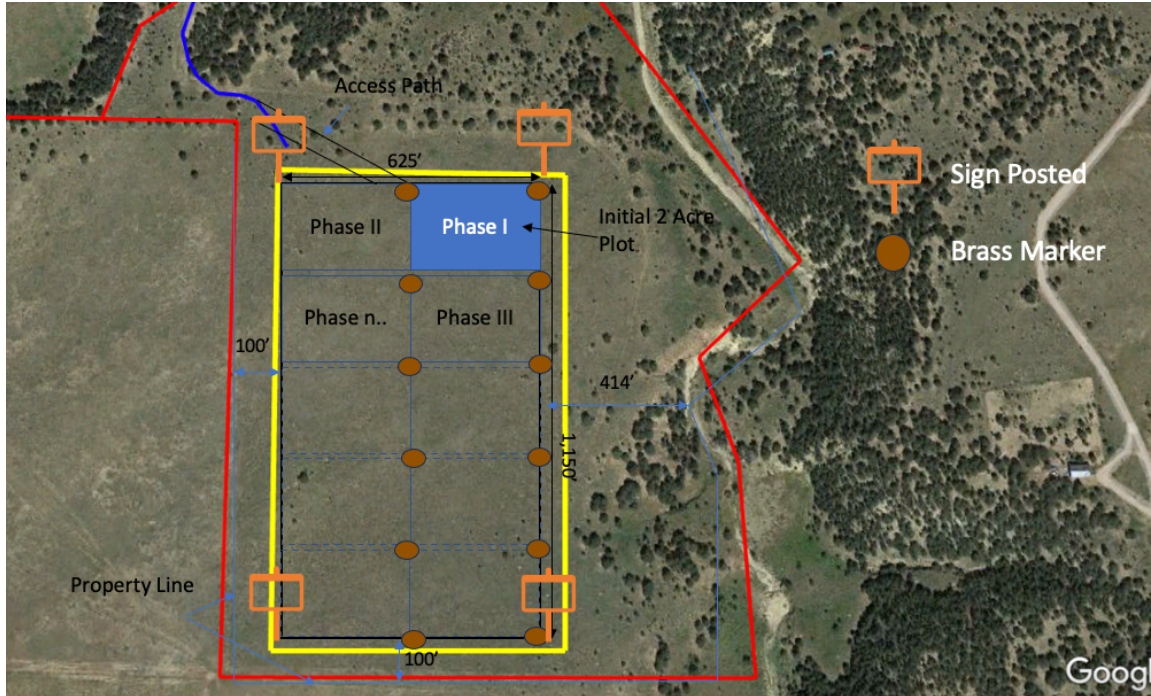
In addition, each of the Phases' pits will be monumented using Brass Markers in a single corner, likely NE, which will be geolocated, used as the original reference point for each pit whose size and location will be documented in the final as-built plot to be filed with the County as per the following:

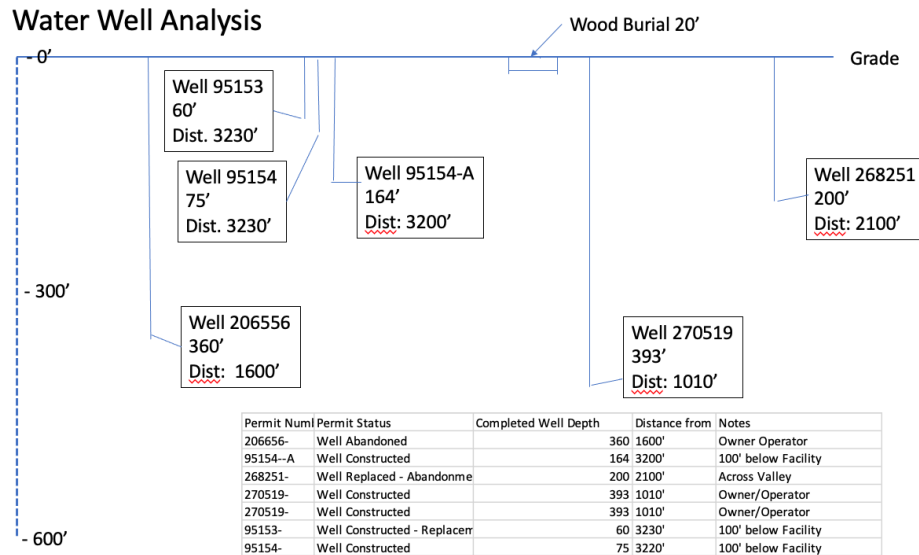
Below is a water well analysis like one presented to the State in our earlier application. Burial depth is 20' maximum with bedrock identified in 3 of 4 sites at less than 30'. Closest well is over 100' feet away (owned by the operator) and is 393' deep. Shallower wells within 3500' are 100' below facility grade to begin with and are near the Cuchara river 3000+' away.

Our facility/pit is designed specifically to keep water out of the storage area thus we do not expect any material leachate to escape the pit boundaries. Further, surface water will be directed away from the facility, irrigation will not be allowed per the Covenant with the state, so run-off will not be impacted by the buried wood which the State agrees is nontoxic in any case.

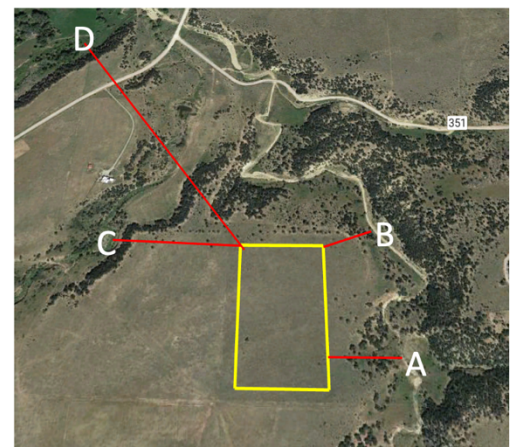
Run-off Analysis – to nearest waterways

Below is a water-way analysis showing the proximity to the facility to each of the potential run-off sources. The facility is out of the 100 year flood plain positioned on a hill. Run-off paths are a substantial distance away which minimizes any potential for leachate reaching them. Again, wood is non-toxic. Methane production should be minimal and will be monitored regularly. If any risks are identified, mitigating actions will be taken.

A) Distance to Ritter Arroyo SE – 538'

B) Distance to Ritter Arroyo NE – 423'

C) Distance to Drury Spring & Arroyo – 984'

D) Distance to Cucharas River – 2630'

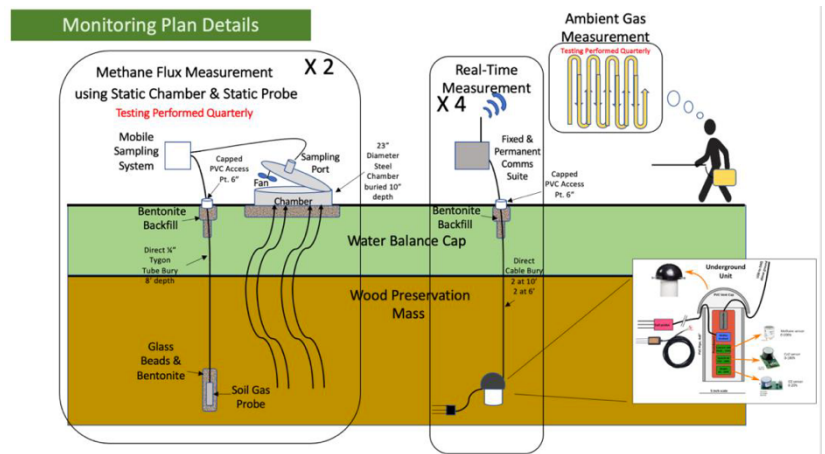
- 1) The materials we are burying are natural, non-toxic and non-hazardous.
- 2) Our Pit cover and topographic design (i.e water balance cap (per State recommendations), berms and drainage paths) are specifically intended to prevent water from entering the wood chamber. Success in the project is a dry storage area.
- 3) We will be performing real-time monitoring of moisture conditions in the pit and will take mitigative actions long before leachate conditions could be reached. The graphic to the right shows the extent of monitoring that will be performed for 30 years or more.
