## Hendersonville Historic Preservation Commission Certificate of Appropriateness Application

Program Name: Renew NC Single-Family Housing Program  
Case ID: NC-HHH-076917

Proposed Historic Property Rehabilitation at: 1040 Patton St,  
Hendersonville North Carolina 28792

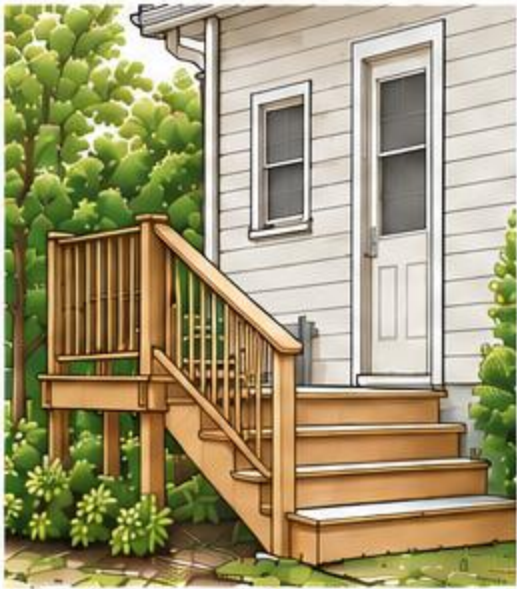
### 2 SIDE STEPS AND LANDING (LEFT ELEVATION)

Replace existing concrete steps and landing with new wood steps, landing and handrail.

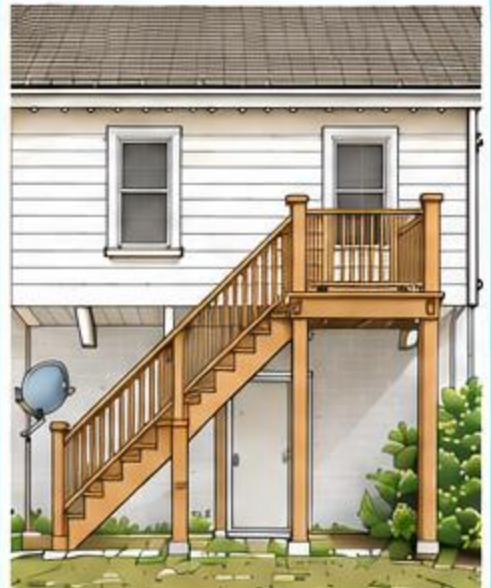
### 7 REAR DECK AND STAIRS (REAR ELEVATION)

New wood deck, stairs and railing at rear elevation.

- Construct new wood deck, stairs and railing at rear elevation
- Match materials and scale to the house
- Paint or stain as appropriate

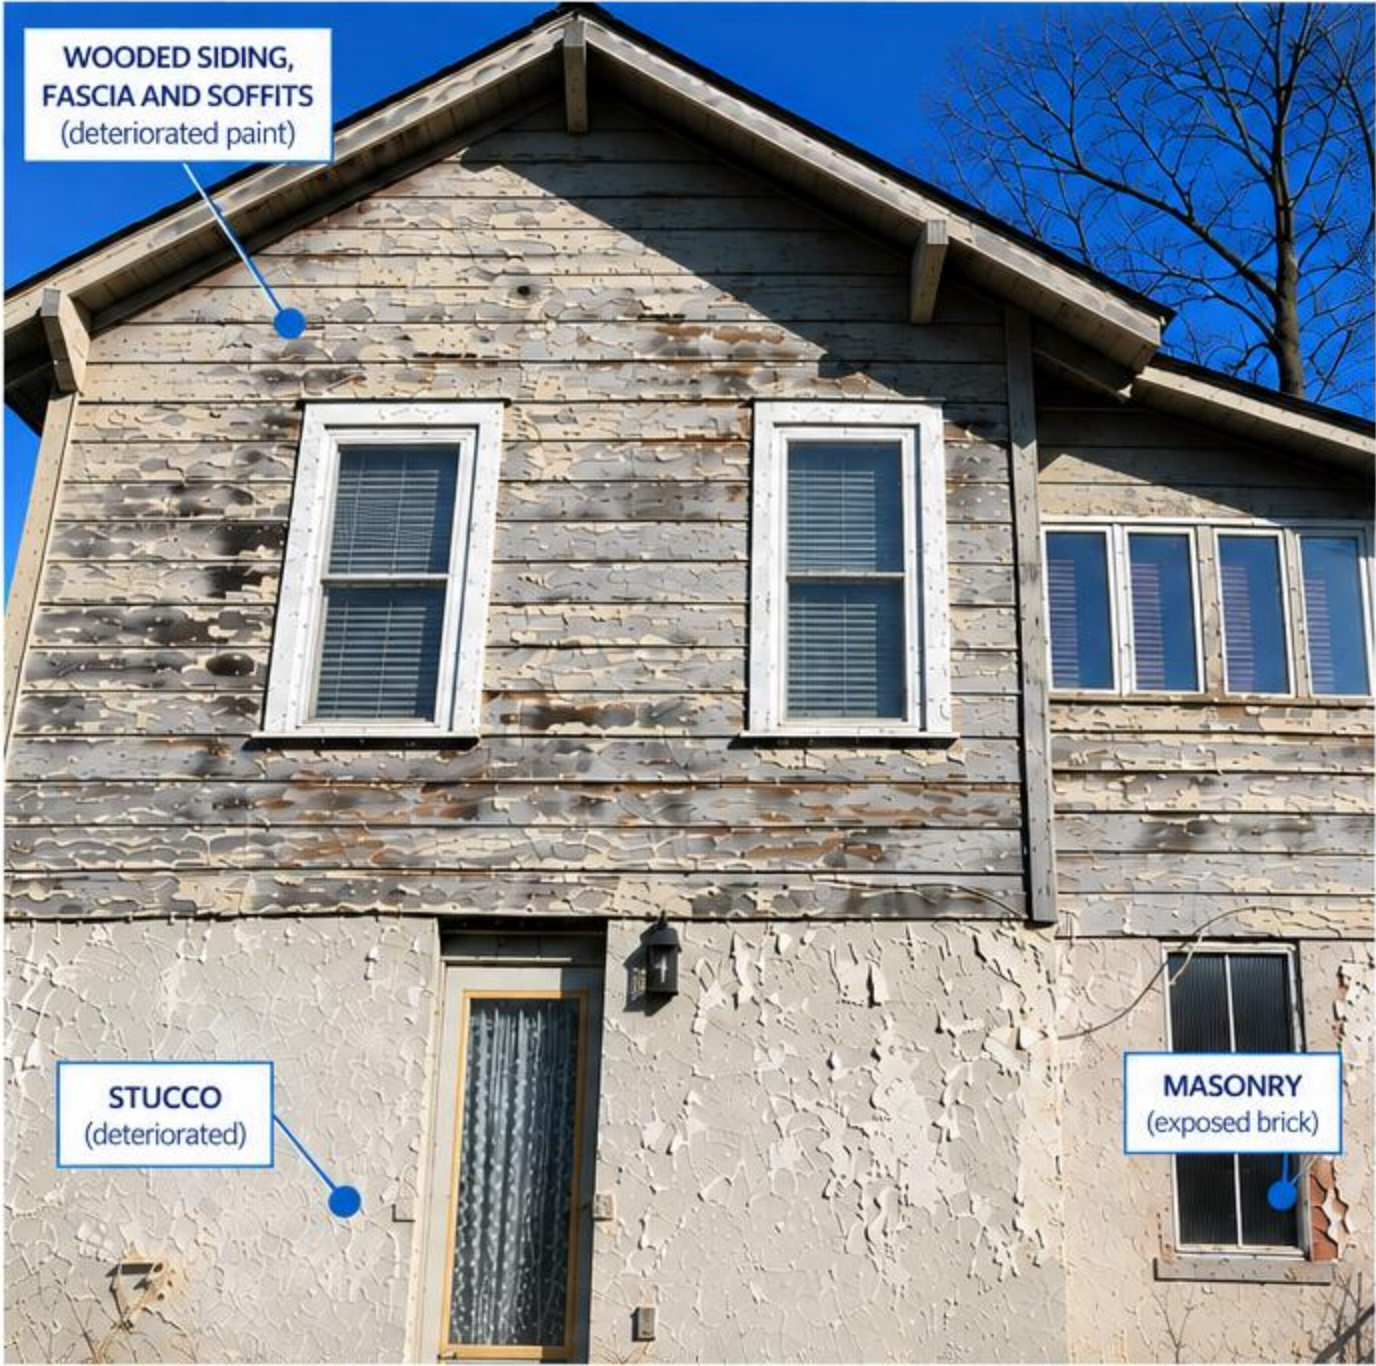
EXISTING CONDITION  
(PARTIAL ELEVATION)

**NOTE:** These images show existing conditions and are meant for illustrative purposes only.  
Proposed repairs will follow the Hendersonville Historic Preservation Commission Residential Design Standards and the Secretary of the Interior's Standards for Rehabilitation.  
Work is proposed for all four elevations.

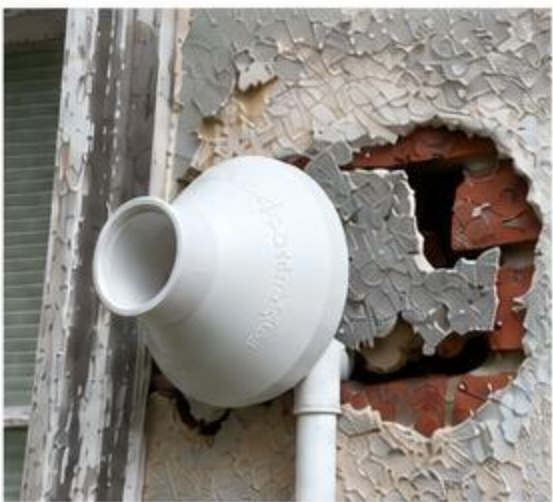
EXISTING CONDITION  
DAMAGED STUCCO / EXPOSED MASONRY

**Stucco (Synthetic)**  
New stucco and a fog coat will be applied to the exterior foundation.

**Masonry**  
Repair by patching, splicing, consolidating, or otherwise reinforcing the masonry using recognized preservation methods. Repair may include the limited replacement in kind.

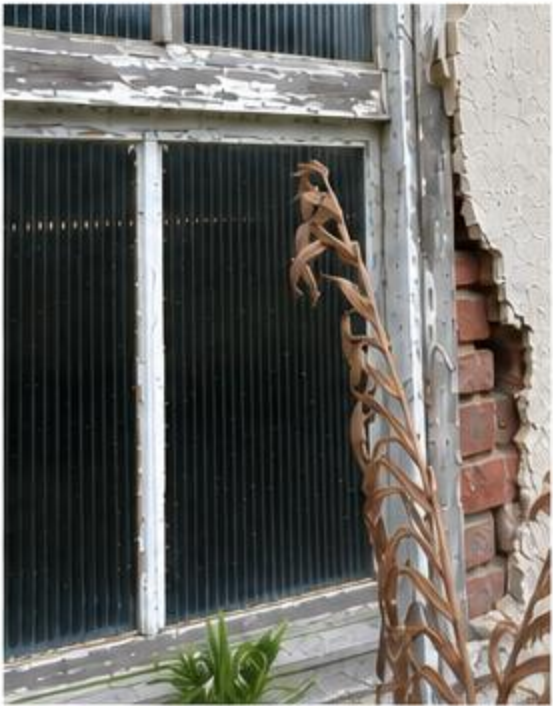
EXISTING CONDITION  
DETERIORATED STUCCO / EXPOSED MASONRY

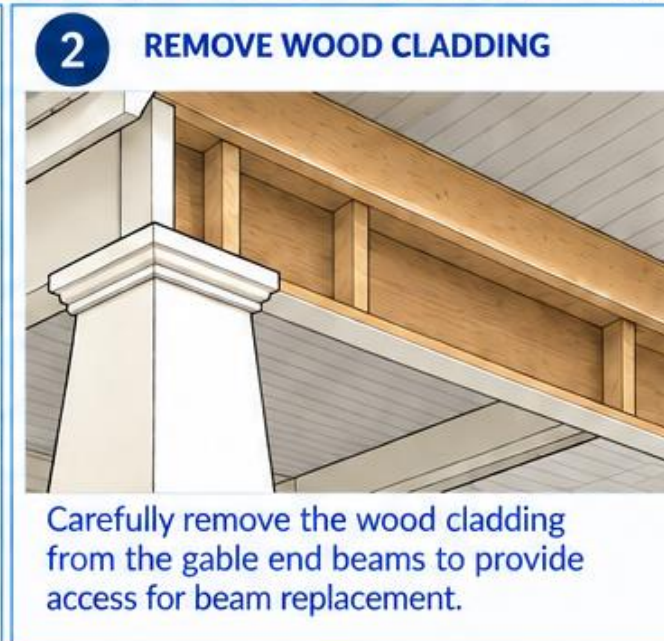
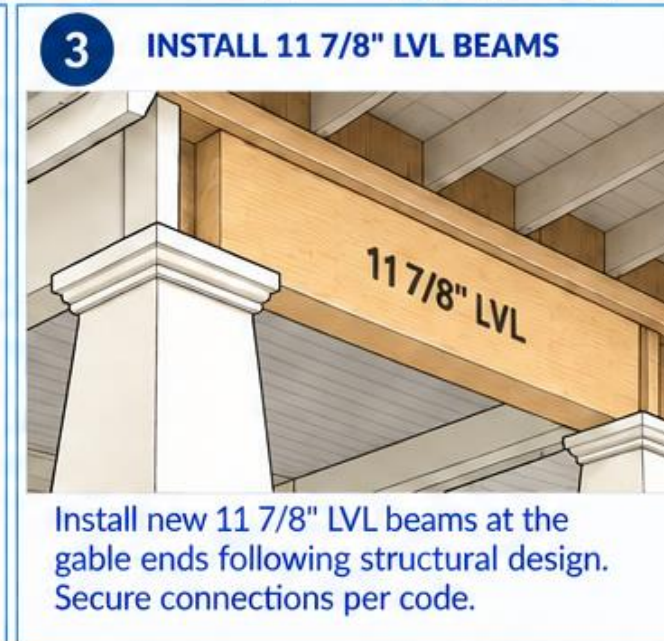
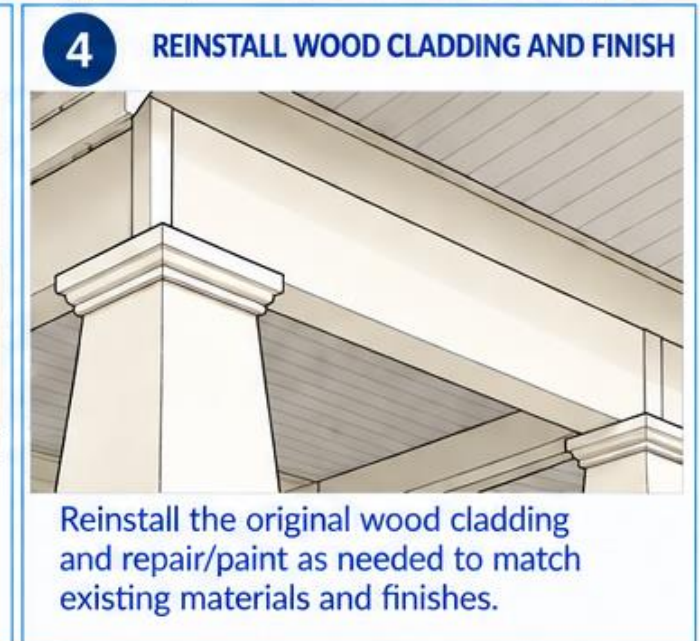
# PORCH BEAM REPAIRS

PRESERVE | REPAIR | STRENGTHEN

- Install new (2) 1 1/8" LVL beam with HUC412 heavy-gauge hangers, as shown in the details.
- The original beam wood cladding will be preserved and reinstalled.
- Use exterior, pressure-treated lumber and corrosion-resistant hardware.
- Match existing dimensions, profile, and appearance.
- Repairs will be limited to the porch structure and will maintain the existing design.

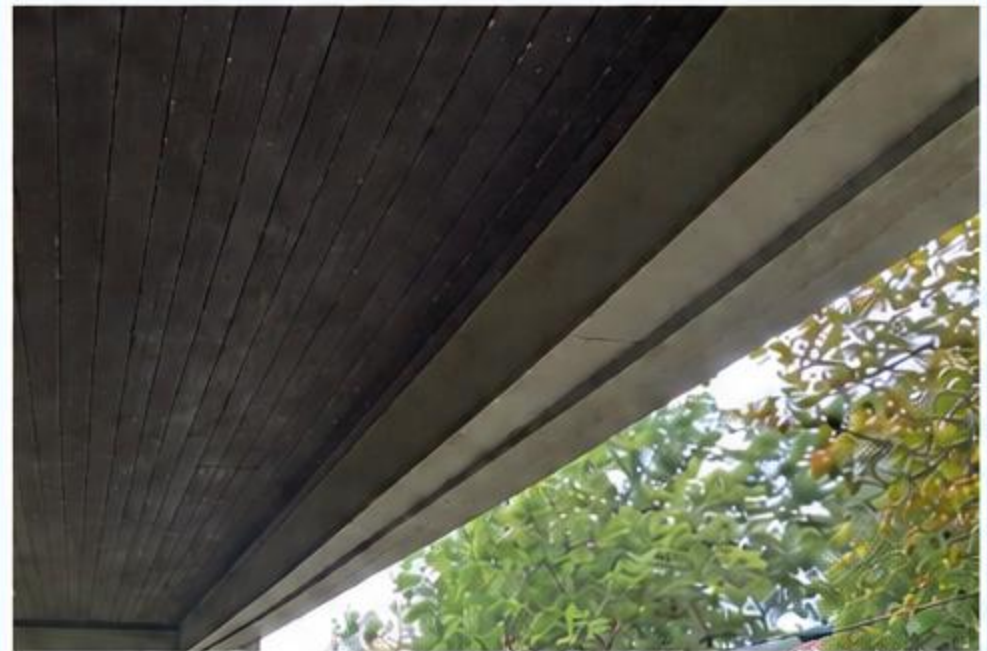
EXISTING CONDITIONS – SOFFIT/BEAM

Existing front porch soffit and beam.

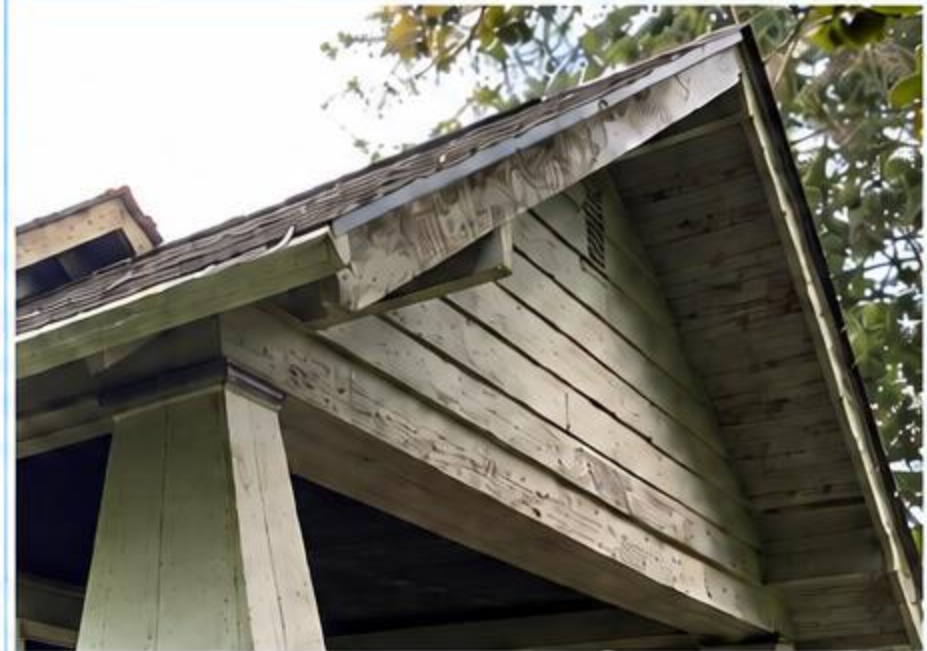
EXISTING CONDITIONS – GABLE/RAKE

Existing front gable and rake board with deteriorated wood elements.

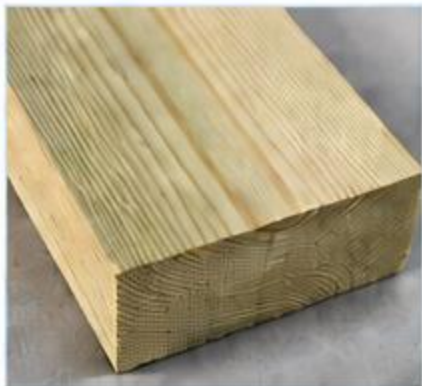
**Pressure-Treated Lumber**  
Use exterior, pressure-treated lumber suitable for outdoor conditions for new beam and framing members.

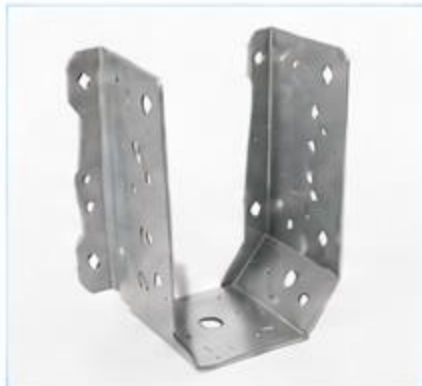
**HUC412 HGR**  
Simpson Strong-Tie HUC412 heavy-gauge hanger for new beam-to-post connection.

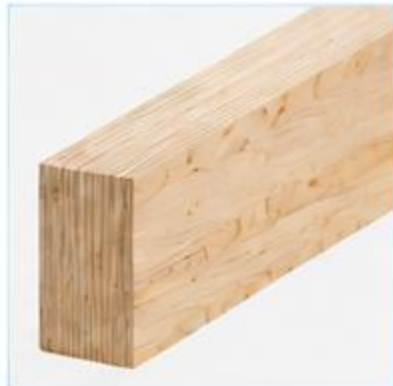
**1 1/8" LVL (Laminated Veneer Lumber)**  
Use new (2) 1 1/8" LVL beams as indicated in the details.

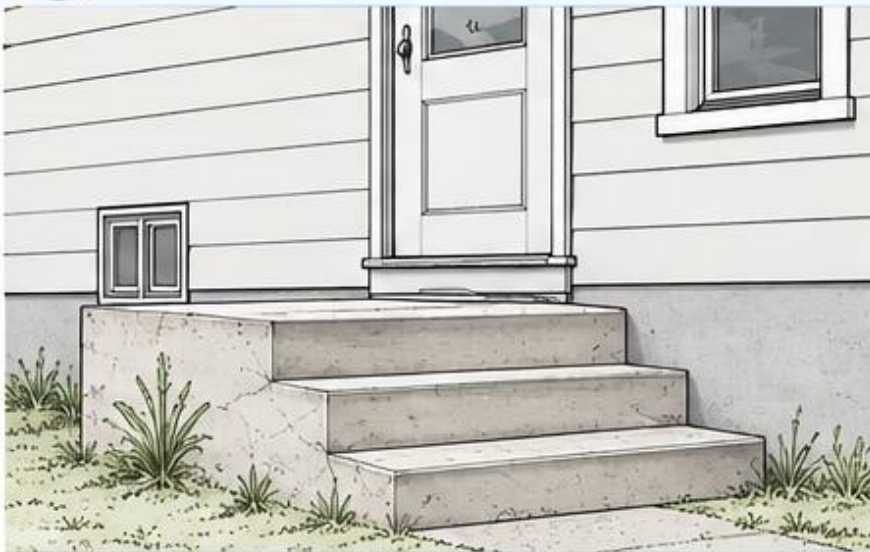
## 1 EXISTING CONDITION

Existing concrete side landing and steps.

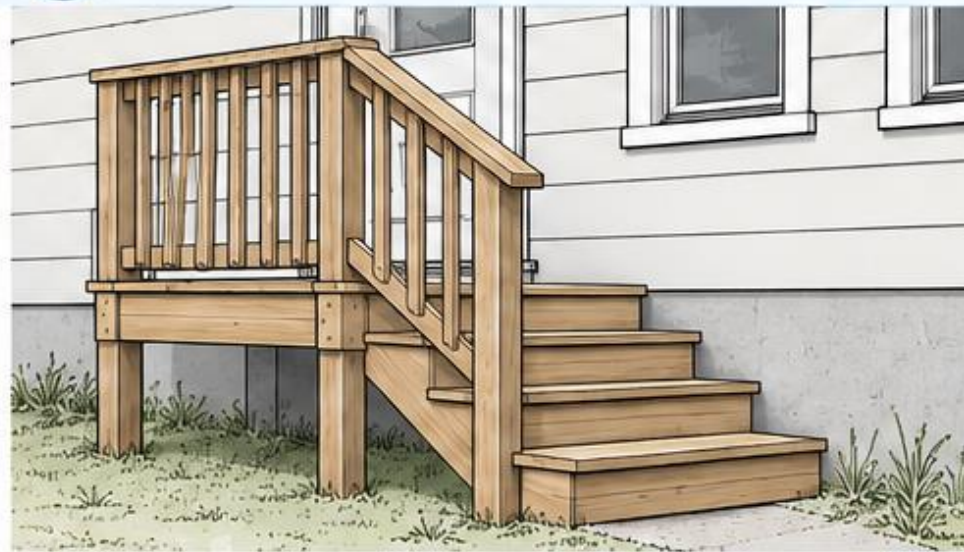
## 2 NEW WOOD LANDING, STEPS AND HANDRAIL

Replace with wood landing, steps and handrail.

- Existing concrete steps and landing will be removed and replaced with a 5-foot by 5-foot wood landing with wood stairs and handrails.
- The existing damaged concrete steps located on the left elevation must be removed to address water infiltration that is damaging the original masonry foundation wall.
- Use exterior, pressure-treated lumber and corrosion-resistant hardware.
- New construction will match the existing location and provide safe access while maintaining the existing design intent.

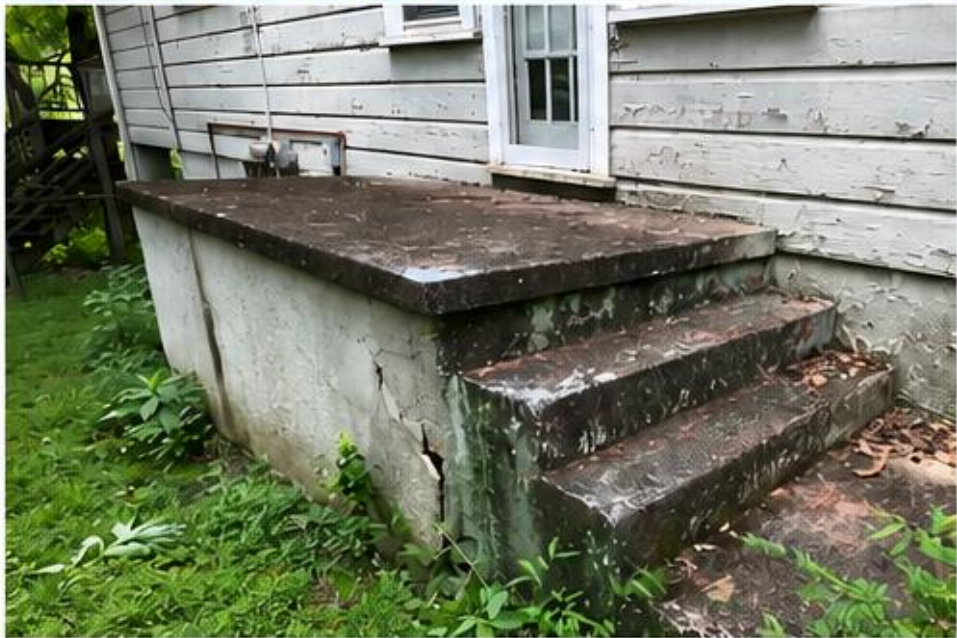
## EXISTING CONDITIONS

Existing concrete steps and platform to be removed.

Example of concrete cracking and deterioration on side steps contributing to water infiltration at the foundation wall.

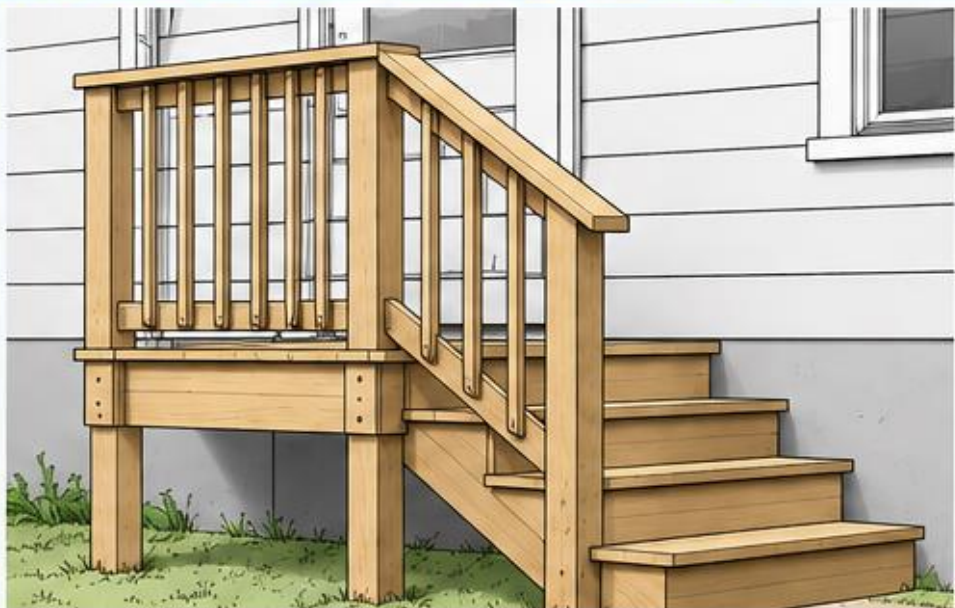
## PROPOSED REPLACEMENT (REFERENCE)

New 5-foot by 5-foot wood landing with wood stairs and handrails (similar configuration). Exact dimensions and design to be verified in field.

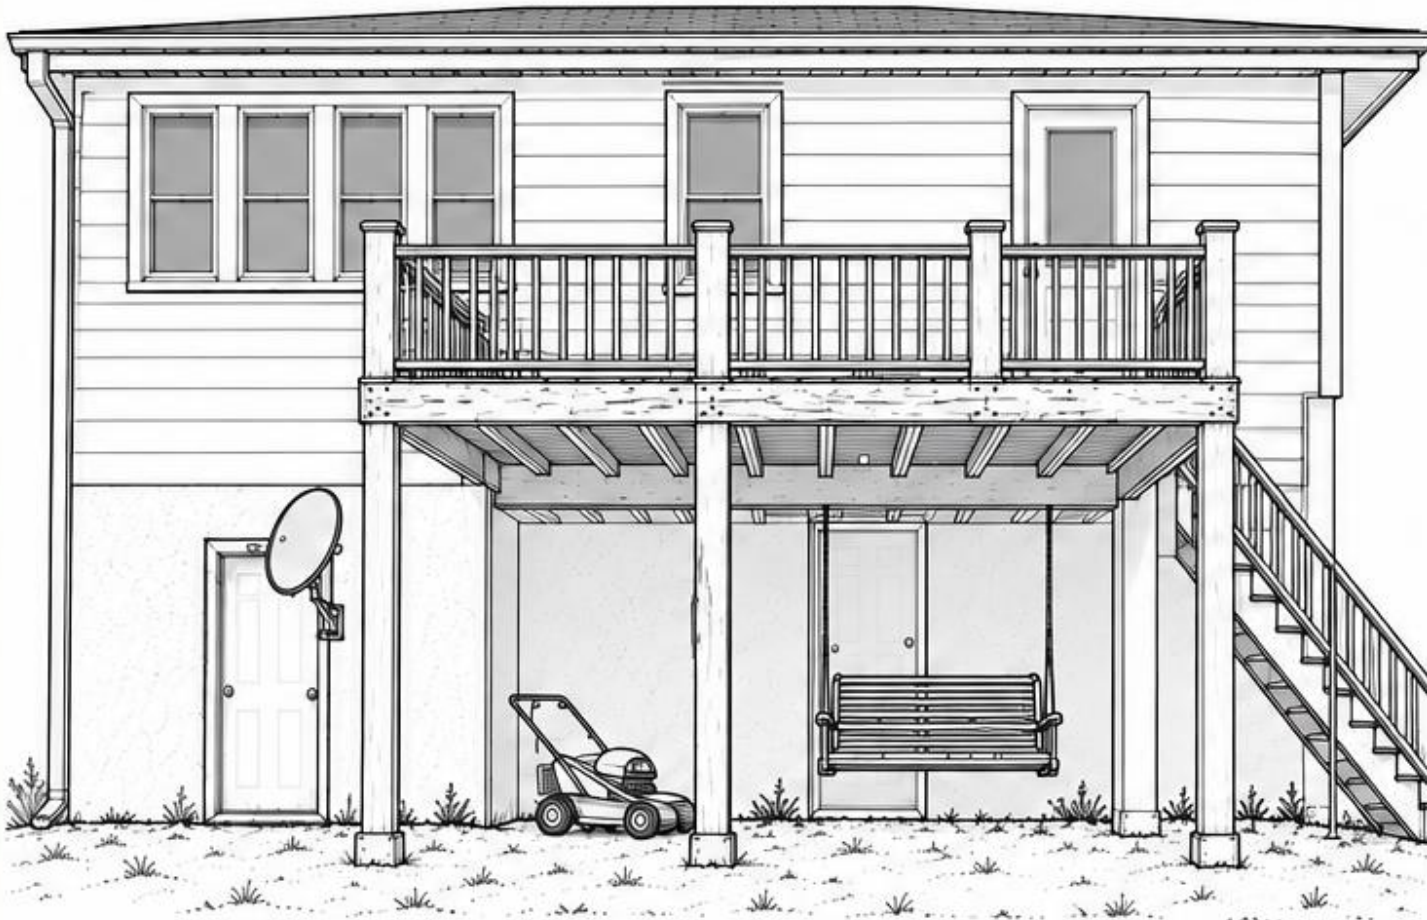
## EXISTING CONDITION (BEFORE REPAIRS)

### EXISTING CONDITION:

- Existing wood deck is deteriorated and damaged.
- Structural elements, decking, and railing are in poor condition.
- Deck will be removed.

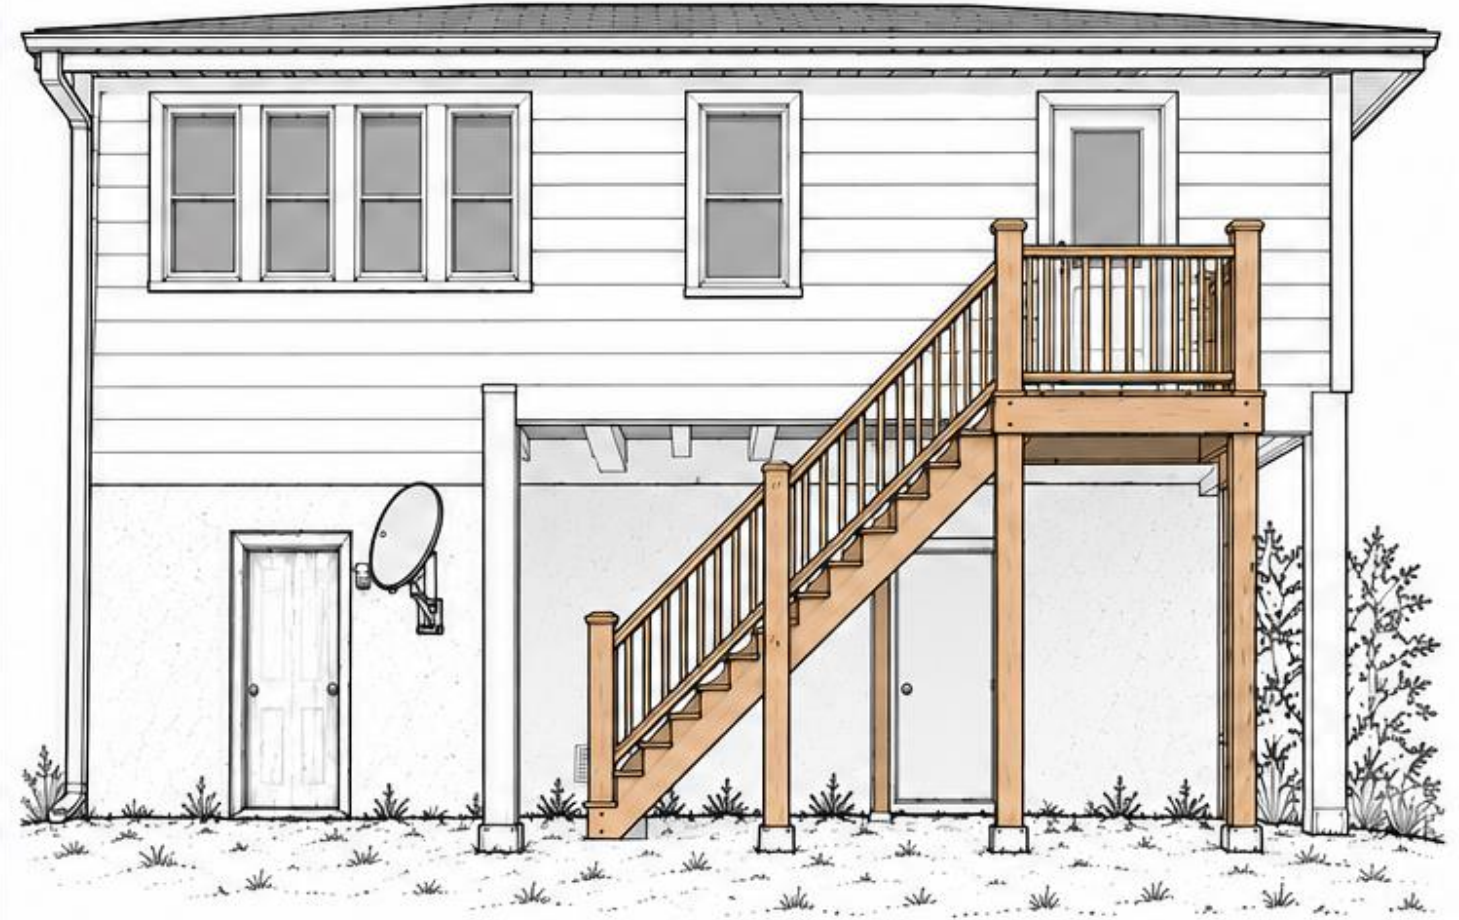
## PROPOSED REPAIRS (AFTER REPAIRS)

### PROPOSED REPAIRS:

- Remove existing damaged deck located on the rear elevation.
- Install new wooden 5' x 5' deck with wood railing and stairs, as shown.

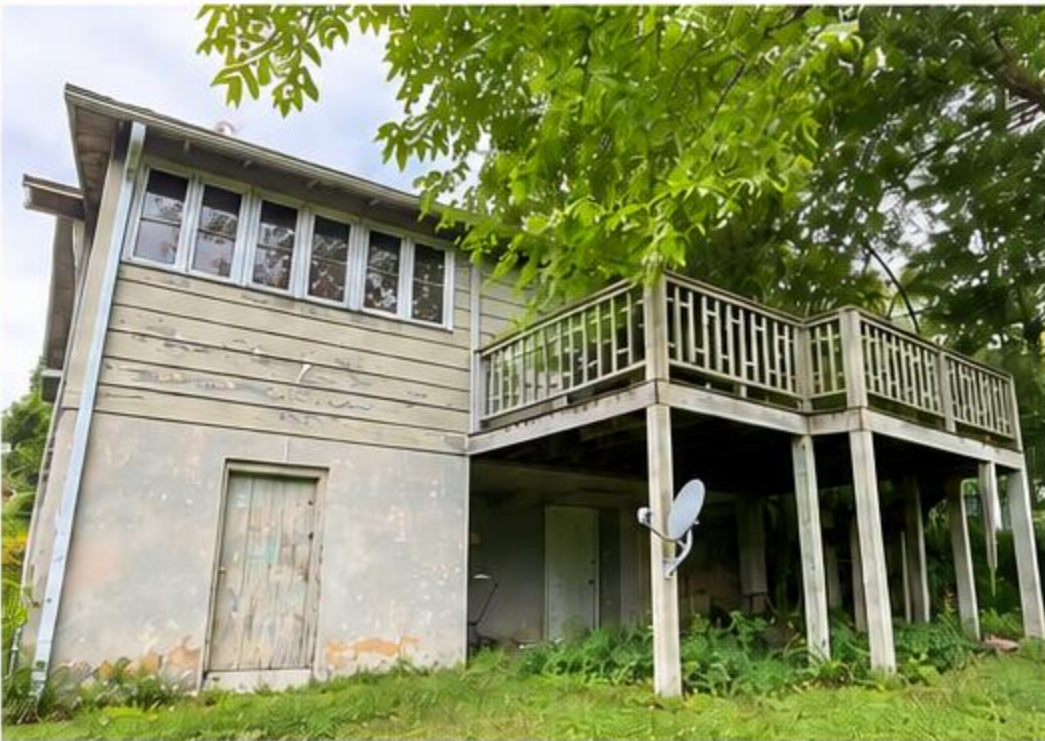
## EXISTING CONDITIONS – REAR ELEVATION

Existing rear elevation showing deteriorated deck.

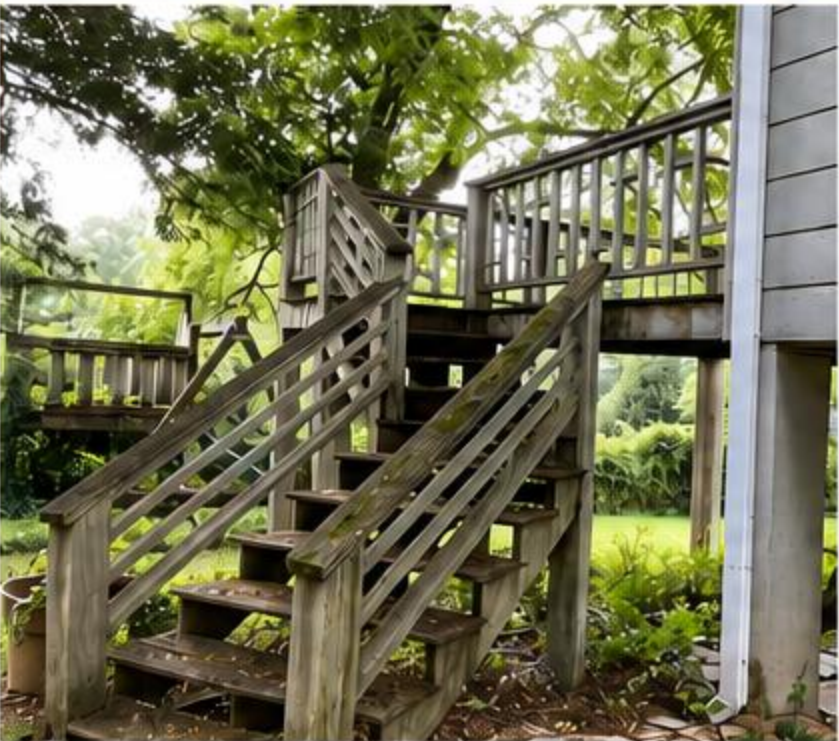
## EXISTING CONDITIONS – DECK AND STAIRS

Existing deck and stairs with deterioration.

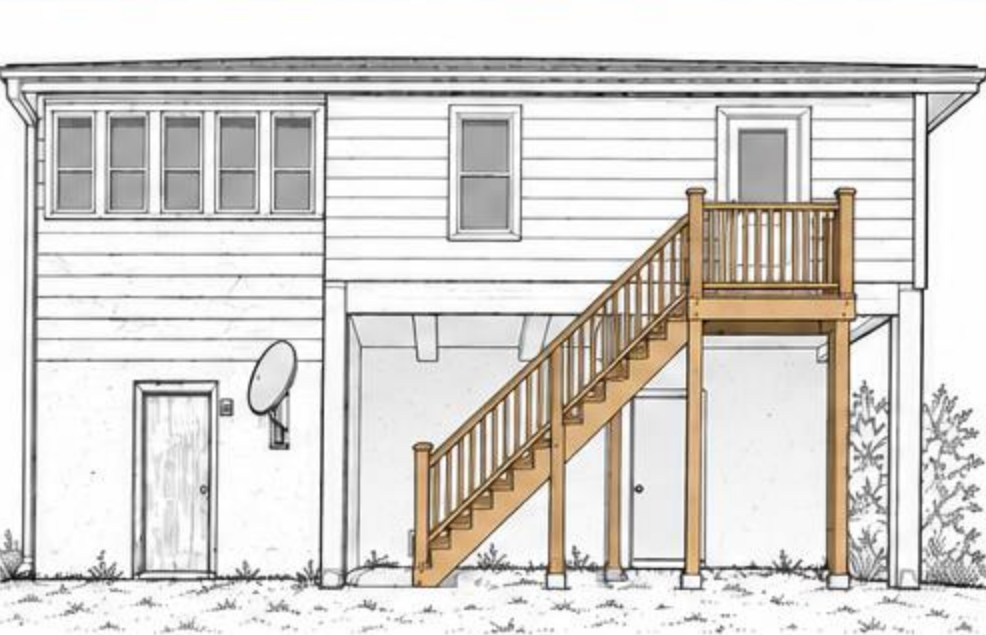
## ELEVATION (REFERENCE)

Rear elevation showing existing deck configuration (for reference).

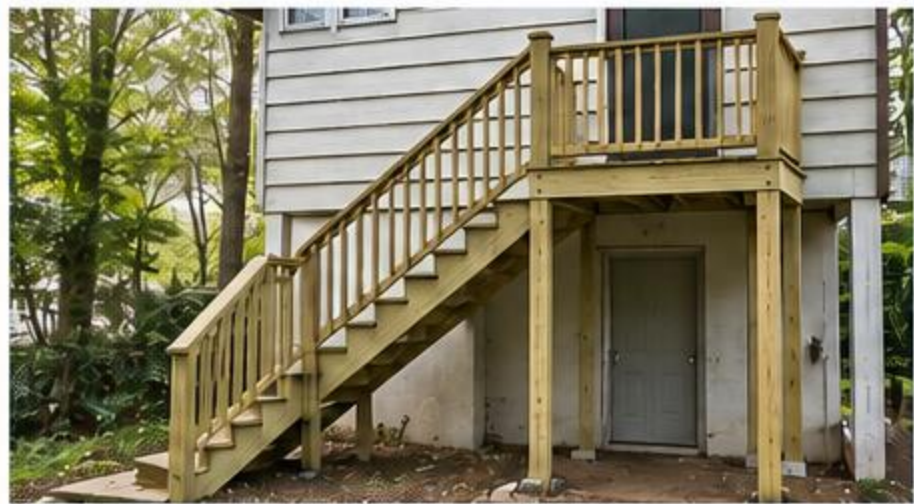
## PROPOSED REPAIR

Replace existing deck with a new 5-foot by 5-foot wood deck/landing with wood stairs and handrails.

- Remove and replace deteriorated deck, stairs, railings, and support posts.
- New wood deck and stairs will match the existing design, location, and dimensions.
- Use pressure-treated lumber and exterior-grade, corrosion-resistant fasteners.

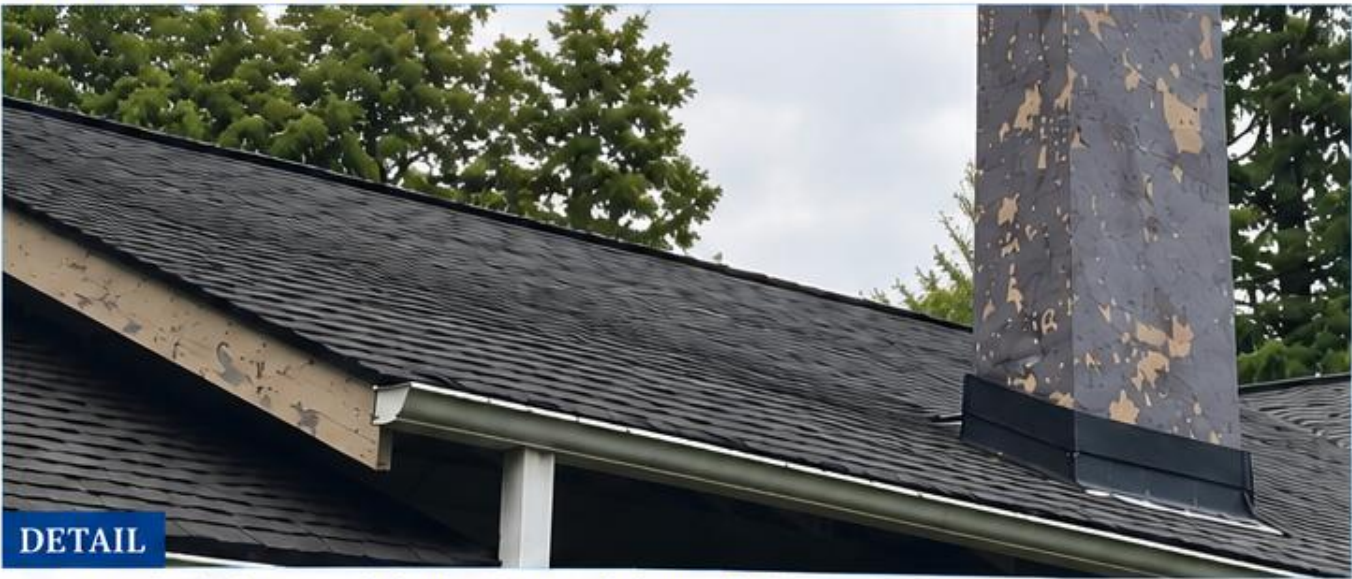
Existing roof with deteriorated shingles, fascia, and chimney flashing.

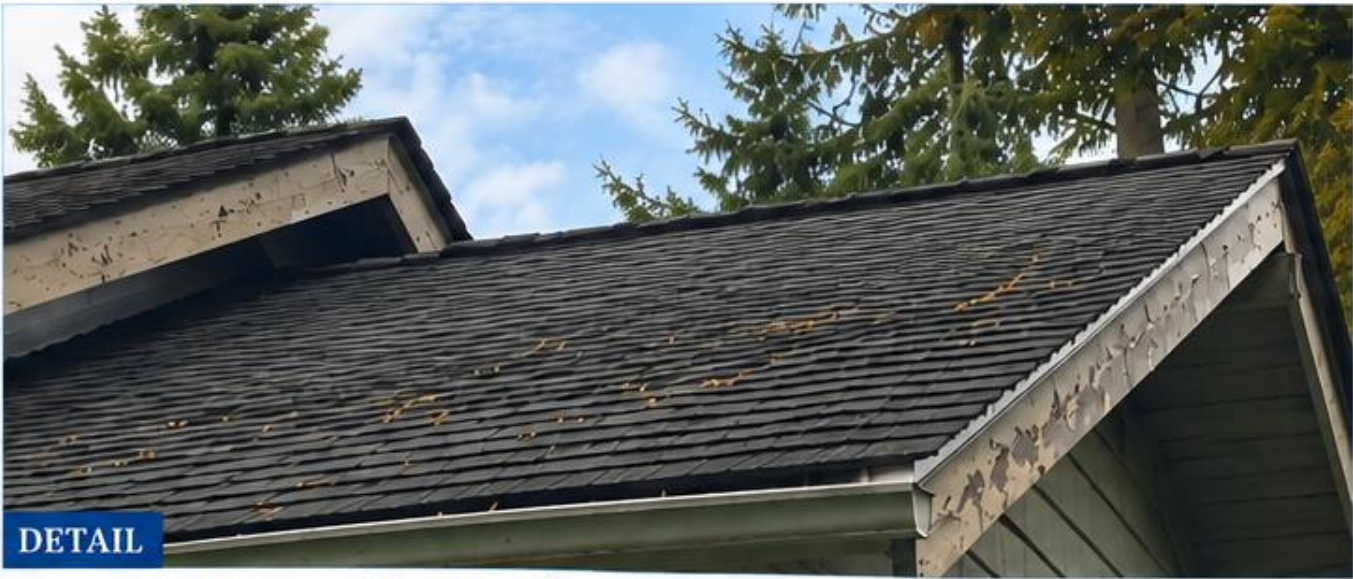
Existing roof with deteriorated shingles and fascia.

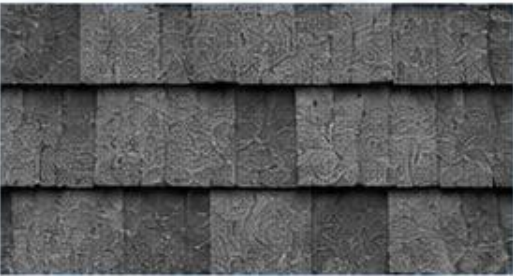
## SHINGLE SPECIFICATIONS

### GAF Timberline HDZ® Pewter Gray

High-definition architectural shingles with a dimensional look and long-lasting performance. The Pewter Gray color will match the existing roof in style, color, and profile.

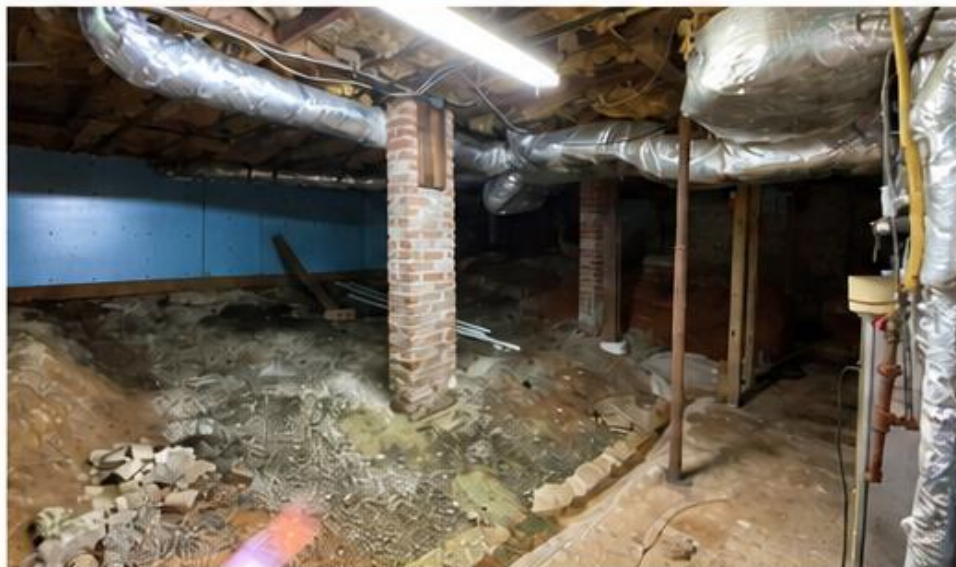
## EXISTING CONDITIONS – CRAWL SPACE

Existing crawl space showing masonry piers and soil floor.

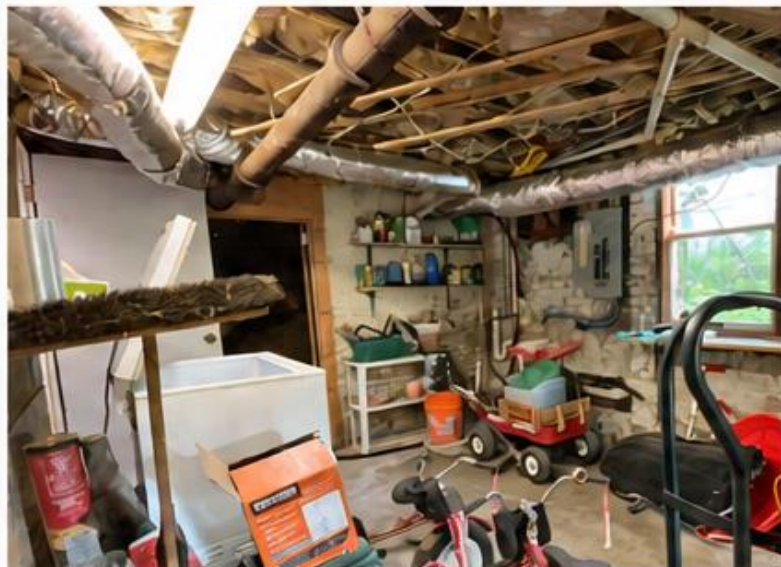
## EXISTING CONDITIONS – BASEMENT

Existing basement showing masonry walls and interior conditions.
