Sandra Drive Flood Mitigation Options

Jason Elkins, Johnstown Public Works Director Johnny Olson, PE, Senior Project Manager Tom Fuentes, PE, Senior Project Manager Austin Fling, EIT, Designer

Johnstown Colorado

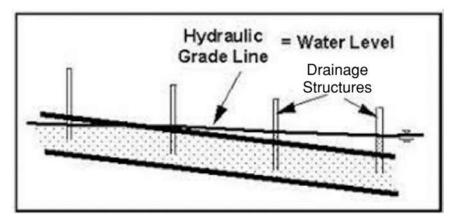
HGL – Hydraulic Grade Line

- Indicates the water level of a pipe system
- 5-year HGL
- 100-year HGL

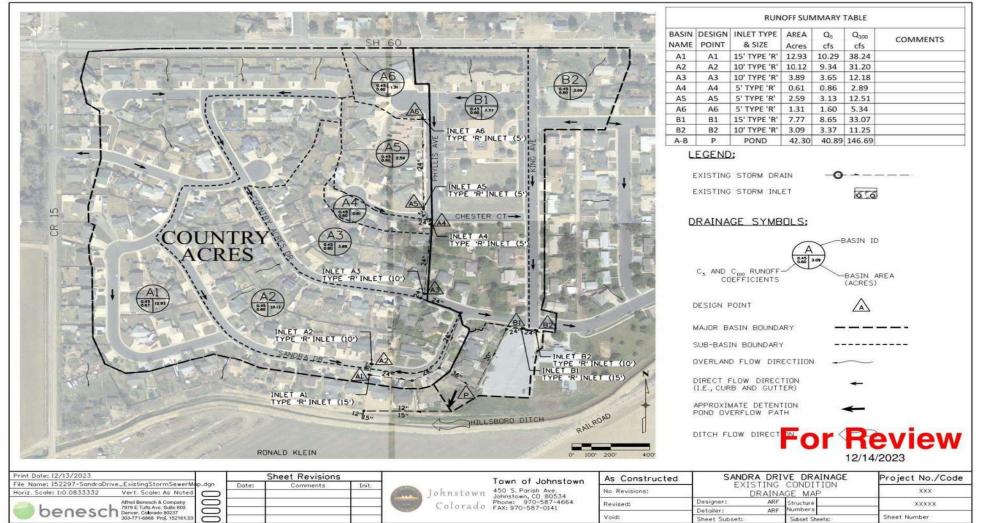
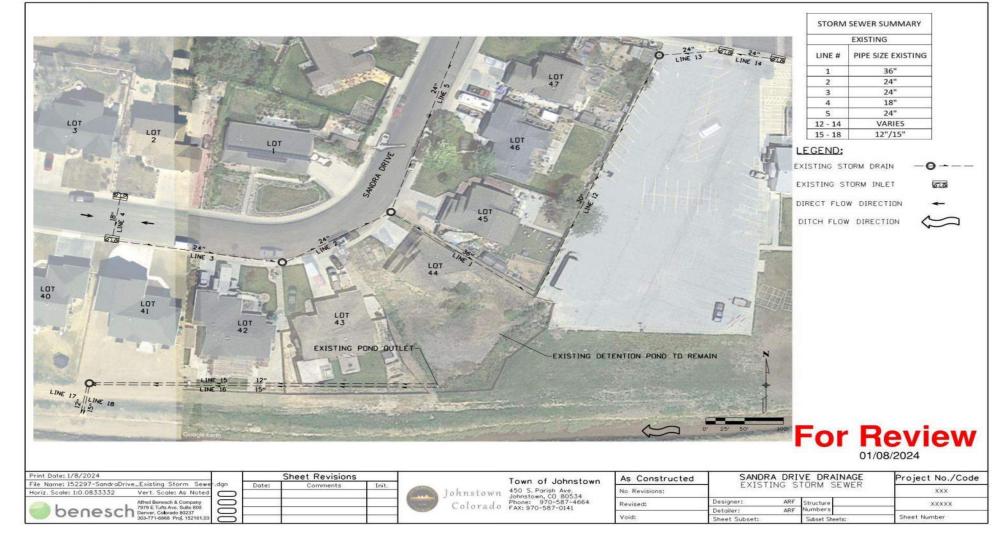
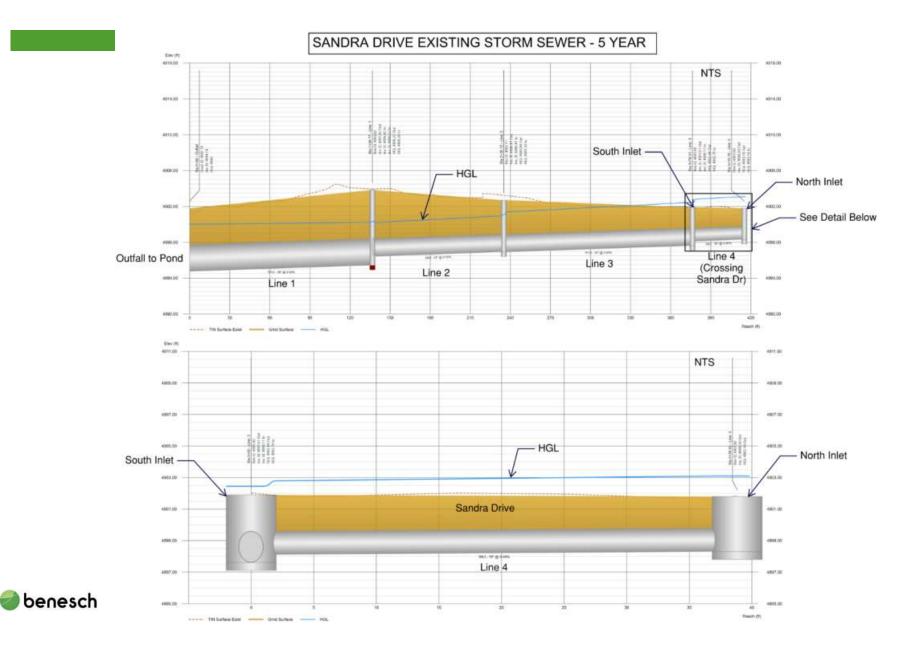
Existing Conditions

- Flooding in Sandra Drive is due to multiple storm/hail events occurring in a short time frame, as well as undersized storm sewer and an undersized pond outlet.

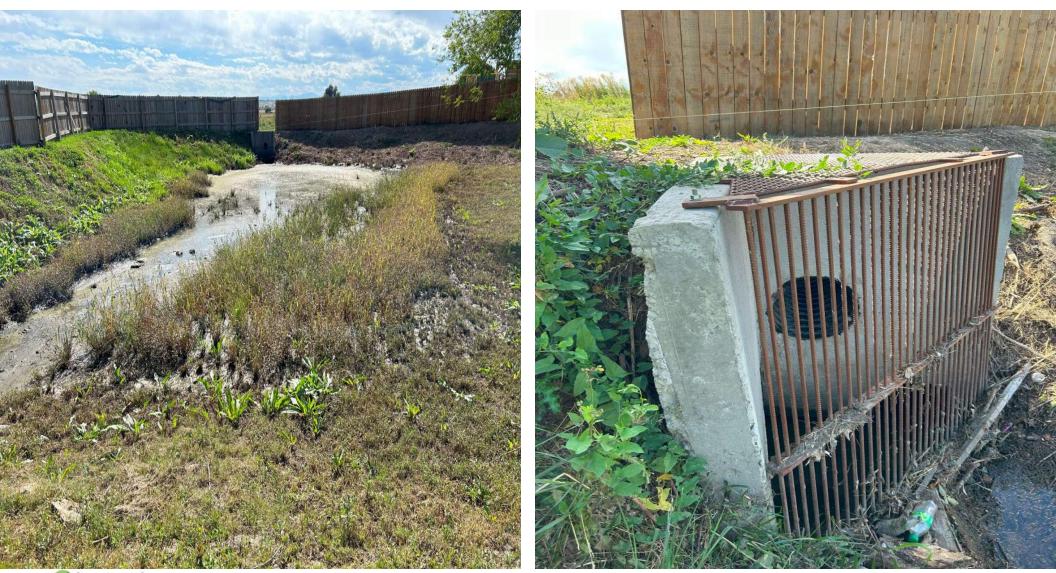
benesch Existing Detention Pond

Existing Pond Outlet

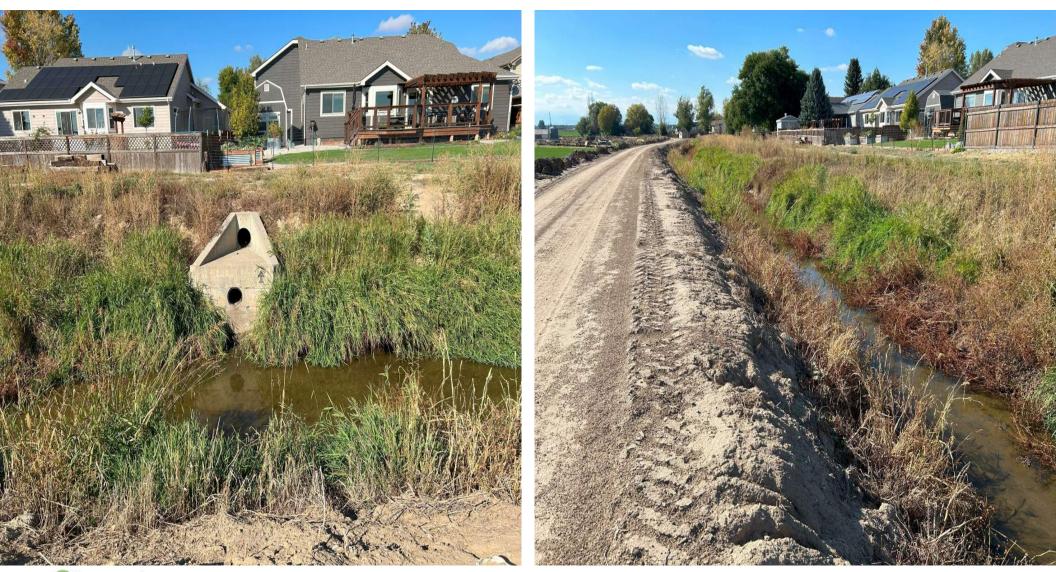
benesch Existing Outfall into Ditch

Hillsborough Ditch Looking Downstream

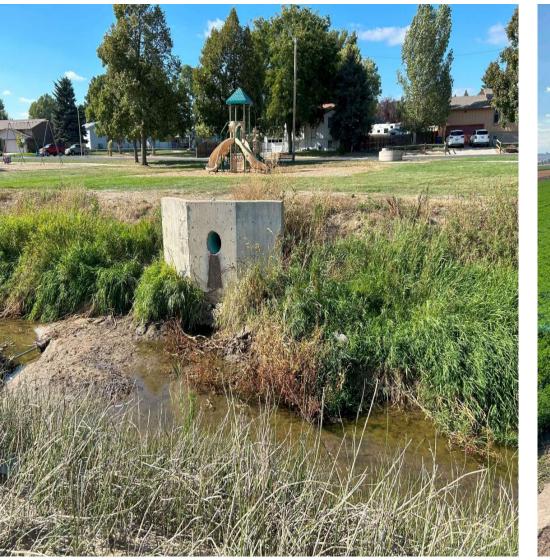
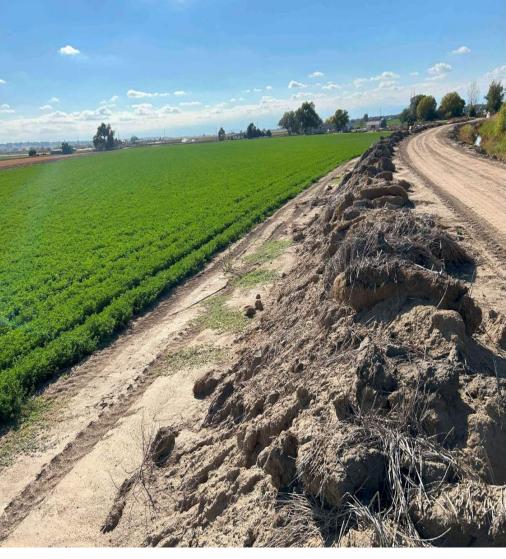
benesch Existing Ditch Connection to the East

Farmland South of Ditch
