Hazardous Material Report for the Former Lake Orion Lumber Yard

**Prepared for:
Village of Lake Orion
Downtown Development Authority**

Re: Pre-Demolition Hazardous Materials and Asbestos Survey

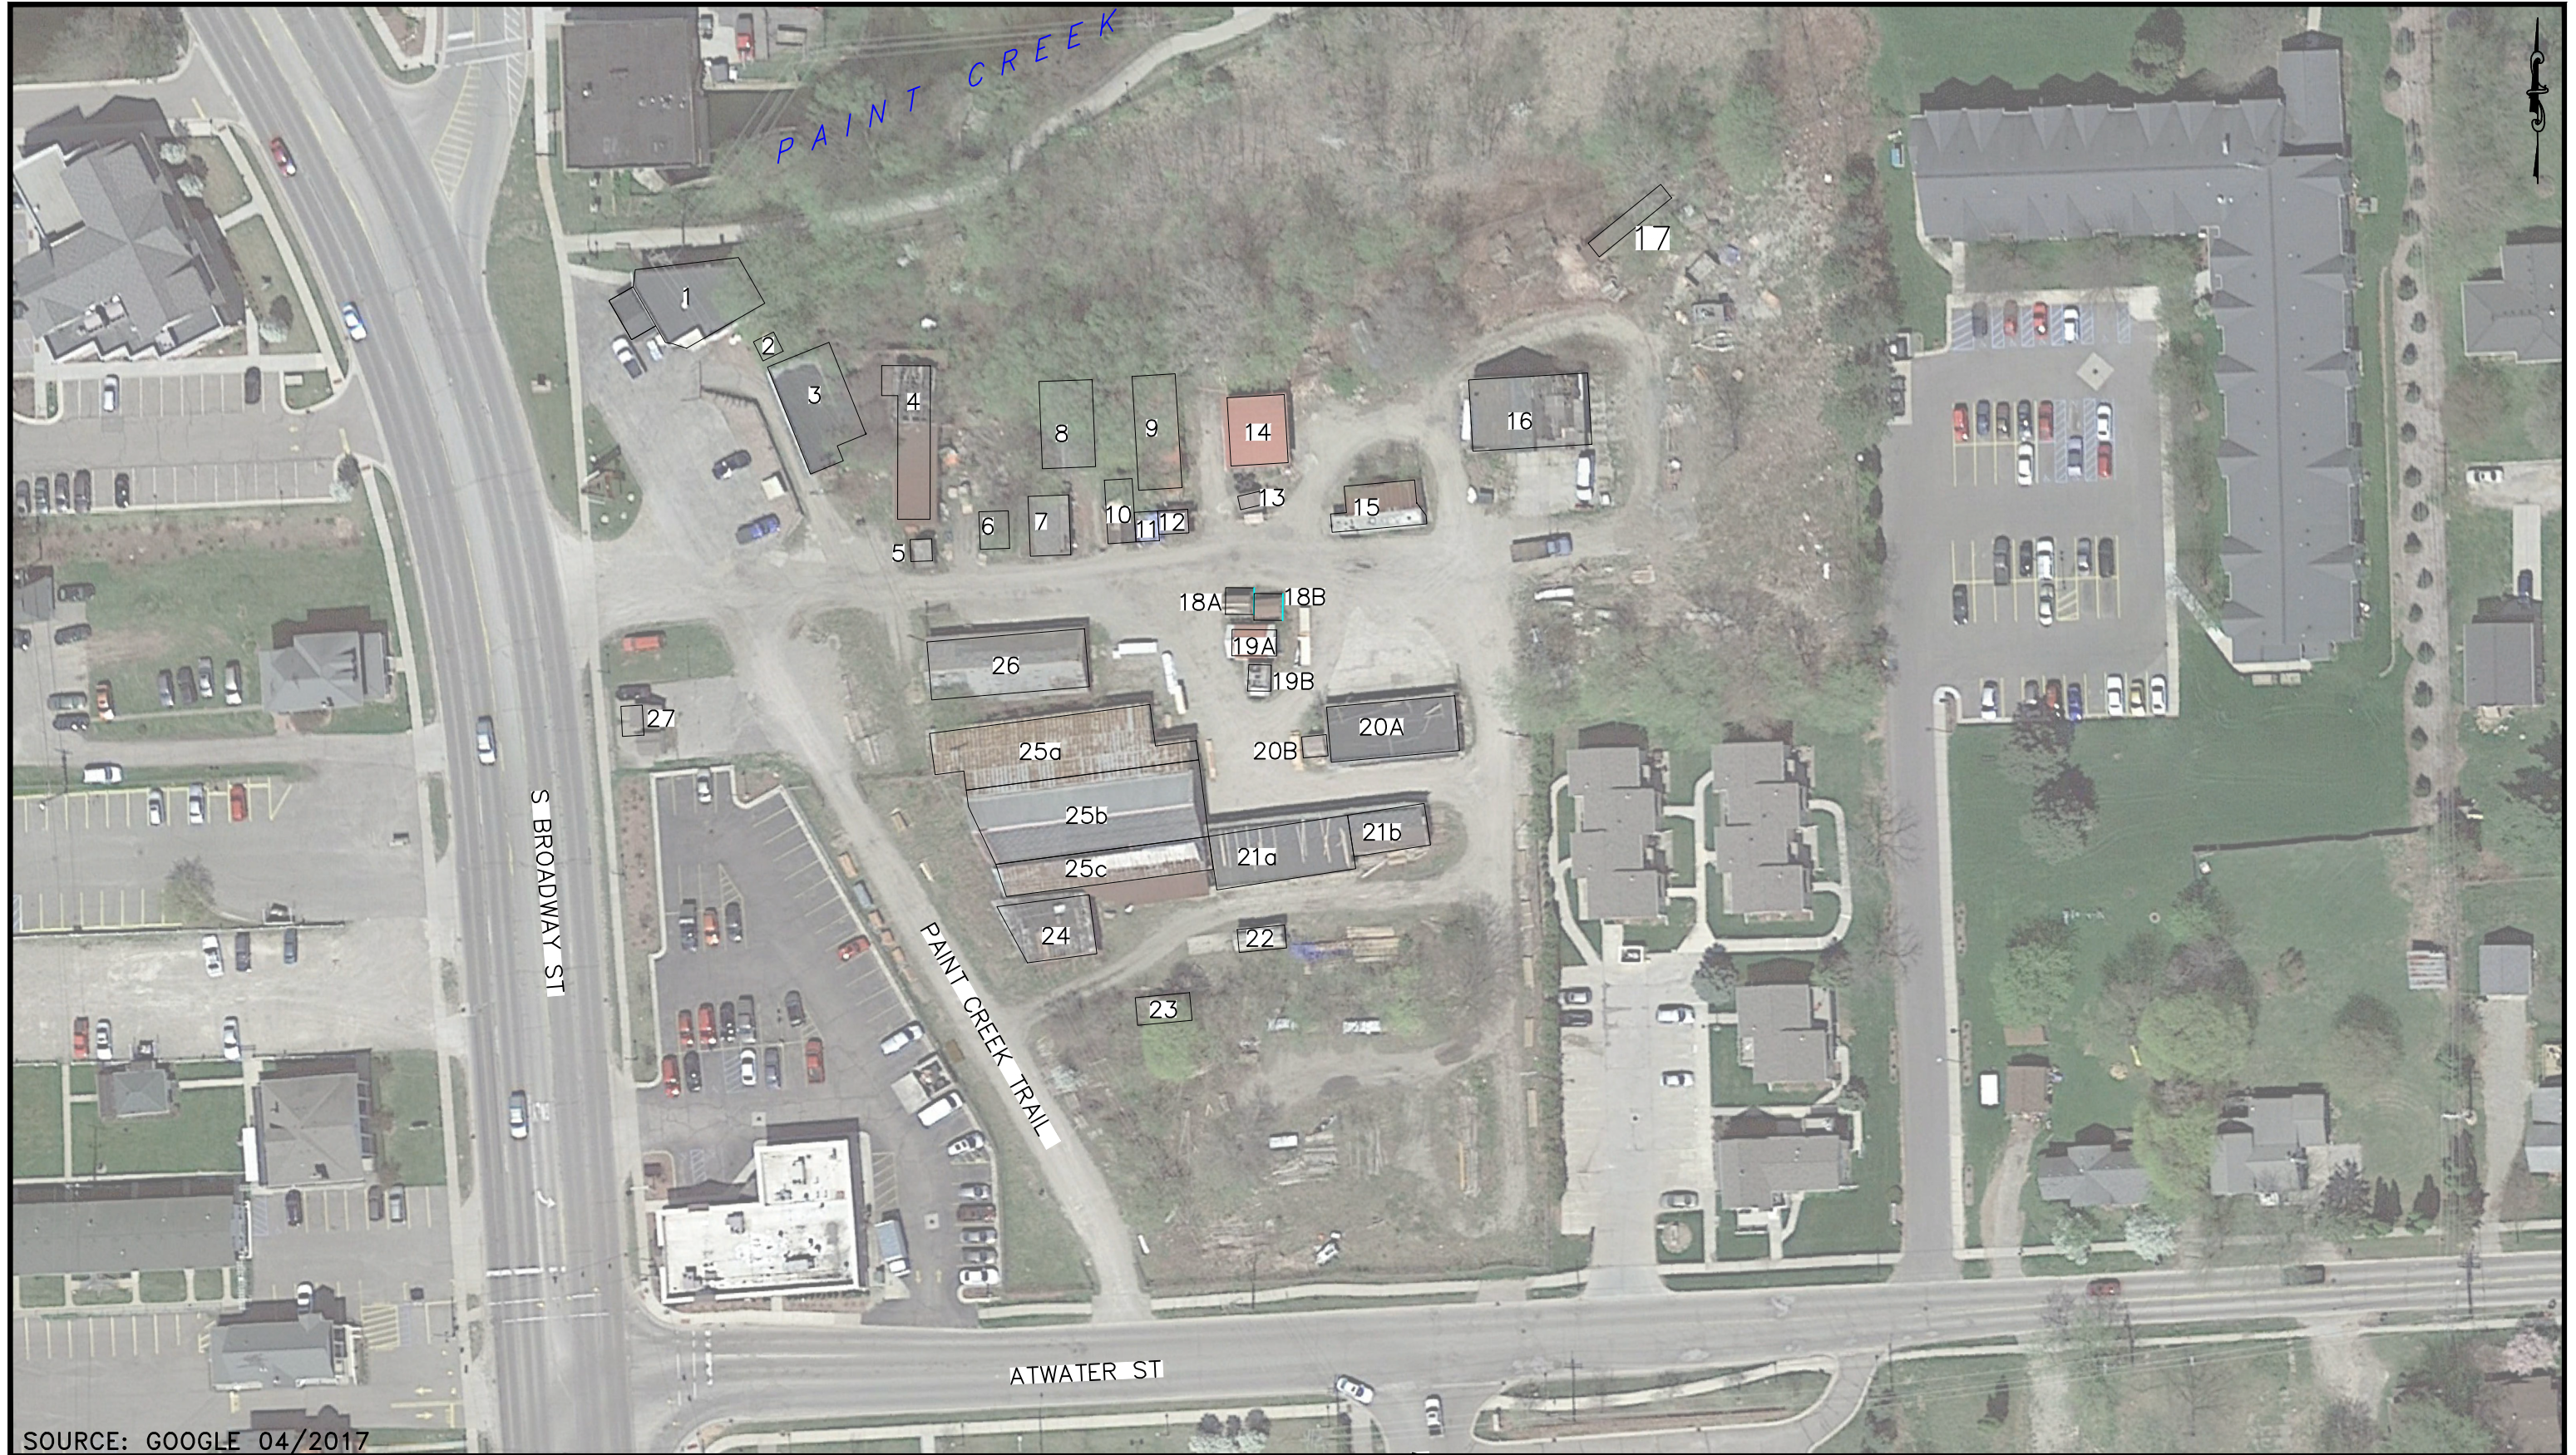
OVERALL BUILDING LAYOUT
 HAZARDOUS MATERIAL SURVEY
 LAKE ORION LUMBER COMPANY
 LAKE ORION, MICHIGAN
