AGENDA REPORT

TO: Historical Commission
FROM: Sean Gallegos, Senior Planner
SUBJECT: H23-0001 – 236 Eleanor Avenue

PROJECT DESCRIPTION

This application seeks advisory review for a proposed project involving the addition of a 1,647 square-foot first story, 327 square-foot second story, and 832 square-foot basement to an existing two-story house that is a designated historic resource. Additionally, a new 588 square-foot detached accessory structure (garage) is also proposed as part of this project.

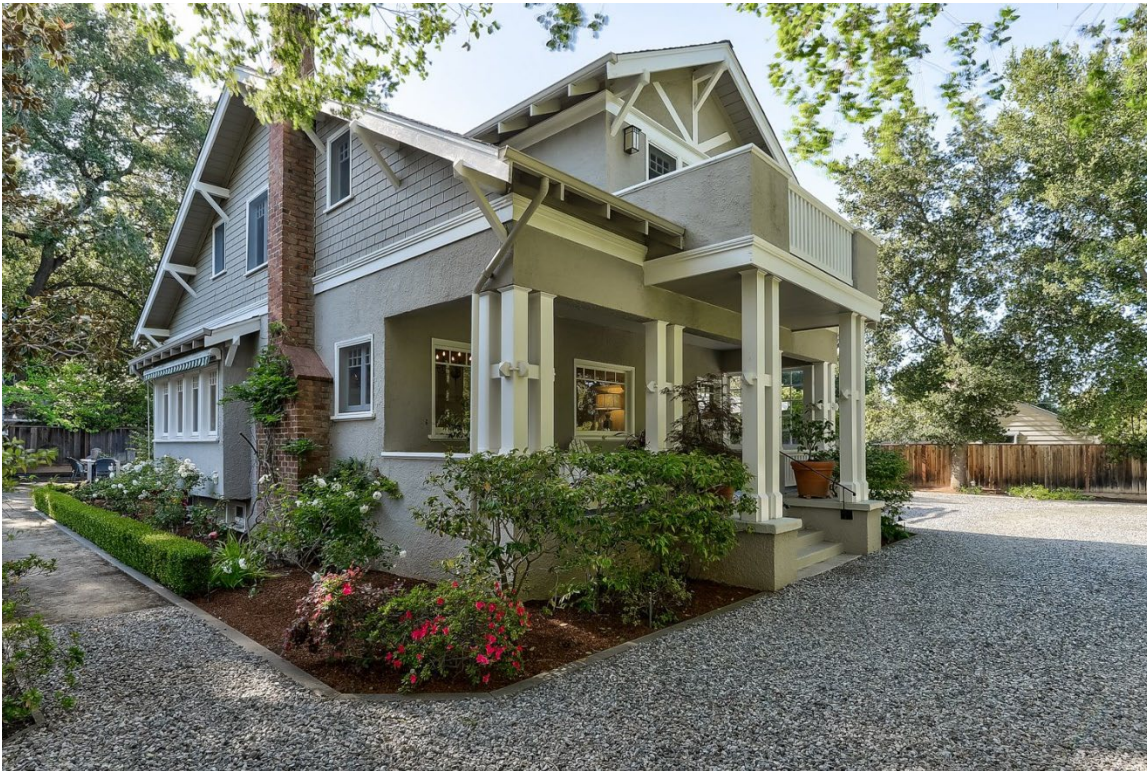
Photograph 2 236 Eleanor Avenue, Los Altos

View: The primary east or front façade showing a full-width covered porch and projecting entry porch on the first level. This level is raised above a basement. The first level is sheathed in stucco, which appears to be an alteration of the original horizontal wood siding. The second story shows a cross-gable roof with a second-story gable. Projecting above the porch is a balcony with side walls and a railing in front; this appears to be an early addition. The south side façade has a brick chimney and continues the Craftsman details with an assembly of windows on the first level and knee braces under the open eaves, and an exposed rafter. Cut shingles are the sheathing on the second level.

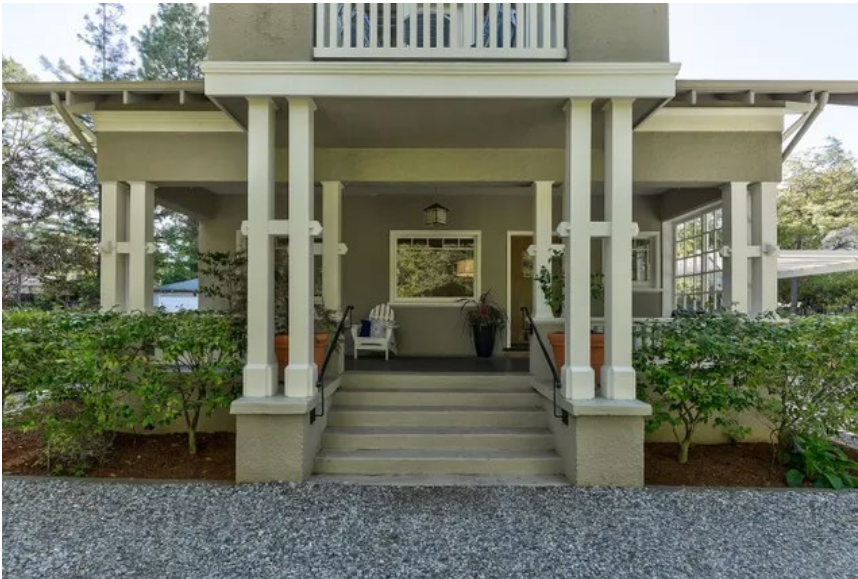
Photograph 3 236 Eleanor Avenue, Los Altos

View: Front entry porch showing the low base and walls for the paired columns and the six stairs to the porch. The entry door is off set to the left.

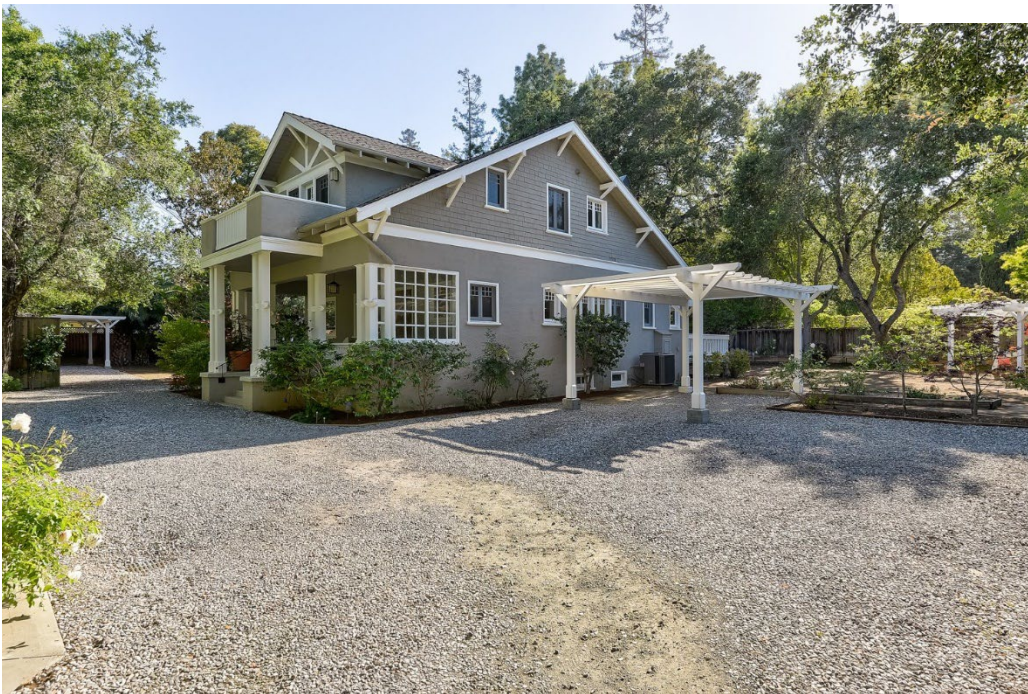
Photograph 4 236 Eleanor Avenue, Los Altos

View: The north side façade showing the window alteration to fill the side of the porch and the second-level gable. A carport is under the pergola structure and the side entrance to the house.

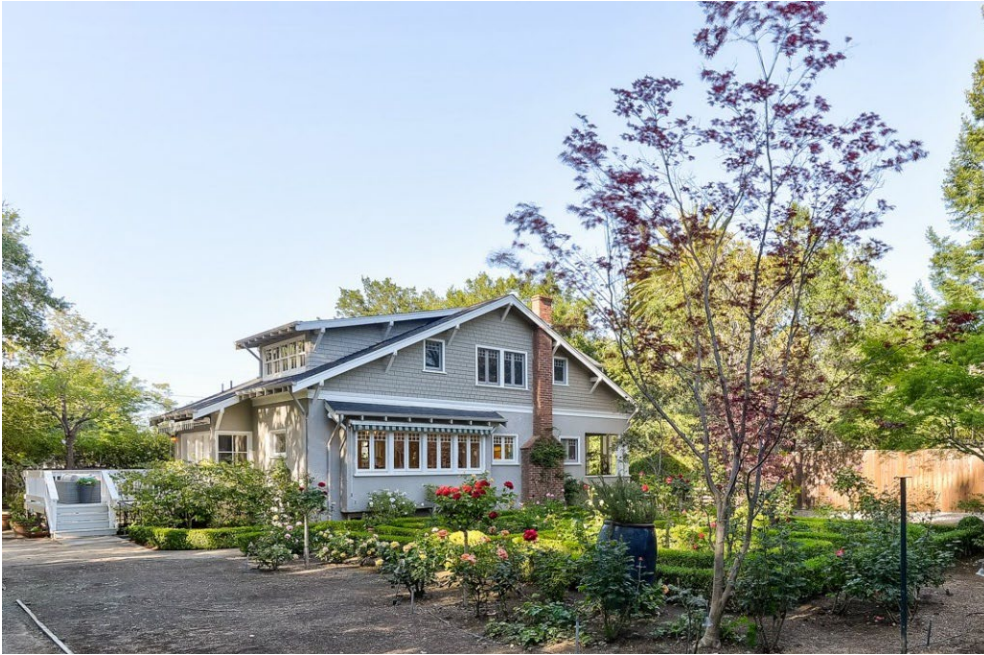
Photograph 5 236 Eleanor Avenue, Los Altos
View: West and rear façades showing the pop-out addition to the original design. The view shows the shed dormer addition on the rear roof, creating a second level.

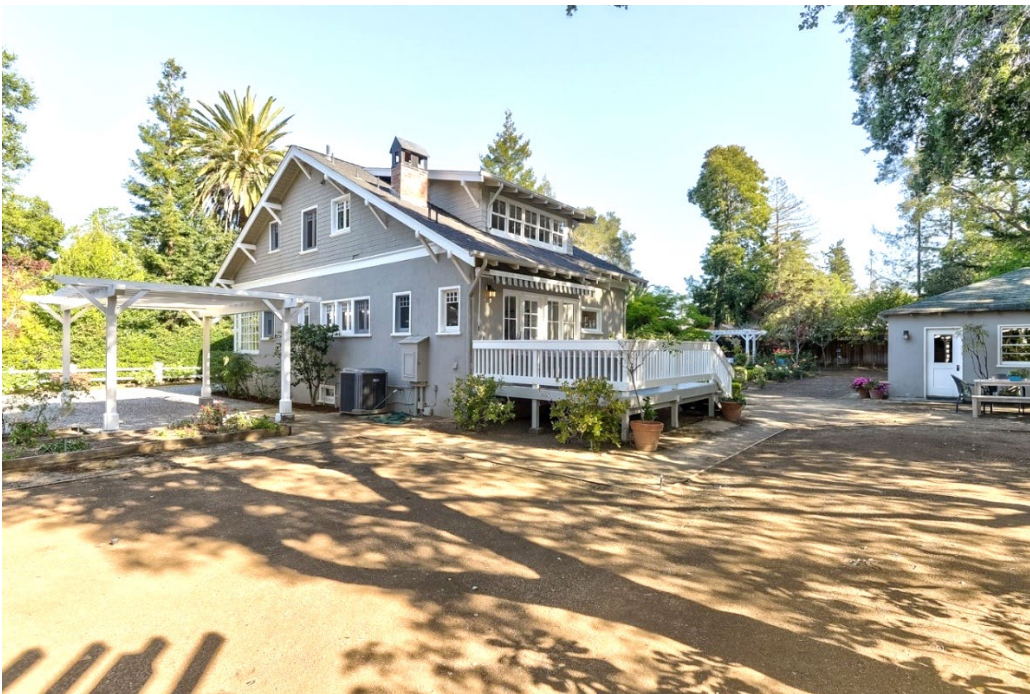
Photograph 6 236 Eleanor Avenue, Los Altos
View: Rear and north side showing the rear and deck additions. A large shed dormer appears to be an addition that is out of proportion with the style and original dormer on the front façade. A contemporary shed is behind the house.

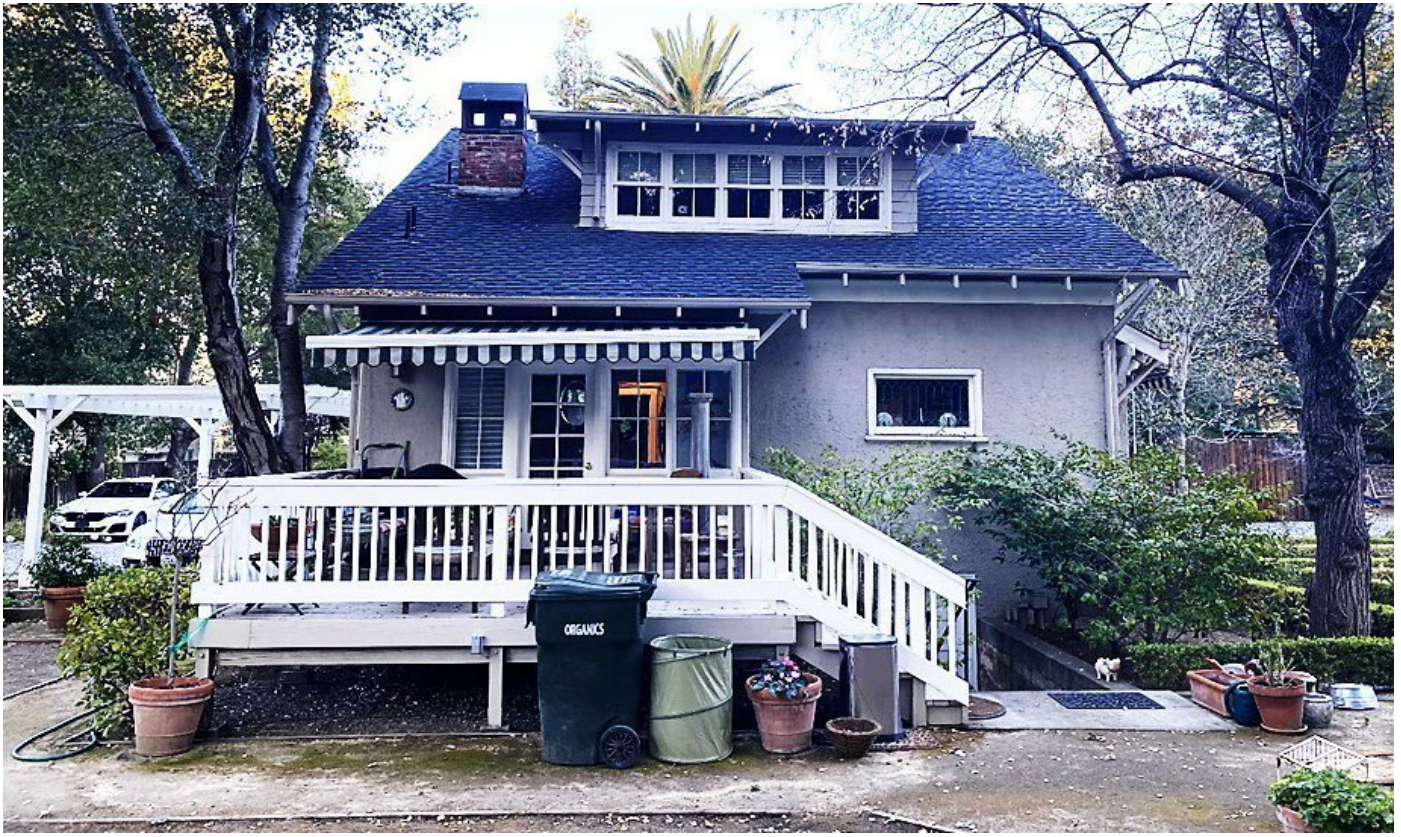
Photograph 7 236 Eleanor Avenue, Los Altos

View: Rear façade showing the extensive alterations, enclosing a utility porch on the right and remodeled wall with glass pane doors and windows.

The rear façade has been significantly altered from the original design as a farmhouse in a variation of the Craftsman style. A search for building permits did not find permits for this work,

Alterations that previously removed historic material include the protruding section with a multi-pane glass door and three wood windows that were not original to the location nor probably to the building. The rear façade facing an orchard would have a utility porch with a wood back door that might have had a glass panel in the top. The porch stairs were usually located to the side. This is the pattern of the existing foundation. The windows would be small with plain frames. All windows appear to be from a previous remodel. The rear of the house was not used for recreation but was utilitarian, with clotheslines, a barn, and other ancillary buildings behind. Windows on the rear were also less formal but operable.

Alterations that previously removed historic material include the protruding section that has a multi-pane glass door and three wood windows that are not original to the location and probably not to the building. The rear facade of an orchard would have the utility porch with a wood back door that might have had a glass panel in the top. Stairs usually were to the side. This is the pattern of the existing foundation. Windows would be small and plain frames. All windows appear to be from a previous remodel. The rear of the house was not used for recreation but was utilitarian with, clotheslines, a barn and other ancillary buildings behind. Windows on the rear were also less formal, but operable.

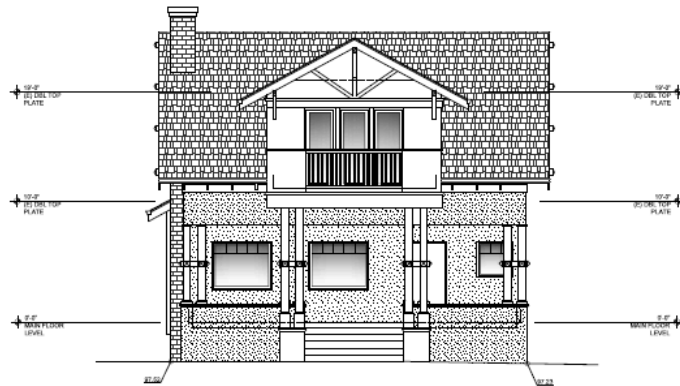
EXISTING FRONT ELEVATION
1/4" = 1'-0"

Figure 2-A 236 Eleanor Avenue - Rehabilitation Plan
View: Existing front façade

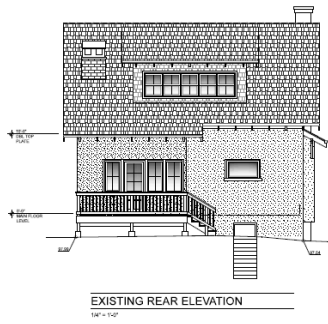
Figure 3-A 236 Eleanor Avenue - Rehabilitation Plan
View: Existing rear elevation

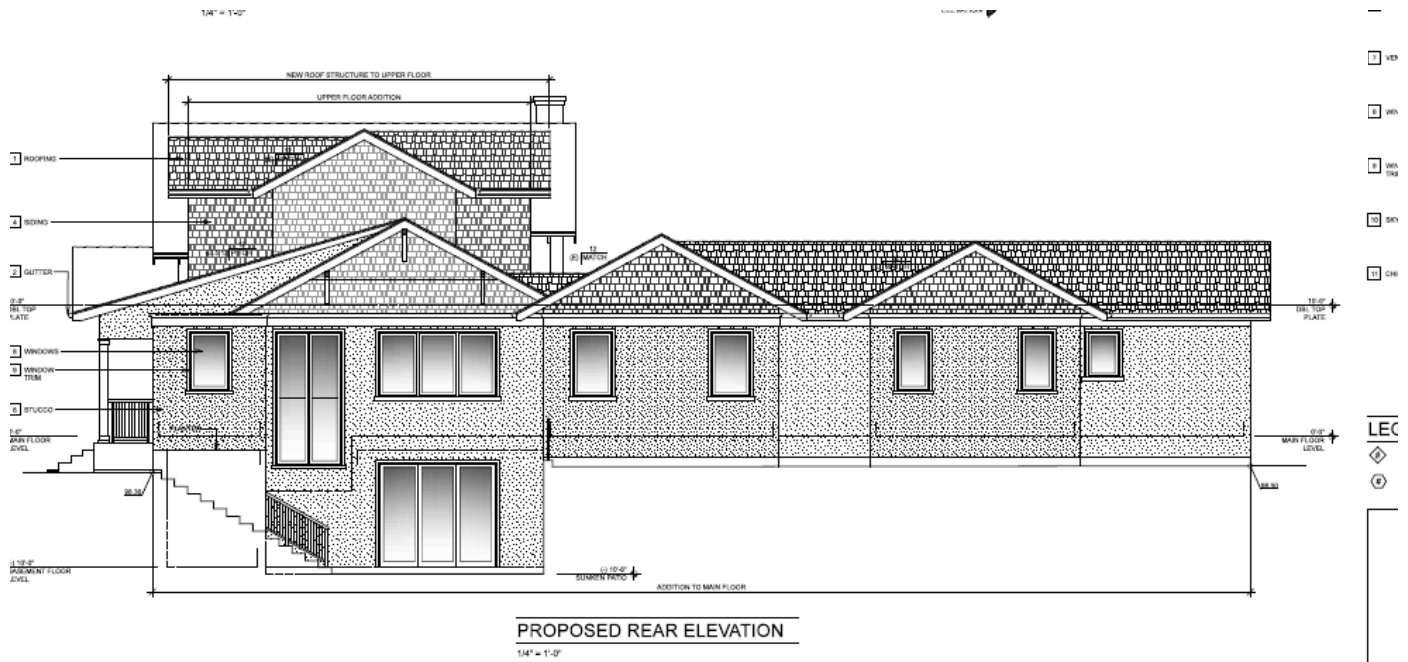
Figure 3 -B 236 Eleanor Avenue- Rehabilitation Plan
View: Rear Façade showing the proposed rear and side additions. The rear of the house had previously been remodeled and was not the original design. Maintaining the elevation of the floor plate in the historic house into the addition provides consistency with the raised elevation of the historic house.
Source: Chapman Design Associates, Jacobsen/Parmacek Residence Sheet A4.0

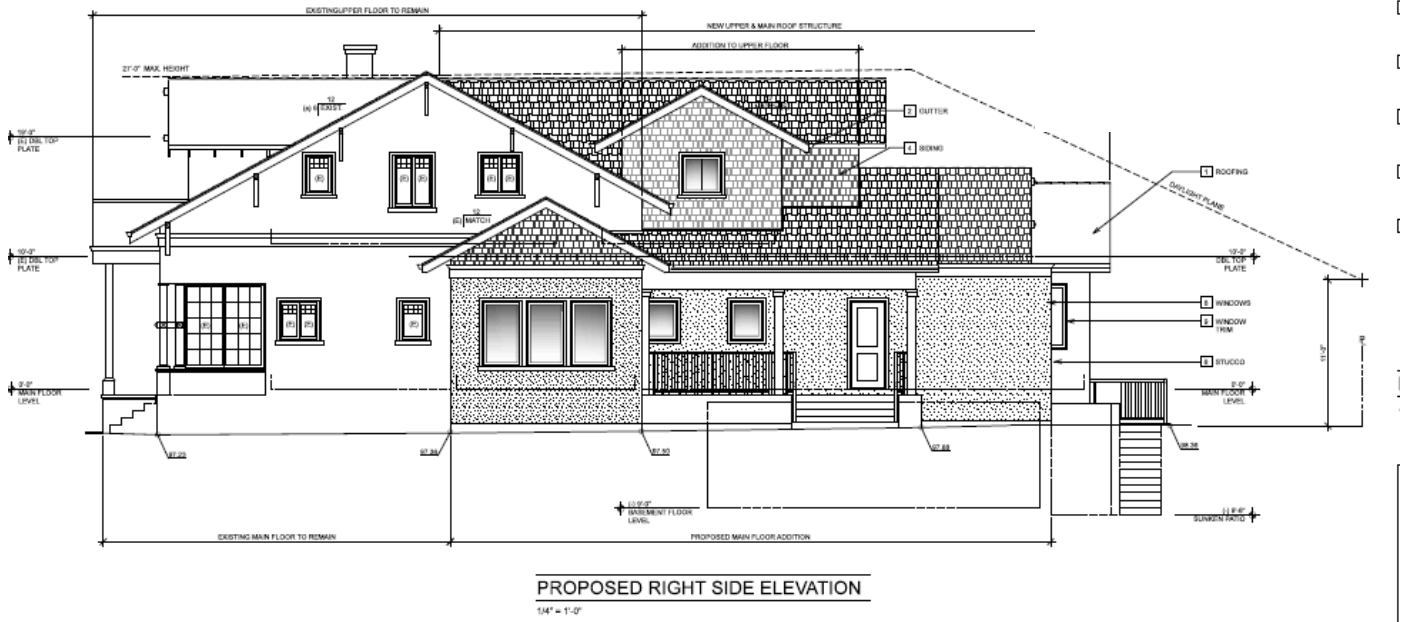
Figure 4 236 Eleanor Avenue- Rehabilitation Plan

View: North (right) Side Façade showing the side of the proposed rear addition and where the roof of the addition meets the historic roof structure. The roof intersection maintains the existing height of the historic building. A simple gable roof (without brackets or braces) is added to the rear as part of the new roof structure. Shingles will be offset in pattern to distinguish the new from the old. The stucco will be similarly slightly different to distinguish the different sections.

Northside façade historic material and features. The side exhibits character-defining features in the roof slope, fenestration with casement windows exhibiting small panes above a larger pane, and siding. There is a loss of historic material on the side and rear roof framing where the addition connects to the main building; composition roofing materials are not historic and are not character-defining elements. There is also a loss of siding and two plain windows. The loss of historic materials is unfortunate, yet placing the addition to the rear and connecting the roof frame and rear side façades appears to provide the addition with the least loss of historic fabric and features.

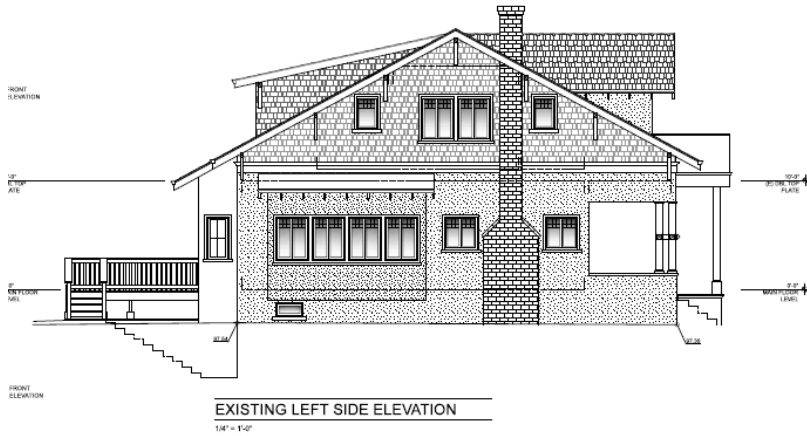
Figure 5-A 236 Eleanor Rehabilitation Plan

View: Existing Historic Building, Left or South elevation.

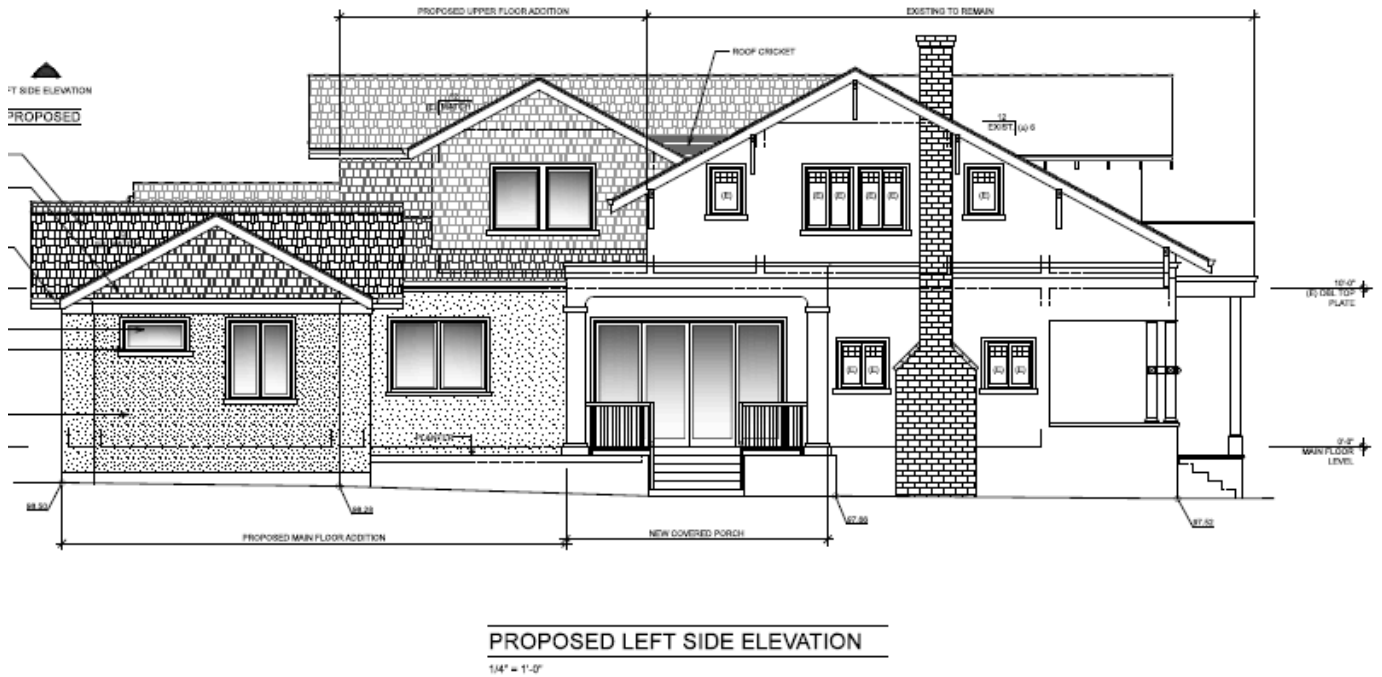
Figure 5 -B 236 Eleanor Avenue- Rehabilitation Plan
 View: Left (South) Façade showing the proposed connection of the new wing. The historic house and front roof structure are shown to remain at a height above the proposed addition. The roof structure is intersected with the new roof structure to create a cross gable in the second story. The plan results in the loss of historic siding materials.
 Source: Chapman Design Associates, Jacobsen/Parmacek Residence Sheet A4.0

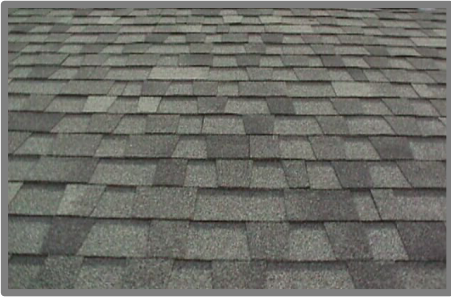
ROOFING

40 YEAR COMPOSITION
SHINGLE

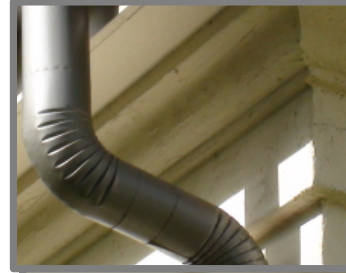
GUTTERS

OGEE & ROUND
DOWNSPOUTS

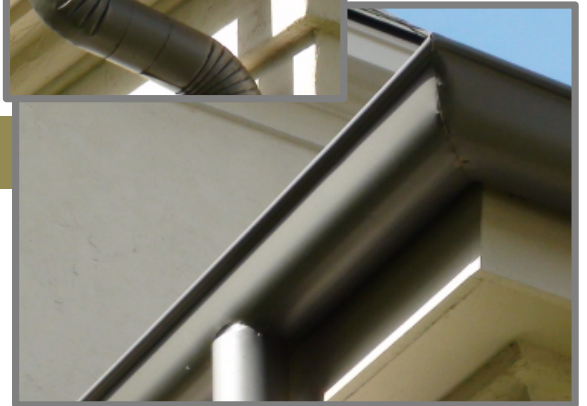
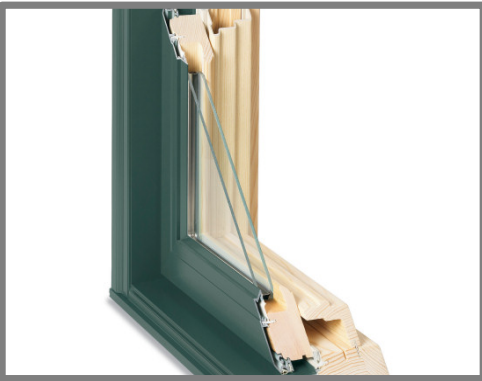
WINDOWS

DUAL GLAZED
ALUMINUM CLAD

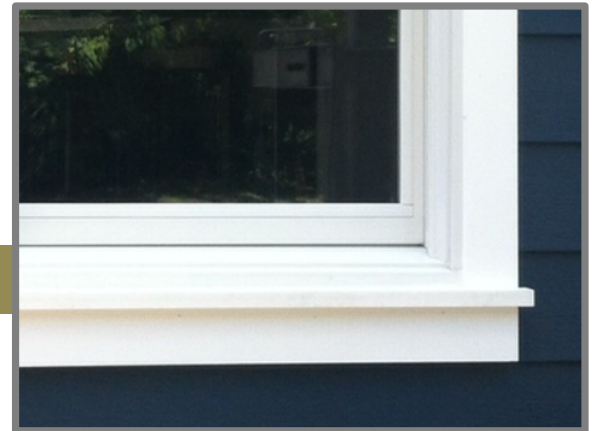
WINDOW TRIM

2X2 WOOD TRIM
2X3 SILL & APRON

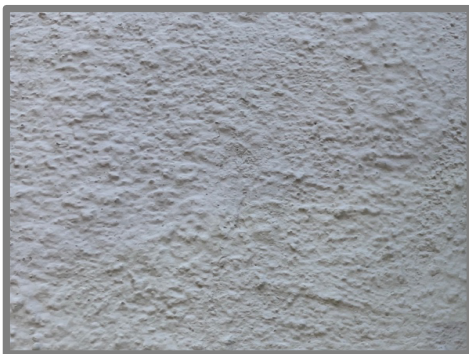
EXTERIOR

MATCH EXISTING
STUCCO

STAGGERED SHINGLES
AT GABLES

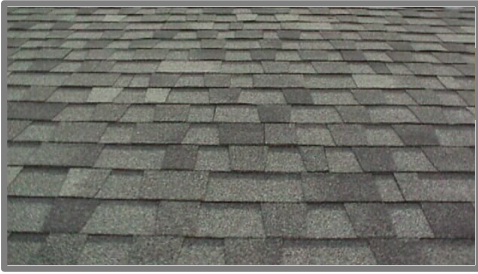
ROOFING
REMAIN AS EXISTING
40 YEAR
COMPOSITION

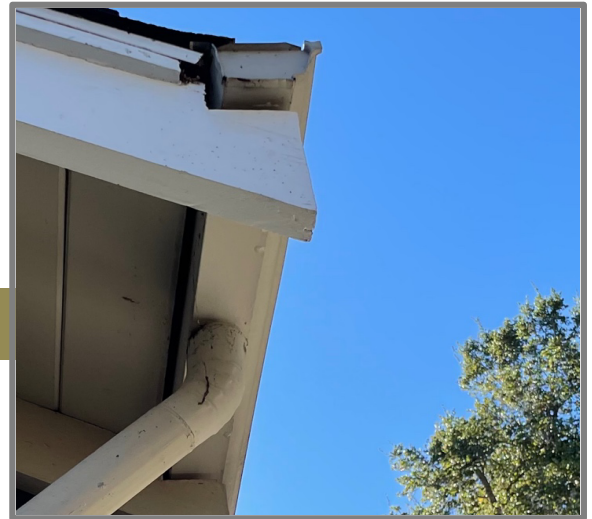
GUTTERS
REMAIN AS EXISTING
OGEE
ROUND DOWNSPOUT

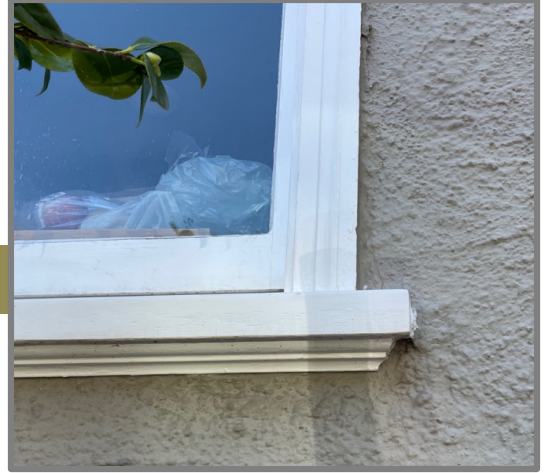
WINDOW TRIM
REMAIN AS EXISTING
2X3 SILL & APRON
WITH CROWN

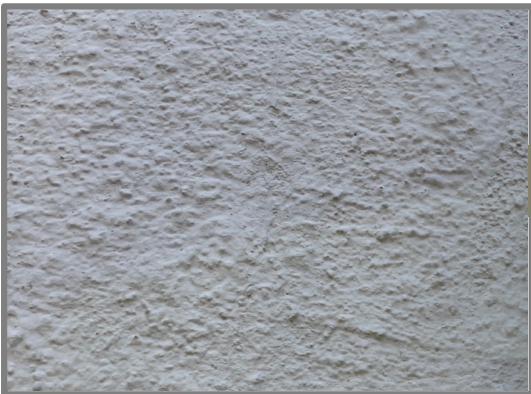
EXTERIOR
REMAIN AS EXISTING
STUCCO

GABLES
STRAIGHT LINED
SHINGLES
