**Project Address:**  
150 Tait Avenue, Los Gatos, CA

## **Exterior Design & Materials**

## **I. Project Scope and Architectural Intent**

This document details exterior materials, finishes, and architectural consistency for the Historic Preservation Committee's review.

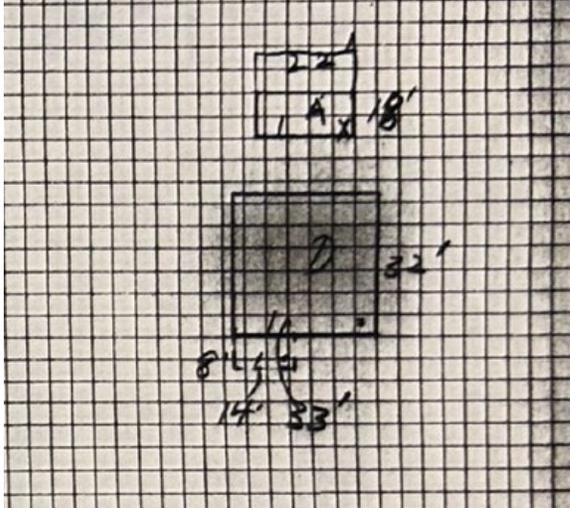
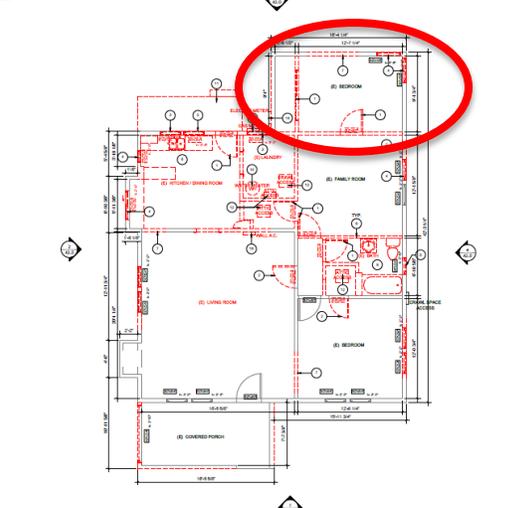
1941 Assessor Survey: No 3 <sup>rd</sup> bedroom	Current Property with the 3 <sup>rd</sup> bedroom

the home suggesting that the entire home was re-sided either when the 3rd bedroom was added or thereafter.

<p><b>3<sup>rd</sup> Bedroom Addition</b></p>	<p>As discussed under Section I, the 1941 Assessor's Survey suggests that the 3<sup>rd</sup> bedroom located in the back of the house was added after 1941. <b>Although the 3<sup>rd</sup> bedroom was clearly added after 1941, its exterior siding seamlessly extends from the rest of the right elevation wall. Further, it is identical in age, installation and type as the rest of the home suggesting that the entire home was re-sided either when the 3<sup>rd</sup> bedroom was added or thereafter.</b></p>

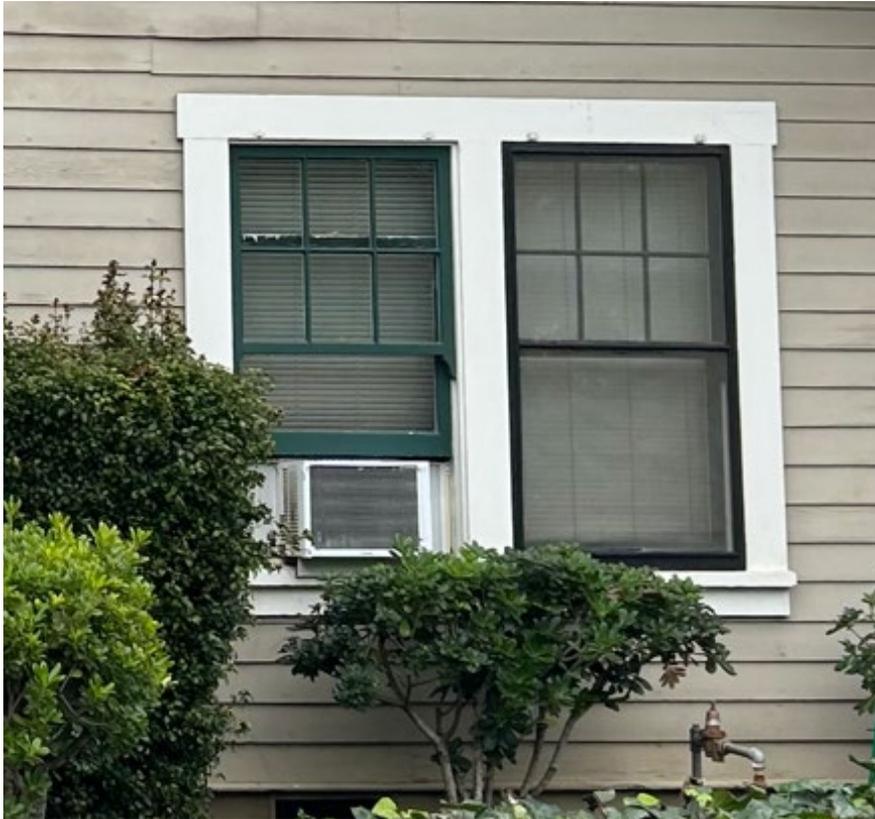
## A. Existing Windows

The existing windows are traditional single-hung wood windows with:

- A divided-light upper sash (multi-lite grille pattern),
- A single-lite lower sash,
- Painted wood frames and trim with flat casing,
- Traditional proportions and narrow sightlines.

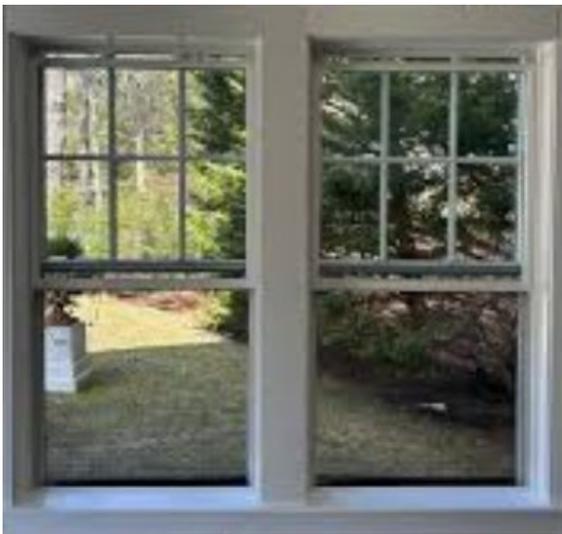
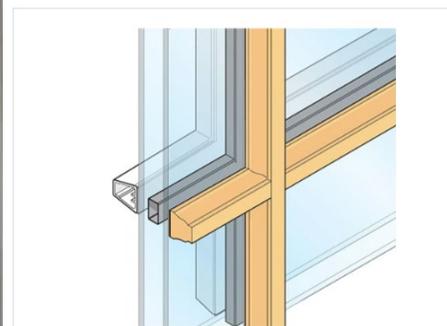
#### 1. Pella Lifestyle Series Wood Clad Windows

5/8" Putty Glaze Integral Light Technology

The homeowner is requesting approval to install Pella Lifestyles Wood Clad windows with Low-E, argon-filled, double-pane glazing. These windows offer the beauty and durability of wood combined with style flexibility.

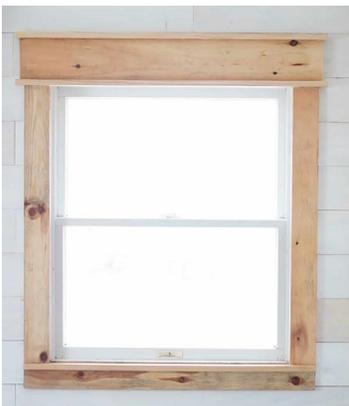
## **3. Proposed Window Casings**

All replacement and new windows will be installed with traditional flat wood casing consistent with historic residential construction, including flat side casings, a substantial flat head casing, and a flat wood sill. The casing will be painted and proportioned to match existing historic windows, ensuring the replacement windows remain visually indistinguishable from the original wood windows. The proposed Pella Lifestyle Series windows will be installed behind the casing, allowing the trim to remain the dominant visual element from the exterior. The casing will:

- Preserve the visual depth of the window opening
- Maintain traditional shadow lines
- Ensure the replacement window reads as a true wood window assembly

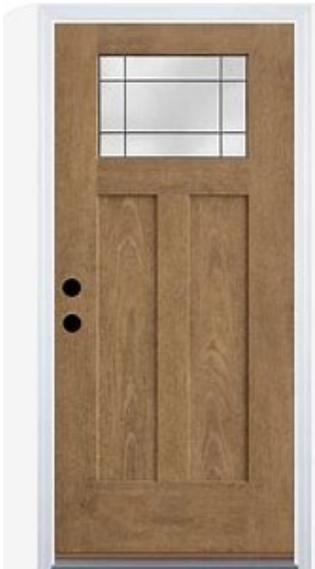
**Proposed Door**

1. **Style:** Classic Craftsman single door panel
2. **Material:** Fiberglass or solid wood door with glazed upper panel
3. **Finish:** Stained natural wood (transparent stain)
4. **Hardware Finish:** Dark bronze / black

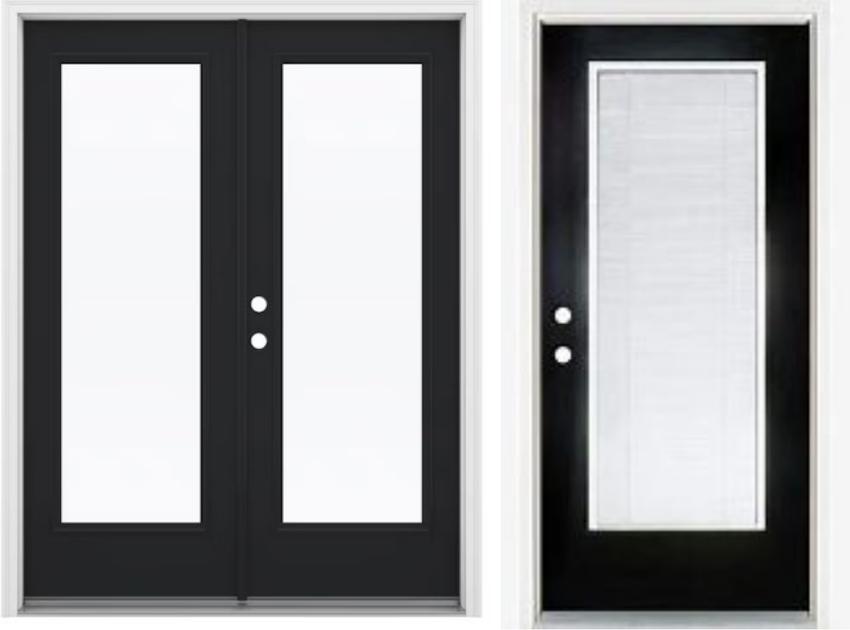
The home has a single door to the back patio. It will be replaced by two Fiberglass French patio doors with Low-E glass similar to those in the picture

below. These doors are not visible from the street and located in the back of the home. For the ADU entrance, which also does not face the street, the homeowner will install a similar single glass panel door.

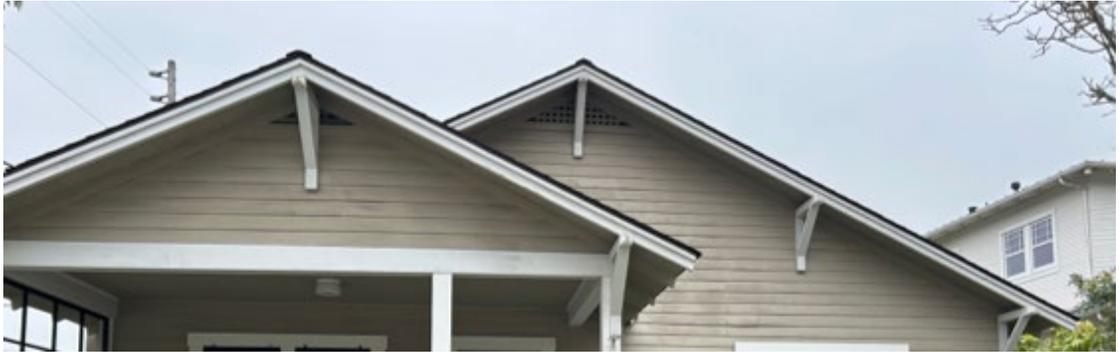
### Existing Roof

**First Floor:** The existing roofing, which consists of two gable style roofs (one over the main home and one over the porch) will remain unchanged in structure but will be refinished with new materials. A roof awning will be added to separate the larger first floor gable from the walls. This is an effective technique to break up large vertical surfaces, add architectural detail, and provide protection from the elements. This type of addition also enhances curb appeal by adding dimension to a flat front.

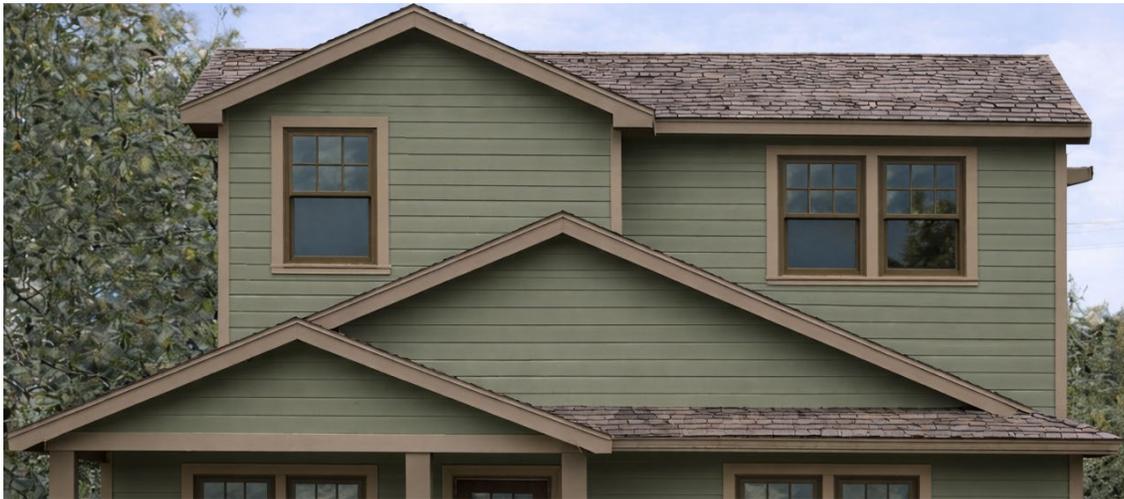
### Proposed Roof

**Second Floor:** The second floor ADU will also consist of a gable roof that will be placed perpendicular to the existing main gable roof.

The existing and new roof gables will use the same siding used for the exterior walls of the home.

The roof will consist of architectural composition shingles. The color to be determined based on the final home color.

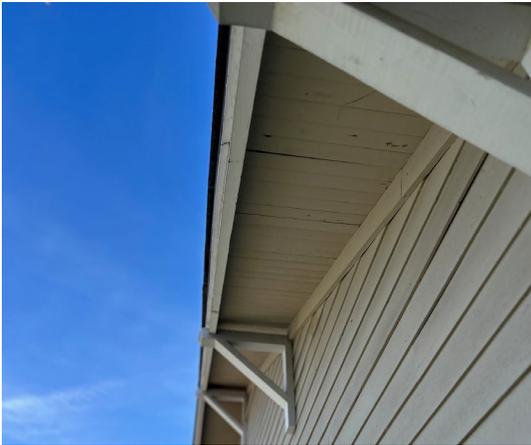
### **Existing Corbels and Brackets (Front and Back)**

Brackets: The existing brackets lack any architectural and character-defining features (e.g., intricate molding, specific 19th-century detailing) and do not add to the historical character of the home. For this reason, the homeowner is requesting to remove the brackets in favor of a cleaner, more intentional design of the home.

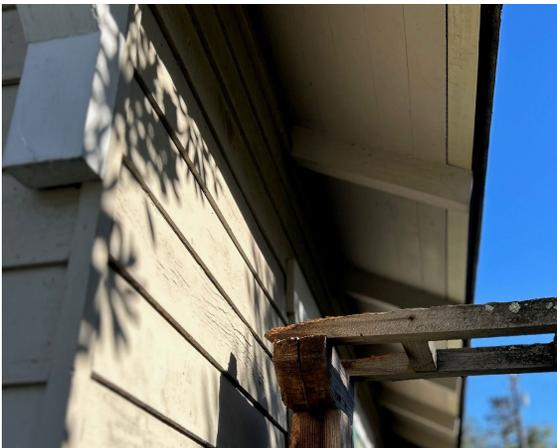
### **Existing Rafters (Sides)**

Rafters: The rafters will remain unchanged and will be painted in the same color as the roof trim, fascia, and rake boards.

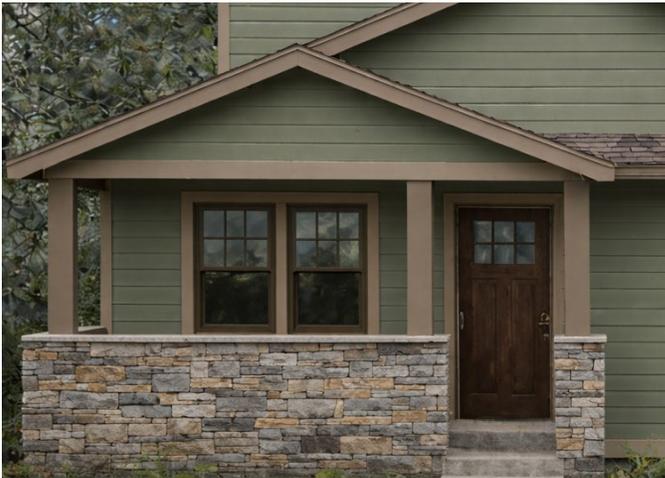
### Proposed Porch

A. **Foundation:** Concrete stem wall, natural gray

- **Material:** Square wood or wrapped structural columns
- **Location:** Front porch structural supports above masonry base

- **Material:** Stacked stone veneer
- **Stone Type:** Natural stone or manufactured stone veneer
- **Color Range:** Mixed neutral tones (gray / tan / cream)
- **Location:** Base of porch columns, Porch knee wall / wainscot below railing height

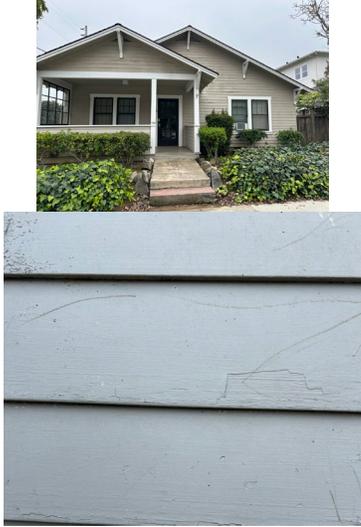
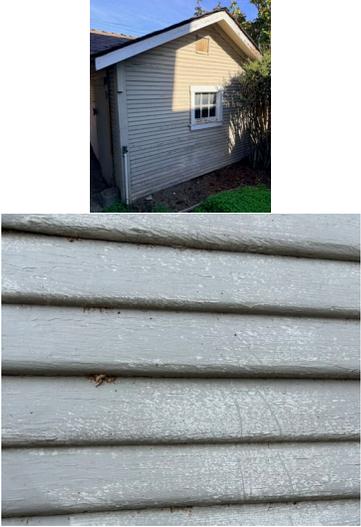
<p><b>Siding Style</b></p>

<p><b>Siding Condition</b></p>	<p>Both the siding on the residence and the garage are very deteriorated. However, the condition of the siding for the residence is overall better than that of the garage, suggesting it is newer than the siding used for the garage.</p>	
<p><b>Siding Size, Thickness and Appearance</b></p>	<p>The residence is clad in a <b>thin redwood 5.25-inch (lap) siding</b> installed over a black paper weather-resistant. The residence siding is <b>uniformly milled and completely smooth bevel siding, reflecting a later fabrication and installation period.</b> Related to this, the relatively thin profile of the house boards as compared to the thicker garage boards also reflects later lumber-efficiency practices associated with the declining availability of old-growth redwood after the 1930s, rather than typical early-1920s construction.</p>	<p>The garage is clad in a <b>thick-profile 3" wide beveled lap siding</b> typical of early 20th-century construction. The boards have a substantially narrower exposure and heavier butt edge than the siding on the residence. The garage clapboards <b>exhibit subtle irregularities, rough-sawn or lightly planed surfaces</b> indicating that it predates the primary home siding.</p>

This is because **the property presents two distinct exterior cladding conditions that differ materially in profile, construction, and weather-management strategy.** As summarized in the following table, while the residence features siding likely fabricated after 1941, the garage features siding likely fabricated before 1941.

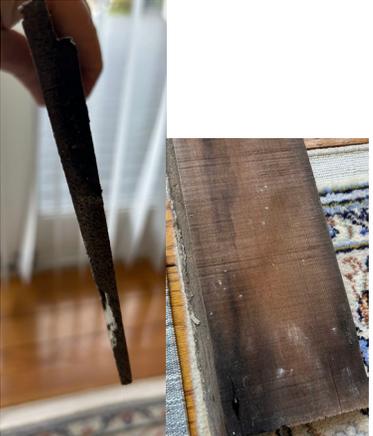
<p><b>Milling Details</b></p>	<p>Examination of the residence's siding indicates that the boards were <b>cut using a circular saw and subsequently finish-</b></p>	<p>Consistent with the early 1920s clapboard siding, the garage siding <b>exhibits greater variation in thickness and profile, reflecting</b></p>

<p>milled on a planer or siding molder to produce the smooth, uniform bevel profile. While circular saws were in use by the early 20th century, the high degree of dimensional consistency and refined taper evident here is characteristic of later industrial planing and molding processes that became widespread after World War II.</p>

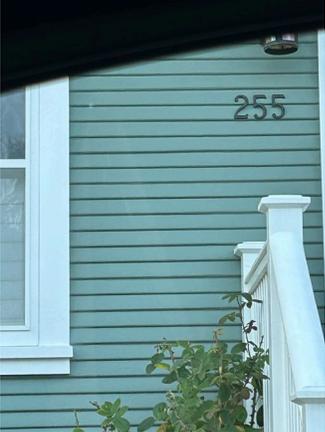
<p><b>Siding of the Neighboring Homes</b></p>	<p>The siding used for 150 Tait does not match any other homes in the nearby vicinity, most of which have siding that is far narrower or wider than that of the residence at 150 Tait. Where the siding of these nearby properties is of similar width to the residence at 150 Tait, they have been installed as tongue-and-groove or batten board, and NOT lap siding. In fact, while the neighboring homes share common siding styles with one another, none of them share a style that is similar</p>	<p>The garage siding is consistent with the neighborhood's historic siding character, including the siding used for the properties immediately to the back of and right of 150 Tait.</p> <p>1) <u>255 Nicholson</u>: This house, which is directly behind 150 Tait, has the same type of siding as the garage, not the residence siding.</p>

<p>to the siding used for the residence at 150 Tait.</p>

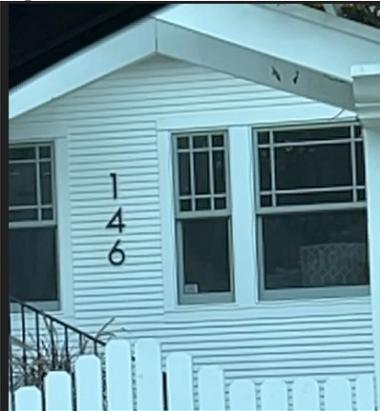
<p>2) <u>146 Tait</u>: The house directly to the right of 150 Tait (which also predates 150 Tait on the Sanborn maps), has the same type of siding as 150 Tait's garage siding, not the residence siding.</p>

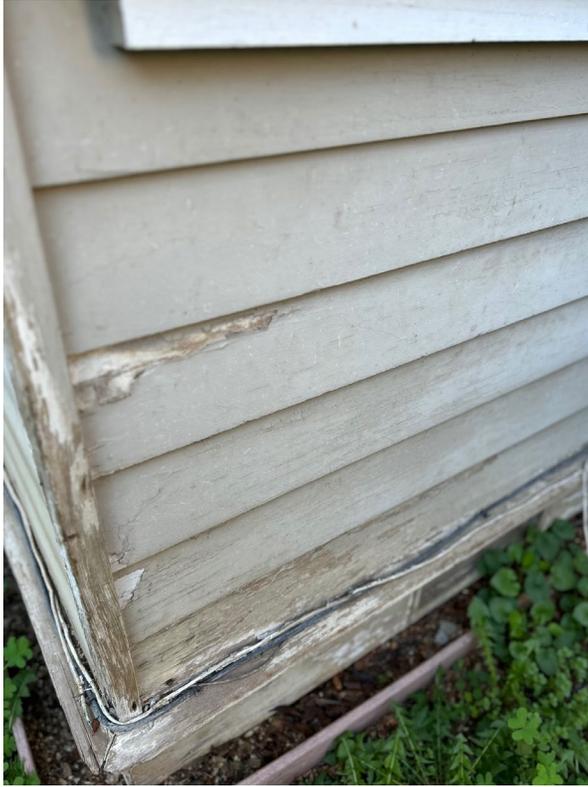
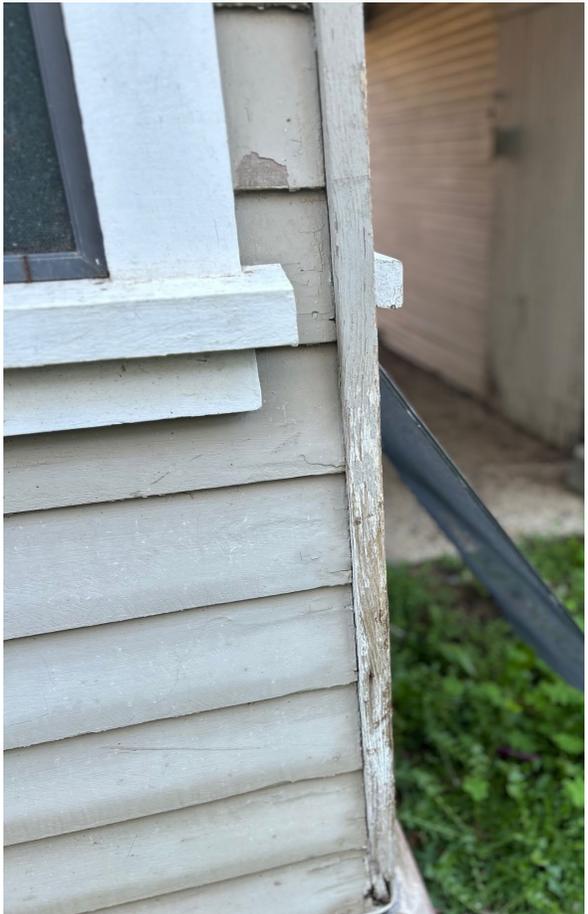
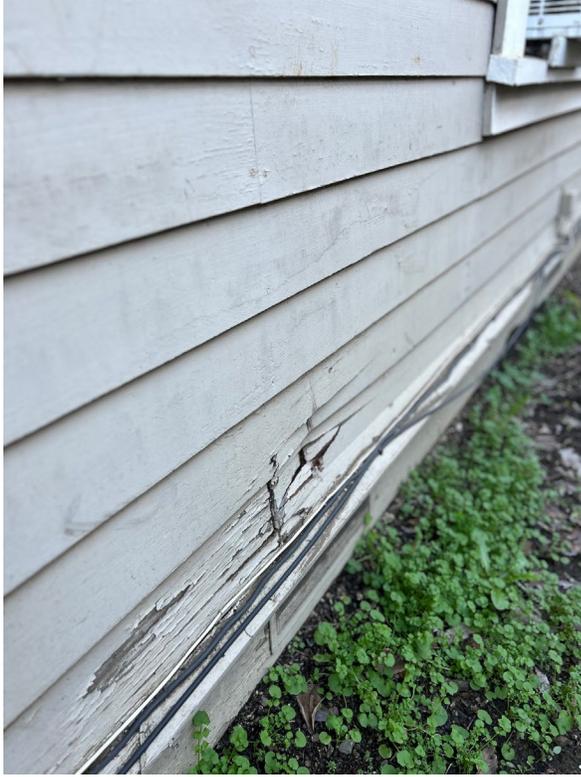
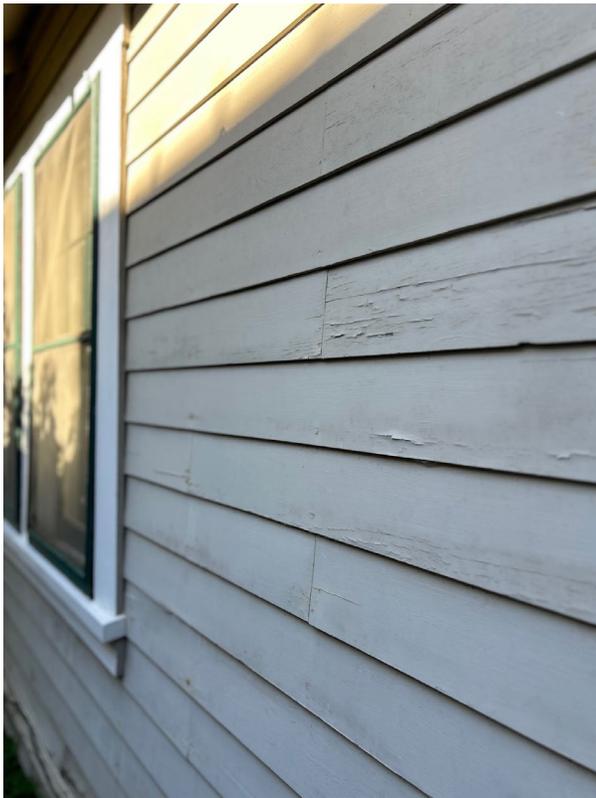
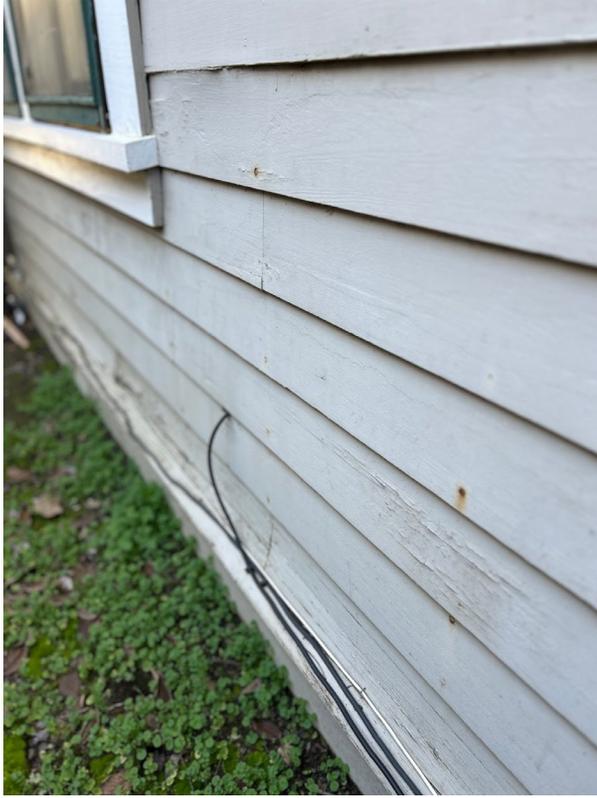
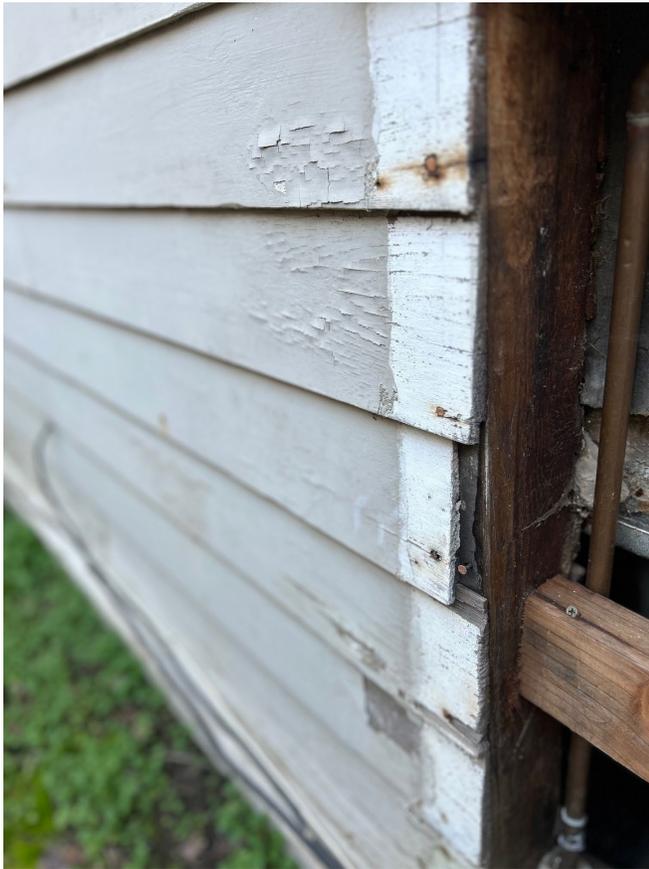
### **C. Existing Siding is Deteriorating (images available at the end of this Appendix)**

- Multiple areas exhibit deep dry rot, indicating long-term water exposure.
- Portions of the siding show fungal decay and structural breakdown.
- Several boards crumble when probed, demonstrating loss of structural integrity.
- Dry rot has affected not only the siding but also isolated trim boards, suggesting systemic deterioration.

Based on the above reasons, continued patch repair is no longer practical and risks incremental loss of historic fabric. Images of the existing siding condition can be found at the end of this Appendix E.
