**CEQA Memorandum  
400 SURMONT DRIVE  
TOWN OF LOS GATOS, SANTA CLARA COUNTY**

**400 Surmont Drive  
Biological Resources Report**

**PROPOSED ANDERSON RESIDENCES**  
**400 Surmont Drive**  
**Los Gatos, California**

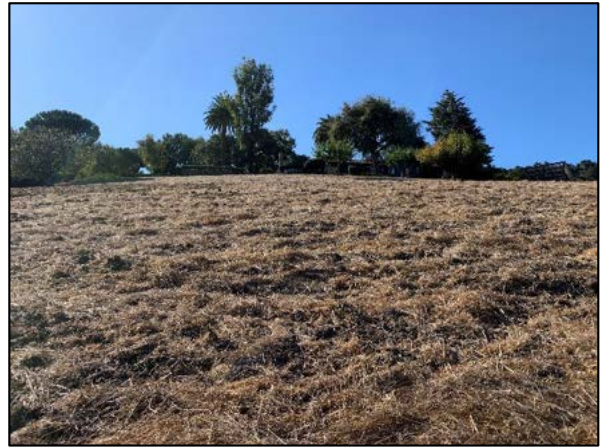
**Vegetation.** Ruderal (i.e. disturbed) grassland habitat is the most extensive vegetation community on the project site (Photo 1). At the time of the reconnaissance survey, this habitat was entirely disked (in open areas) or mowed and partially disked (beneath trees). Based on evaluation of the remaining stubble, it appears that prior to mowing and disking the vegetation was largely dominated by non-native grasses such as wild oat (*Avena fatua*) and various bromes (*Bromus* spp.). Intermittent patches of stinkwort (*Dittrichia graveolens*) are also present as well. There were also a few orchard trees scattered throughout the grassland habitat, including the rootstock of stone fruit (*Prunus* sp.), which are likely remnants from an historical orchard on the site.

**Photo 1. Ruderal grassland habitat.**

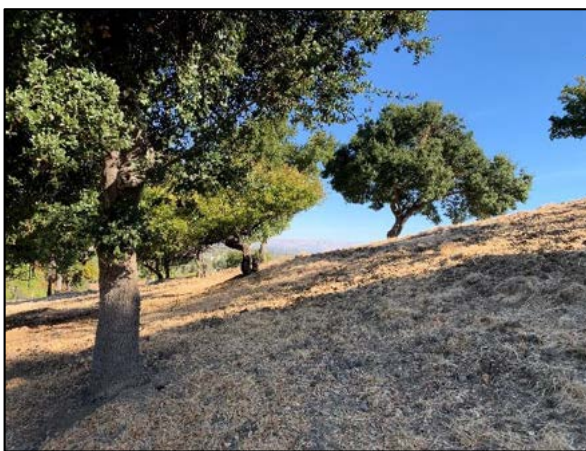
**Vegetation.** A small portion of the site contains a coast live oak woodland (Photo 2). Within the south west portion of the project site, this habitat is situated on a westward-facing slope (30–40%) and abuts the dirt road that runs along the western boundary of the site. This habitat is dominated by mature, closely spaced coast live oak (*Quercus agrifolia*) trees. The understory of the coast live oak woodland is mowed, partially disked, and mostly devoid of any vegetation, except for small patches of wild oats around the bases of trees.

**Photo 2. Coast live oak woodland habitat.**

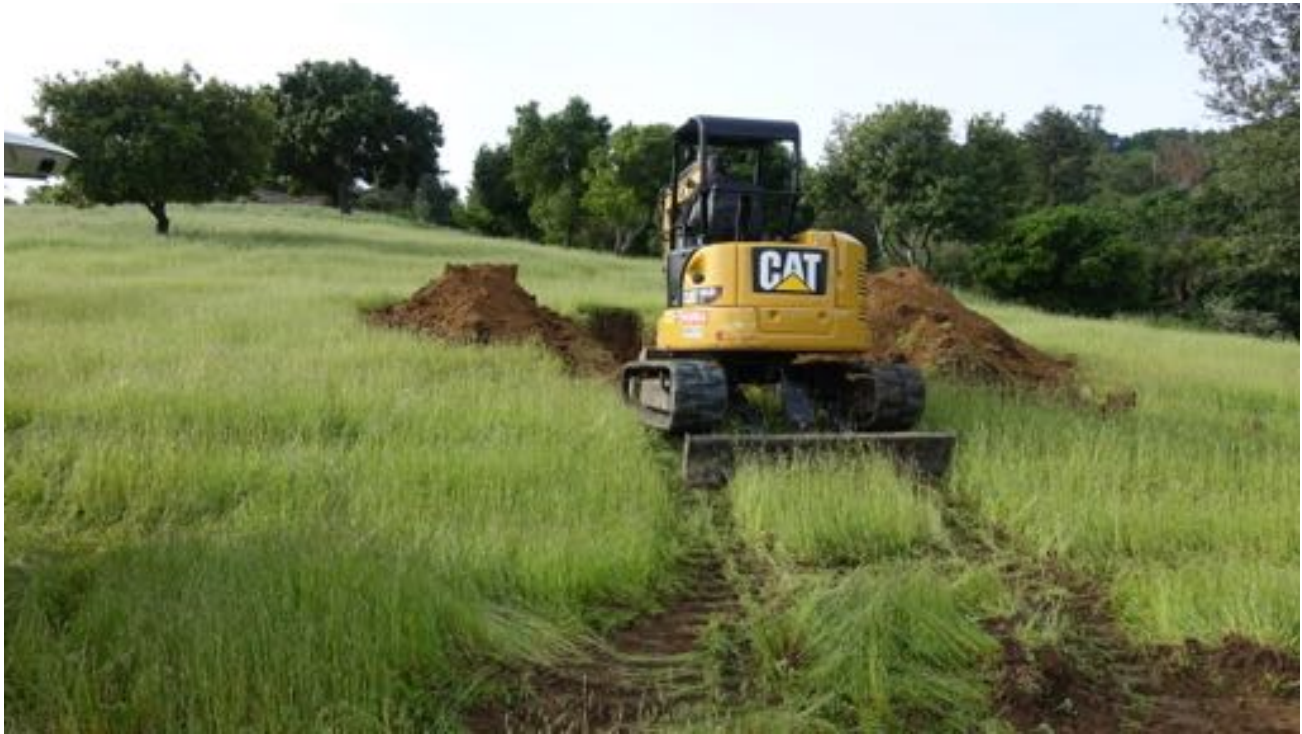
Photo 3: View of backhoe excavating Test Pit 1.

As part of this investigation, four test pits were initially excavated on the property, in the approximate locations shown on Figure 9, using a track-mounted excavator (see Photo 3 above). When Test Pit 4 encountered anomalous materials, a fifth test pit was excavated to investigate geologic relationships. Test Pit 2 was later lengthened and deepened as part of further investigation. Detailed logs of the materials encountered in Test Pits 1 through 5 are shown on Figures 10 through 14, Logs of Test Pits 1 through 5. Groundwater was not encountered in any of the excavations.

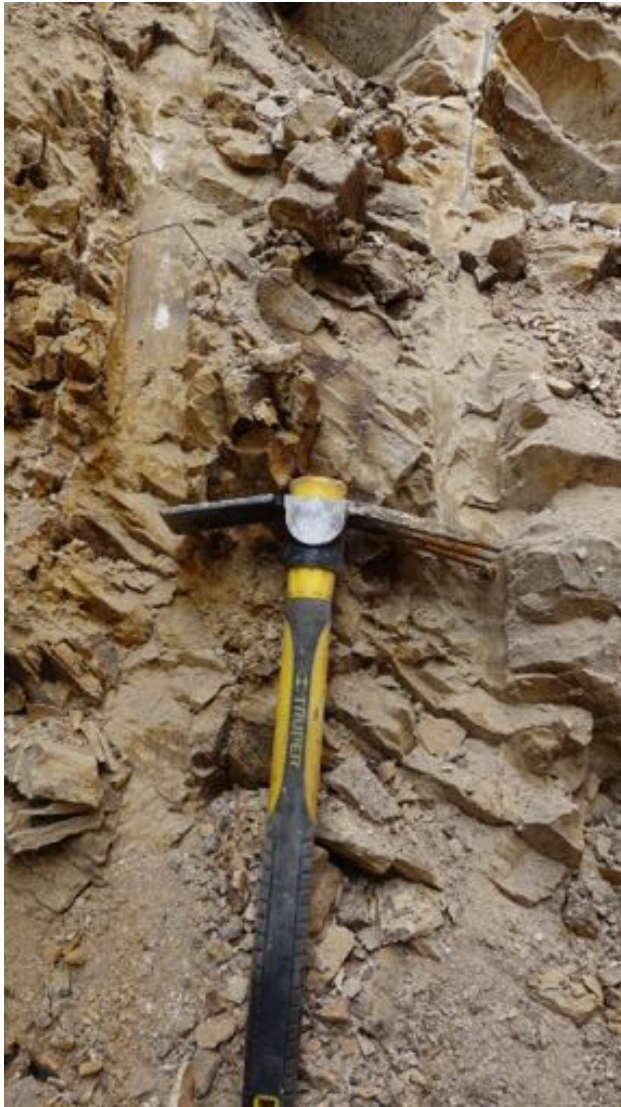
Photo 5: View of Santa Clara Formation exposed in Test Pit 4.

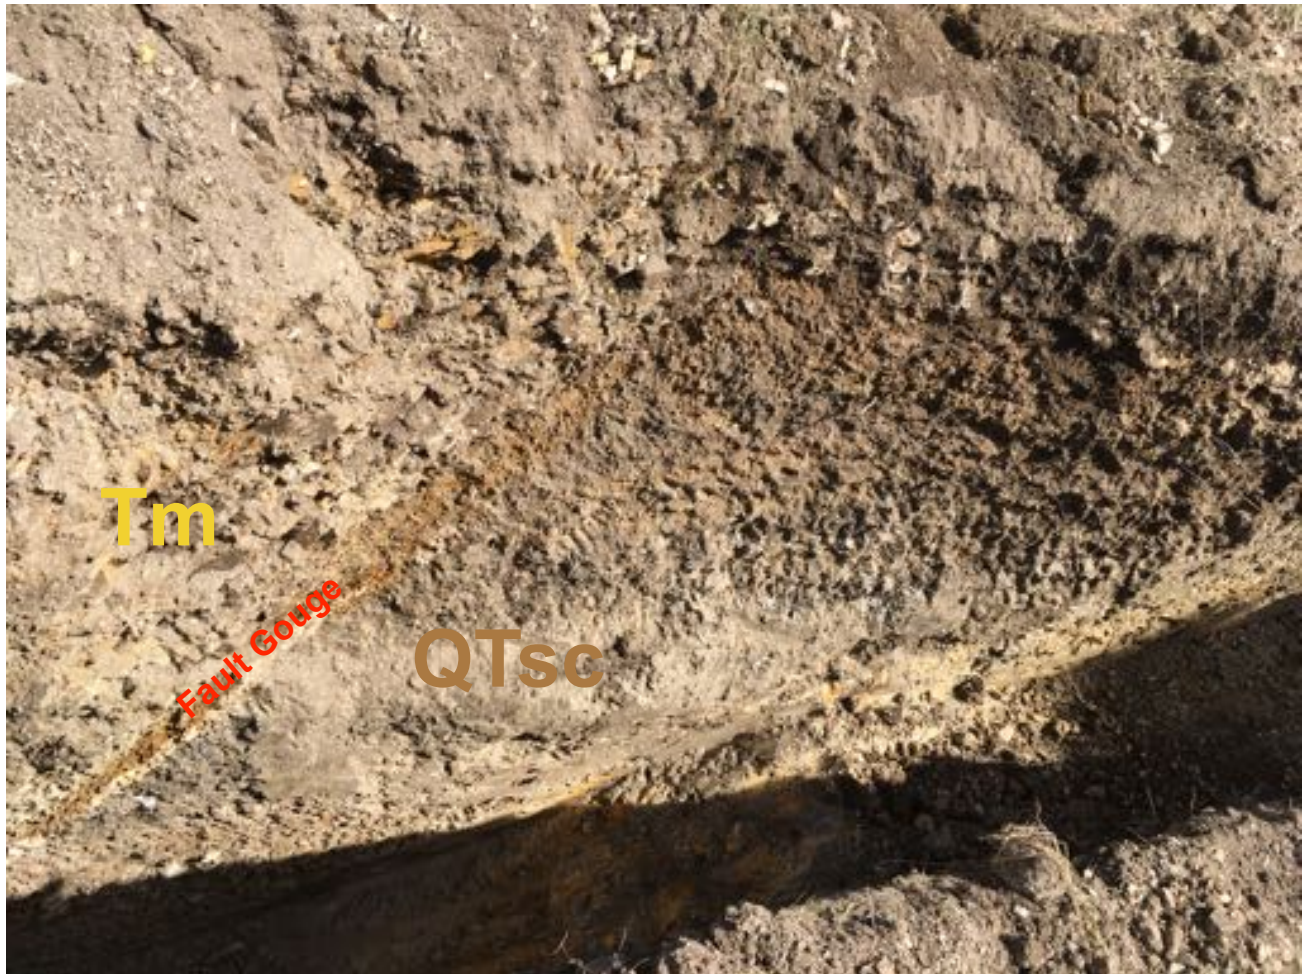
Photo 7: View of the eastern wall of Test Pit 4. Closely-bedded Monterey Shale **Tm** is exposed to the left of the photo. Strong brown-colored fault gouge defines a thrust fault that thrusts older Monterey Shale over younger Santa Clara Formation sediment **QTsc** in the right of the photo.

A prominent fault defined by a 4 to 6-inch-wide layer of fault gouge composed of strong brown, highly plastic, clay separates the Monterey Shale in the northern portion of Test Pit 4 from the Santa Clara Formation and Monterey Shale in the southern end of the pit (see Photo 6 above and Photo 7 below). The fault plane is oriented parallel to bedding in the Monterey Shale and is bounded at its base by white carbonate veins and carbonate deposits up to 3 inch thick. The fault gouge thins and flattens out in the uphill direction as depicted on Figure 13. The fault thrusts older Monterey Shale rocks over younger Santa Clara Formation rocks in an uphill direction, antithetical to the common range front thrust dynamics in the site vicinity.

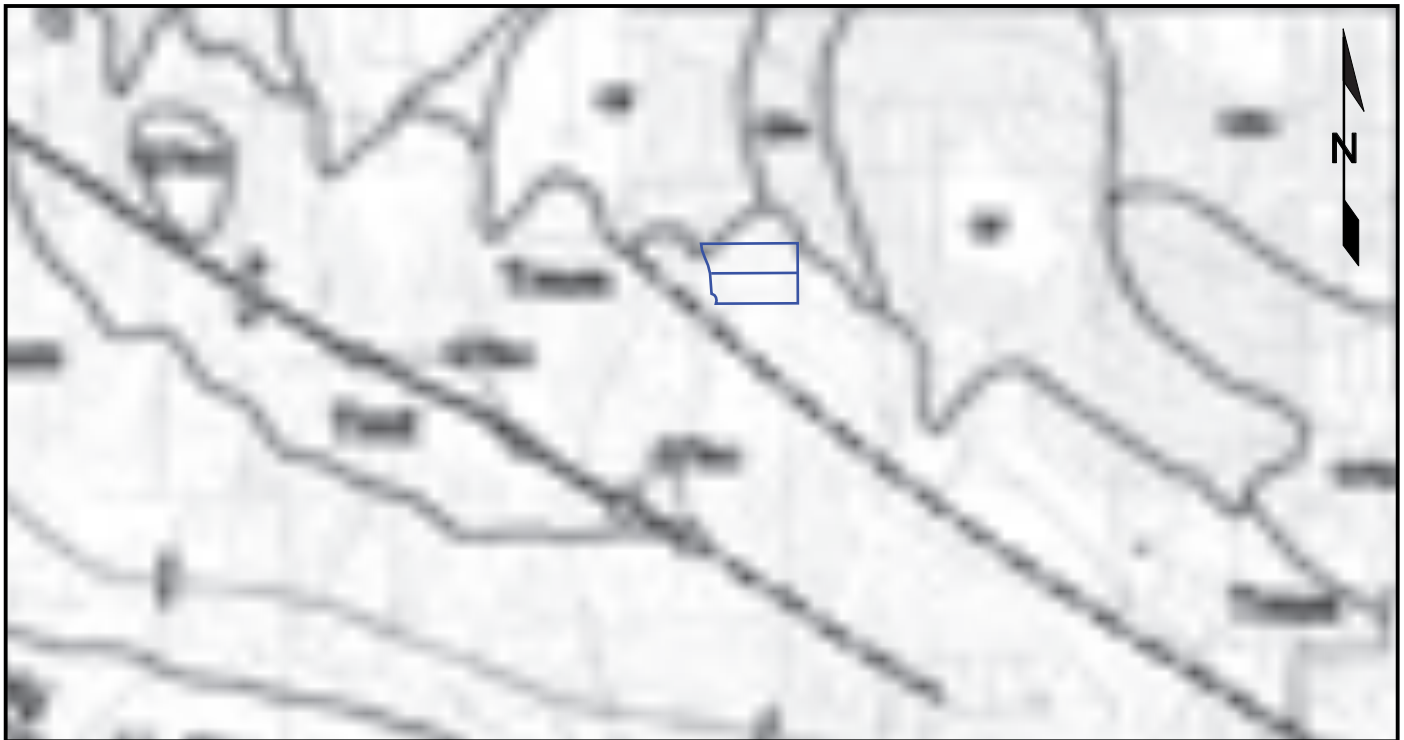
### EXPLANATION

| <b>Qfl</b> | Modern fluvial deposits | <b>Qtsc</b> | Santa Clara Formation |

Nolan Associates (2002) identified similar geologic relationships on a geologic hazards map produced for the Town of Los Gatos, as shown on Figure 4, Town Geologic Hazards Map. Landslide deposits are not mapped on the property or immediate site vicinity.

As previously discussed, an un-named fault has been mapped about 200 feet to the southwest of the property, as shown on Figure 3, Regional Geologic Map and Figure 4, Town Geologic Hazards Map. The County of Santa Clara (2004) includes this fault within a County Fault Rupture Hazard Zone, as shown on Figure 6, County Fault Rupture Hazard Zone Map. The Blossom Hill fault was identified by Steven F. Connelly, C.E.G. (2003) as an active fault, and is located about 1200 feet to the southwest.
