RE: 143 + 151 East Main Street

I reviewed the new drawings in the context of its immediate neighborhood. My comments and recommendations are as follows:

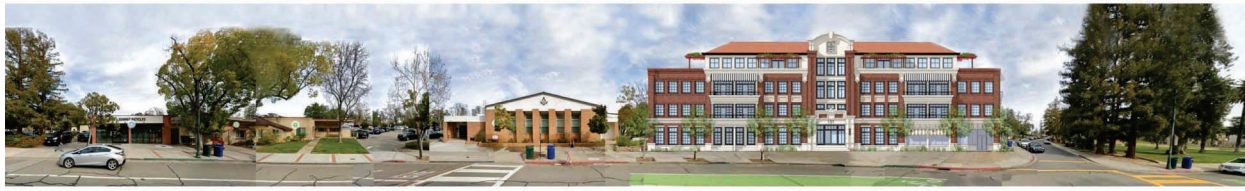
EAST MAIN STREET LOOKING NORTH

Broken up facade treatment appears out of character with the proposed formal architectural style

1. The design appears to draw on the traditional formality and details of the adjacent high school structure with its punched window openings in a solid wall facade and classic architectural details. However, the main facades of this proposed building are broken up into smaller segments with a strong vertical appearance which is at odds with the adjacent high school and other nearby buildings.

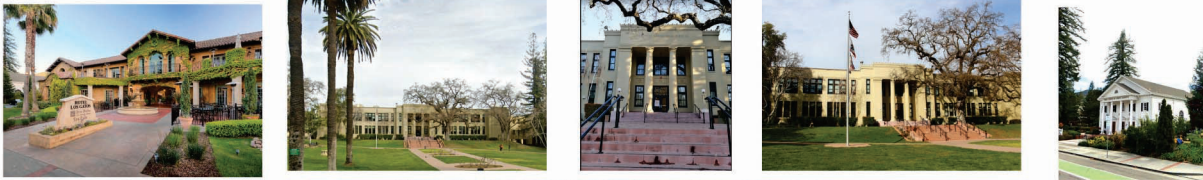
Nearby important structures are more formal and have less fragmented facades

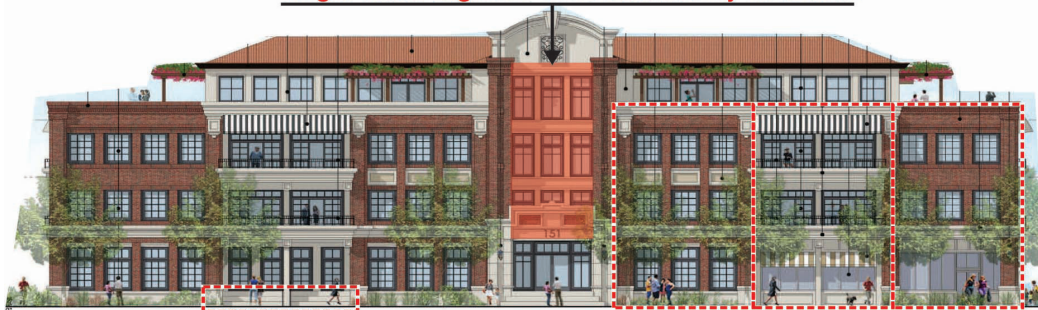
Vertical element seems to over emphasize building height which is greater than other nearby structures

wide concrete area different than on floor plan

Broken up facade treatment appears out of character with the proposed formal architectural style

2. The separation of the facades into elements that are less unified than in traditional architecture also tends to make the facade overly fragmented and more vertical in its appearance. This carries through with the two side elevations having a distinctly different appearance than the front and rear facades.
3. The verticality of the facades which draw attention to its substantial scale difference from its surrounding context is further emphasized by the four story light colored facade over the main building entry.

5. There is a small issue with the smaller residential unit entries facing the streets. The entries and stairs are shown graphically different on the floor plan and the elevations. The elevation shows a rather long stretch of concrete steps along the East Main Street sidewalk frontage. Given the reduced setback requested by the applicant along the frontage, it seems like an emphasis on more landscaping might be appropriate.
6. One issue of unit livability that might be an issue is the relatively deep units in some locations where some interior living spaces may be further away from a window than normally expected in high quality housing.

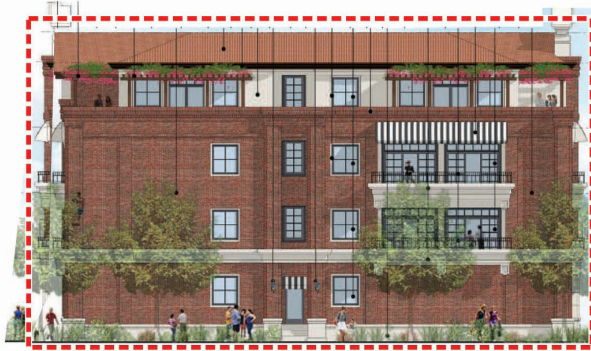
Both side facades appear very different from front and rear facades

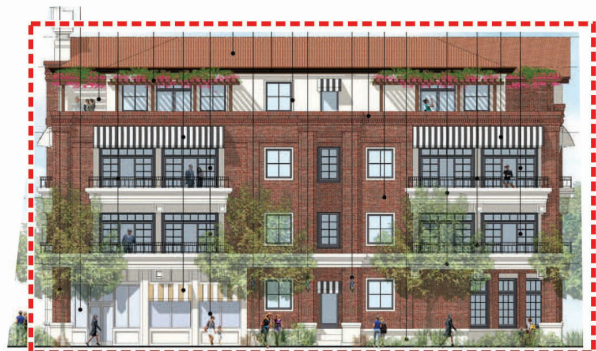
Both side facades appear very different from front and rear facades

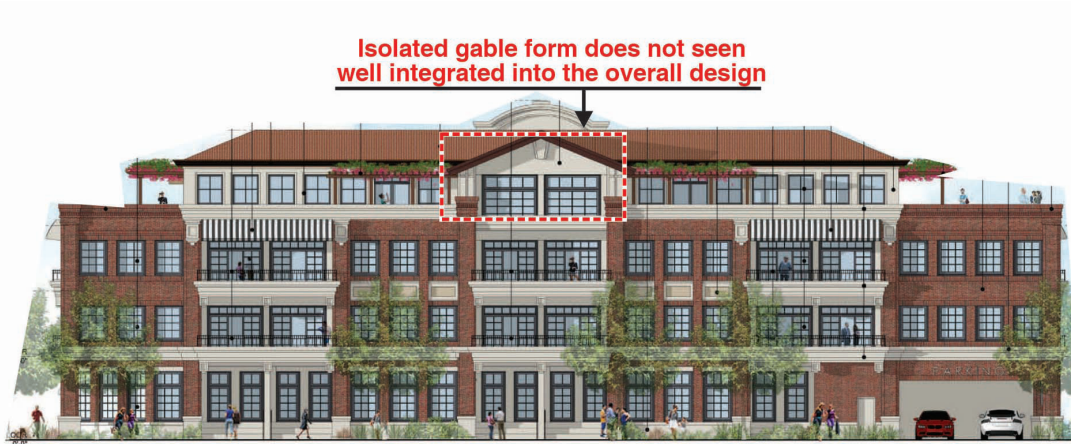
4. The central gable roof on the rear facade is a form not found elsewhere on the building and seems out of place in the overall unity of the design.

4. Modify the gable roof form on the rear facade to blend in better with the overall building design.

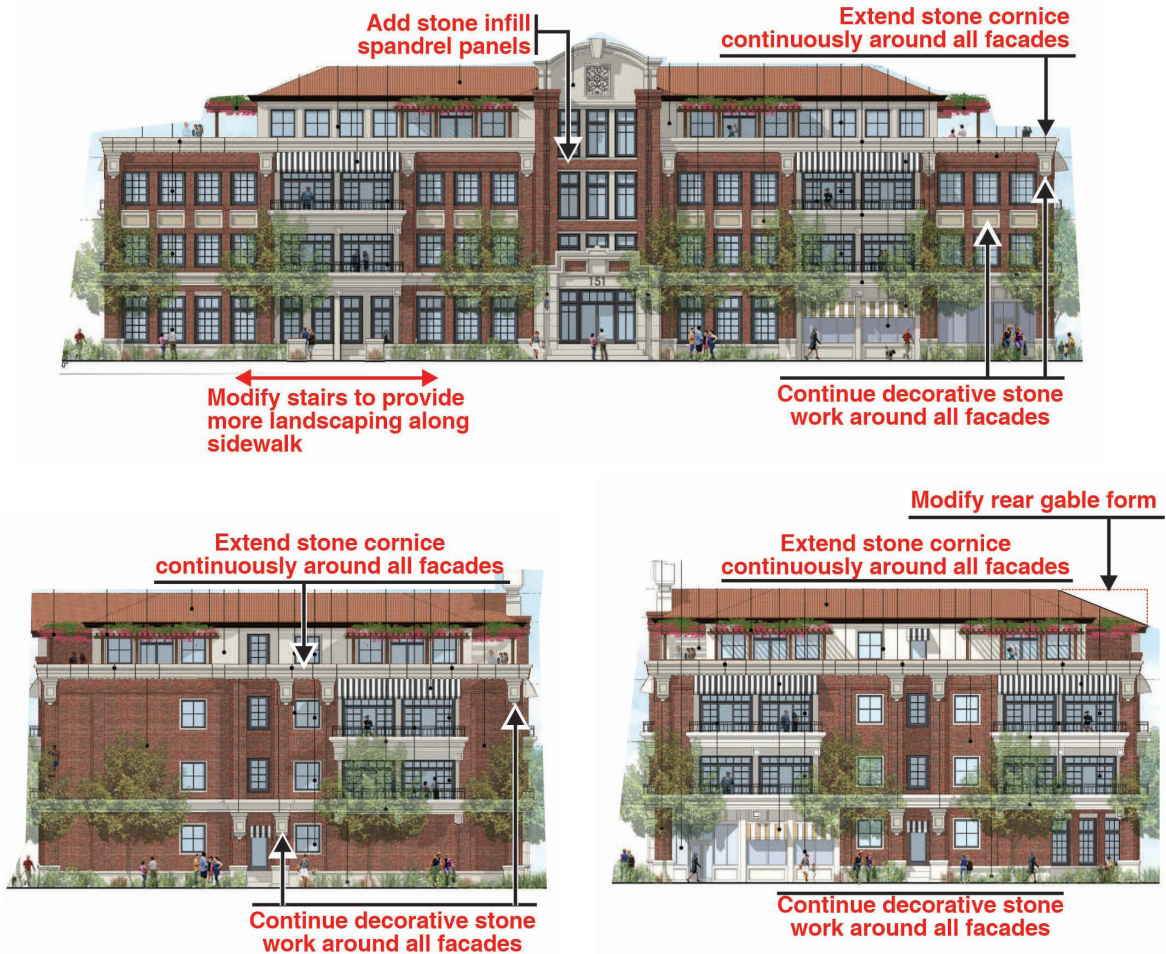
2. Extend the stone cornice and decorative stone work consistently around all sides of the building.
3. Add brick spandrel infill on the four story tall wall over the primary East Main Street entry to reduce its vertical emphasis.
