Minturn Fitness Center
Minturn, CO

Report #: 47744-0
Beginning: May 1, 2023
Expires: April 30, 2024

RESERVE STUDY
"Full"

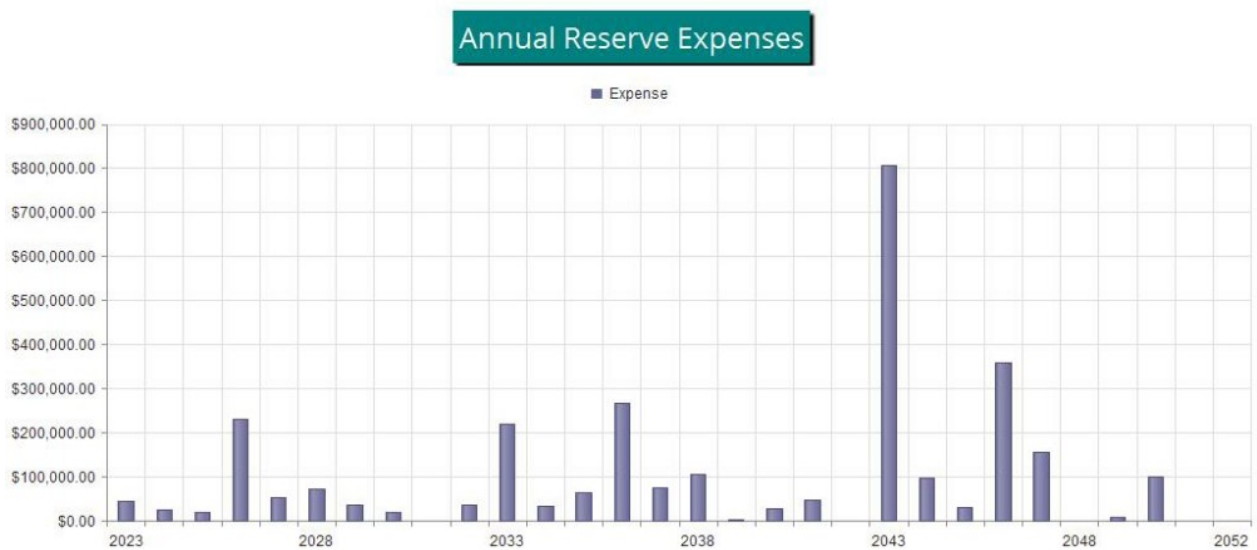
Figure 1

The figure below summarizes the projected future expenses as defined by your Reserve Component List. A summary of these expenses are shown in the 30-Year Reserve Plan Summary Table, while details of the projects that make up these expenses are shown in the 30-Year Income/Expense Detail.

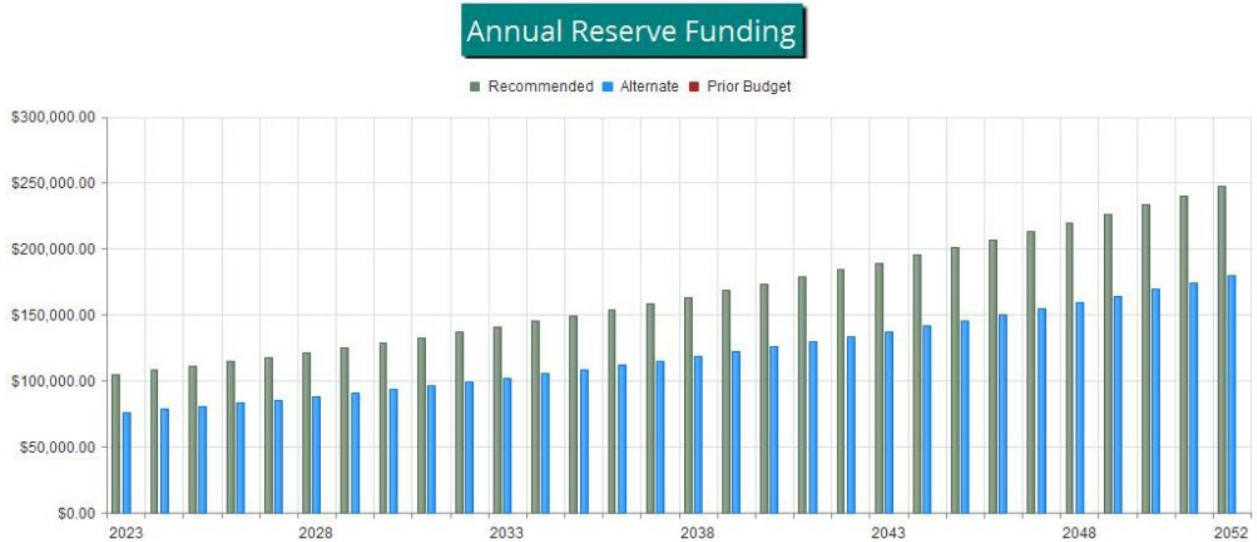
Figure 2

Based on your current Percent Funded and your near-term and long-term Reserve needs, we are recommending Annual budgeted contributions of \$105,000 along with a one-time special assessment of \$0. The overall 30-Year Plan, in perspective, is shown below in the Annual Reserve Funding (Fig. 2). This same information is shown numerically in both the 30-Year Reserve Plan Summary Table and the 30-Year Income/Expense Detail.

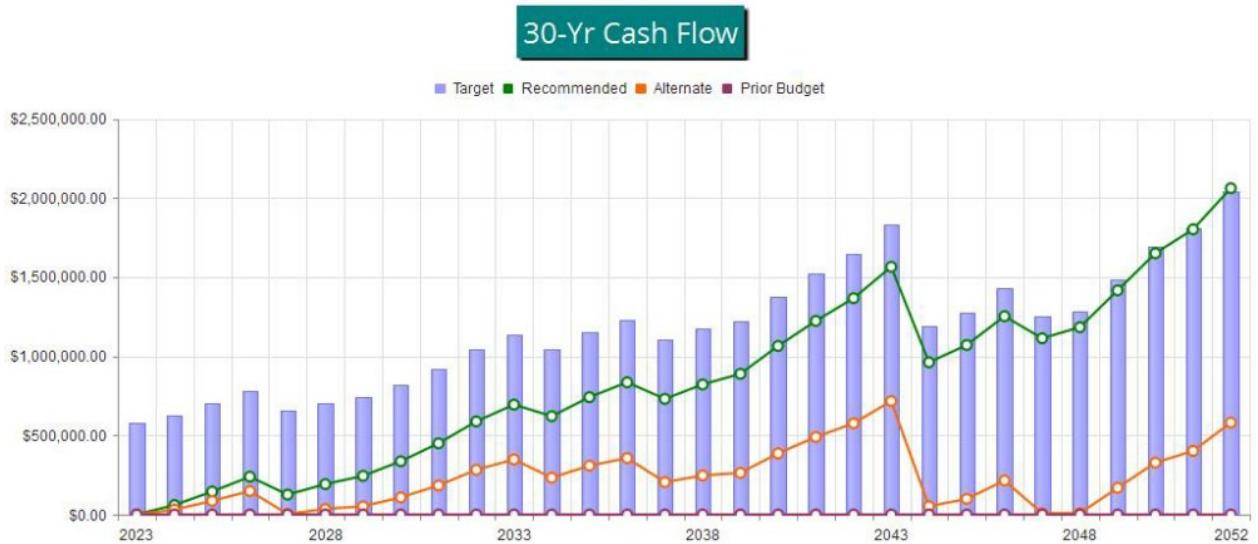
The reserve balance under our recommended Full Funding Plan, an alternate Baseline Funding Plan, and at your current budgeted contribution rate, compared to your always—changing Fully Funded Balance target is shown in the 30-Yr Cash Flow (Fig. 3).

The information from Figure 3 is plotted on a Percent Funded scale in Figure 4. It is clear here to see how your Reserve Fund strength approaches the 100% Funded level under our recommended multi-yr Funding Plan. A client that has a percent funded level of <30% may experience an ~ 20%-60% chance risk of special assessment. A client that is between 30% and 70% may experience an ~ 20%-5% chance risk of special assessment. A client that has a percent funded of >70% may experience an ~ <1% chance risk of special assessment.

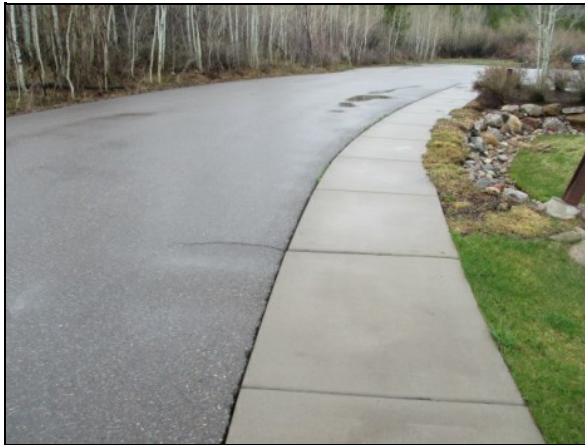
Comp #: 21090 Concrete Walkways - Repair - 5%

Useful Life:
5 years

Remaining Life:
1 years

Best Case: \$ 1,200

Worst Case: \$ 1,600

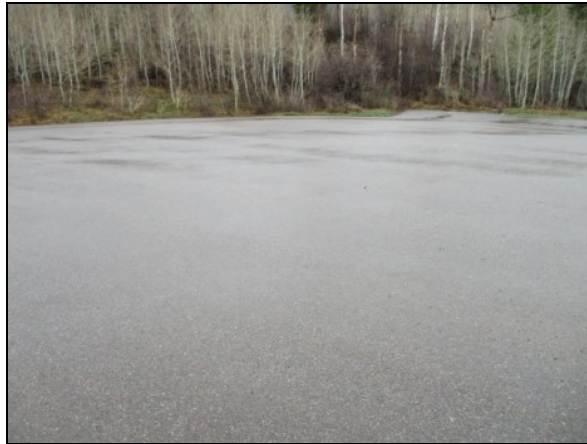
Comp #: 21190 Asphalt - Seal/Repair

Useful Life:
3 years

Remaining Life:
0 years

Best Case: \$ 19,000

Worst Case: \$ 38,000

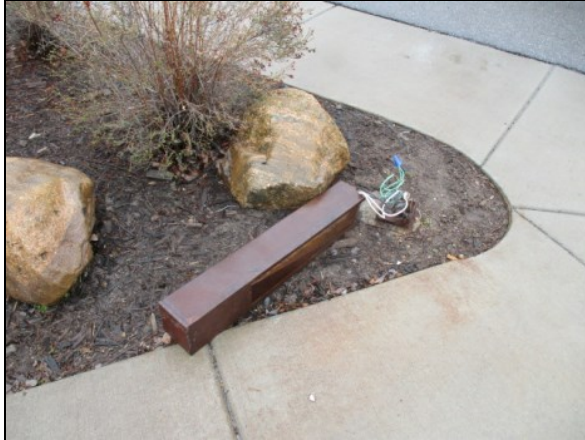
Comp #: 21670 Bollard Lights - Replace

Useful Life:
30 years

Remaining Life:
20 years

Best Case: \$ 7,000

Worst Case: \$ 9,000

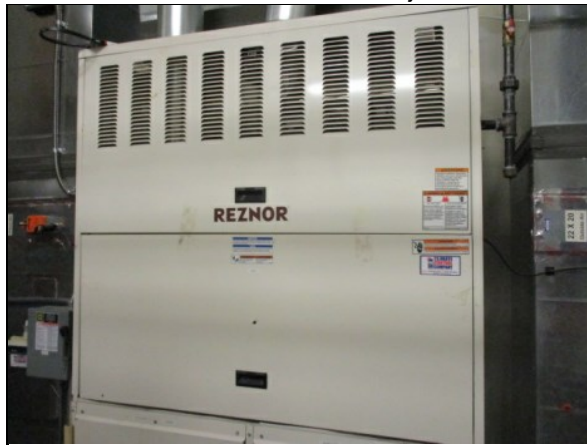
Comp #: 25210 Reznor MAU - Replace

Comments: Includes (1) Reznor 300,000 BTU Makeup Air Unit (M: CAUA300-S-2, S: EBMK78X3N58603X) (2013). Minimal or no subjective/aesthetic value for this component. Useful life is based primarily on normal expectations for service/performance life in this location. Unless otherwise noted remaining useful life expectancy is based primarily on original installation or last replacement/purchase date our experience with similar systems/components and assuming normal amount of usage and good preventive maintenance. We recommend that routine repairs and maintenance such as filter replacements system flushing etc. be budgeted as an Operating expense. Useful life can often be extended with proactive service and maintenance. Unless otherwise noted funding for system with same size/capacity as the current system. For split systems we recommend budgeting to replace the entire system (condensing unit and air handler) together in order to obtain better unit pricing and ensure maximum efficiency refrigerant compatibility etc. If additional costs are expected during replacement such as for system reconfiguration or expansion ductwork repairs electrical work etc. costs should be re-evaluated and adjusted as needed during future Reserve Study updates.

Useful Life:
25 years

Remaining Life:
15 years

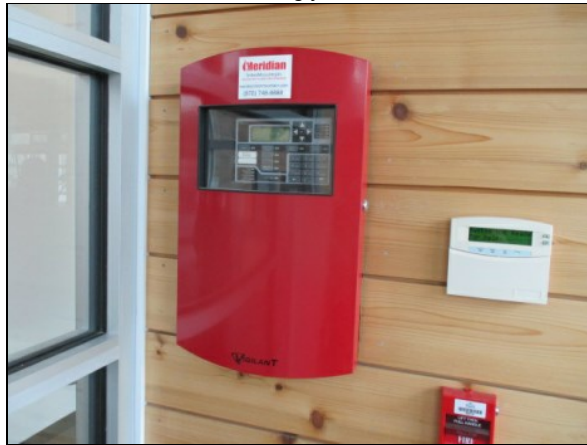
Comments: Includes (1) Vigilant Fire Panel. Our inspection is for planning and budgeting purposes only fire alarm equipment is assumed to have been designed and installed properly and is assumed to comply with all relevant building codes. Regular testing and inspections should be conducted as an Operating expense. In many cases manufacturers discontinue support of equipment after a certain number of years which may limit availability of replacement parts as the system ages. Cost estimates assume that existing wiring can be re-used and that only panel and devices will be replaced. If wiring requires replacement estimates should be increased accordingly but in our experience wiring should have an indefinite useful life. Cost estimates are based on quantity and type of existing equipment not including any expansion or upgrades which may be required. We recommend reviewing system components with fire alarm vendor on a regular basis. If expansion of system is found to be required the Reserve Study should be updated and any additional costs should be factored accordingly.

Useful Life:
20 years

Remaining Life:
10 years

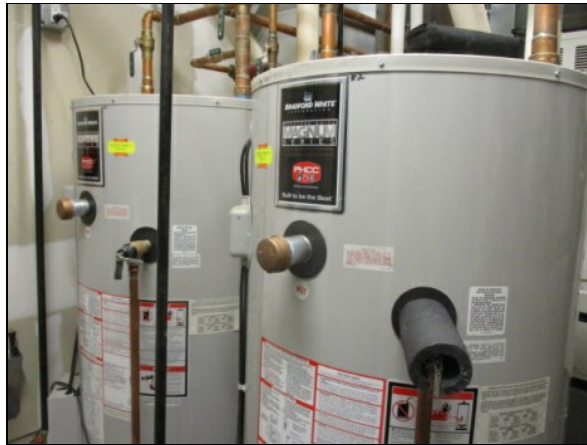
Comp #: 25460 Water Heaters - Replace

Comments: Includes (2) Bradford White Magnum Series 100 Gallon, 199,000 BTU Water Heaters (M: PDV100S2003N, S: LD34331209, LD 34331210). Minimal or no subjective/aesthetic value for this component. Useful life is based primarily on normal expectations for service/performance life in this location. Unless otherwise noted remaining useful life expectancy is based primarily on original installation or last replacement/purchase date our experience with similar systems/components and assuming normal amount of usage and good preventive maintenance. Water heater life expectancies can vary greatly depending on level of use type of technology amount of preventive maintenance and other factors. Should be inspected and repaired as needed by servicing vendor or maintenance staff. Unless otherwise noted expected to be functional. Plan to replace at the approximate interval shown below. When evaluating replacements we recommend choosing high-efficiency or tankless models if possible in order to minimize energy usage.

Useful Life:
15 years

Remaining Life:
5 years

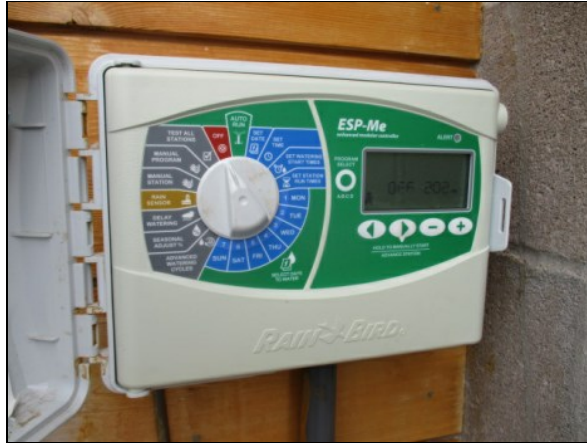
Comp #: 25570 Irrigation Clocks - Replace

Comments: Includes (1) Rainbird ESP-Me. Minimal or no subjective/aesthetic value for this component. Useful life is based primarily on normal expectations for service/performance life in this location. Unless otherwise noted remaining useful life expectancy is based primarily on original installation or last replacement/purchase date our experience with similar systems/components and assuming normal amount of usage and good preventive maintenance. Irrigation controllers should have a relatively long life expectancy under normal circumstances. Replacement is often required due to lack of available replacement parts lightning strikes etc. as opposed to complete failure of existing equipment. Exposure to the elements can affect overall life expectancy and controllers should be located in protected areas or within protective enclosures whenever possible. When evaluating replacement options the client should consider replacement with smart" models (i.e. respond to projected weather data) to minimize unnecessary water usage. Payback period for efficient controllers that minimize water use is typically very short

Useful Life:
15 years

Remaining Life:
5 years
