PRELIMINARY GEOTECHNICAL STUDY FOR

CASTLE VALLEY RANCH
WEST OF CASTLE VALLEY BOULEVARD
AND CLUBHOUSE DRIVE
NEW CASTLE, COLORADO

> JUNE 12, 2006 PROJECT NUMBER 90114

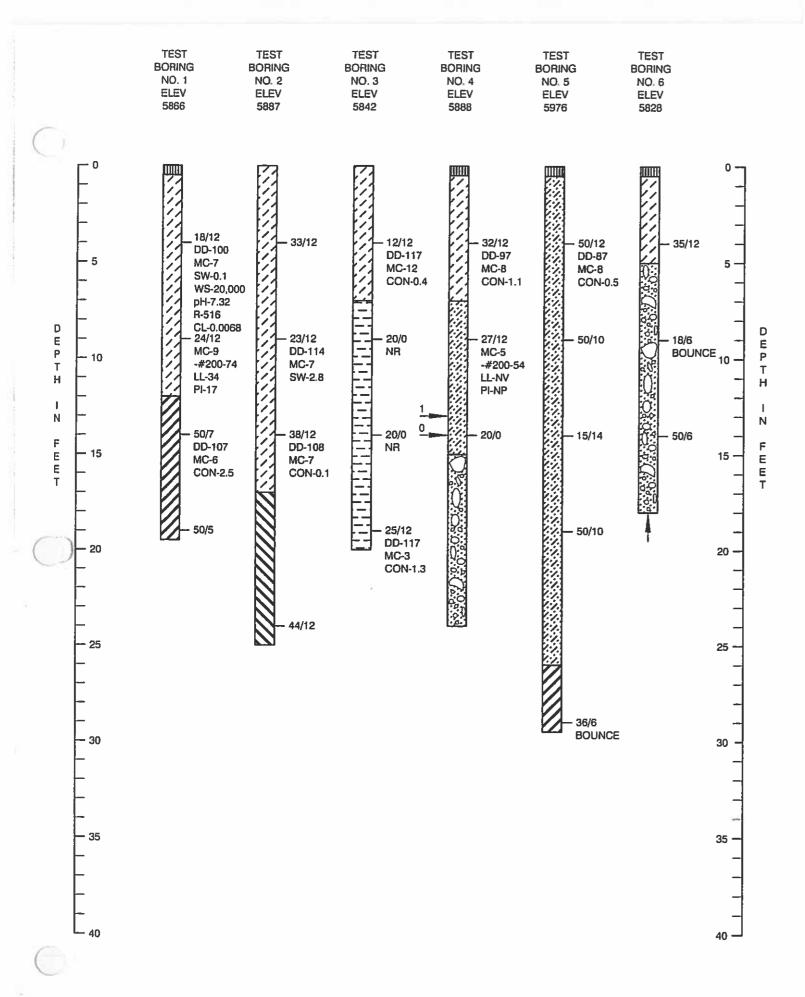
EXPLORATORY BORING LOGS FIGURE 2

SEE FIGURE 5 FOR LEGEND AND NOTES TO EXPLORATORY BORINGS

on Figures 2 through 5.

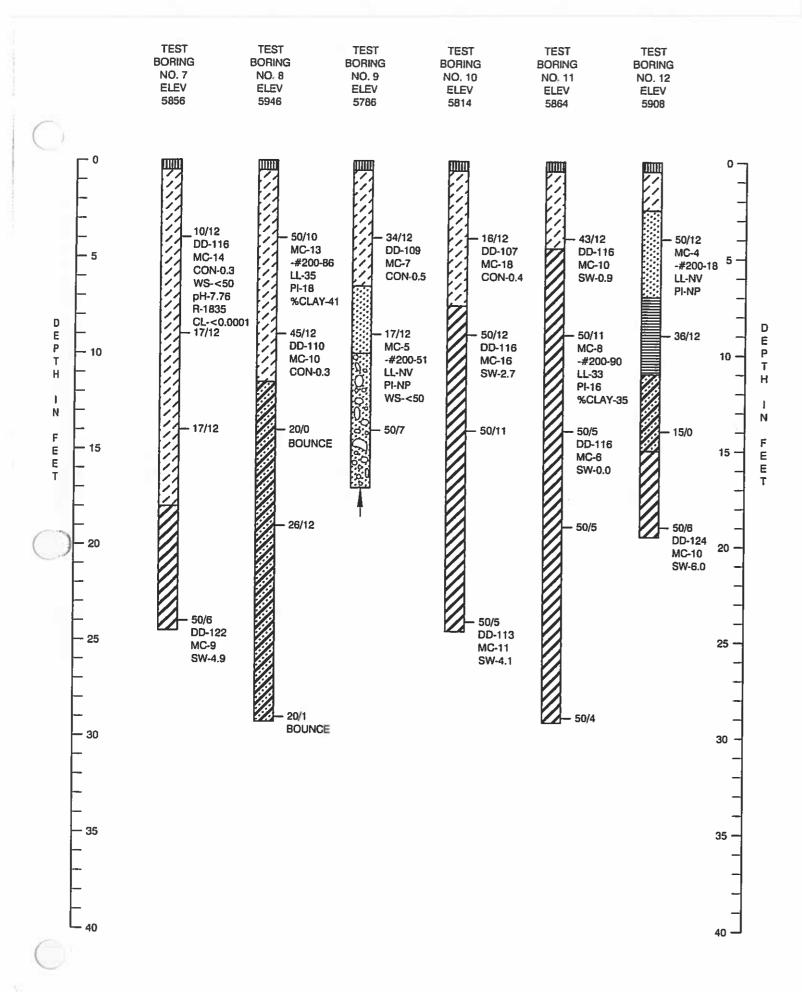
EXPLORATORY BORING LOGS FIGURE 3

SEE FIGURE 5 FOR LEGEND AND NOTES TO EXPLORATORY BORINGS

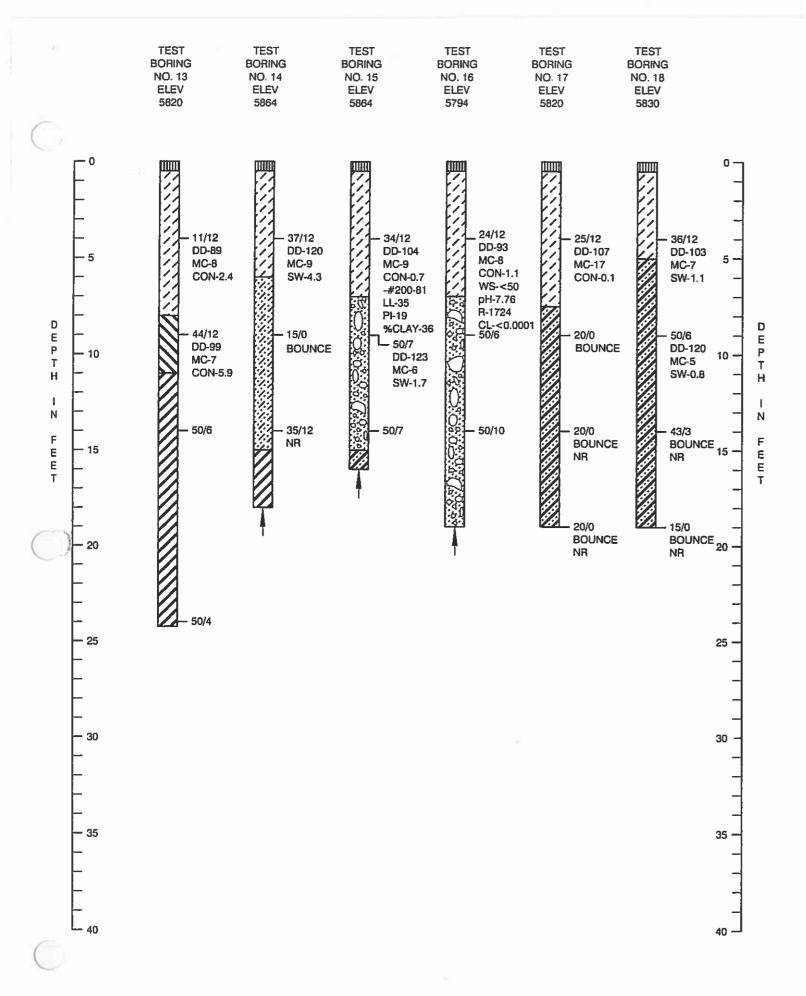
EXPLORATORY BORING LOGS FIGURE 4

SEE FIGURE 5 FOR LEGEND AND NOTES TO EXPLORATORY BORINGS

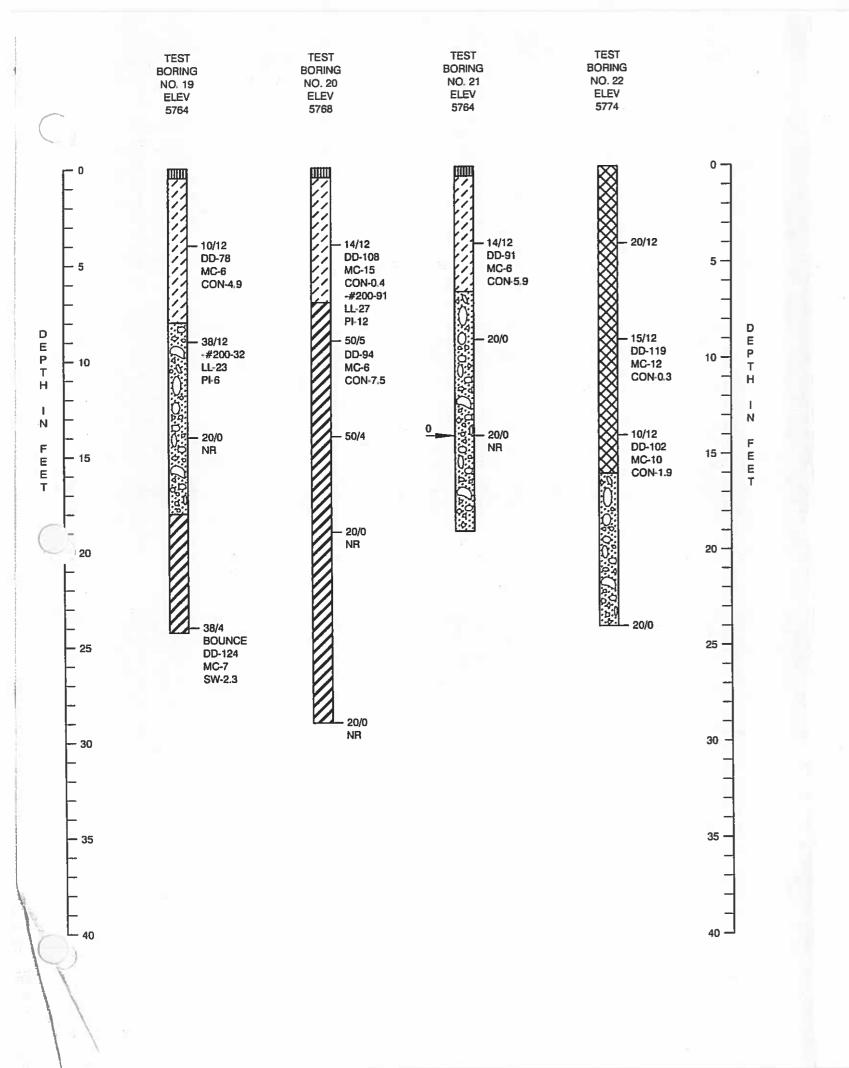
TOPSOIL, CLAY, SANDY, ORGANIC, MOIST, DARK BROWN

FILL (MAN-MADE), CLAY, COMPACT, SANDY, MOIST, MOTTLED BROWN (AF)

CLAY, STIFF TO VERY STIFF, SILTY, SANDY, WITH SCATTERED GRAVEL, CALCAREOUS, SLIGHTLY MOIST, BROWN TO RED BROWN (CL)

CLAYSTONE (BEDROCK), MEDIUM HARD, SILTY TO VERY SILTY, SLIGHTLY SANDY, WITH GYPSUM, MOIST, OLIVE

SANDSTONE (BEDROCK), VERY HARD, MODERATELY TO WELL CEMENTED, SILTY, SLIGHTLY MOIST, RED BROWN

- 1. TEST BORINGS WERE DRILLED MAY 17 & 18, 2006 WITH A 4-INCH DIAMETER, CONTINUOUS FLIGHT POWER AUGER.
- 2. NO FREE WATER WAS OBSERVED AT THE TIME OF DRILLING.
- 3. LOCATIONS OF TEST BORINGS WERE DETERMINED BY RECONNOITERING FROM FEATURES SHOWN ON THE SITE PLAN PROVIDED BY OTHERS.
- 4. ELEVATIONS ARE APPROXIMATE AND REFER TO THE TOPOGRAPHIC SITE PLAN PROVIDED BY OTHERS.
- 5. THE HORIZONTAL LINES SHOWN ON THE LOGS ARE TO DIFFERENTIATE MATERIALS AND REPRESENT THE APPROXIMATE BOUNDARIES BETWEEN MATERIALS. THE TRANSITIONS BETWEEN MATERIALS MAY BE GRADUAL
- 6. DRILL LOGS SHOWN IN THIS REPORT ARE SUBJECT TO THE LIMITATIONS, EXPLANATIONS, AND CONCLUSIONS OF THIS REPORT.

Corrosivity". The test results are summarized on Figures 2 through 5 and Table I.

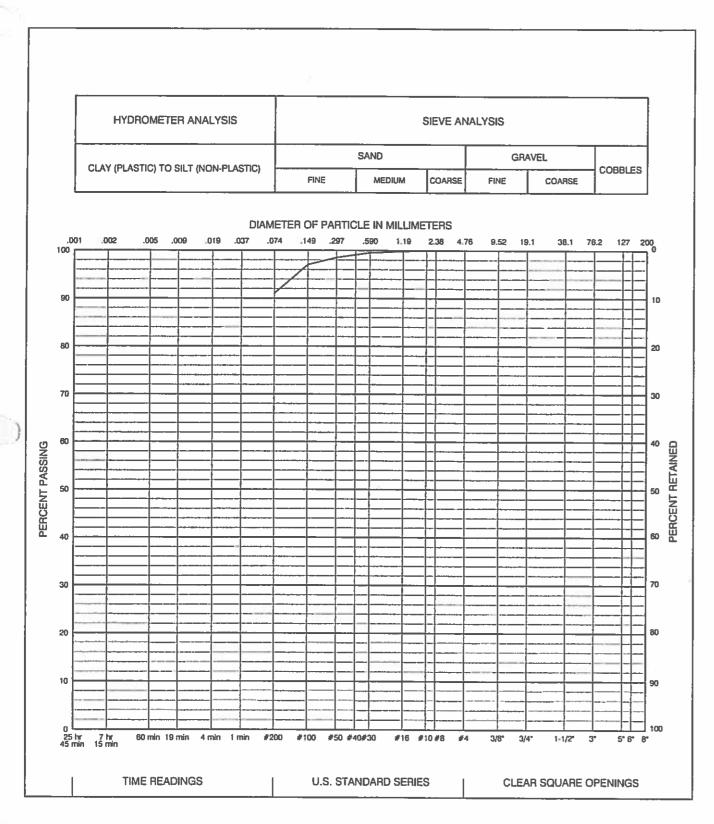
GRADATION TEST RESULTS

LOCATION	TEST BORING NO. 20 @ DEPTH OF 4'	GRAVEL	_0	%	LIQUID LIMIT	27
SAMPLE DESCRIPTION	ON <u>CLAY, SLIGHTLY SANDY (CL)</u>	SAND	9	%	PLASTICITY INDEX	12
CLASSIFICATION/	AASHTO A-6 (9)	SILT & CLAY	91	%	•

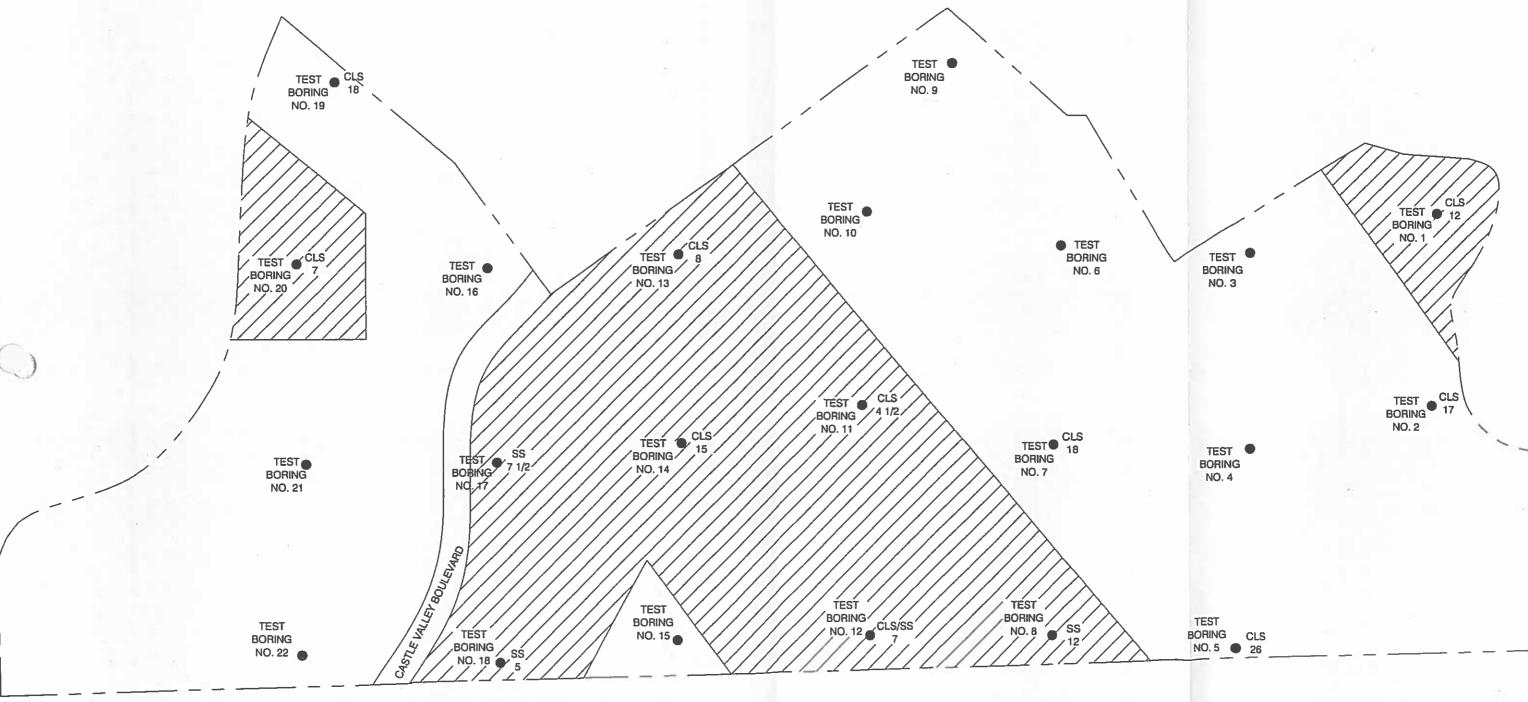
INDICATES ESTIMATED AREA WHERE BEDROCK IS LESS THAN 15 FEET BELOW THE EXISTING GROUND SURFACE

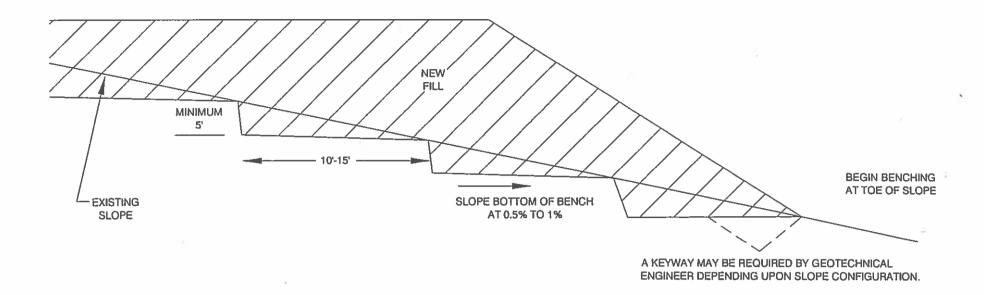
BENCHING REQUIRED WHEN EXISTING SLOPE IS 5:1 (HORITONTAL: VERTICAL) OR GREATER

NOTES: DRAINS MAY BE REQUIRED IF GROUND WATER IS ENCOUNTERED.

ADDITIONAL CUTTING BACK OF SOME SLOPES MAY BE REQUIRED BY GEOTECHNICAL ENGINEER IF SLOPE INSTABILITY IS NOTED.
