**Hazardous Material Survey Report**  
**824 4<sup>th</sup> Street, Orland, CA 95963**  
**912 3<sup>rd</sup> Street, Orland, CA 95963**

February 20, 2026

Project No. 260036001

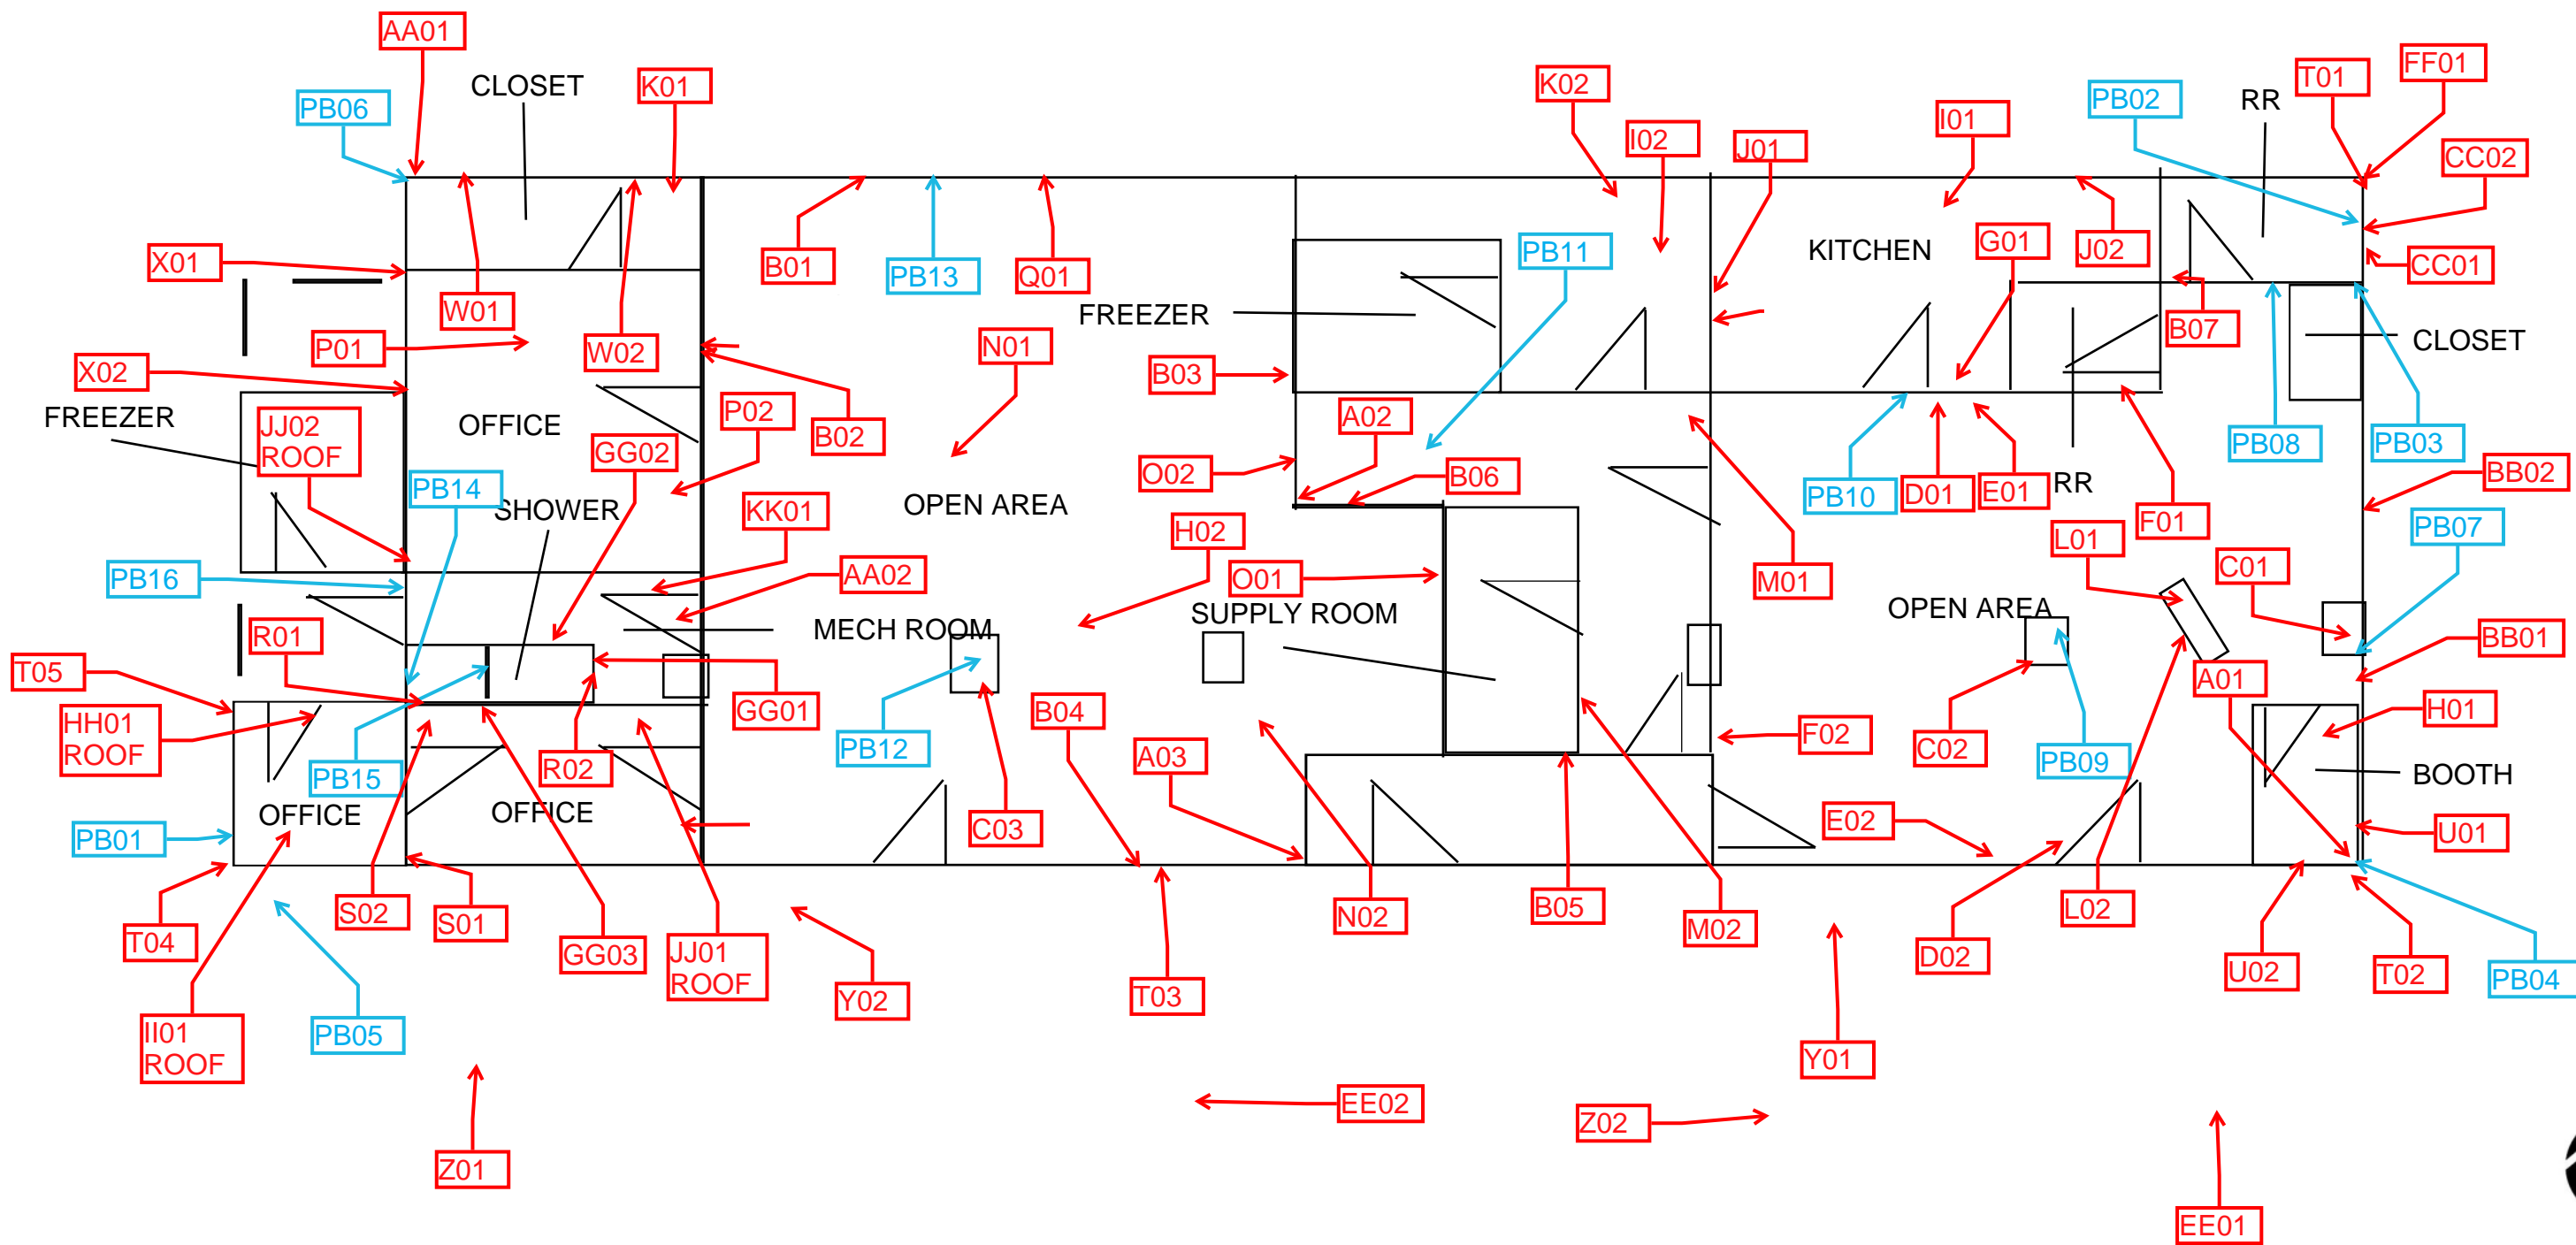
824 4<sup>TH</sup> STREET, ORLAND  
 ASBESTOS SAMPLING INVENTORY

HOMOGENEOUS ID	MATERIAL	DESCRIPTION	# OF SAMPLES
X	Sealant	Gray, Flashing	2
Y	Concrete	Gray, Walkway	2
Z	Concrete	Gray, Driveway	2
AA	Concrete	Gray, Foundation	2
BB	Sealant	White, Aluminum Window Frame	2
CC	Putty	White, Metal Windows	2
DD	Insulators	Unknown. Switch Gear	Assumed
EE	Concrete	Gray, Parking Lot Patches	2
FF	Sealant	White, Wall Seams	1
GG	Paint/Plaster	White/Gray, Walls & Ceiling	3
HH	Sealant	White, Metal Roof	1
II	Mastic	Silver & Gray, Metal Roof	1
JJ	Mastic/Felt	Gray & Black, Flashing	2
KK	Insulation	Brown, Fire Door	1

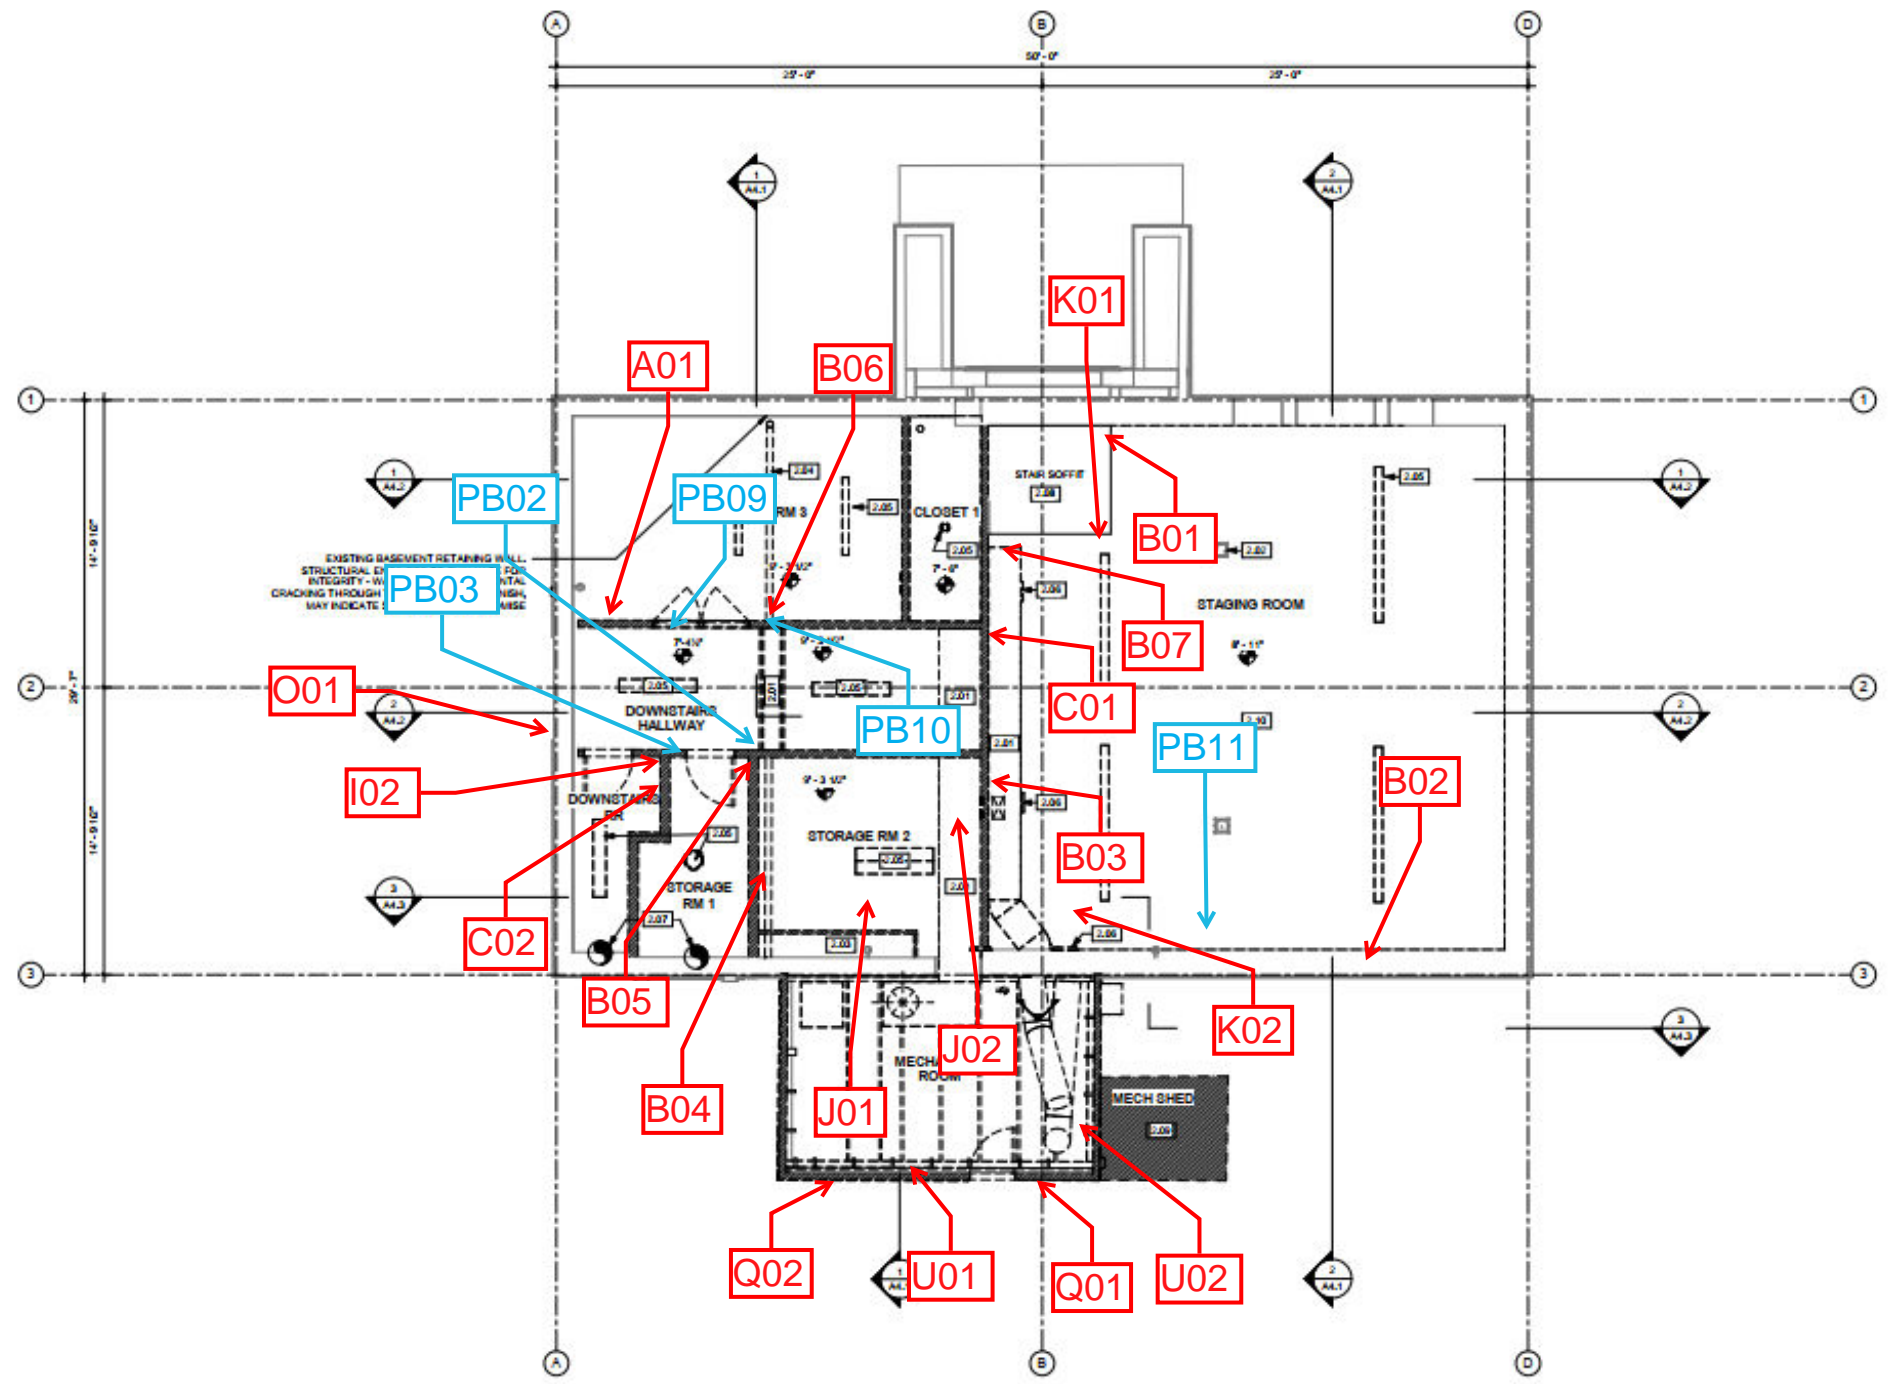
HOMOGENEOUS ID	MATERIAL	DESCRIPTION	# OF SAMPLES
A	Paint/Plaster	Beige/White	3
B	Texture Coat	White, Medium	7
C	Wallboard/Joint Compound	White/White	2
D	Vinyl Sheet Flooring/Backing	Beige, Square Pattern/Beige	2
E	Mastic	White, Sink	1
F	Vinyl Floor Tile/Mastic	12" White, Green Streaks/Yellow	2
G	Vinyl Sheet Flooring	Beige, Swirl	2
H	Basecove/Mastic	6" Beige/Yellow	2
I	Mastic	Yellow, Wainscot	2
J	Vinyl Floor Tile/Mastic	9" Beige/Yellow	2
K	Acoustical Ceiling Tile	12" White, Uniform Hole	2
L	Paint/Stucco	Red/Gray, Exterior	3
M	Brick/Mortar	Tan/Tan	2
N	Stone/Mortar	Red/Gray	2
O	Sealant	White, Door Frame (Basement)	1
P	Paint/Putty	Brown/White, Wood Windows	2
Q	Faux Brick/Mortar	Tan/Off-White	2
R	Patch	Gray, Stucco	2
S	Concrete	Gray, Walkway	2
T	Sealant	Gray, Store Front	1
U	Vapor Barrier	Black, Wall	2
V	Insulation	White, Blown-In	3
W	Patch	White, Brick Walls	1
X	Mastic	Yellow, Carpet	2
Y	Concrete	Gray, Foundation	2
Z	Basecove/Mastic	2" Brown/Beige	1

AA	Roofing	Gray & Black, Built-Up	2
BB	Mastic	Gray & Black, Roof	2
