# **PALMER LAKE FEASIBILITY STUDY**

for development of a Public Safety Facility

**Architvity**

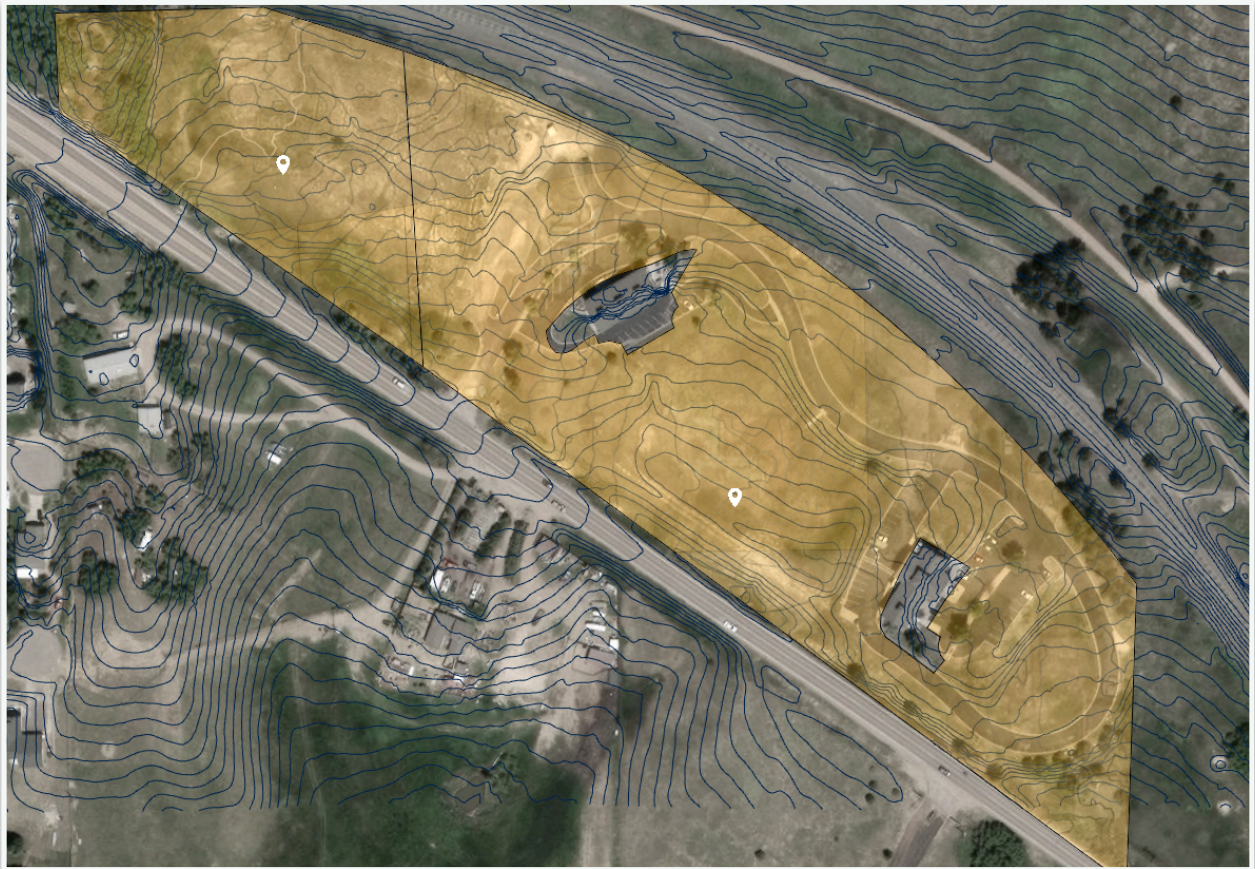
Diagram 2B: Santa Fe Ridge Topography

- Topography [refer to diagram 2B] on Tract A is sharply sloping from the north to the south, and then generally flat with a defined lower depression for drainage catchment. There are drainage swales and rip-rap entering from the north, west, and east sides which direct water from adjacent Lots within the development.

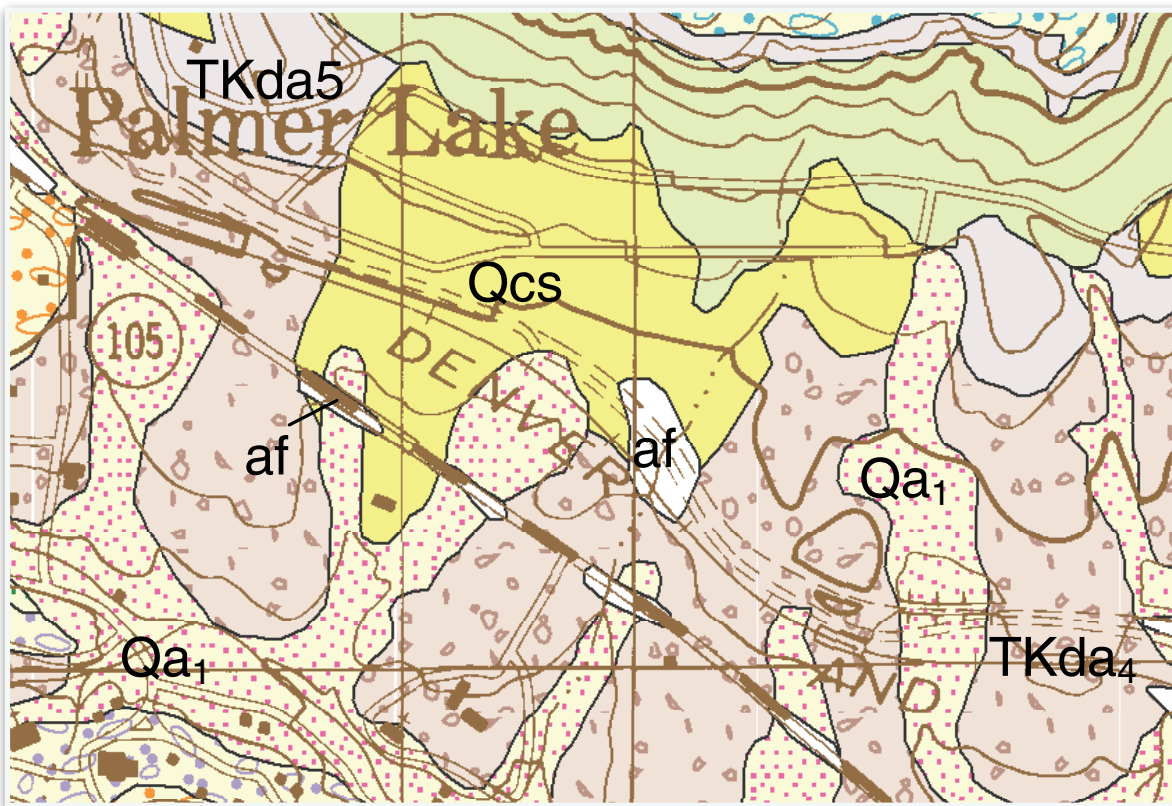
Diagram 2C: portion of Colorado Geological Survey Map - Palmer Lake - SantaFe Ridge Site

- Geology: Data reviewed from the Colorado Geological Survey Map for the Palmer Lake Quadrangle indicates the Santa Fe Ridge Site is located within a geological area that may not be generally suitable for building construction without a geotechnical investigation and report provided by a geotechnical engineer. The engineer will determine requirements for foundations, which may include over excavation, soil amendment and/or deeper foundations. This would likely apply to any Lot within the Santa Fe Ridge development. Geology found within the limits of the Santa Fe Ridge location: TKda<sub>4</sub>, Qcs, Qa<sub>1</sub> [Refer to diagram 2C and Overall Map and Legend found in Appendix A & B].

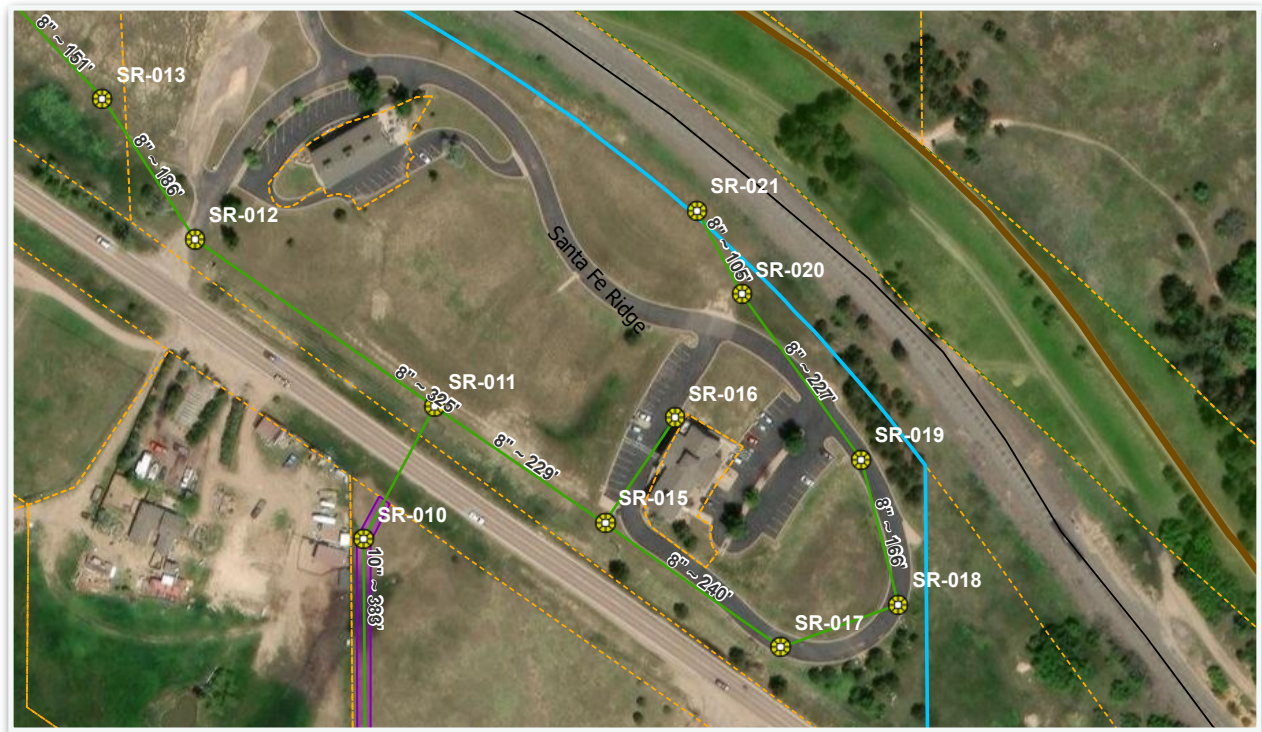
Diagram 2.5b: Wastewater Service Lines - Santa Fe Ridge

- The existing wastewater (sewer) line is an 8-inch diameter pipe, running along the southern Tract A property line, parallel to Highway 105, with a manhole roughly in the center. [refer to Diagram 2.5b]

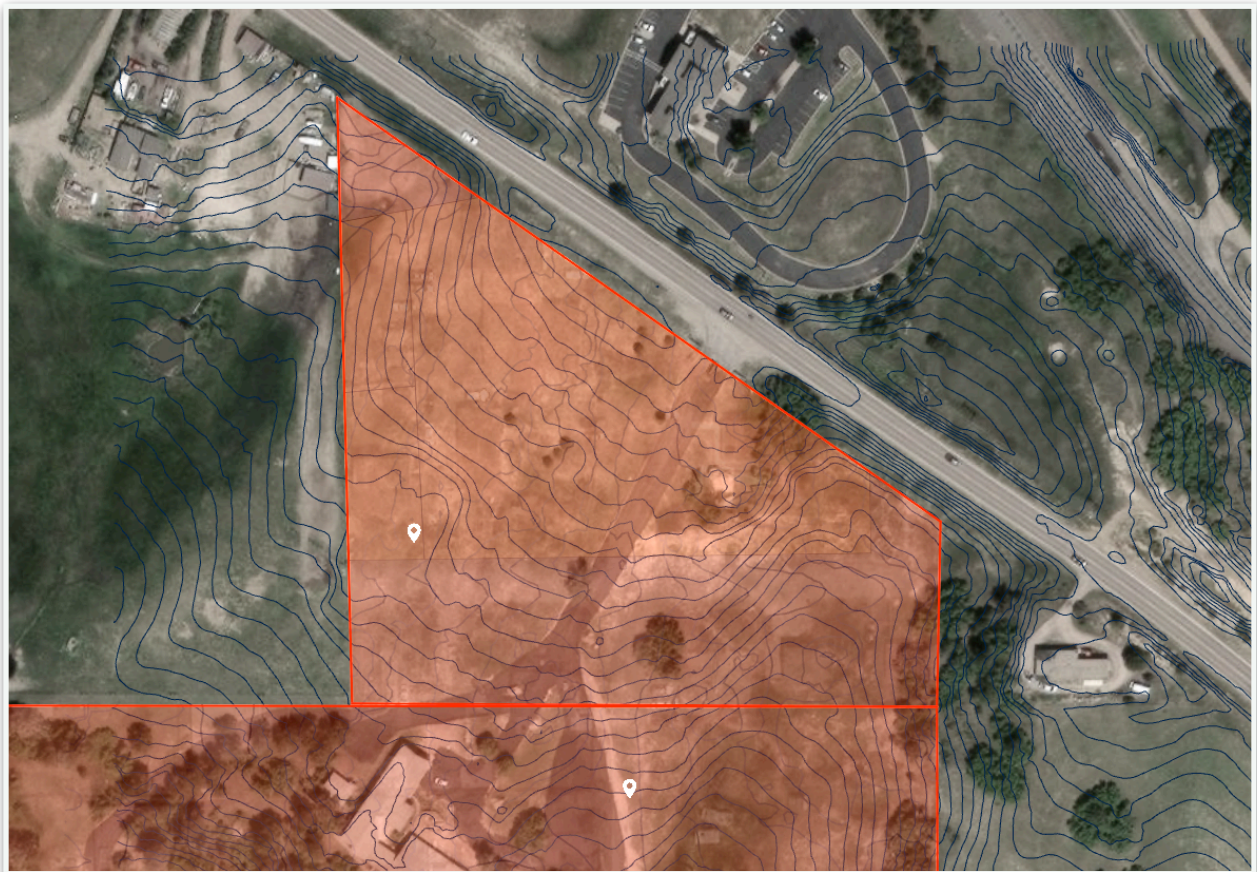
Diagram 3B: Topography for Elephant Rock Site.

- Topography [*refer to diagram 3B*] The Elephant Rock site is gently sloping land that is highest at the north and sloping gradually toward the southwest. The north 1/3 of the 6 acre parcel has steep sloping land forming a drainage to the southwest. The buildable area may be limited to approximately 4 acres of the overall 6-acre parcel based on topography and setback requirements, see below.

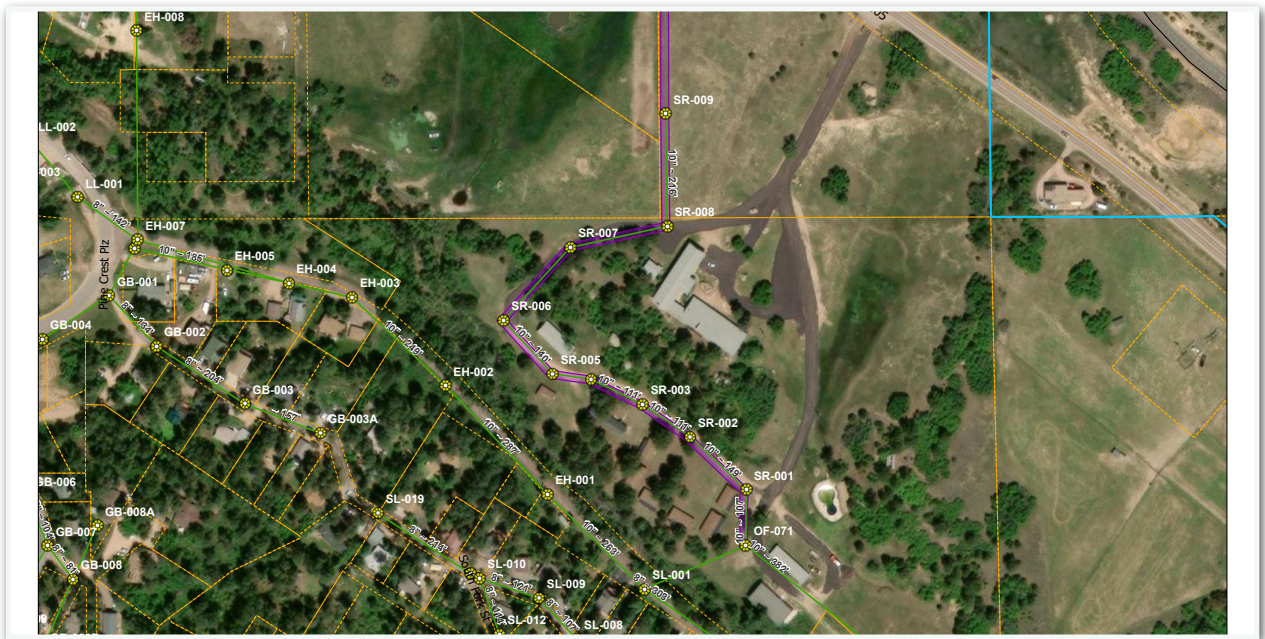
Diagram 3.5b - Wastewater Service Lines - Elephant Rock

- The existing wastewater (sewer) line is a 10-inch diameter pipe, and runs along the western property line toward the south. There are several manholes along the line through the site. There is no sewer line along the south side of Highway 105 at this location. (Refer to Diagram 3.5b)

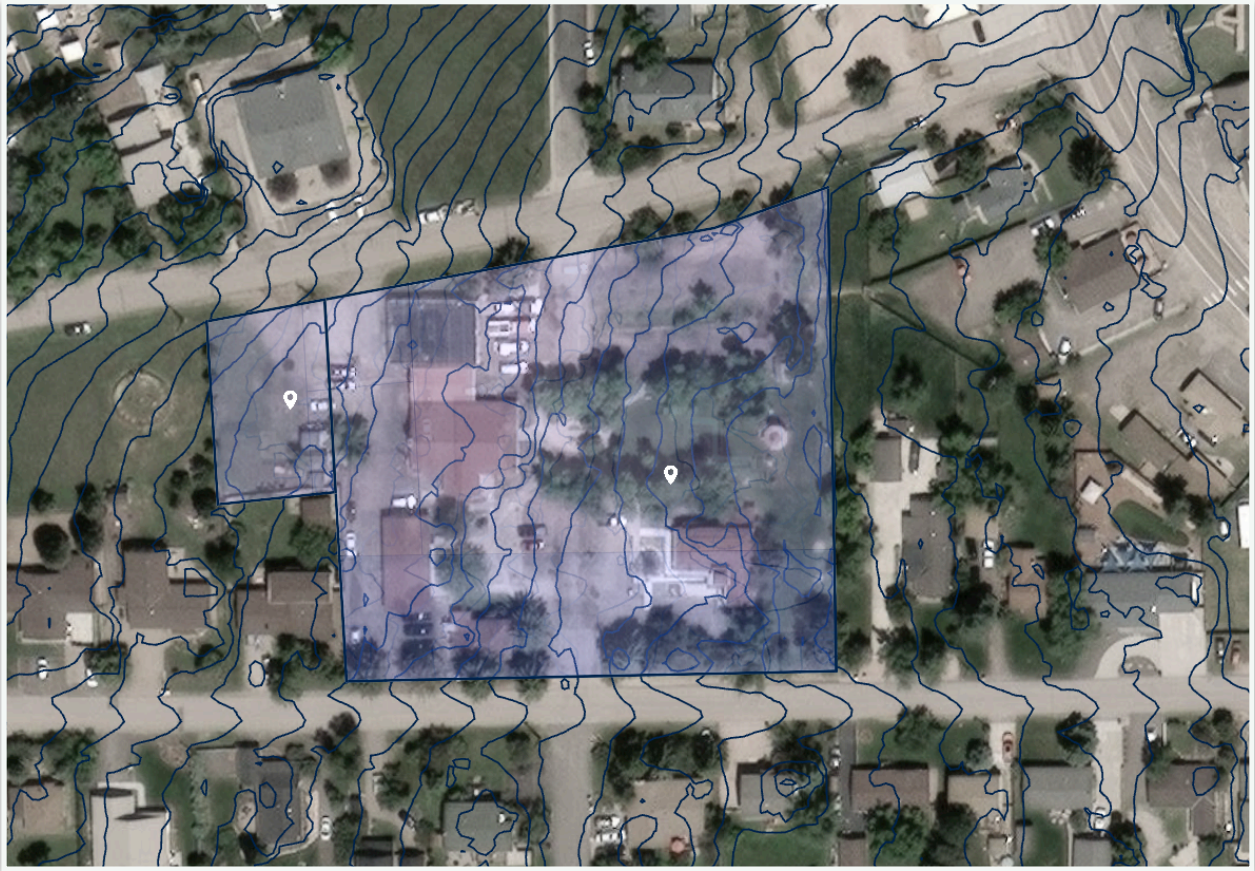
Diagram 4B: Topography for Valley Crescent Site

- Topography [*refer to diagram 4B*] The Valley Crescent site is perceptibly flat land, though sloping to the east, with contours running north - south across the site. The elevation is higher on the west, gently dropping to low on the east.

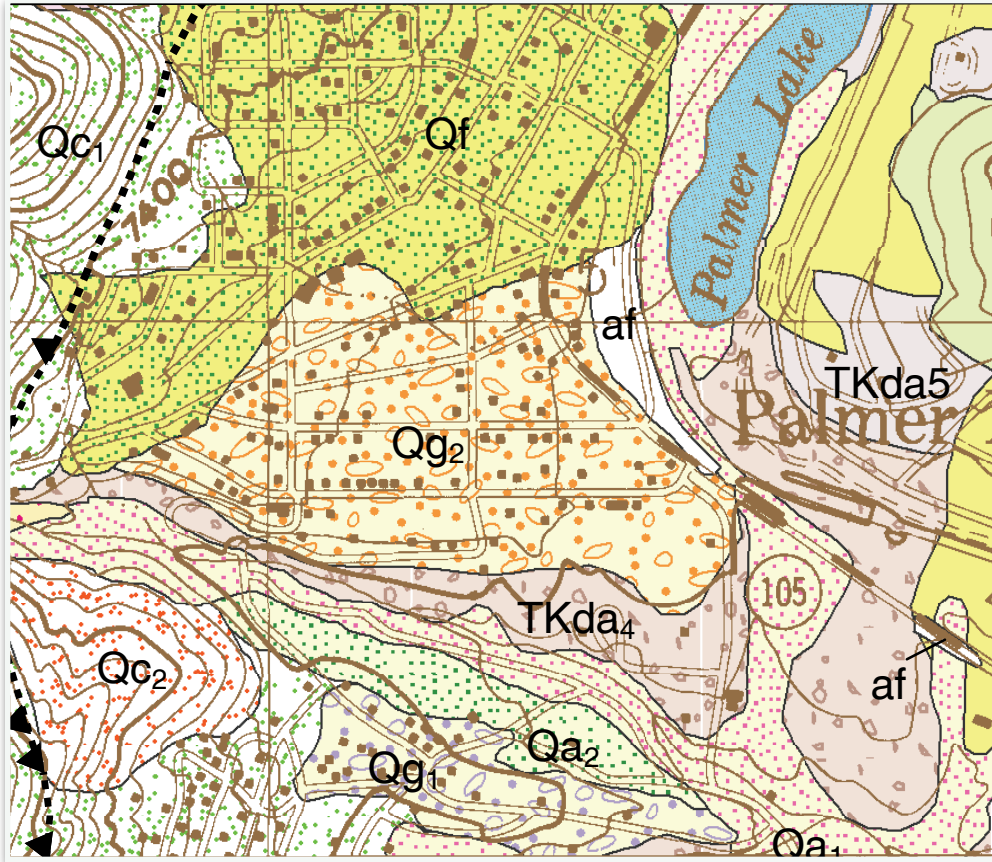
Diagram 4C: Portion of Colorado Geologic Survey Map - Palmer Lake - Valley Crescent Site

- Geology: Data reviewed from the Colorado Geological Survey Map for the Palmer Lake Quadrangle indicates the Valley Crescent Site is located within a geological area that appears to be generally suitable for building construction. A geotechnical investigation and report provided by a geotechnical engineer will be necessary to determine requirements for foundations. The site appears to be within a Gravel Deposit soil area. Geotechnical test borings will be required prior to building design. [*refer to diagram 4C*]

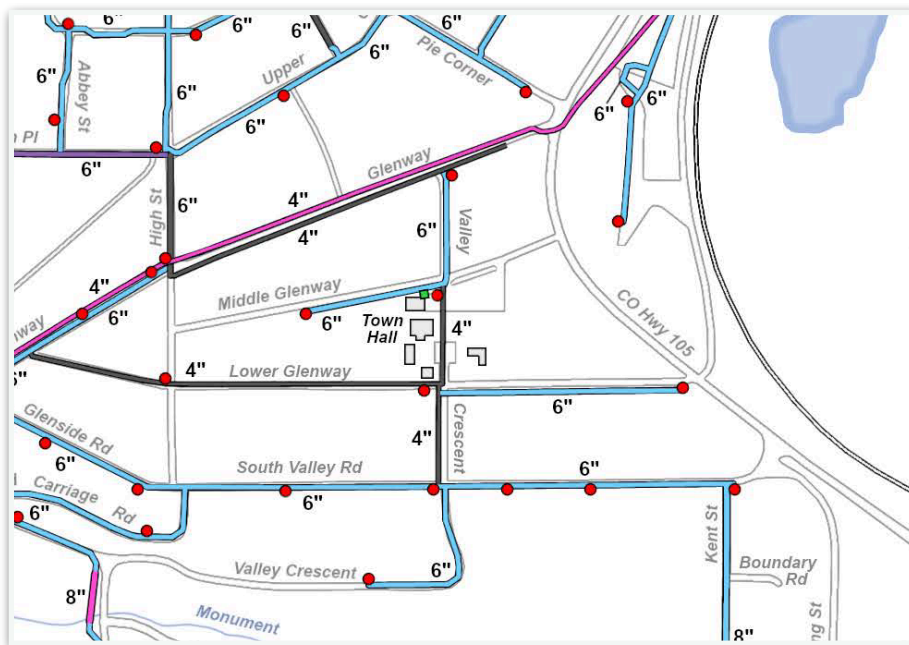
Diagram 4.5a: Water Service Lines - Valley Crescent

- Availability of Public Utilities:
  - Water service is provided to the Valley Crescent Site by a 4-inch cast iron service line running within Valley Crescent St through the center on the plane, and a 6" PVC line that runs along the south side of Middle Glenway St. There are two fire hydrants nearby, located at the corners of Valley Crescent St. There is a Raw Water hydrant located

- adjacent to the existing Fire Station. [*refer to Diagram 4.5a*]
- The existing wastewater (sewer) line is an 8-inch diameter pipe, and runs along the eastern side of Valley Crescent St toward the south, through the site from Middle Glenway to Lower Glenway St. There is a manhole in the dirt parking lot on the north of the site. [*refer to diagram 4.5b: Sewer lines are represented in green*]
- Electrical service is provided by Core, and is supplied by overhead power lines with 3-phase power that comes from lines along the north, east, south and west perimeter of the site and enters the site near the

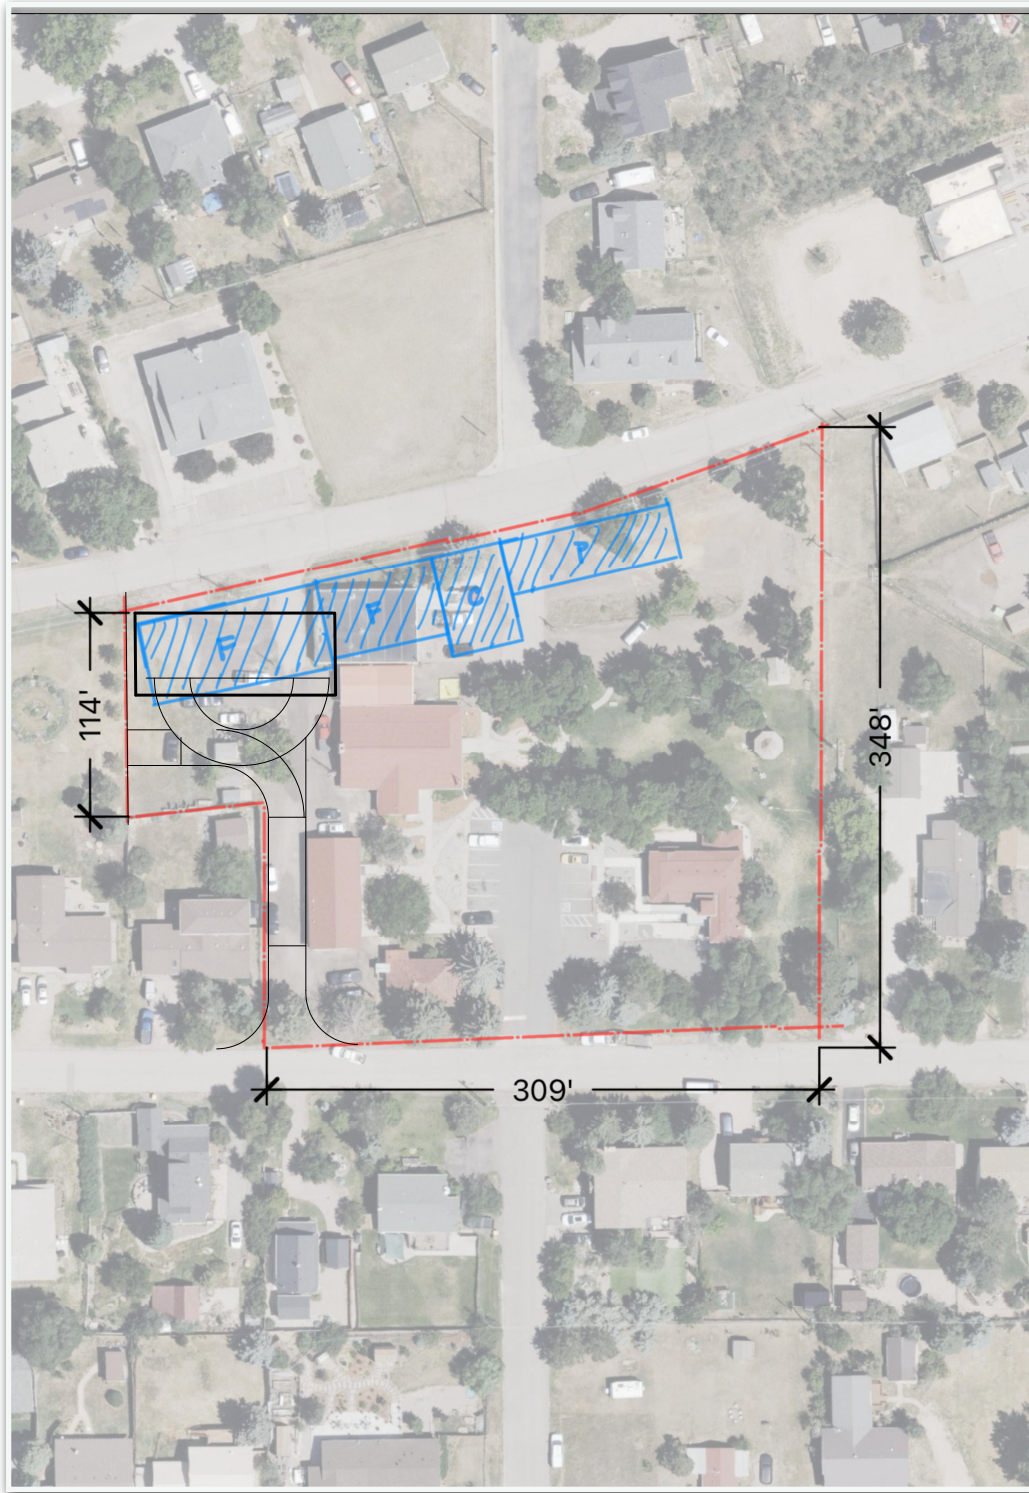
Valley Crescent Site Diagram with Fire Equipment Turning Radii

Fire Truck Turning Radii for 3 potential Sites

- Existing Emergency Service Vehicles in-use by the Town of Palmer Lake:
  - Engine (2011) Height 9.5ft Length 29.7ft, Turning Radii:
    - Curb-to-curb: 40 feet, 11 inches

- Wall-to-wall: 47 feet, 0 inches
    - Inside Turn: 25 feet, 1 inch
  - Engine (2015) Height 9.5ft Length 29.3ft, Turning Radii:
    - Curb-to-curb: 39 feet, 9 inches

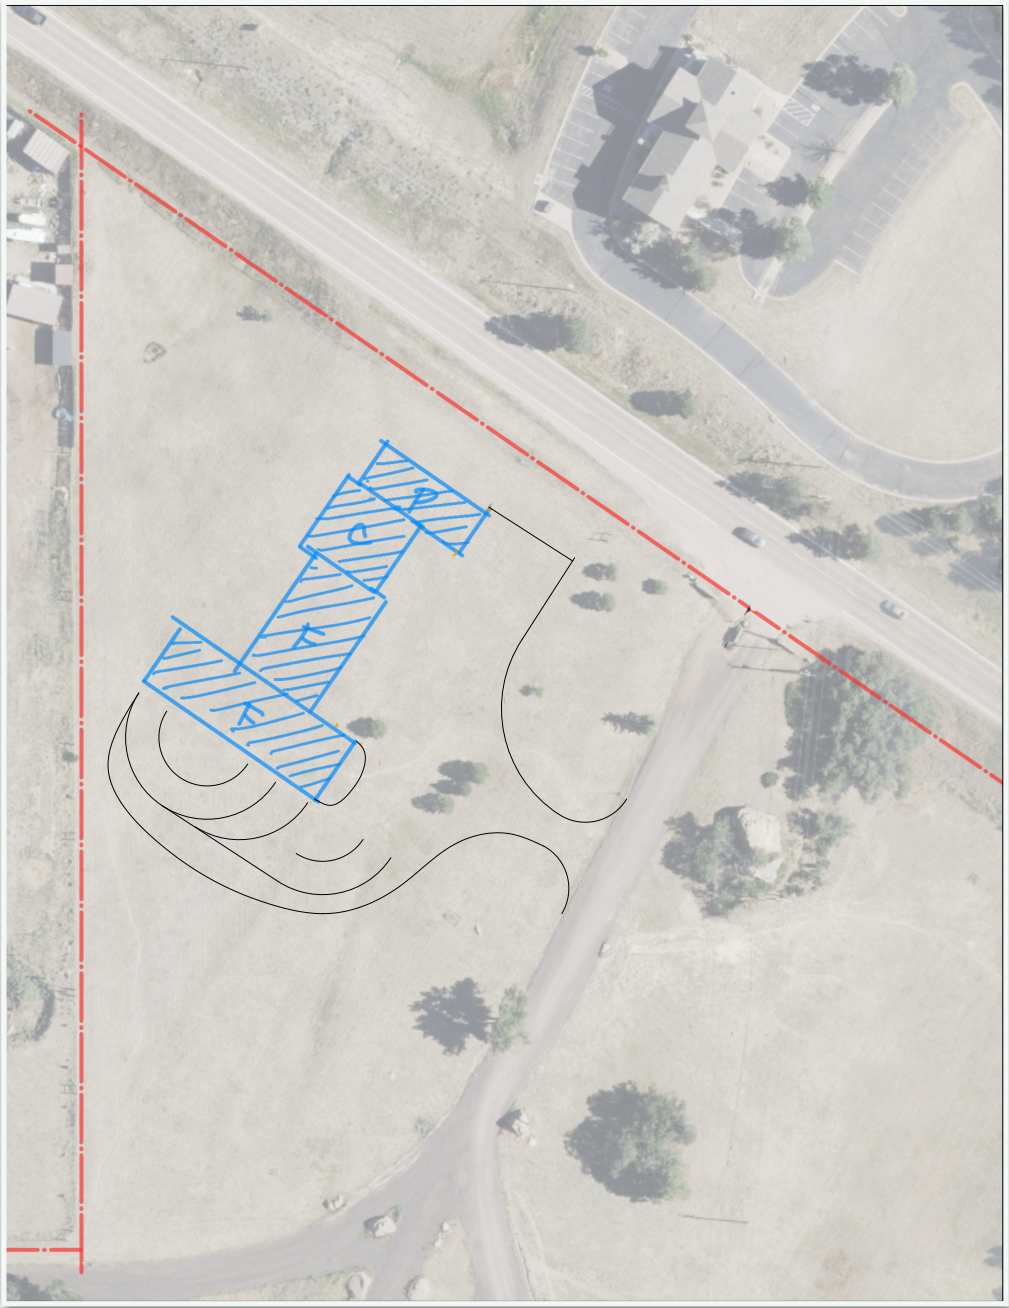
**Appendix F-3**

Elephant Rock Site Diagram with Fire Equipment Turning Radii

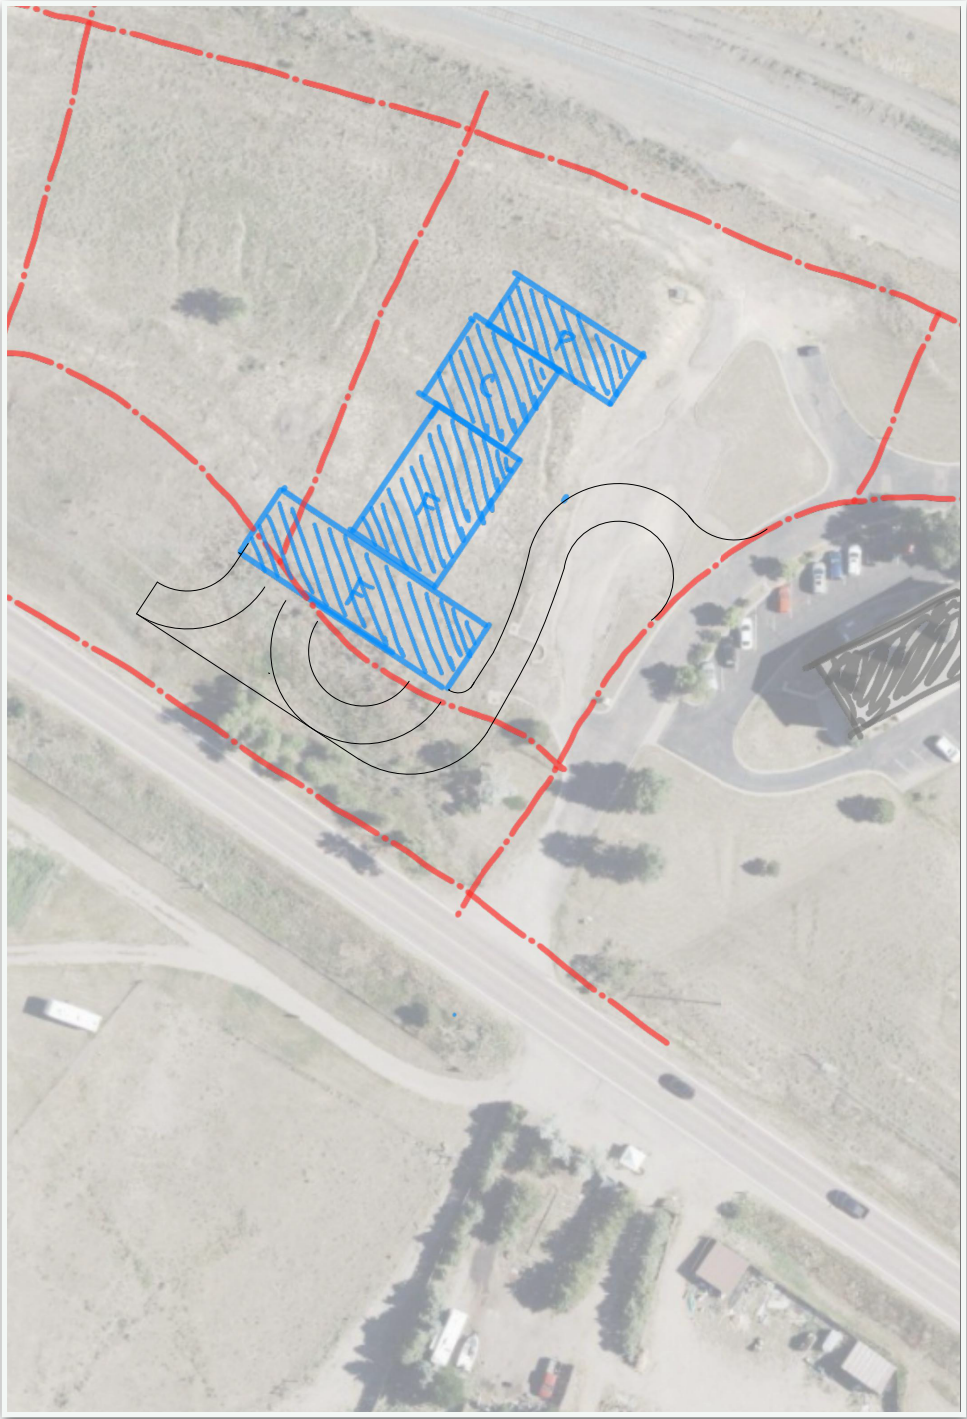
Santa Fe Ridge Site Diagram with Fire Equipment Turning Radii
