## SOILS AND GEOLOGY STUDY

**Elephant Rock Villas  
Lot 2, Rancho Iraceme Sub, Filing No. 2  
Town of Palmer Lake, El Paso County, Colorado**

**JOB NO. 190736**

**October 21, 2022  
Amended January 4, 2023**

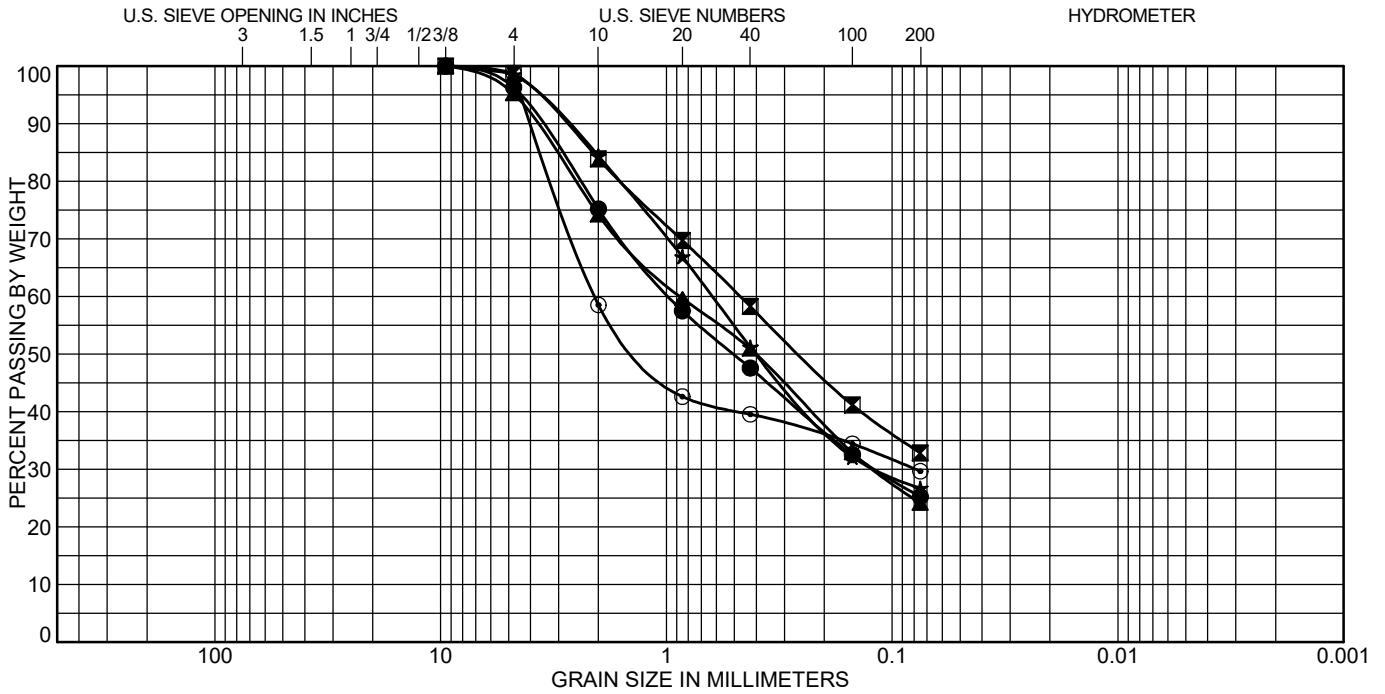
FIGURE No. 7

COBBLES	GRAVEL		SAND			SILT OR CLAY
	coarse	fine	coarse	medium	fine

Test Boring	Depth (ft)	Classification	LL	PL	PI
● 1	4.0	CLAYEY SAND(SC)	32	17	15
☒ 2	7.0	CLAYEY SAND(SC)	27	13	14
▲ 2	24.0				
★ 3	9.0	CLAYEY SAND(SC)	28	13	15
◎ 3	24.0	CLAYEY SAND(SC)	31	10	21

Soil laboratory testing was performed as part of this investigation. The laboratory tests included moisture content, grain-size analyses, and Atterberg Limit tests. A Summary of Laboratory Test Results is presented in Figure 6. Soils Classification Data is presented in Figures 7 and 8.

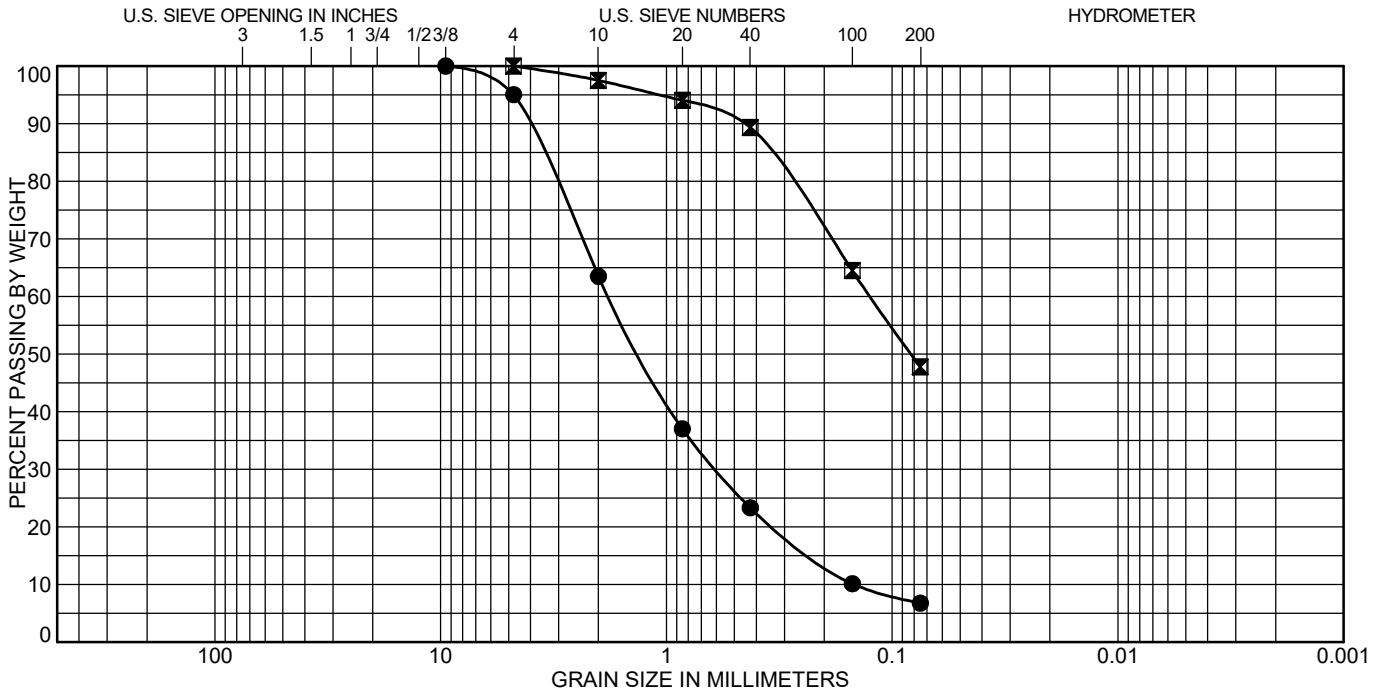
FIGURE No. 8

COBBLES	GRAVEL		SAND			SILT OR CLAY
	coarse	fine	coarse	medium	fine

Test Boring	Depth (ft)	Classification	LL	PL	PI
● 4	2.0	WELL-GRADED SAND with SILT(SW-SM)	NP	NP	NP
☒ 4	19.0	CLAYEY SAND(SC)	30	16	14

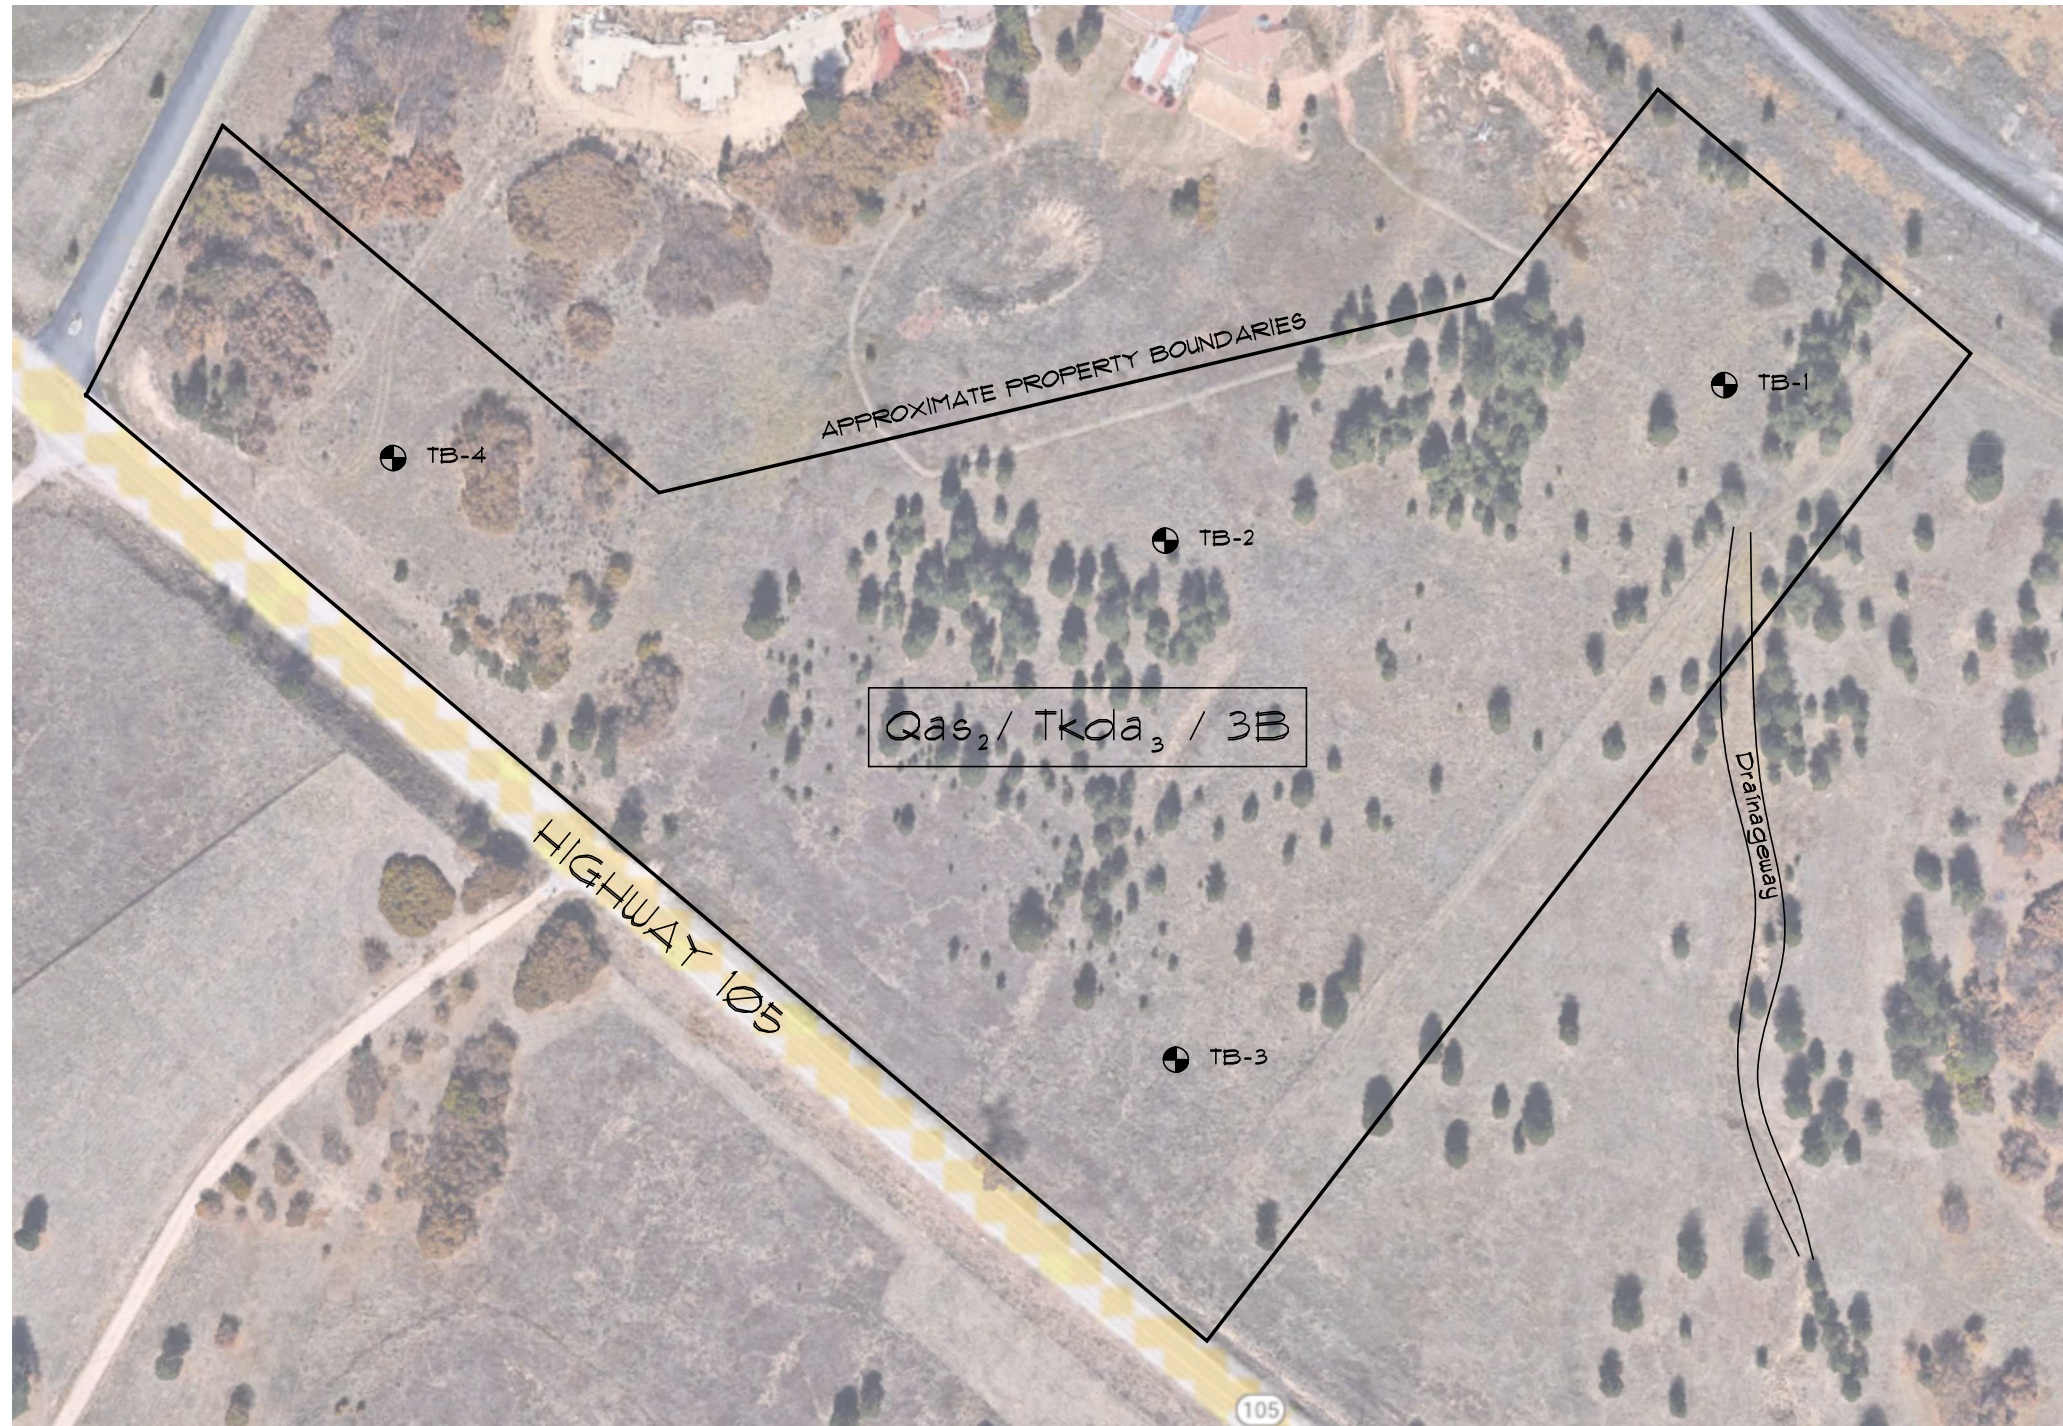
SHEET No. FIG-11

**General Geology**

*Qas<sub>2</sub>* - Middle alluvium-slope deposits (middle Paleocene) - The unit is comprised of sheetwash and stream-deposited alluvium that spans a broad range of time and includes deposits of more than one age. Estimated thickness is approximately 5 to 40 feet. The alluvium was encountered in our test borings to depths ranging between 7 to 12 feet.

ENGINEERING GEOLOGY MAP

Based on our field observations and review of relevant geologic maps, we identified the geologic conditions (listed below) affecting the development, as shown on the Engineering Geology Map, Figure 11.
