State of Wisconsin
DEPARTMENT OF NATURAL
RESOURCES
FITCHBURG SERVICE CENTER
3911 FISH HATCHERY RD
FITCHBURG WI 53711

FILE REF:
PWS ID#: 12500873
Ridgeway Waterworks-MC
Iowa County

Subject: Sanitary Survey Report and Notice of Noncompliance

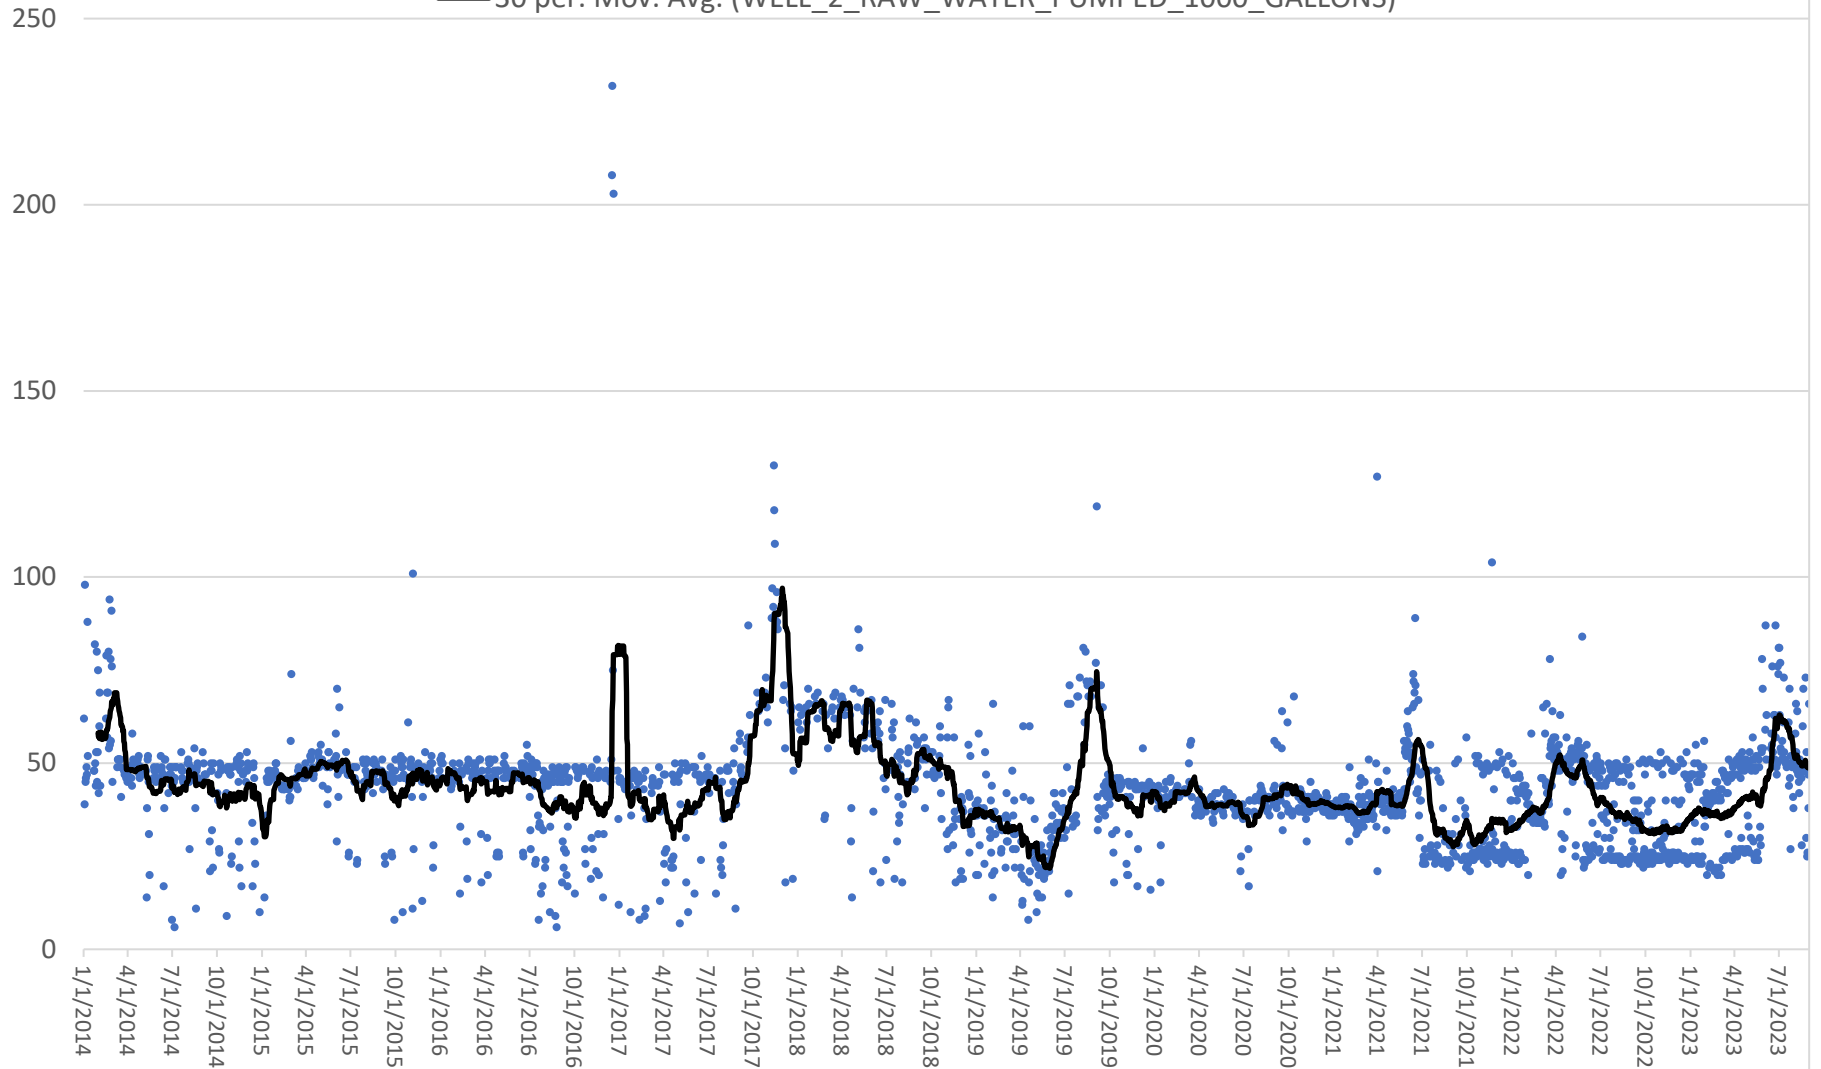
• WELL_2_RAW_WATER_PUMPED_1000_GALLONS

— 30 per. Mov. Avg. (WELL_2_RAW_WATER_PUMPED_1000_GALLONS)

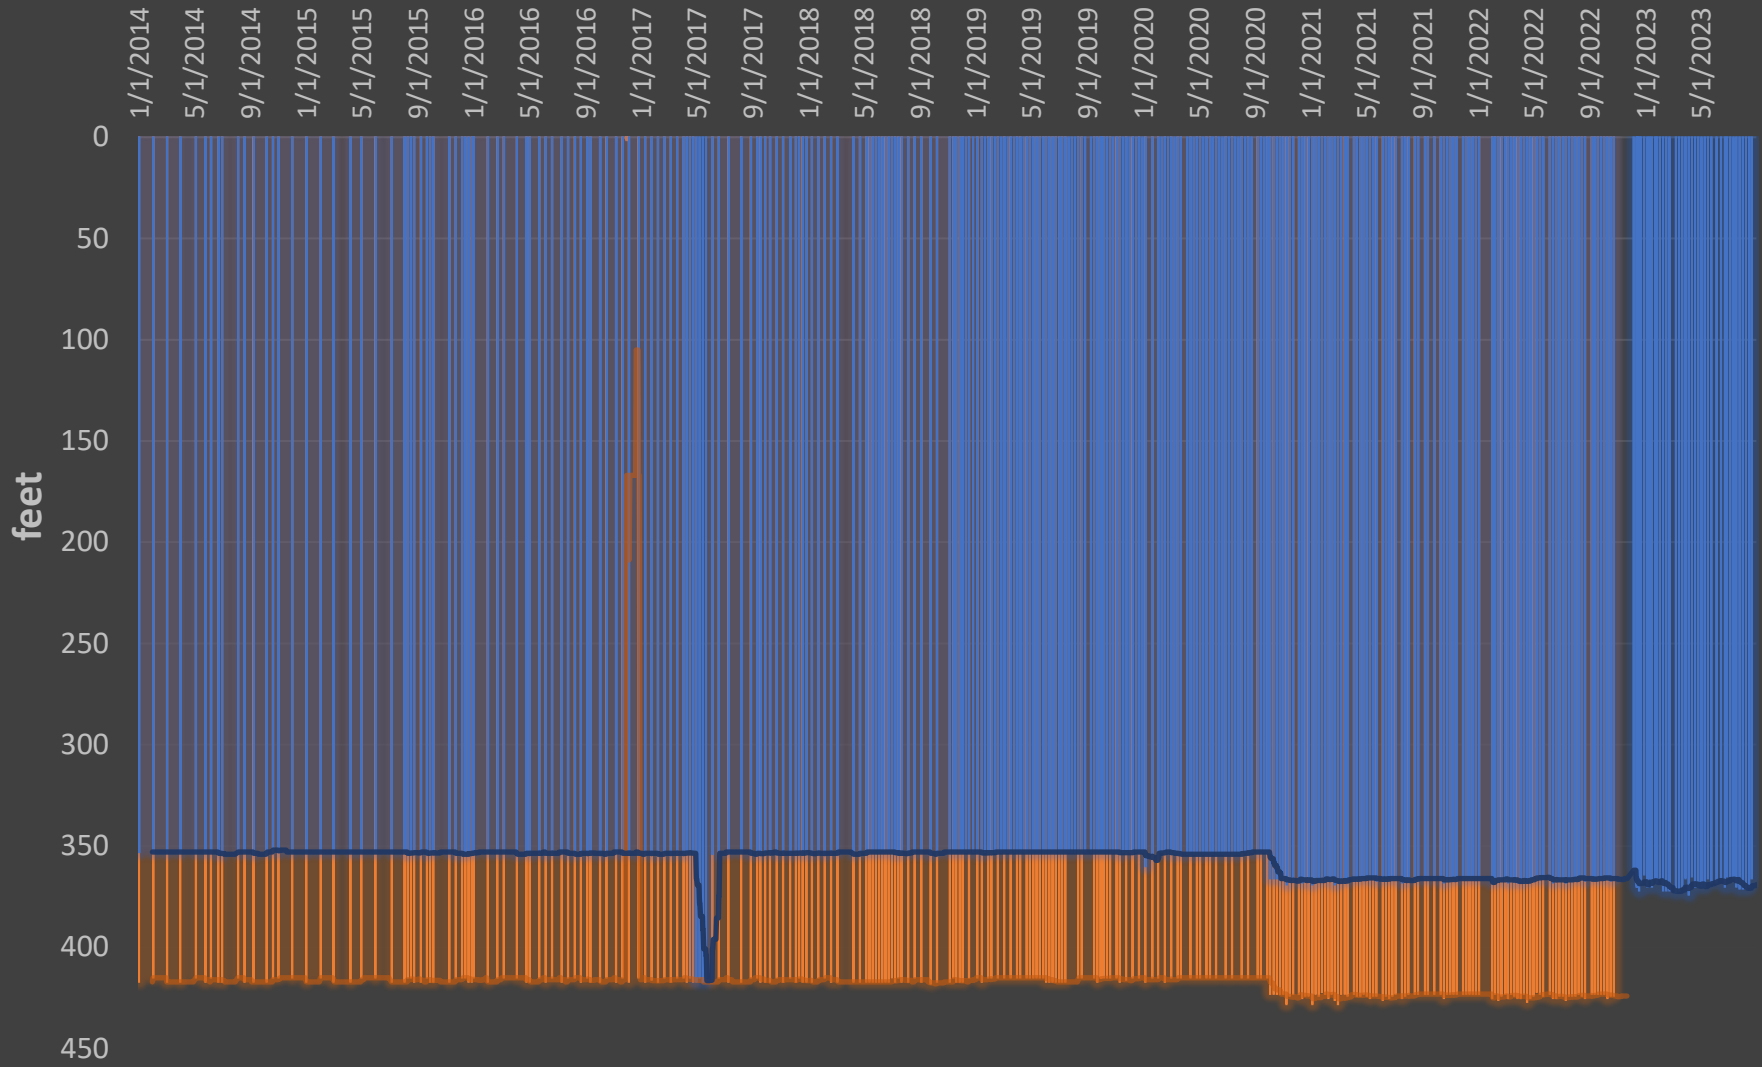
Well 2 Pumping and Static Levels

□ WELL_2_WELL_WATER_LEVELS_PUMPING_WATER_LEVEL_FEET

□ WELL_2_WELL_WATER_LEVELS_STATIC_WATER_LEVEL_FEET

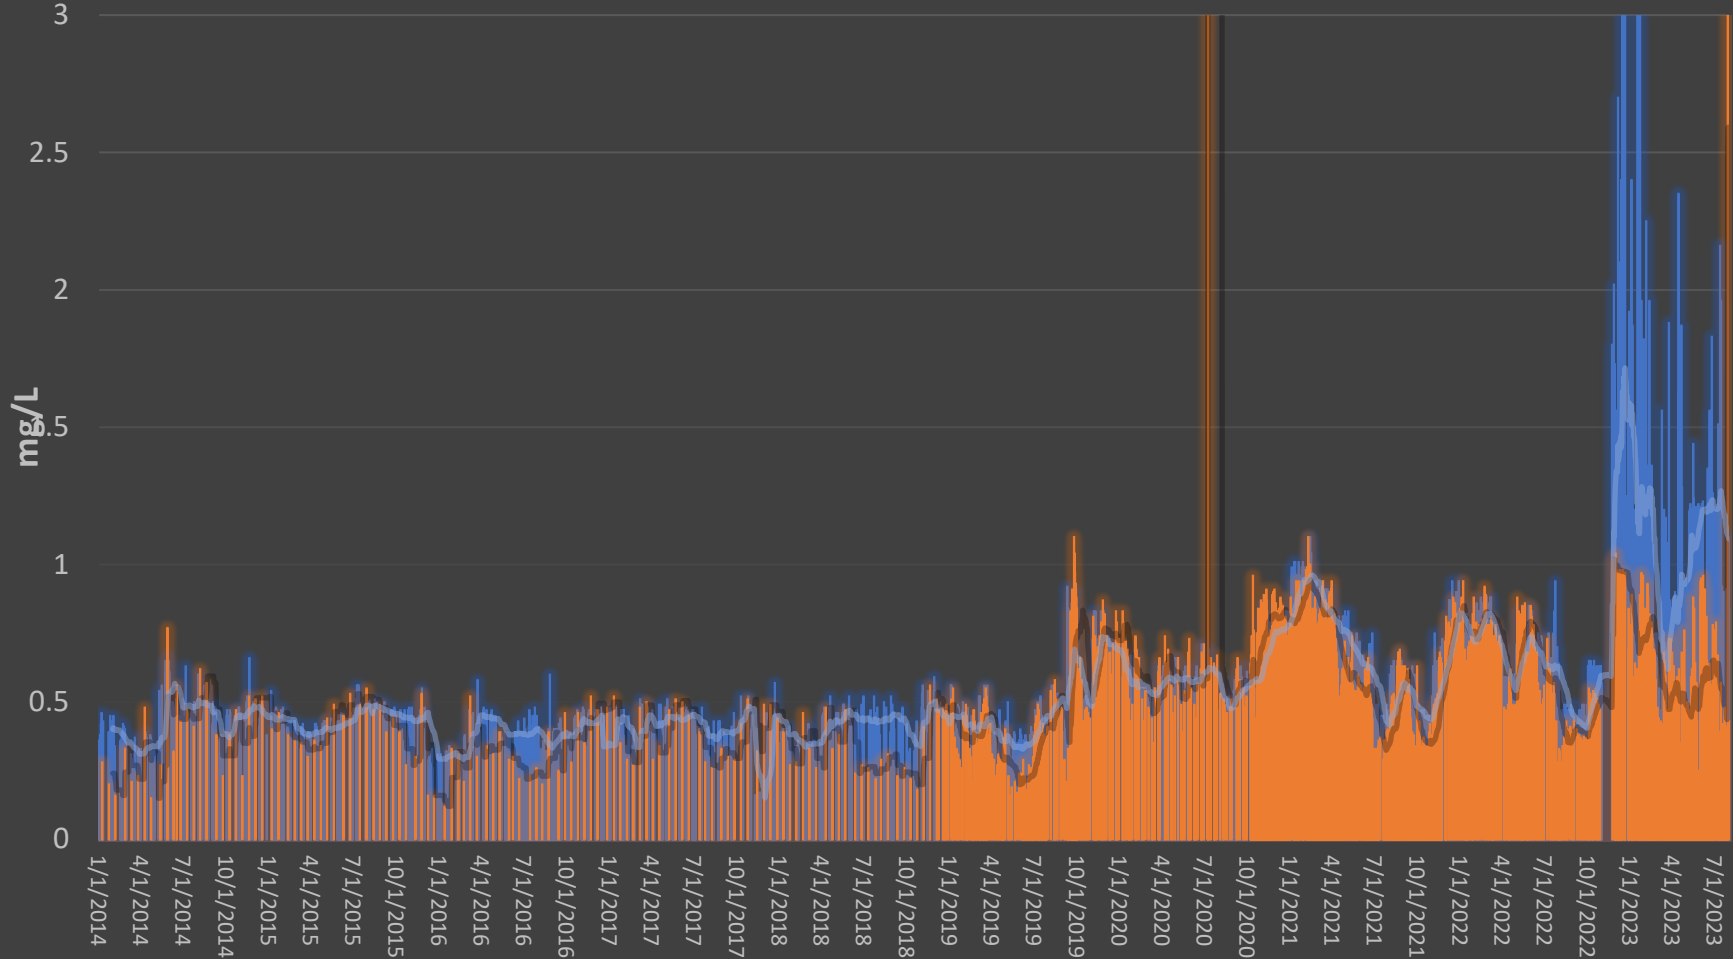
Well 2 Calculated vs. Residual Chlorine dose

- WELL_2_CHLORINE_CALCULATED_DOSE_MGL
- System Operational Area, Free Chlorine Residual

Trendlines are 30 day moving averages

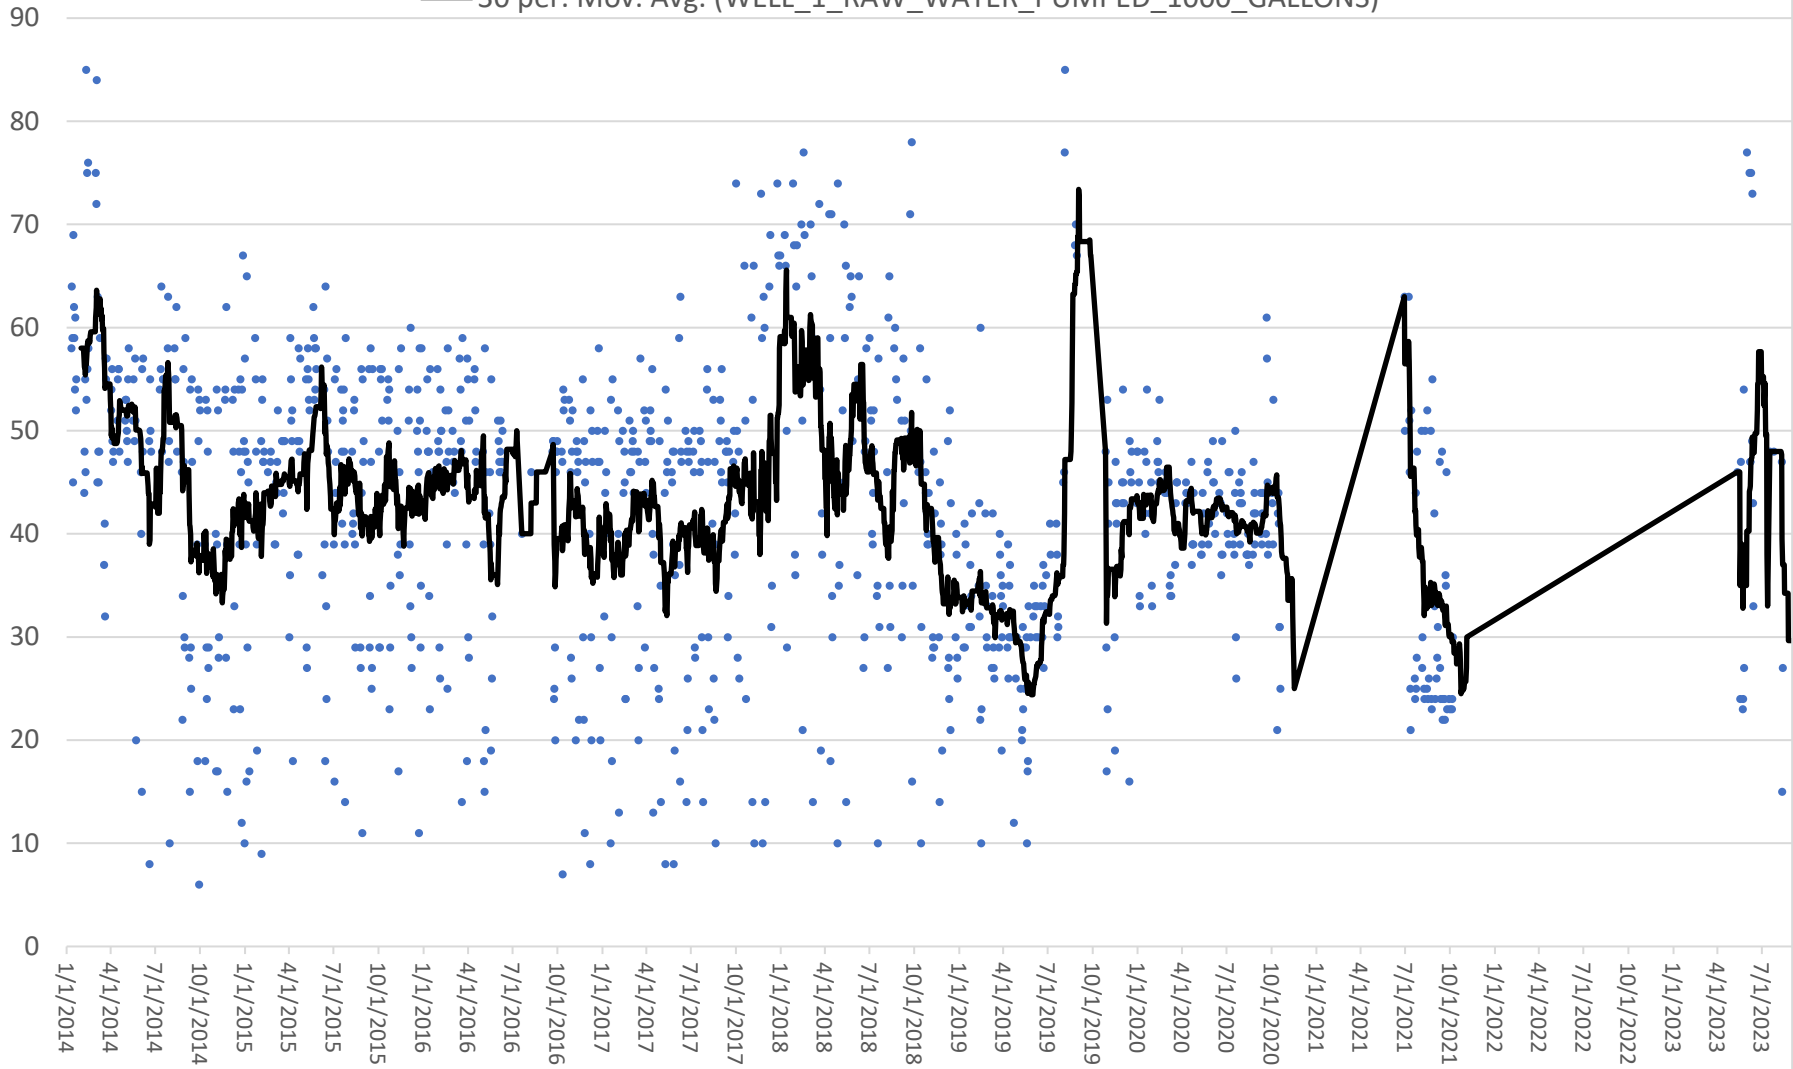
WELL_1_RAW_WATER_PUMPED_1000_GALLONS

• WELL_1_RAW_WATER_PUMPED_1000_GALLONS

— 30 per. Mov. Avg. (WELL_1_RAW_WATER_PUMPED_1000_GALLONS)

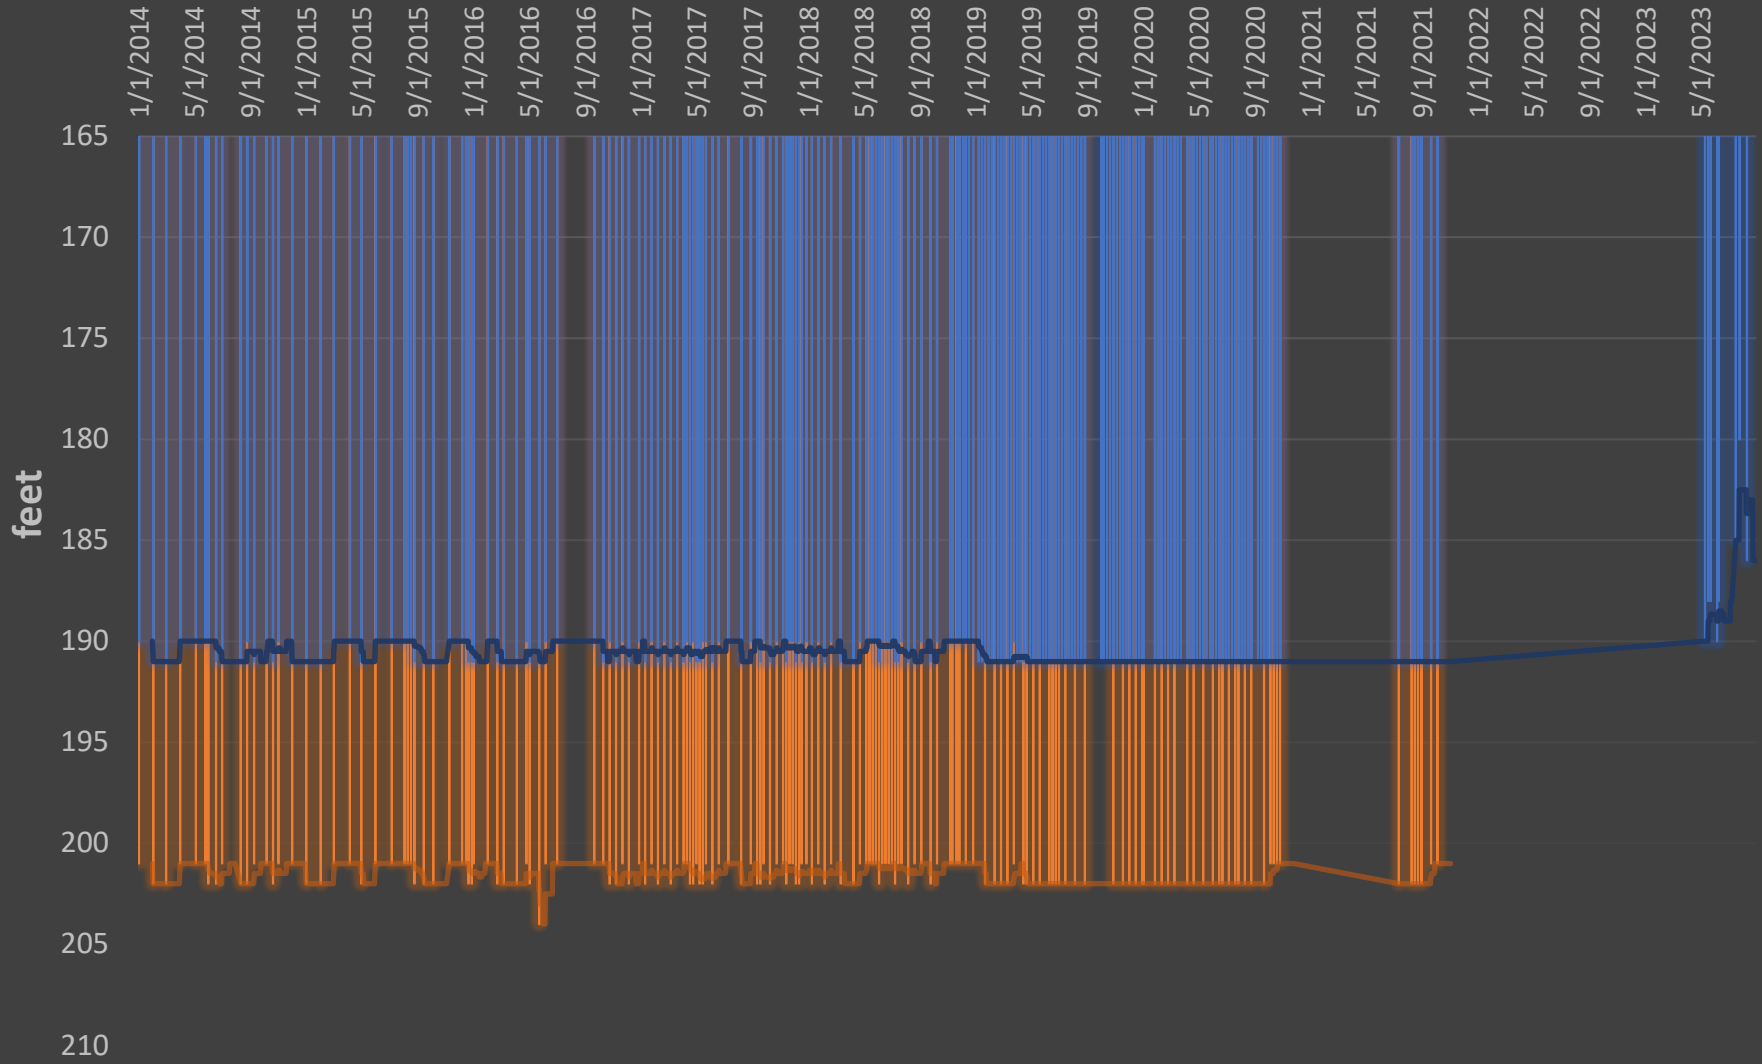
Well 1 Pumping and Static Levels

- WELL_1_WELL_WATER_LEVELS_PUMPING_WATER_LEVEL_FEET
- WELL_1_WELL_WATER_LEVELS_STATIC_WATER_LEVEL_FEET

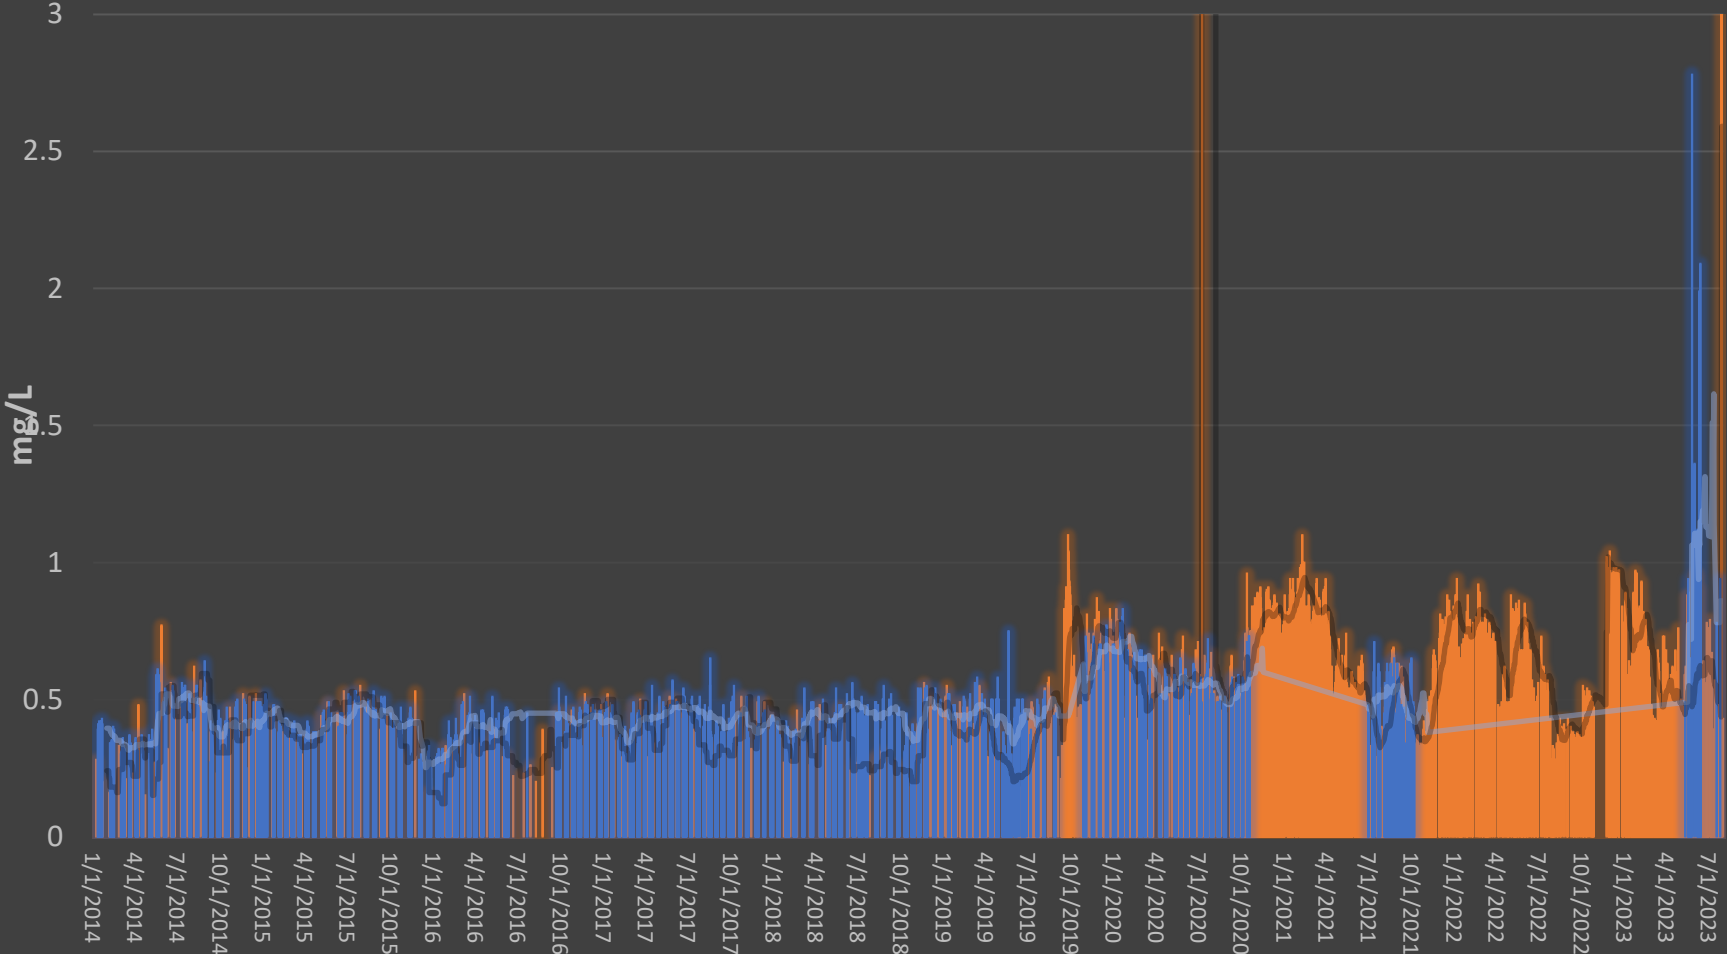
Well 1 Calculated vs. Residual Chlorine dose

- System Operational Area, Free Chlorine Residual
- WELL_1_CHLORINE_CALCULATED_DOSE_MGL

Trendlines are 30 day moving averages

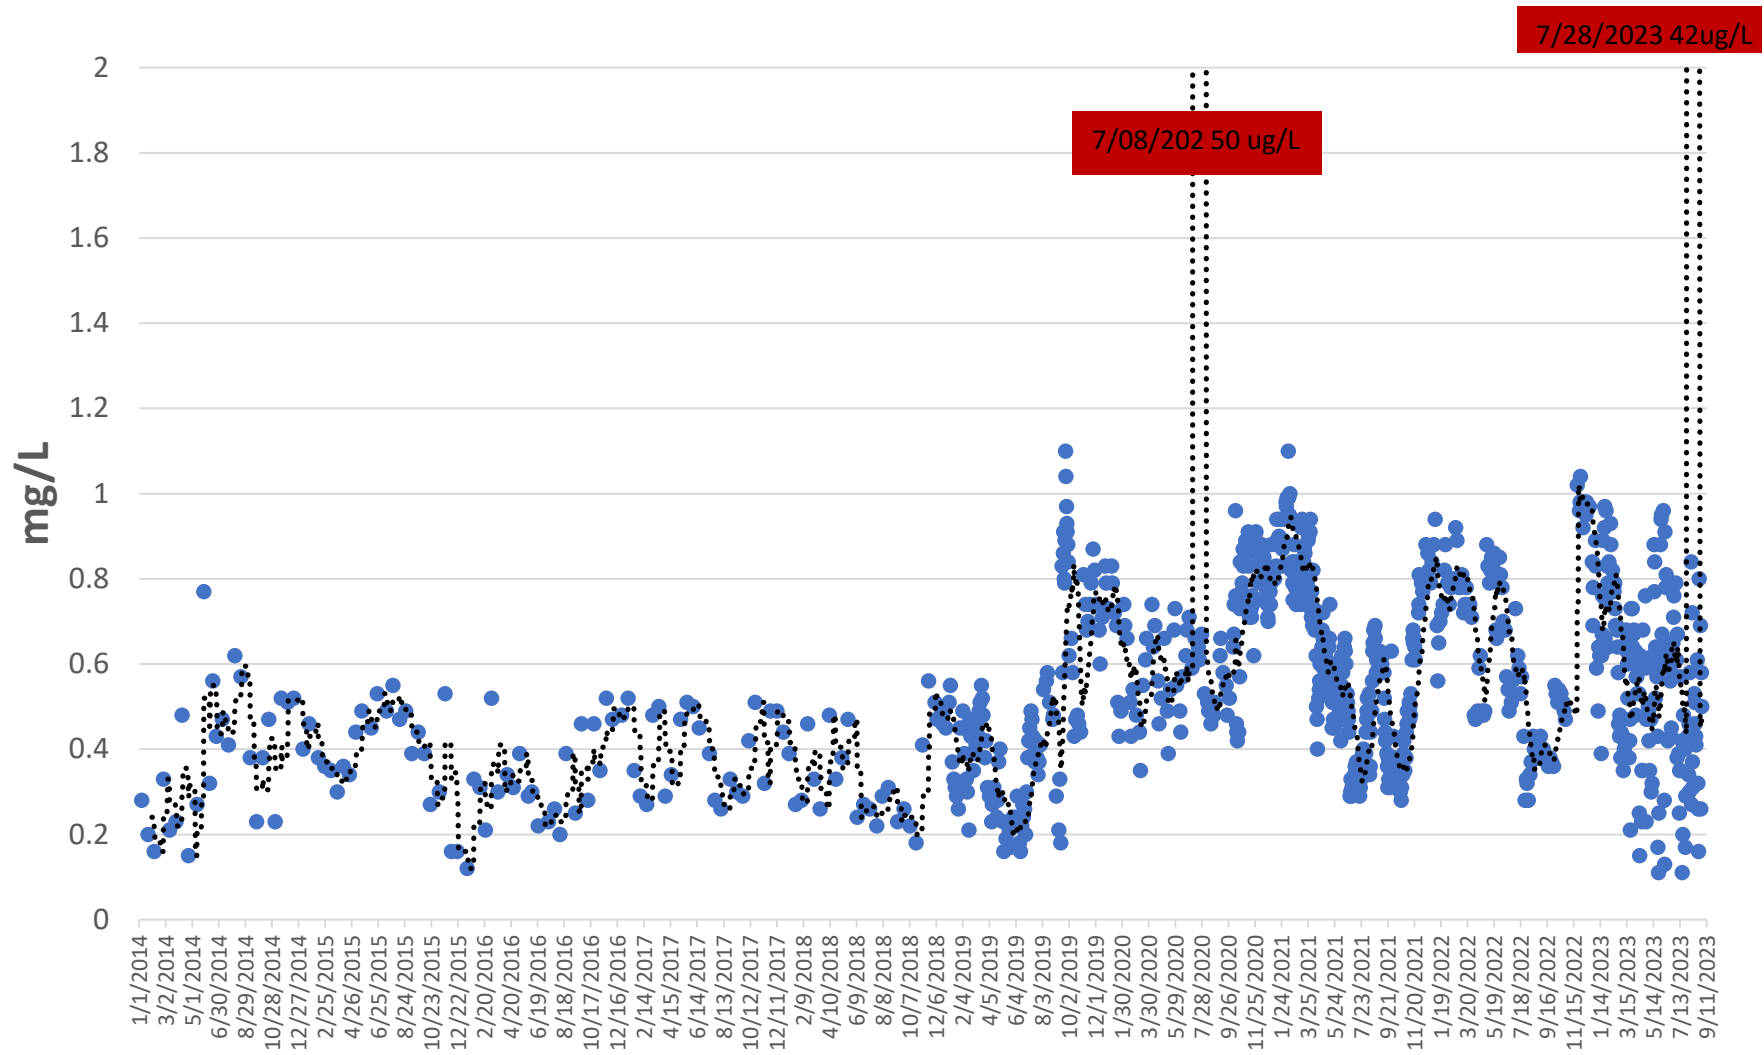
System Operational Area, Chlorine Residual - free

- System Operational Area, Free Chlorine Residual
- 30 per. Mov. Avg. (System Operational Area, Free Chlorine Residual)
