Summary Report

City of Sheboygan Shoreline Metro Main Headquarters Facility Condition Assessment

Sheboygan, WI

April 8, 2026

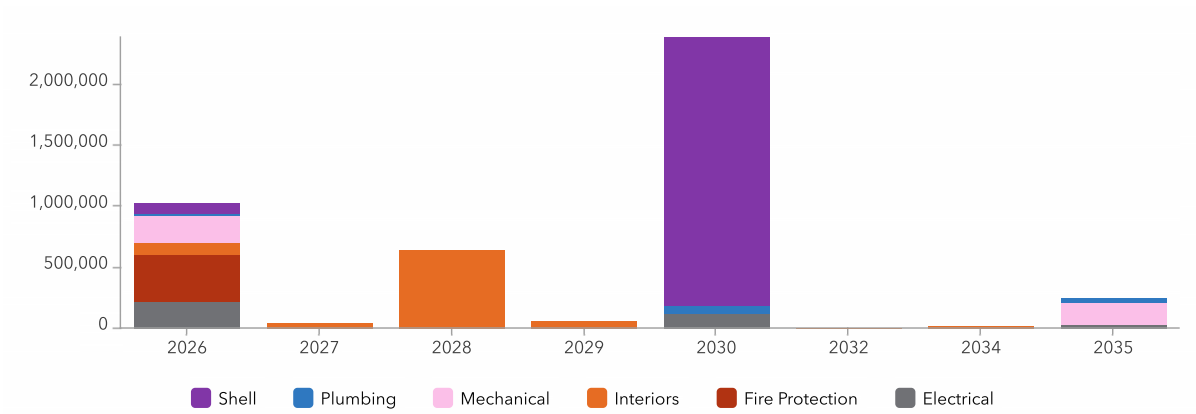
Cost Breakdown by Discipline Per Year (2026-2035)

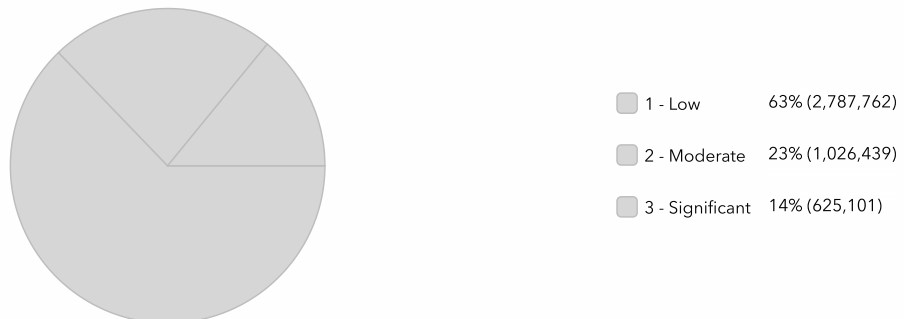
Low	Moderate	Significant	High
1-6	7-10	11-16	17-25

Total Cost Summary by Risk Category (2026-2035)
