То:	The City of Bay St. Louis
From:	Sai Kiran Duvvuri, P.E.
Date:	February 16, 2024
Subject:	Bay Saint Louis Municipal Harbor – Bulkhead Settlement – Inspection Findings and Recommendations
M&N Job No.:	230619

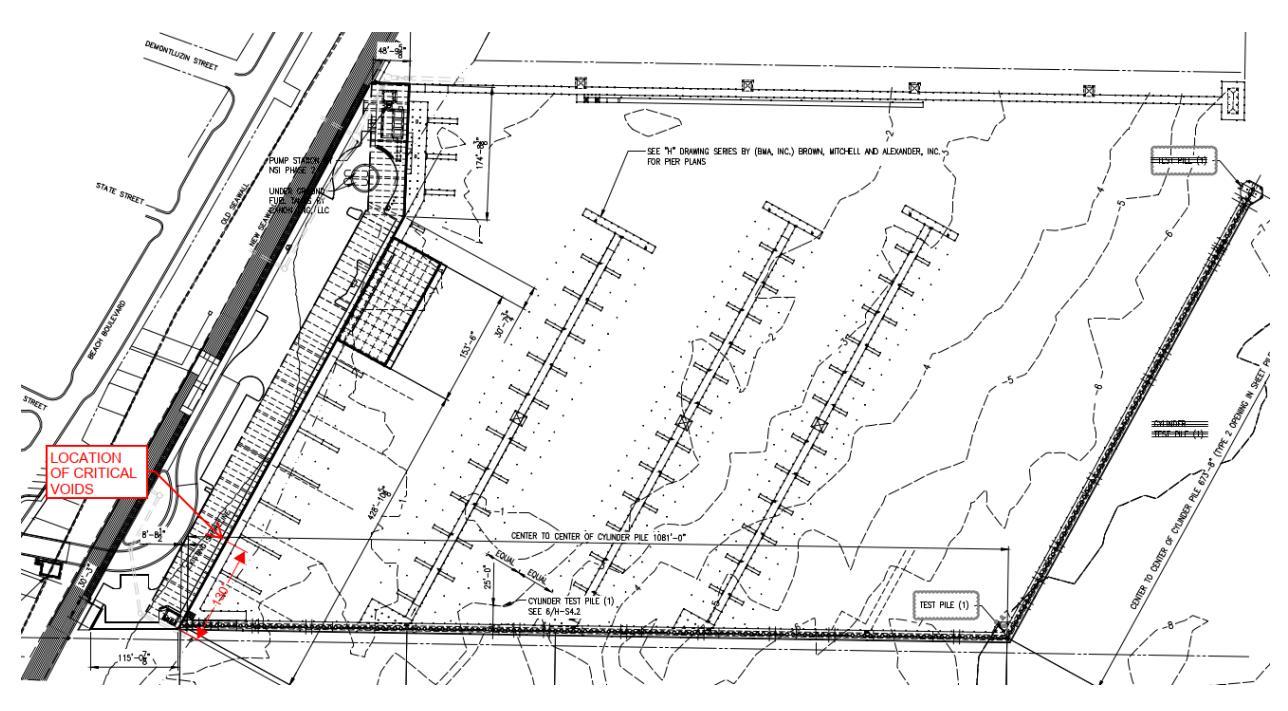
Figure 1: Location of Critical Voids

The critical location identified is approximately 130 feet north of the southwest corner of the bulkhead (Station 2+60 in M&N's field alignment), as indicated in the figure below. At this location, the bottom of the void was found to be 2 feet and 3 inches below the bottom of the pavement. During investigation, M&N inserted a steel rod used for soil probing 6 feet into the soils below the void without encountering resistance, indicating ongoing loss below the current void depth. Additionally, the concrete pavement immediately behind the bulkhead was observed to have cracked through its full width.

This option involves targeted repair at a specific location where critical voids exist below the pavement, while slab jacking is employed elsewhere. The targeted repair includes localized pavement demolition, backfilling of voids with sand (without excavation), and subsequent repaying. It's important to note that this option does not address sealing the bulkhead joints below.
