## **Staff Report**

Professional Services Agreement for Boulder Creek Intake Maintenance Improvements Presenter: Rob Charles, Utilities Manager Time Estimate: 5 minutes

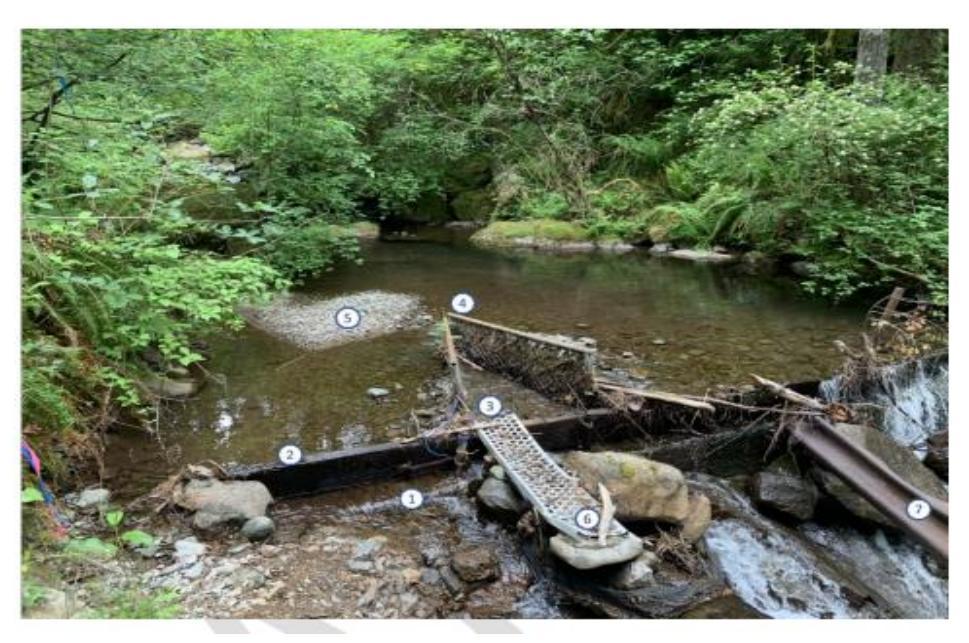
- Concrete dam tied-in to bedrock channel.
  3" x 10" timber flashboard set
- 3" x 10" timber flashboard set atop dam.
- 3 Drain intake leading to 10° pipe
- Chain link screen surrounding intake
- Sediment deposits upstream of dam
- 6 Access platform
- Metal guardrail in channel downstream of dam, presumed from eroded bank.

Figure 1: Photo of existing dam and intake structure from downstream of dam looking upstream

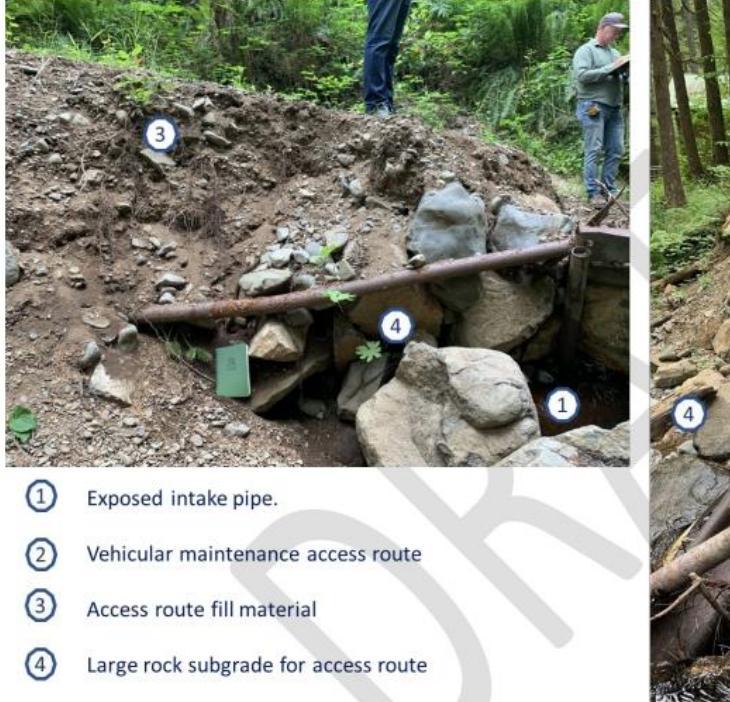
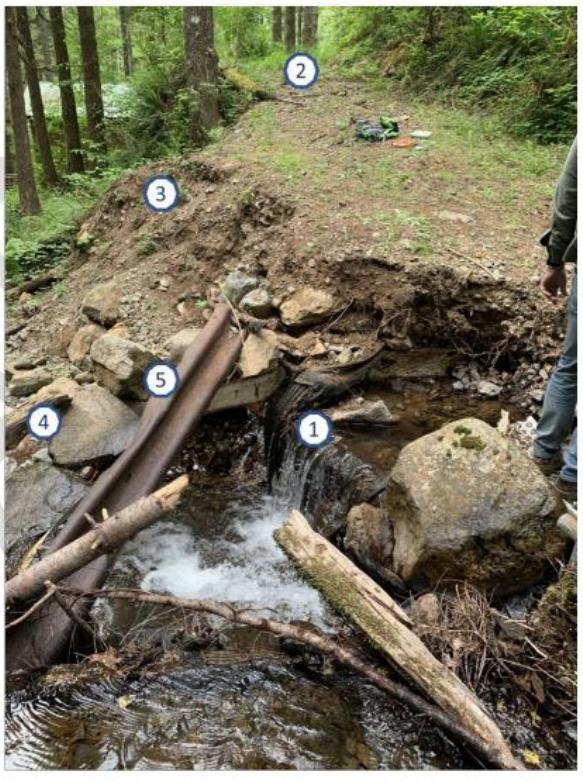
Guardrail and sheet metal debris believed to have been used as retaining structure

Figure 3: Existing bank erosion along right bank of Boulder Creek looking downstream in intake structure.

**SUMMARY:** To fully utilize the capacity of the intake, creek bed material will need to be pulled from the stream channel around the intake. This material can then be used to stabilize the creek bank and also be used to reconstruct the eroding maintenance road. Shell Engineering is proposing to coordinate with multiple agencies for permitting requirements to maintain this intake. In addition, a survey of the area will be completed to confirm the quantity of material which will be dredged from the creek. When plans and specifications are completed, the project will be bid and the low bid award will be brought back to council. The work window in the stream is limited to the month of August.
