Technical Preservation Services

Roofs

5/11/22, 3:23 PM	The Secretary of the Interior's Standards for Rehabilitation & Illustrated Guidelines for Rehabilitating Historic Buildings-Roofs
	Removing a major portion of the roof or roofing material that is repairable, then reconstructing it with new material in order to create a uniform, or "improved" appearance.
	Changing the configuration of a roof by adding new features such as dormer windows, vents, or skylights so that the historic character is diminished.
	Stripping the roof of sound historic material such as slate, clay tile, wood, and architectural metal.
	Applying paint or other coatings to roofing material which has been historically uncoated.
Roofs	Protect and Maintain
recommende	ed Protecting and maintaining a roof by cleaning the gutters and downspouts
	and replacing deteriorated flashing.
	Roof sheathing should also be checked for proper venting to prevent moisture condensation and water penetration; and to insure that materials are free from insect infestation.

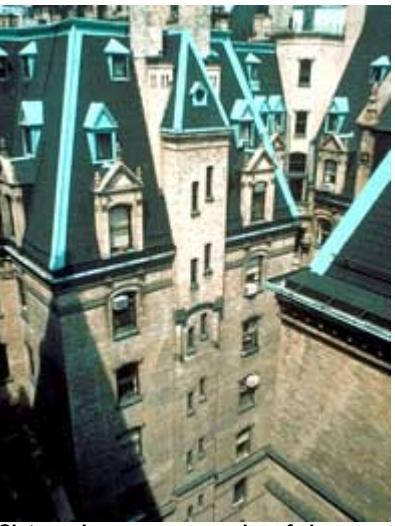
Slate and copper mansard roofs in an urban canyon.

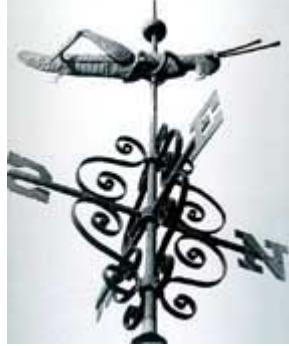
Copper and wrought iron weathervane.

This includes the roof's shape, such as hipped, gambrel, and mansard; decorative features, such as cupolas, cresting chimneys, and weathervanes; and roofing material such as slate, wood, clay tile, and metal, as well as its size, color, and patterning.

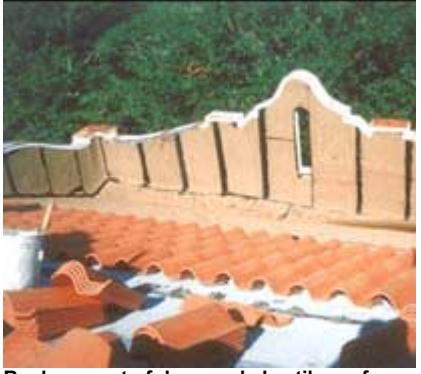
Replacement of damaged clay tile roof.

Replacing in kind an entire feature of the roof that is too deteriorated to repair--if the overall form and detailing are still evident--using the physical evidence as a model to reproduce the feature.

Examples can include a large section of roofing, or a dormer or chimney.

If using the same kind of material is not technically or economically feasible, then a compatible substitute material may be considered.
