BARNES LAKE ANNUAL REPORT 2024

AQUATECHNEX, LLC. P.O. BOX 118 CENTRALIA, WA 98531

Spring 2024 Survey Discussion

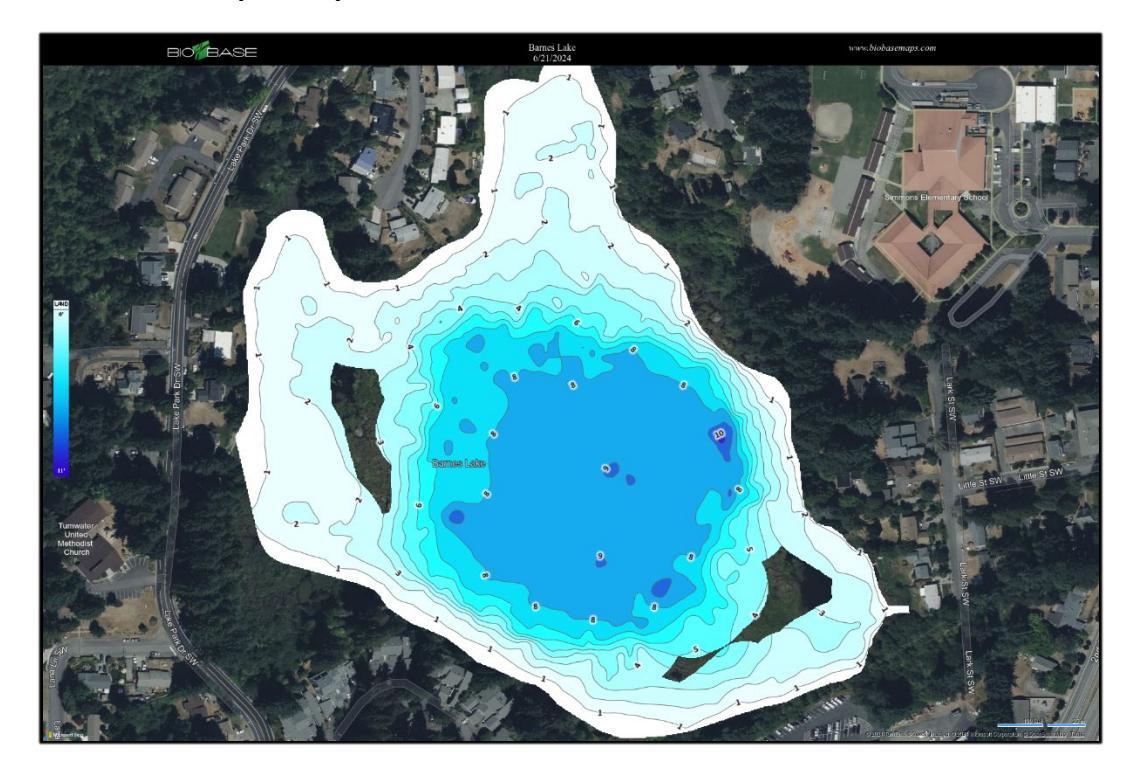
Barnes Lake Depth Map 2024

In the above map, we can see the depth contours of Barnes Lake. The lighter colors indicate shallower areas, where the darker colors indicate deeper areas. According to the hydro-acoustic mapping software, the max depth detected was around 12ft. This area is located near the eastern shoreline, where we can see the 10ft contour. The majority of the basin is below 3ft, which can be seen on the map by the lighter colors around the outer edge of the basin. This means that Barnes Lake has a large littoral area, where plants can grow.

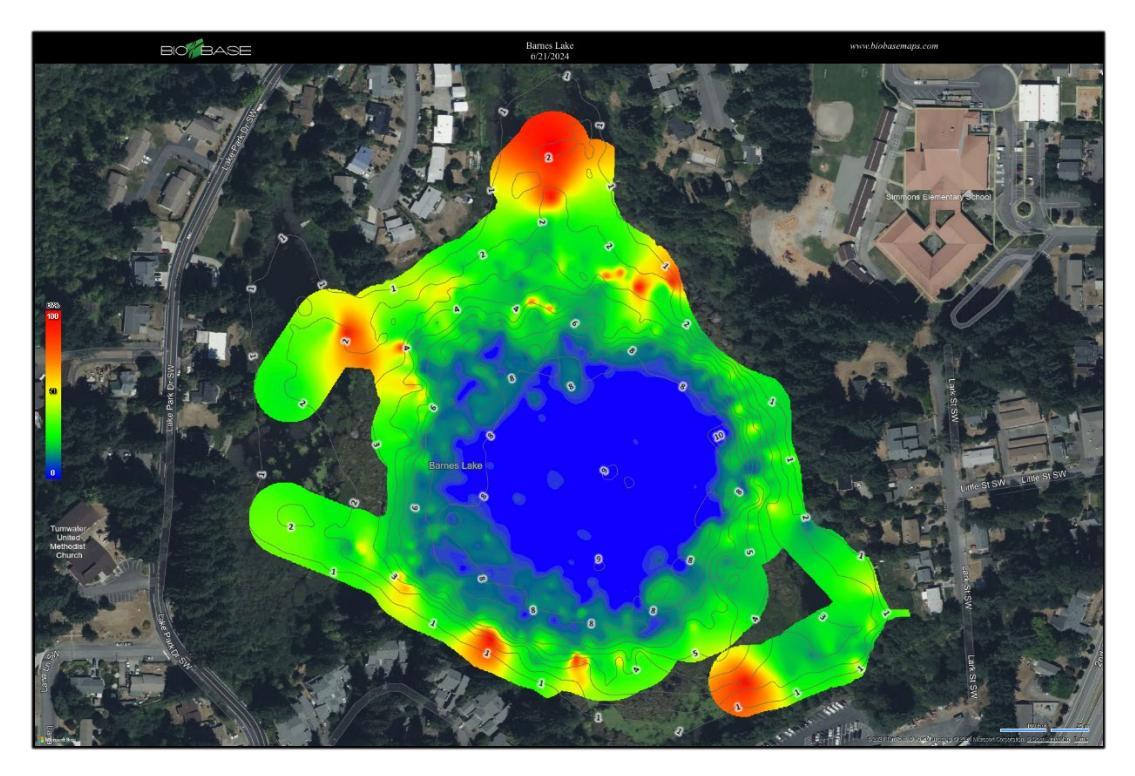
Barnes Lake Vegetation Heat Map 2024

The above map is the vegetation heat map that was taken during the hydro-acoustic survey. The colors indicate different levels of vegetation height that is taking up the water column. The hotter colors red, orange, and yellow indicate a high level of vegetation. The cooler colors green and blue indicate low levels of vegetation. The highest level of vegetation was in the northern part of Barnes Lake at the time of the survey. This area is also very shallow, which allows for vegetation to grow in. The middle of basin had little to no plant growth at time of survey. Purple bladderwort was observed floating around the middle of the basin during this survey.

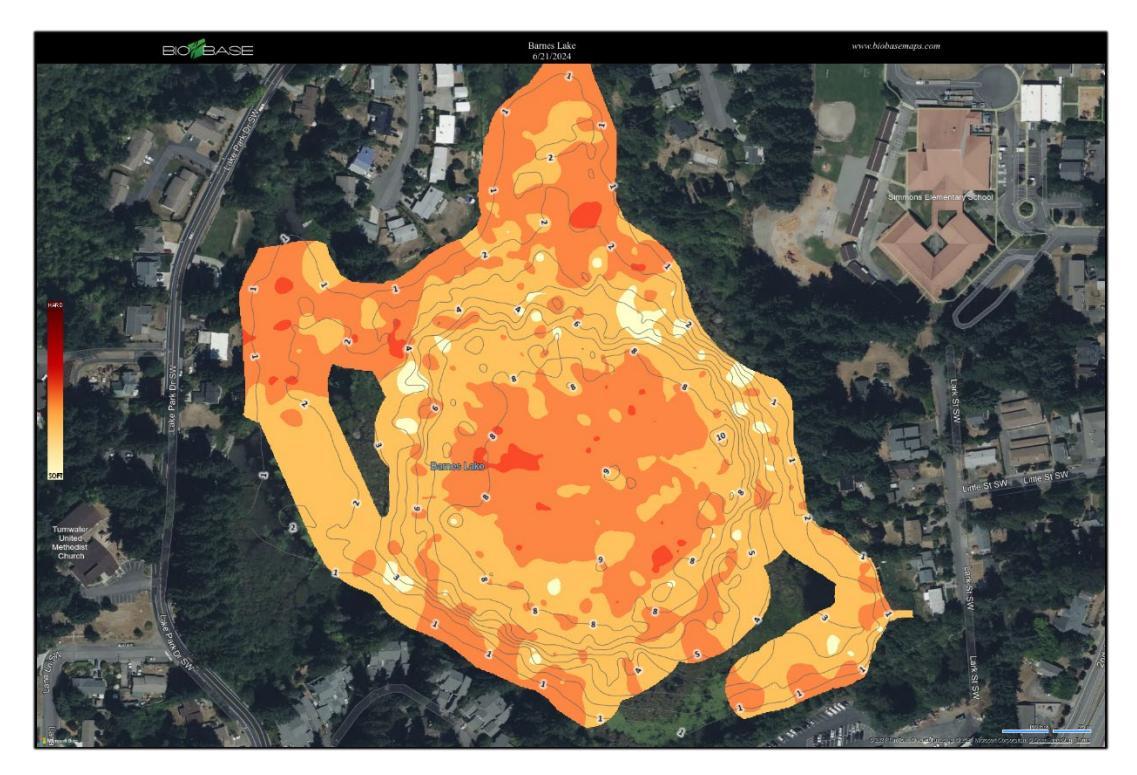
Barnes Lake Bottom Composition Map 2024

The above map is the bottom composition map generated from the hydro-acoustic mapping survey. The hotter colors, red and dark orange, on this map indicate hard substrates. The cooler colors, cream and light orange, indicate soft substrates. It was unexpected that most of the lake bottom was not soft, especially in the northern area. With the amount of sedimentation occurring in this area, we would expect to see softer sediment types here. Due to the high vegetation, there could have been an error in the readings that took place. Also, the depth of that area was very shallow which could have caused a misreading of the bottom sediments.

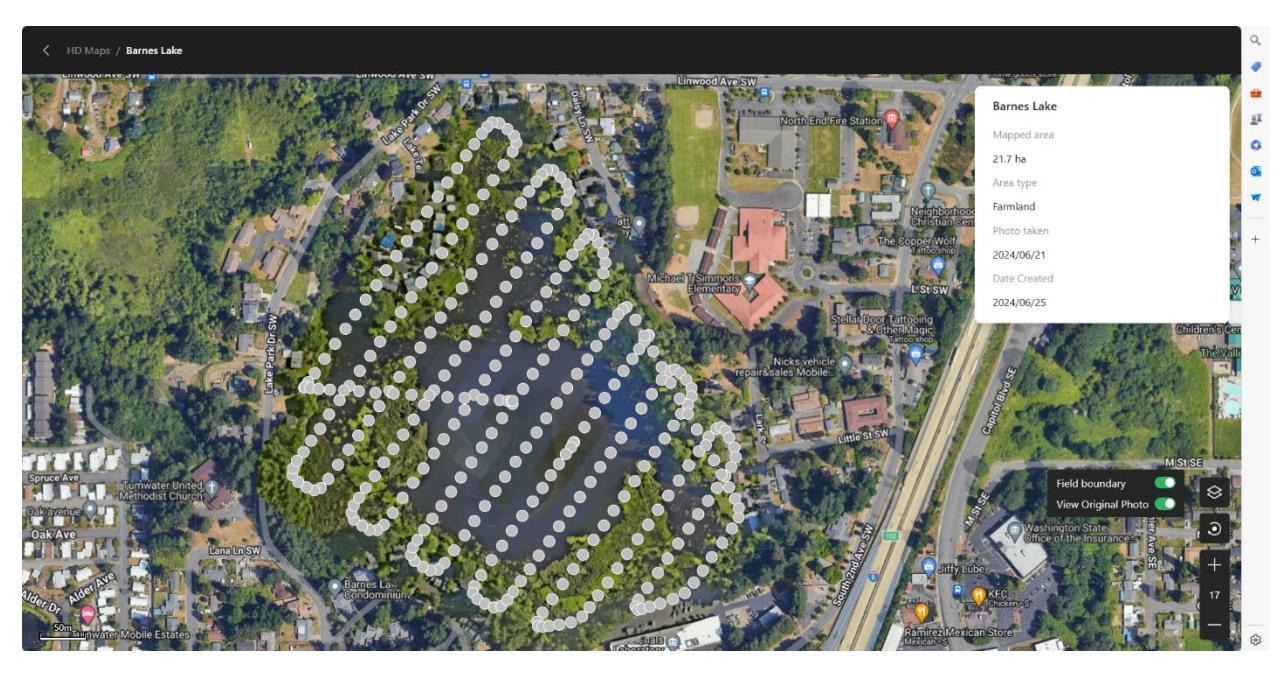
Figure 2: Flight Path of the Drone Survey

Additionally, prior to the survey on the lake, a drone was deployed to take aerial images of the lake. This drone was operated by Aquatechnex owner, Terence McNabb. During the survey, the drone flew a pre-programmed route that was uploaded. This resulted in 337 pictures being taken of the lake (figure 3). The following images provide the flight path, locations of each image, and an image of the consolidated images. Unfortunately, we were unable to fly the lake in the fall due to new restrictions that the manufacture put in place. These new restricted zones are shown in figure 4. These zones almost completely cover Barnes Lake, preventing a complete survey. We are hoping to remedy this for next season, to be able to provide pre and post treatment results from a higher point of view.

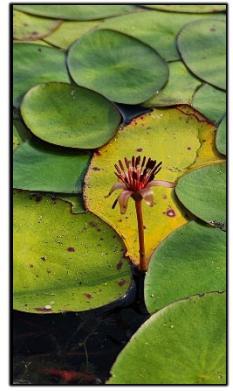
Figure 5: Watershield and it's flower.

Barnes Lake is a healthy lake in terms of biodiversity within the lake. Several different species of aquatic macrophytes and algae were observed at the time of the surveys that occurred. The most dominant floating leaved species in the lake was watershield (*Brasenia schreberi*). This is a native species that thrives in warm, shallow waters. This species is often lumped into the same category as lilies; however, it is its own species. Watershield (figure 5) is characterized by it oval shaped leaf and purple flower. It can also have different colored leaves such as green, yellow, or red. This species does produce a flower (figure 5) that is pollinated via wind drift. This then produces a leathery fruit that contains seeds. In addition to watershield, the following species were observed in various densities:

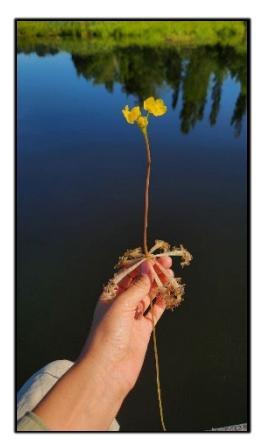
Figure 6: Common Bladderwort flower found at Barnes Lake.

As 2024 was our first year taking over the management of Barnes Lake, we learned a lot about Barnes Lake, and we have some recommendations to implement for 2025. In 2025, we recommend a full lake Sonar (fluoridone) application. This would systematically target the bladderwort that has become wider spread. This species of bladderwort produces a seed that drops during the season. Due to Bladderworts modes of reproduction and mobility, this aquatic plant will require multiple seasons to achieve control. Earlier season control prior to the Bladderwort's seed production will be required.

If Sonar is not utilized, we recommend using Aquathol K vs. Diquat for the treatment of bladderwort. We recommend this chemistry because unlike diquat, it does not become inactivated once in contact with sediment and other particles that it could encounter prior to

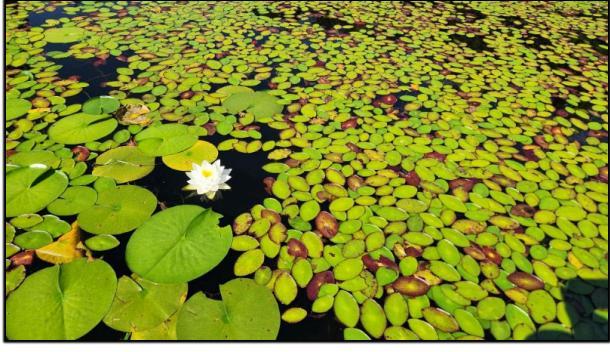
Figure 7: White water lily and watershield at Barnes Lake.

the survey. These species are the white-water lily (figure 7) and bladderwort. Himalayan blackberry and water hemlock were not part of this survey; however, they were noted by the biologist on site as species of concern. A fall survey was conducted from shore due to the shallow depth of Barnes Lake. Due to this, points were not able to be taken to accurately represent the locations of the species of concern.

Additionally, we recommend utilizing Imazamox, also known as ClearCast, to treat the whitewater lily (WWL) that is around the lake. Sonar may have some initial effects on the WWL that is present in Barnes Lake, however, it will rebound later in the season, once the concentration has decreased throughout the lake. Imazamox is an EPA register reduced risk herbicide, meaning that it is less harmful to the environment and humans than other older chemistries.

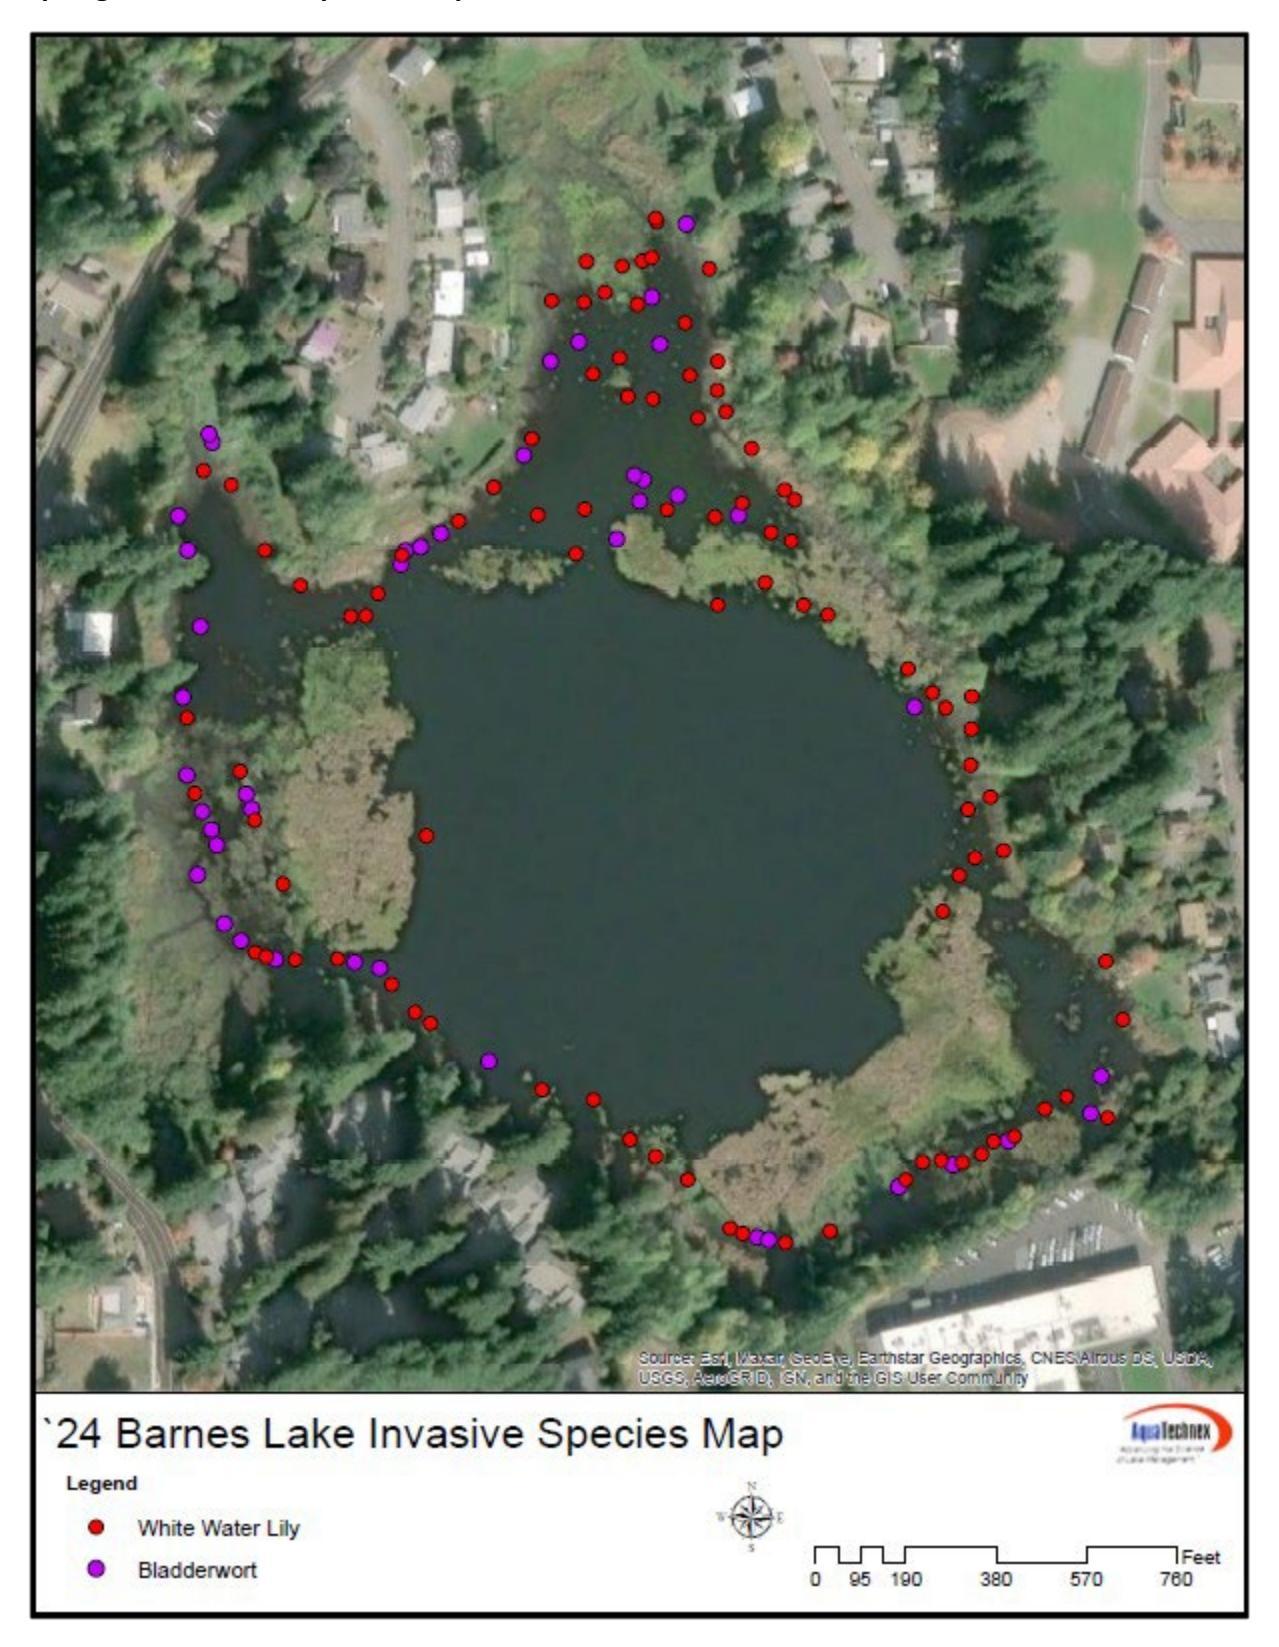
Spring 2024 Invasive Species Map

The following map shows the locations of the invasive species that were present at the time of

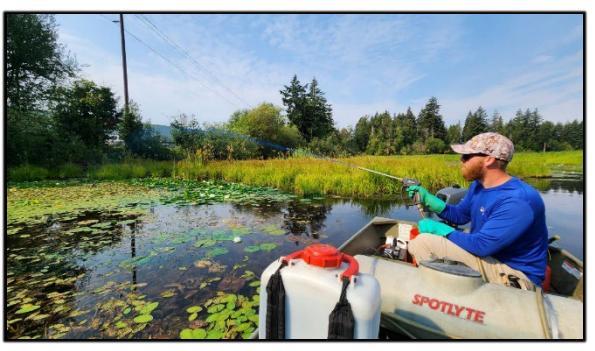
completed on the same day, (August 9, 2024). Aquatic Biologist Scott Conrade and Aquatic Technician Ellie Karpf were on site for the application. The treatment crew utilized a 10ft john boat, equipped with a 2.5 hp Yamaha motor. A Spotlyte treatment system was used to apply diquat to the bladderwort using a boom with drop hoses. The Spotlyte system was also utilized to apply Imazamox to treat the WWL, via a foliar application (figure 8). A surfactant was also added to the mix to help break through

Figure 8: Aquatic Biologist, Scott Conrade treats WWL. (*Not pictured*) *Aquatic Technician Ellie Karpf aids in the application.*

the cell walls of the lilies and help keep the product in place until it has entered the plant.
