Public Draft
Initial Study & Mitigated Negative Declaration
PENNSYLVANIA AVENUE WIDENING PROJECT

June 2021

City of Beaumont
550 East 6th Street
Beaumont, CA 92223
Contact: Carole Kendrick

moffatt & nichol
4225 E Conant Street
Long Beach, CA 90808
Contact: Stephanie Oslick, AICP, ENV SP

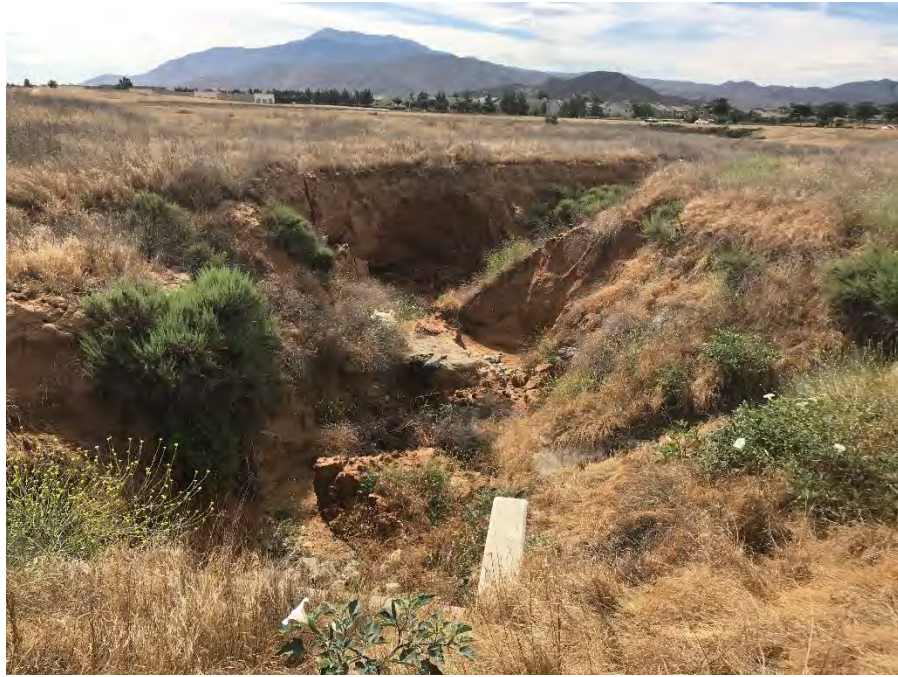
Photo 5 – Drainage B
canyon connected to
box culvert.

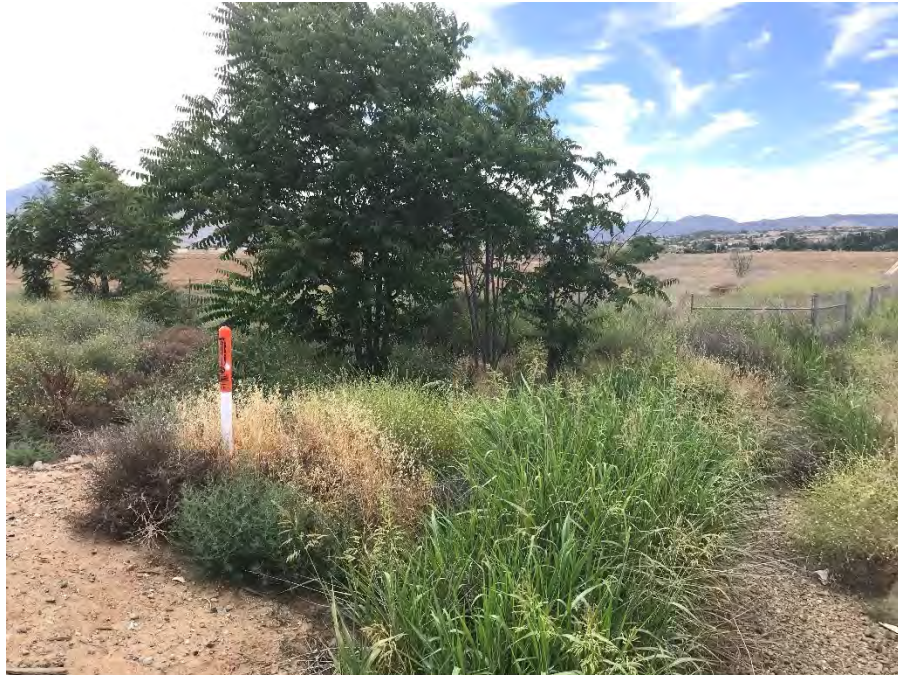
Photo 7 – Drainage A.
Tree of Heaven and
rushes/grasses growing
near culvert

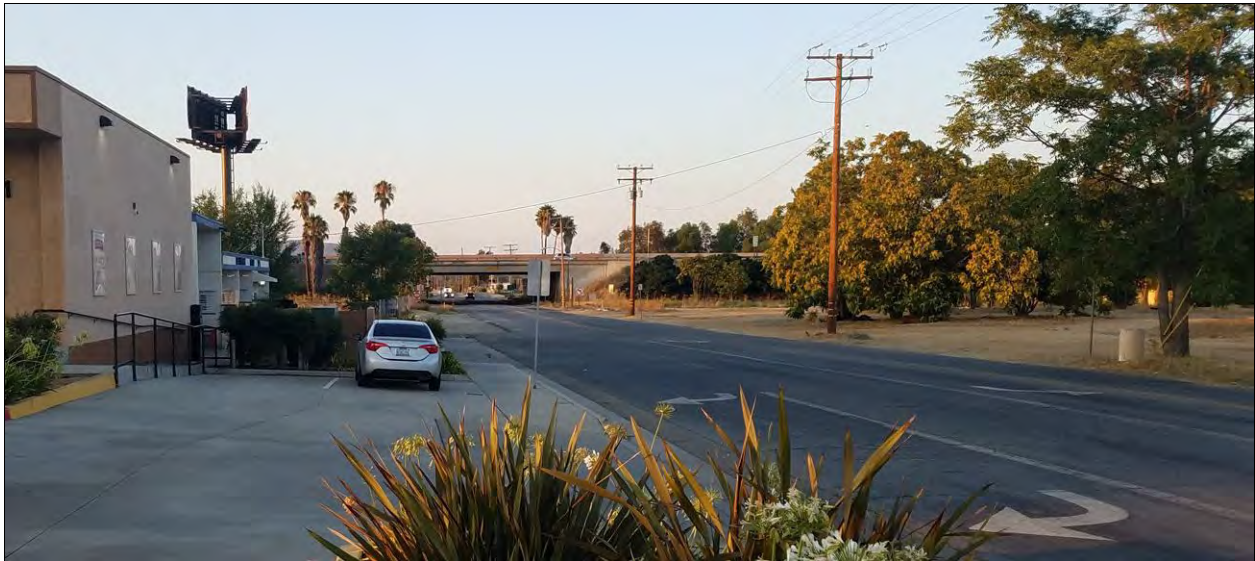
Figure 4. The project area north of the I-10 freeway, view to the south from Sixth Street. (Photograph taken on August 13, 2018)

In the project area, Pennsylvania Avenue presents an overall rural appearance as a two-lane asphalt road with dirt or gravel shoulders, few curbs, and sporadic lighting. From the northern end at the intersection with Sixth Street, the road alignment crosses under the I-10 freeway about 675 feet to the south and then the Union Pacific Railroad at grade some 150 feet further south before extending another 1,975 feet to First Street. Despite the numeric sequence, no other streets cross the project area, though Third Street dead-ends at Pennsylvania Avenue from the west. A corner market and a self-service carwash are located on adjacent properties to the east at the intersection with Sixth Street (Fig. 4). South of I-10 and the railroad tracks, a palette and truck trailer storage facility is located on the west side of the road (Fig. 5). All other adjacent parcels are currently undeveloped.

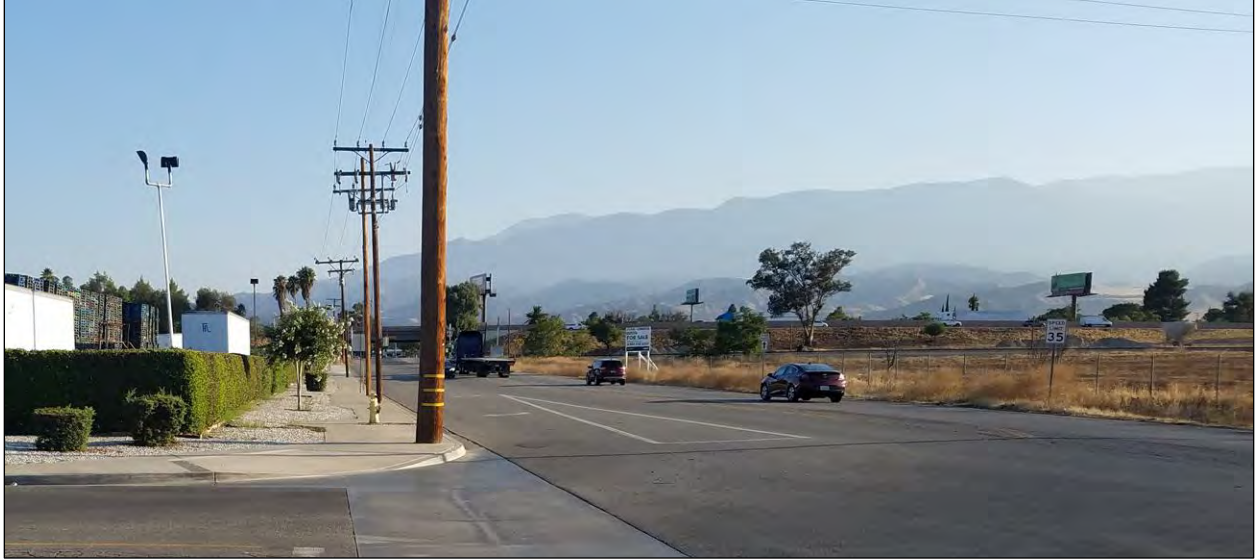
Figure 5. The project area south of the I-10 freeway, view to the north from Third Street. (Photograph taken on August 13, 2018)

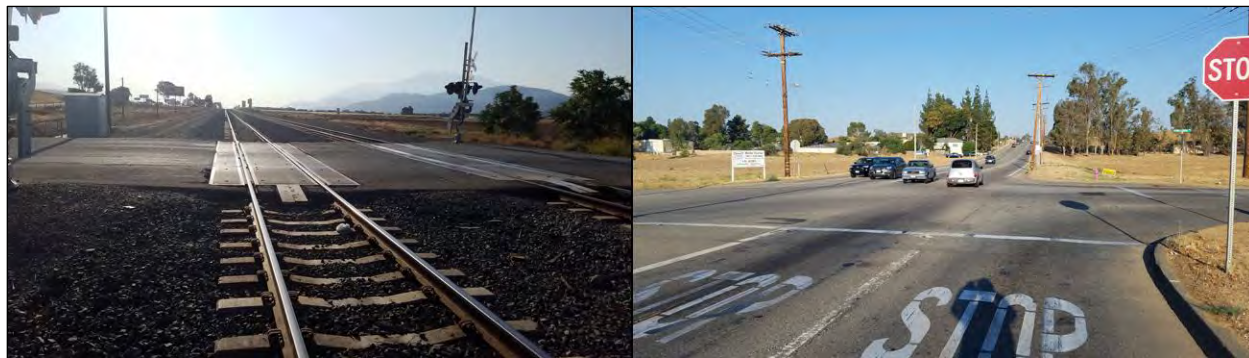
Figure 11. Current condition of Site 33-009498, the former SPRR (*left*, view to the east), and Site 33-023484, the SCE power transmission line (*right*, view to the west). (Photographs taken on August 14, 2018)

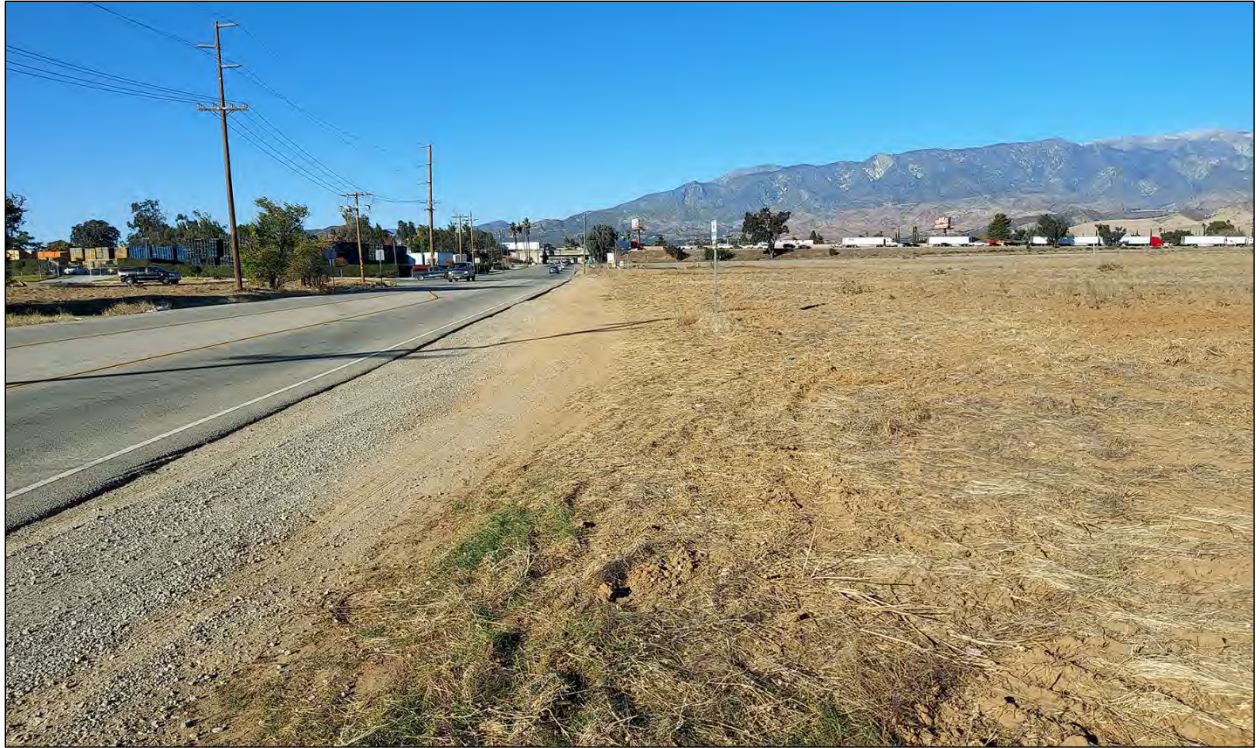
Figure 4. Overview of the current natural setting of the project area. (Photograph taken on December 1, 2020; view to the north)

In the project area, Pennsylvania Avenue presents an overall rural appearance as a two-lane asphalt road with dirt or gravel shoulders, few curbs, and sporadic lighting. From the northern end at the intersection with Sixth Street, the road alignment crosses under Interstate Highway 10 (I-10) about 675 feet to the south and then the Union Pacific Railroad at grade some 150 feet further south before extending another 1,975 feet to First Street. Despite the numeric sequence, no other streets cross the project area, though Third Street dead-ends at Pennsylvania Avenue from the west. A corner market and a self-service carwash are located on adjacent properties to the east at the intersection with Sixth Street. South of I-10 and the railroad tracks, a palette and truck trailer storage facility is located on the west side of the road. All other adjacent parcels are currently undeveloped (Figure 4).

greatly disturbed by construction activities associated with the roadways, the railroad, and nearby buildings as well as agricultural operations in the past. Soils in the vicinity consist of medium-yellowish brown sandy silt mixed with some rocks. Vegetation is sparse within the public rights-of-way but becomes denser on open fields nearby, and include foxtails, tumbleweeds, wild mustard, datura, and other common grasses and shrubs (Figure 4). Introduced landscaping plants dominate around the developed parcels.

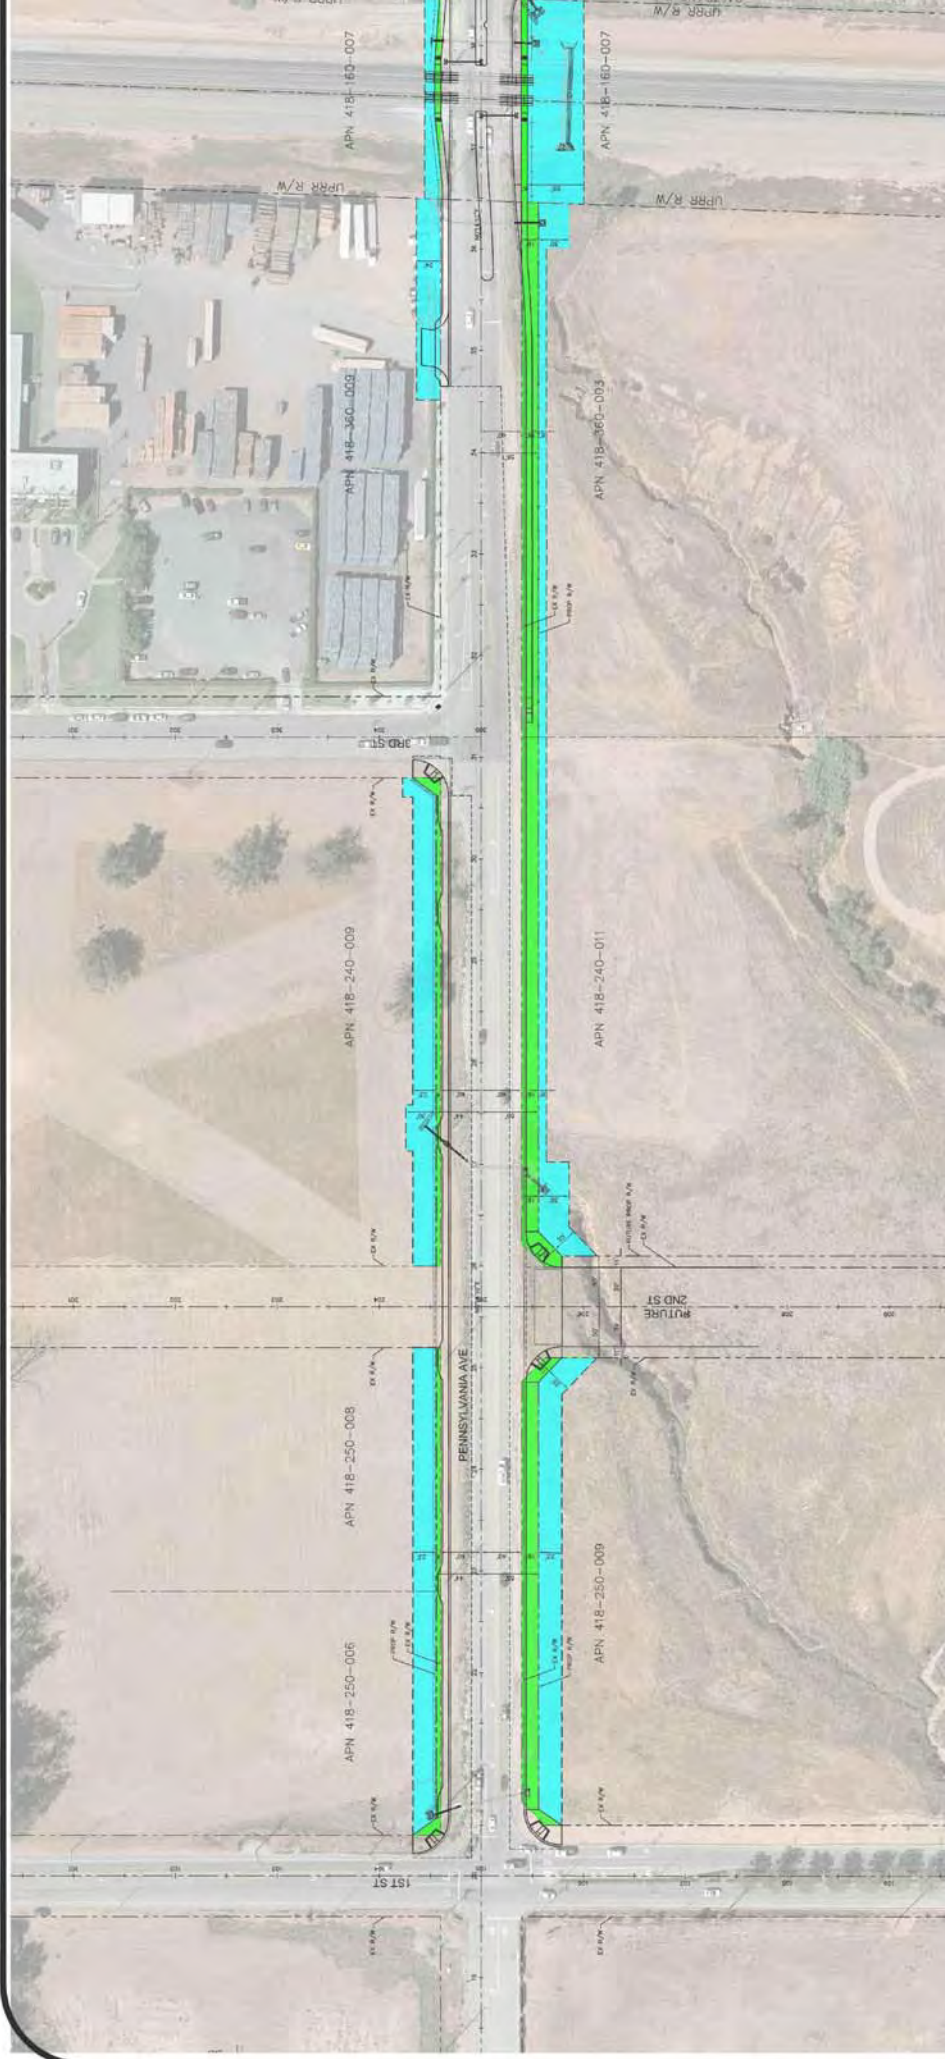
Figure 3

DESIGN PLAN
 Pennsylvania Avenue Widening Project
 Beaumont, California

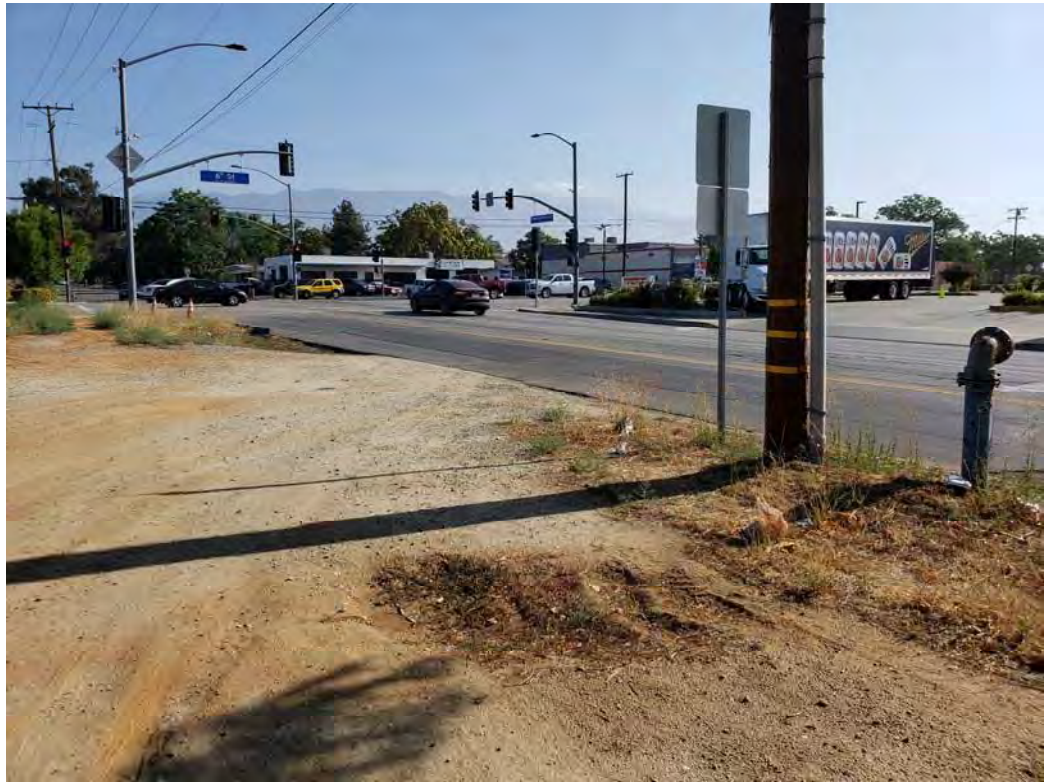
Photo No. 2

View of the
Pennsylvania Avenue
and the I-10
Overcrossing Bridge.

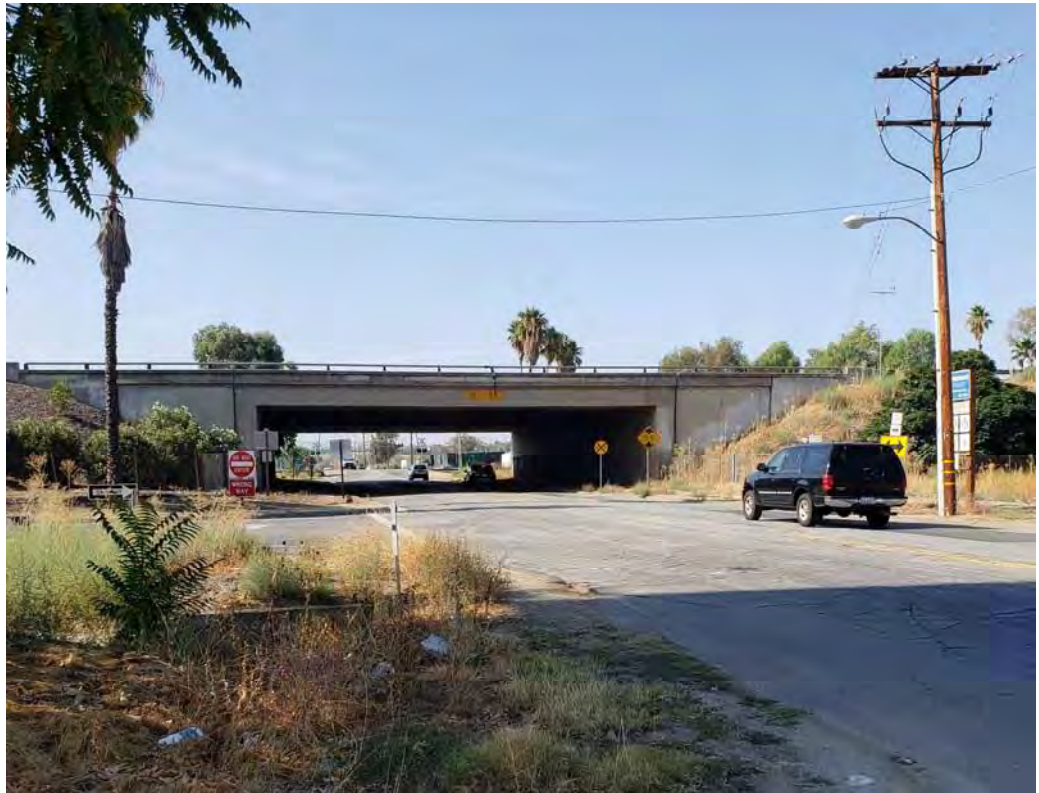
Photo No. 4

View of the railroad
crossing at
Pennsylvania
Avenue.

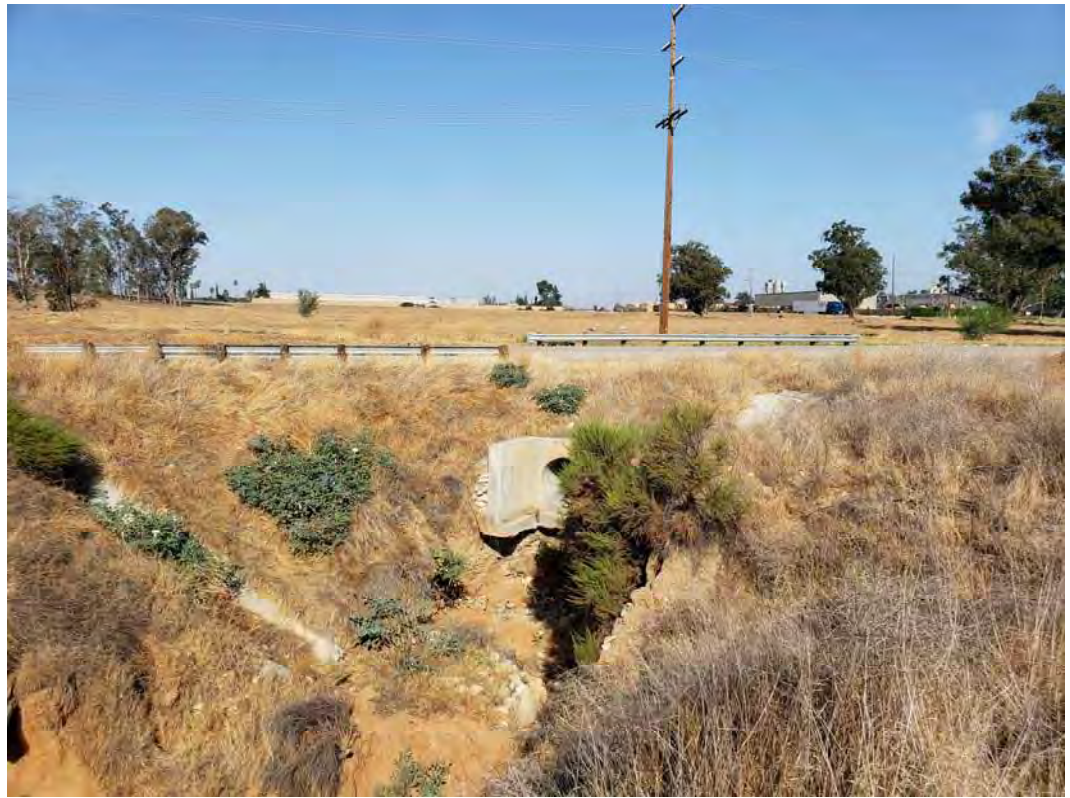
Photo No. 10

Another view of the drainage channel originating from the western adjacent parcel located southwest of 3rd Street and Pennsylvania Avenue. This drainage channel empties onto the parcel located southeast of 3rd Street and Pennsylvania Avenue.

Evidence of pits, ponds, lagoons, septic systems, wastewater, drains, cisterns, and sumps was not observed at the Site. A large diameter storm water pipeline was observed transecting the southern portion of the Site south of 3rd Street (Photos 9 and 10, Appendix A). This pipeline empties into an unnamed drainage channel that follows to the southeast through the southeastern adjacent property. A clarifier was not observed near the acquisition area or TCE as observed from the ROW, at the Beaumont Auto Spa facility, located at 590 East Pennsylvania Avenue.

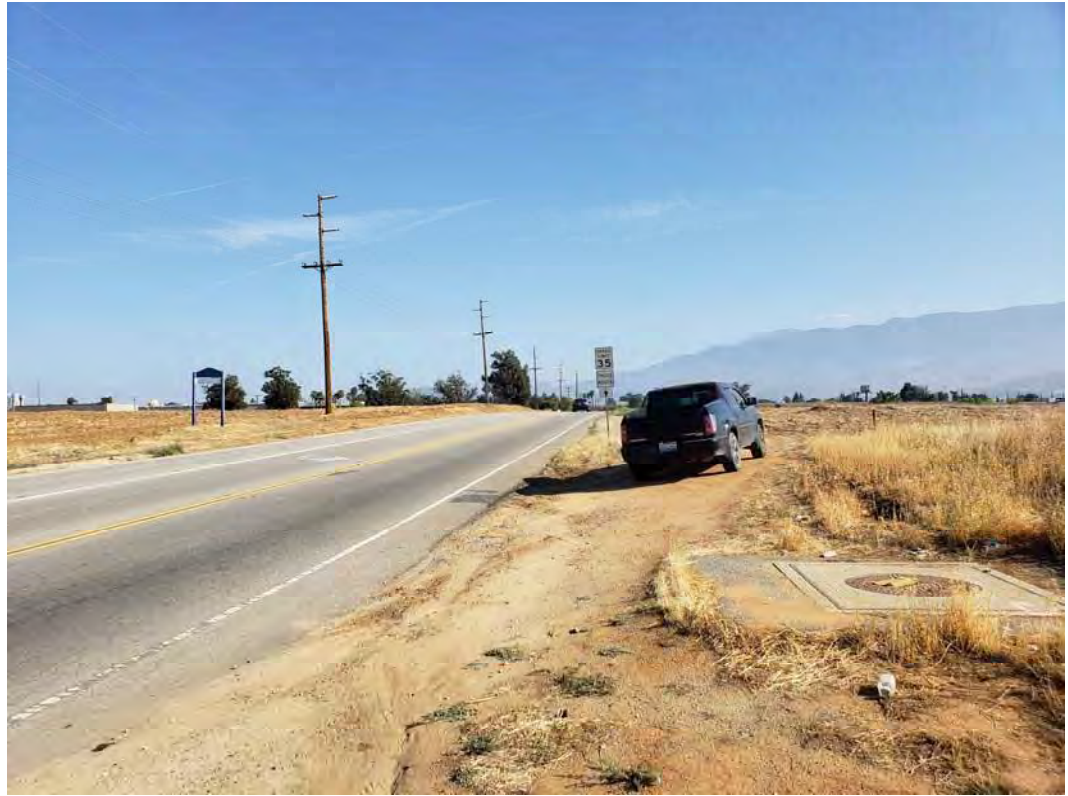
Photo No. 12

View of the intersection of Pennsylvania Avenue and 1st Street and a storm water drainage pipe.

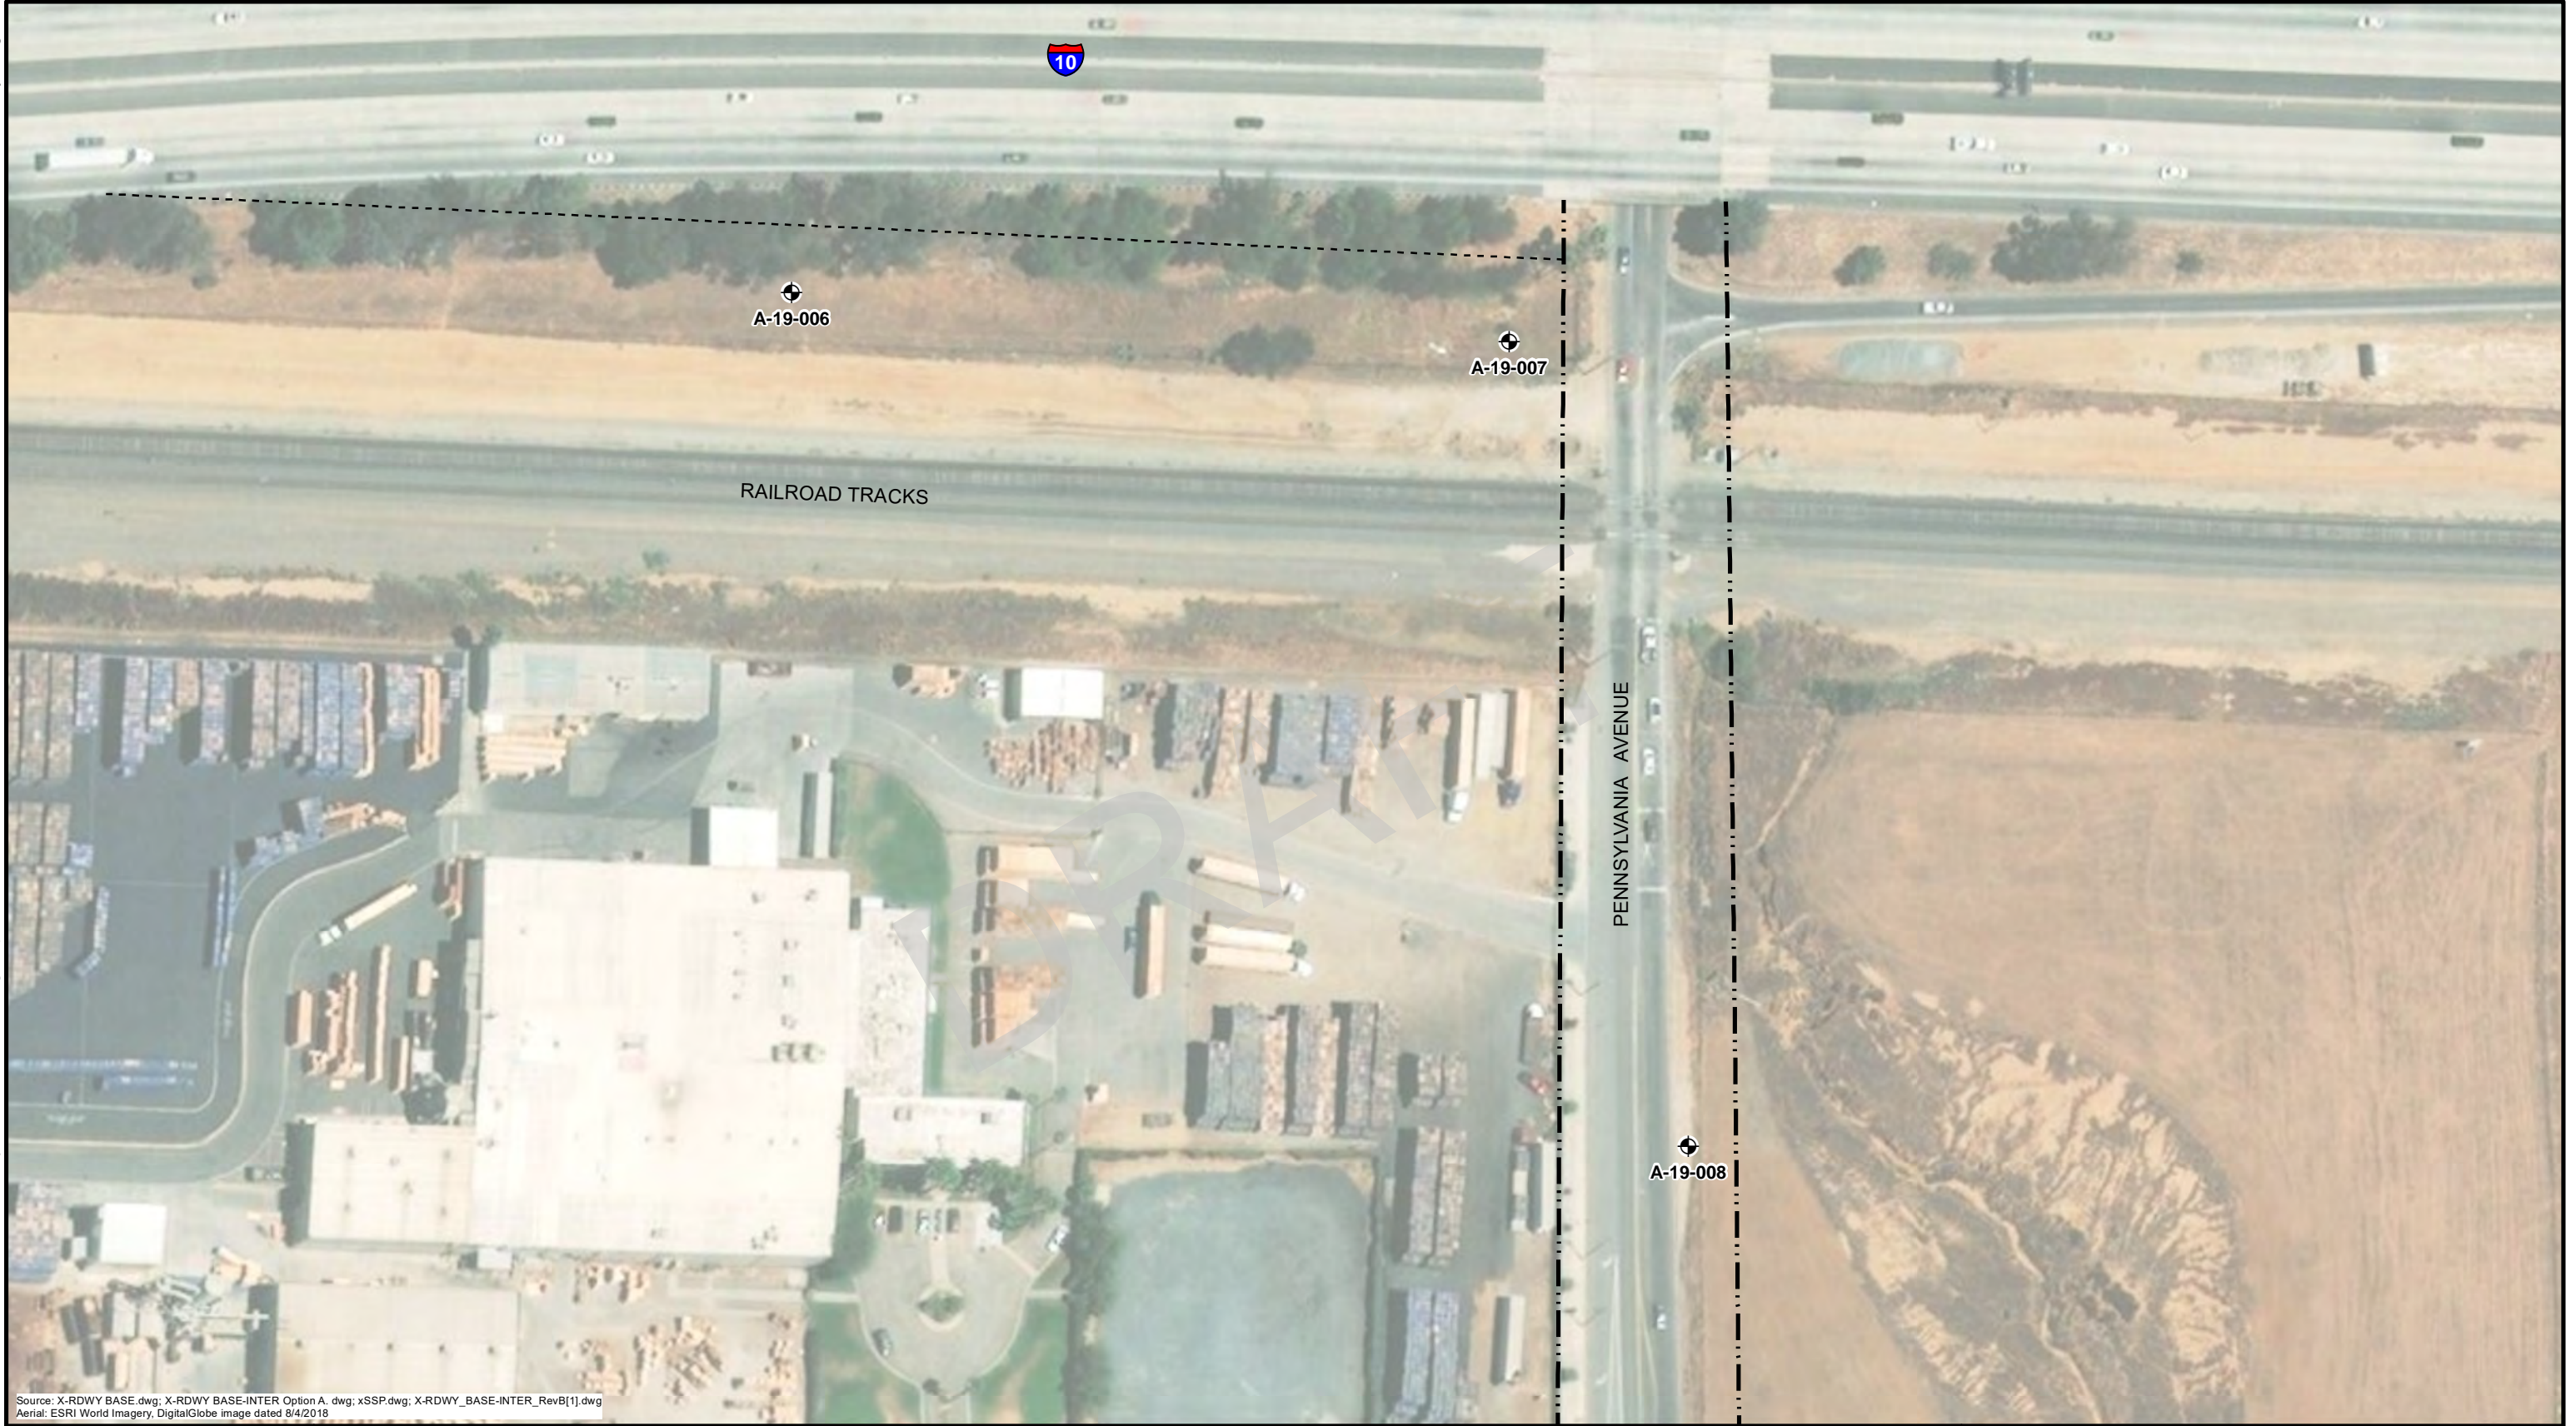
BORING LOCATION MAP
I-10 PENNSYLVANIA AVENUE INTERCHANGE IMPROVEMENT PROJECT BEAUMONT, CALIFORNIA

- LEGEND**
- ⊕ Approximate Location of Geotechnical Boring
 - - - - Approximate Proposed Centerline
 - · - · - Approximate Limits of Pennsylvania Avenue Widening

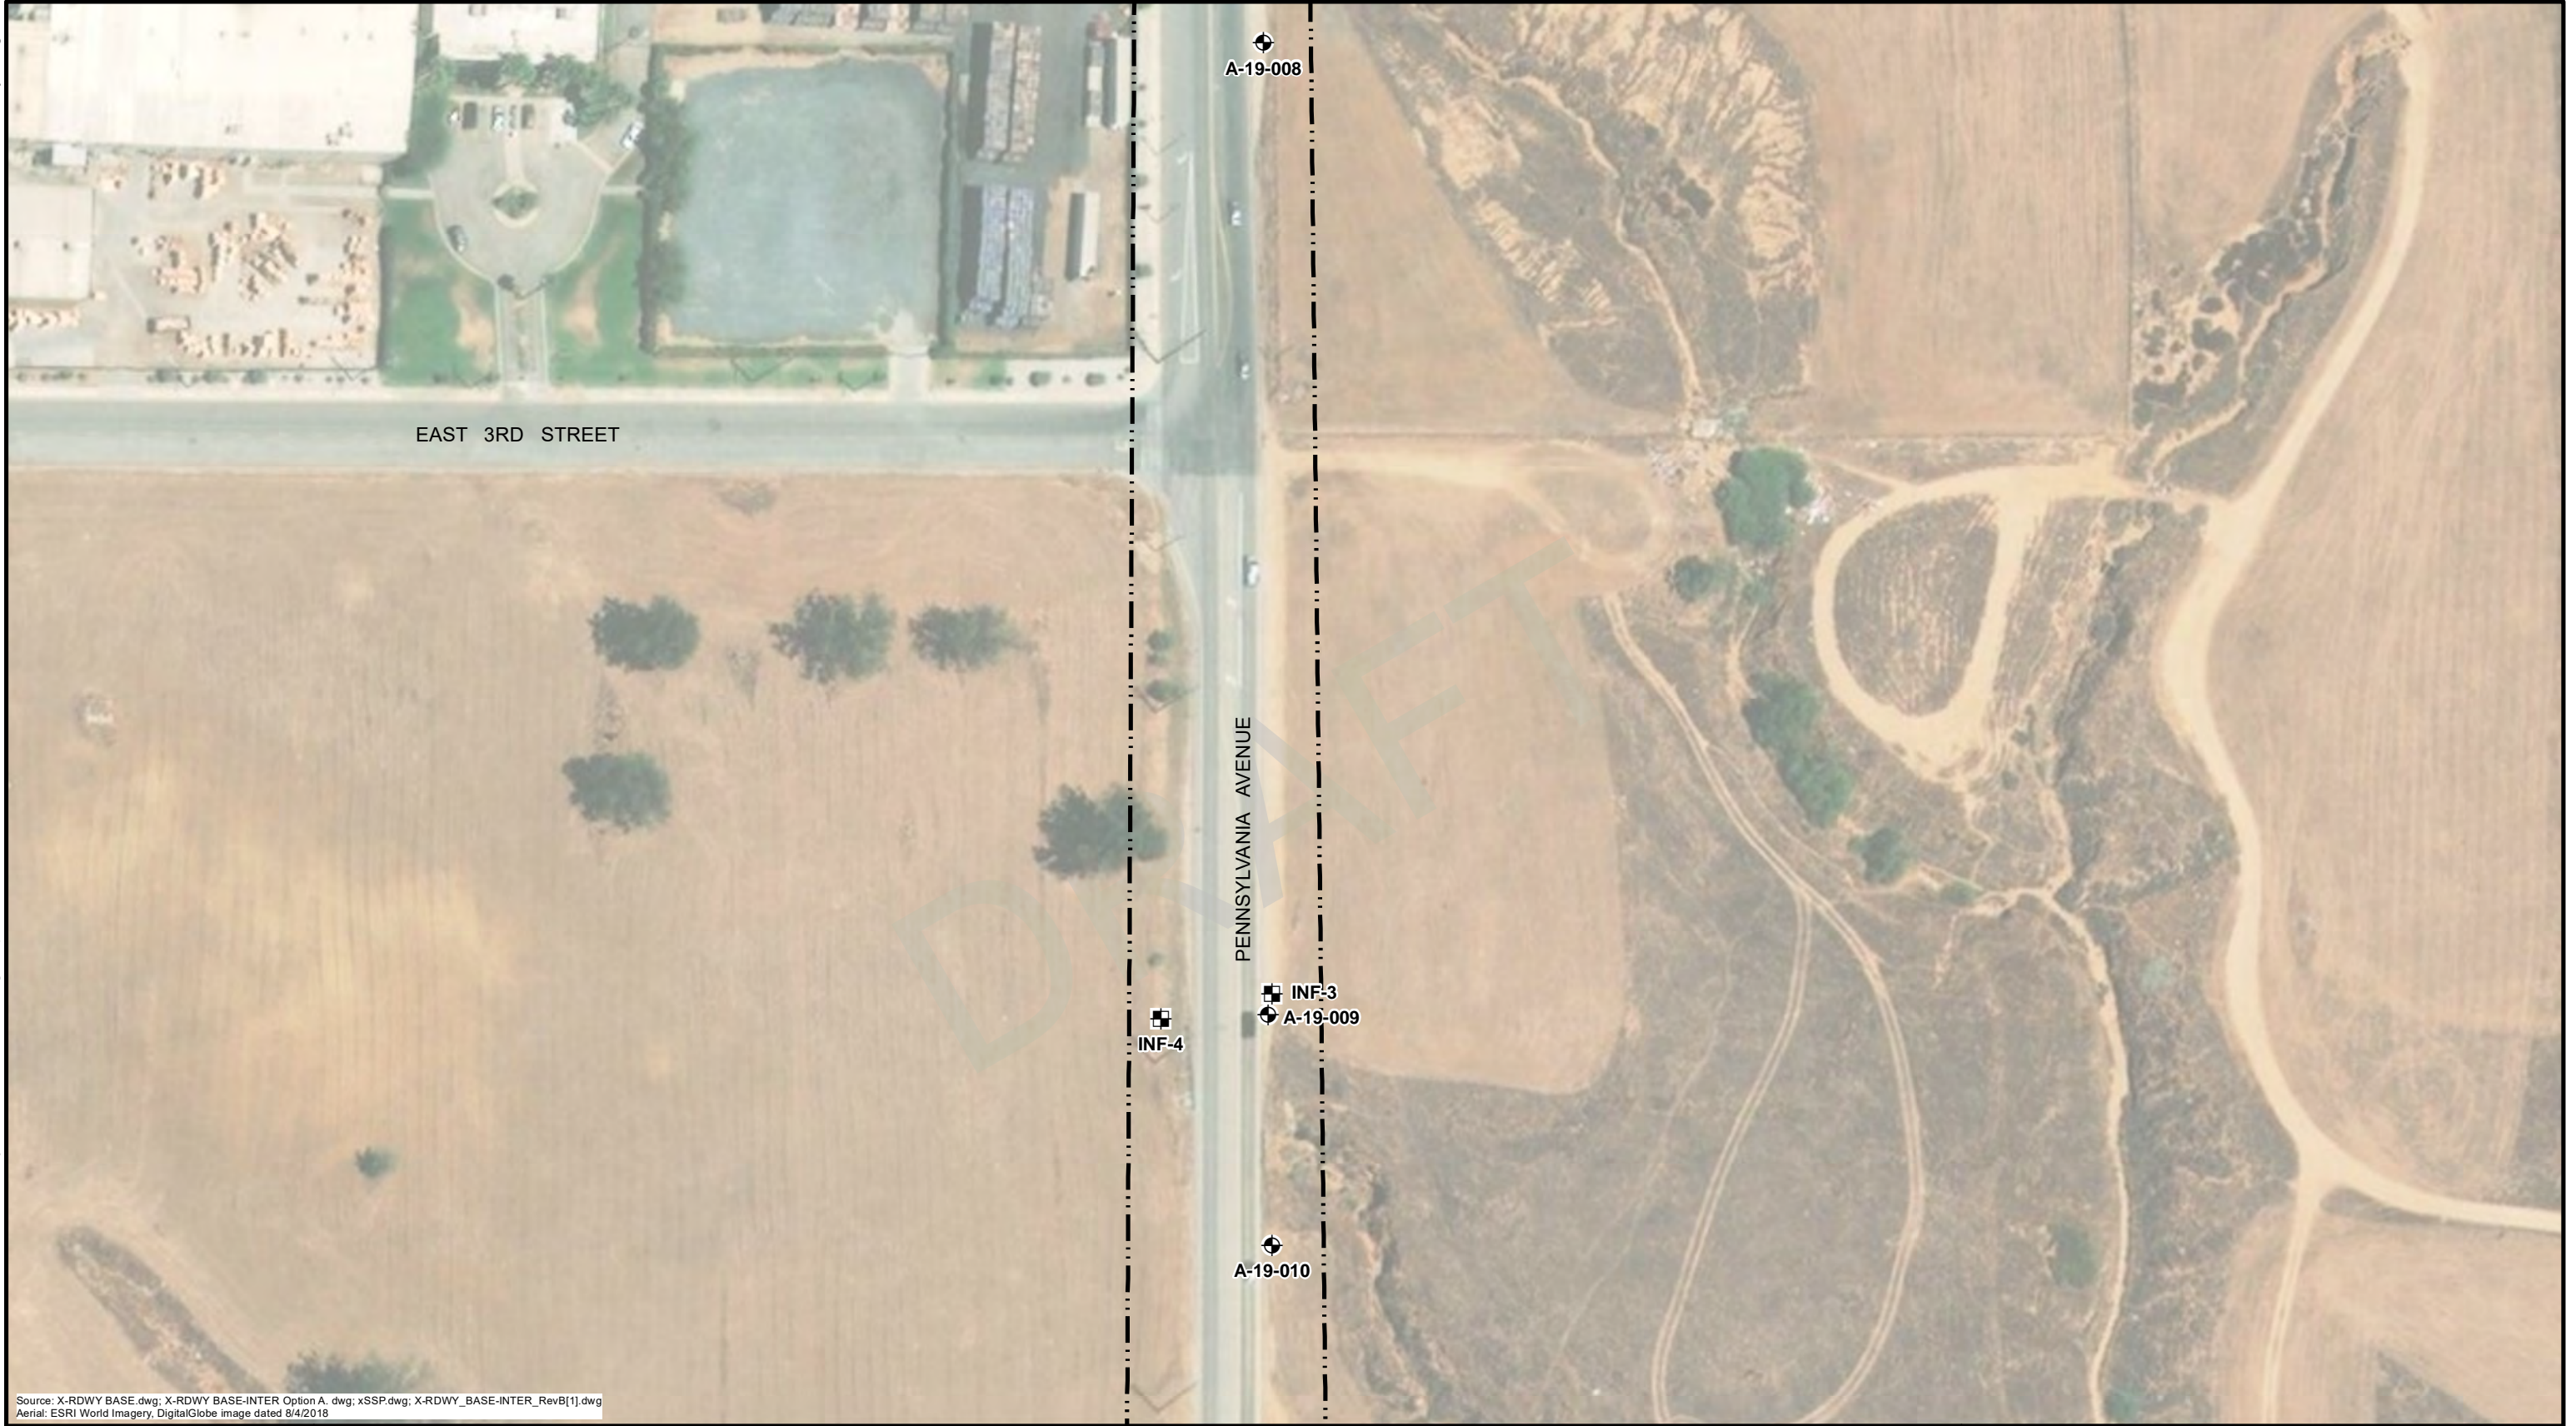
FIGURE
2B

BORING LOCATION MAP	
I-10 PENNSYLVANIA AVENUE INTERCHANGE IMPROVEMENT PROJECT BEAUMONT, CALIFORNIA

Source: X-RDWY BASE.dwg; X-RDWY BASE-INTER Option A.dwg; xSSP.dwg; X-RDWY_BASE-INTER_RevB[1].dwg
 Aerial: ESRI World Imagery, DigitalGlobe image dated 8/4/2018

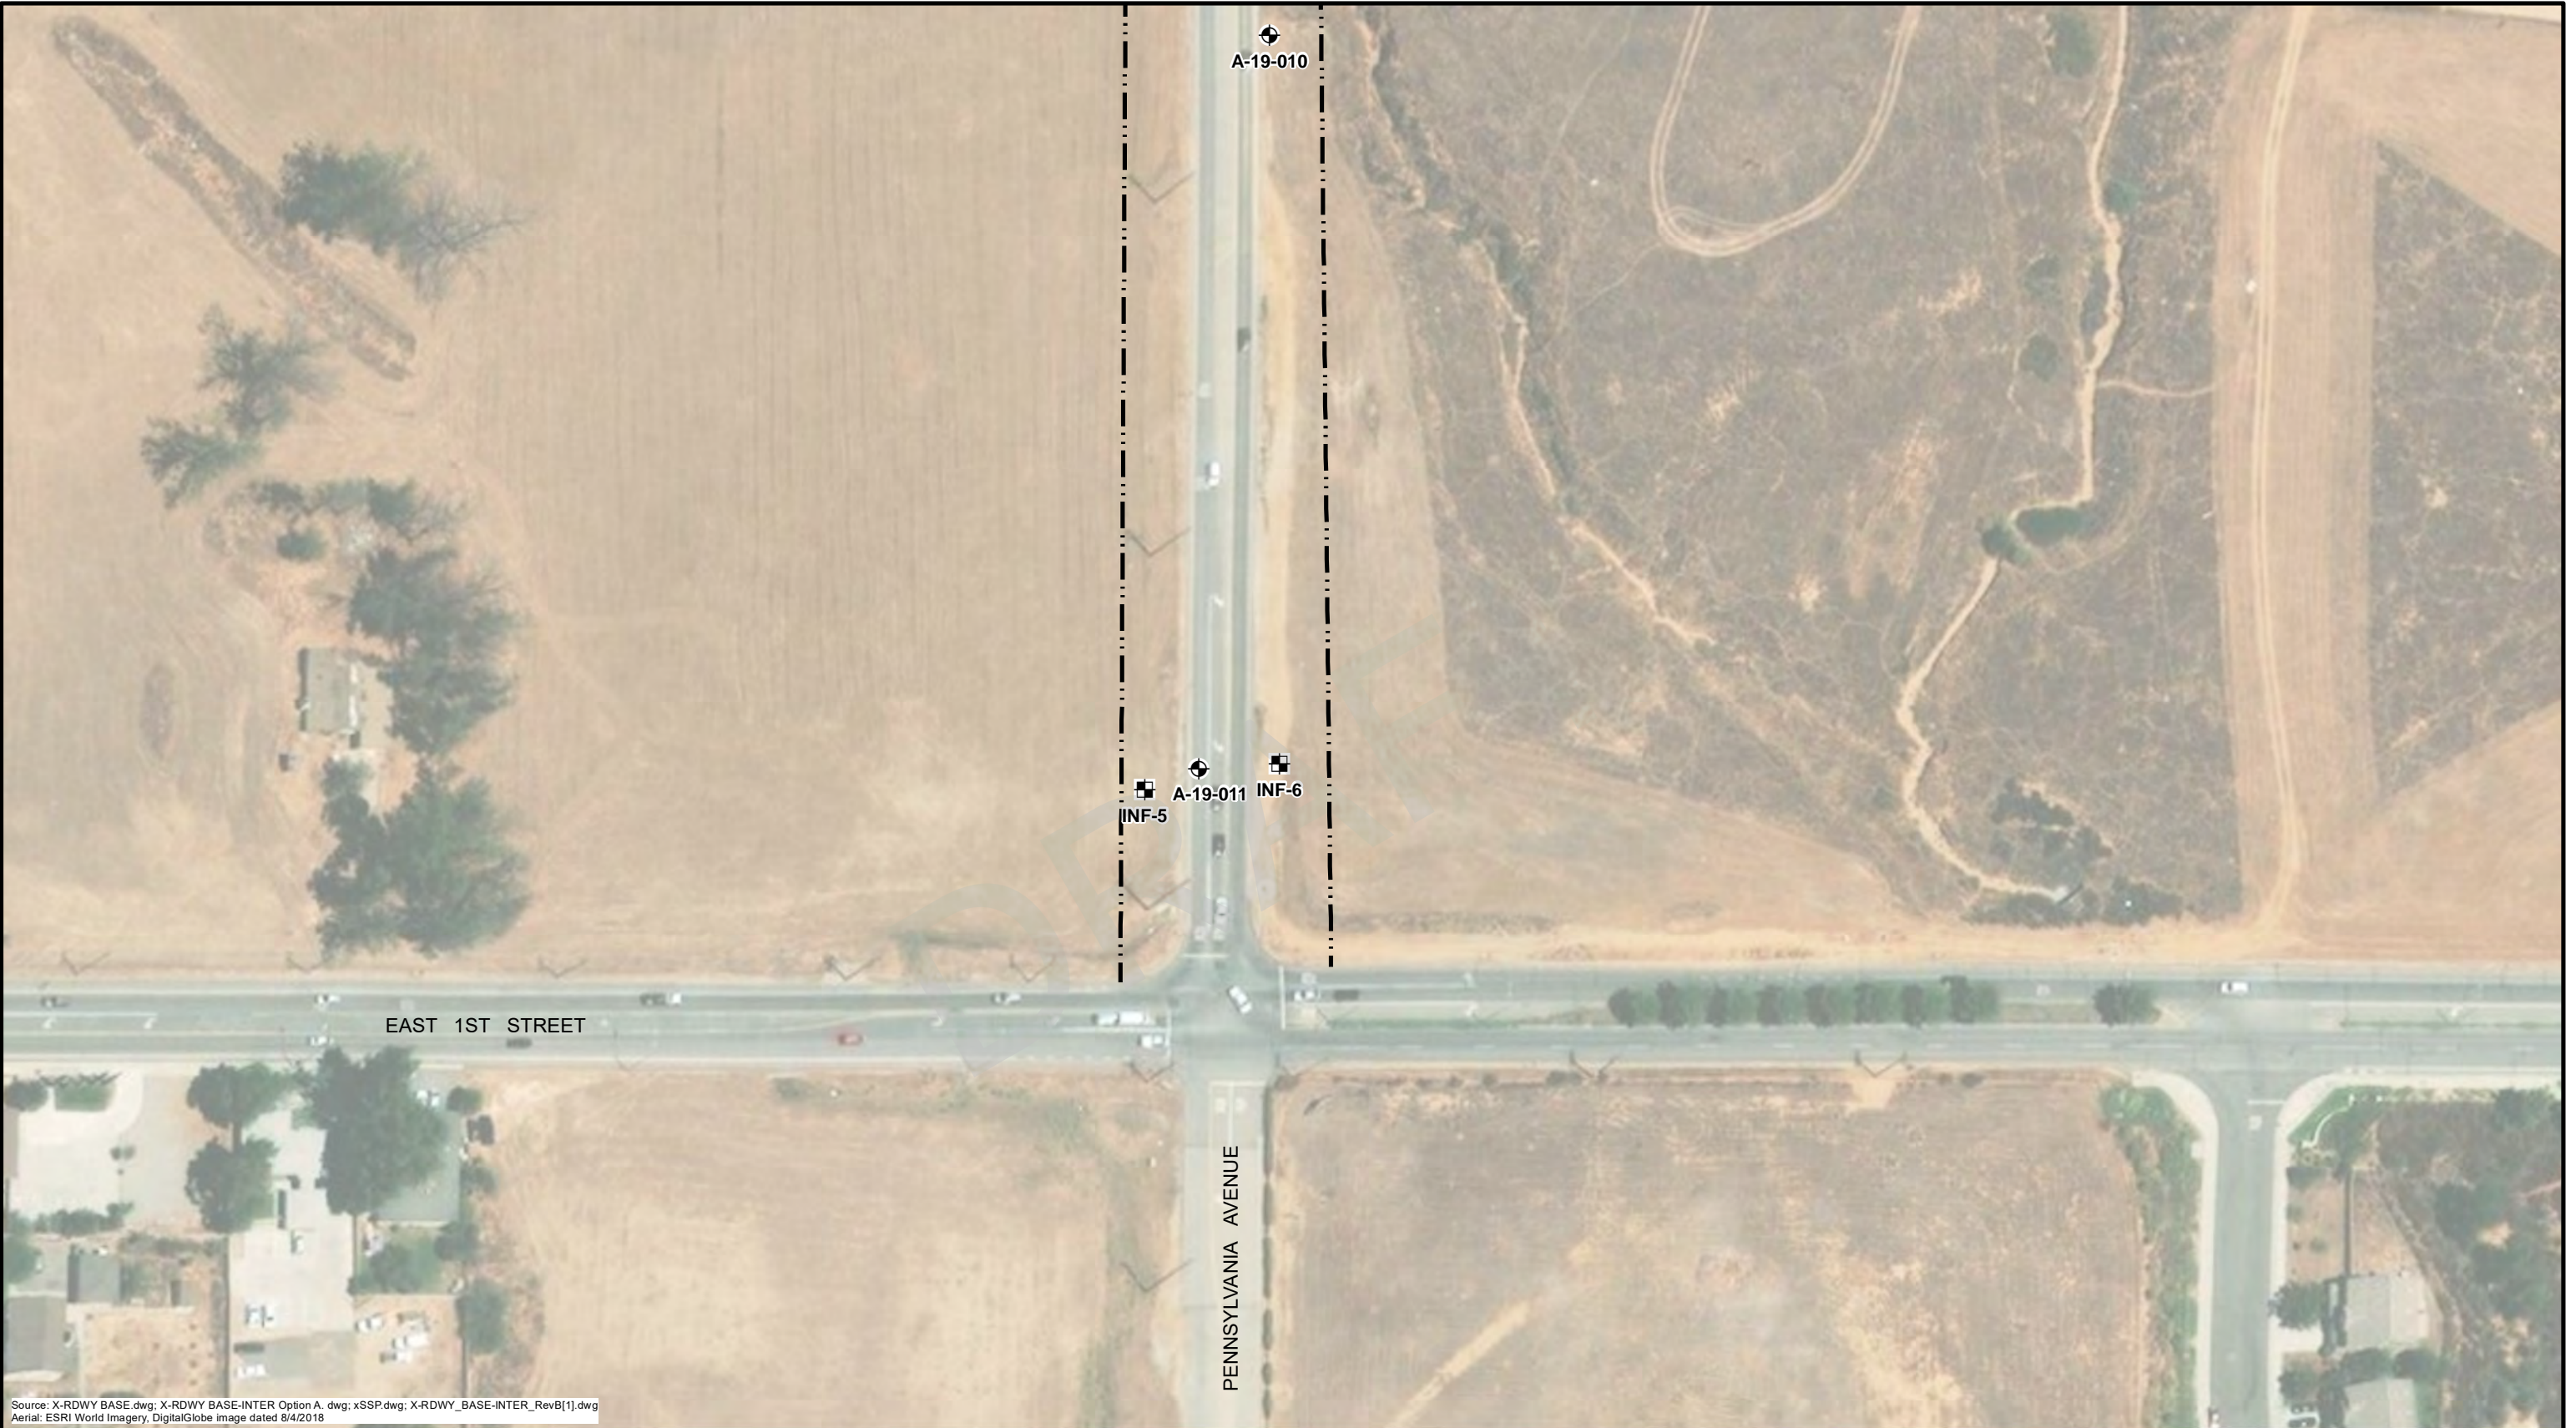
FIGURE
2C

BORING LOCATION MAP	
I-10 PENNSYLVANIA AVENUE INTERCHANGE IMPROVEMENT PROJECT BEAUMONT, CALIFORNIA

- LEGEND**
- ⊕ Approximate Location of Geotechnical Boring
 - ⊞ Approximate Location of Infiltration Test
 - · - · - Approximate Limits of Pennsylvania Avenue Widening

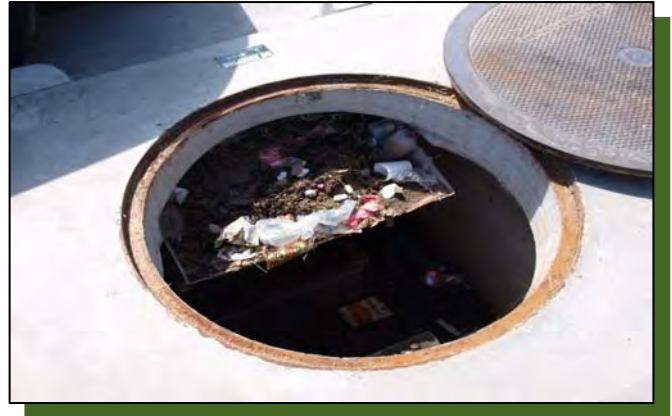
Screening Device

The screening device is located directly under the manhole or grate over the Pre-Treatment Chamber. It's mounted directly underneath for easy access and cleaning. Device can be cleaned by hand or with a vacuum truck.

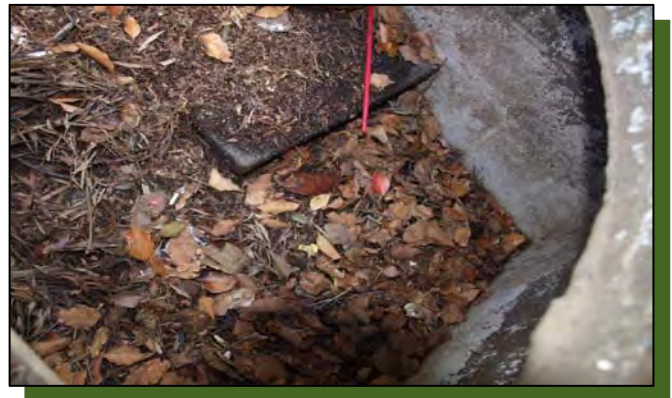
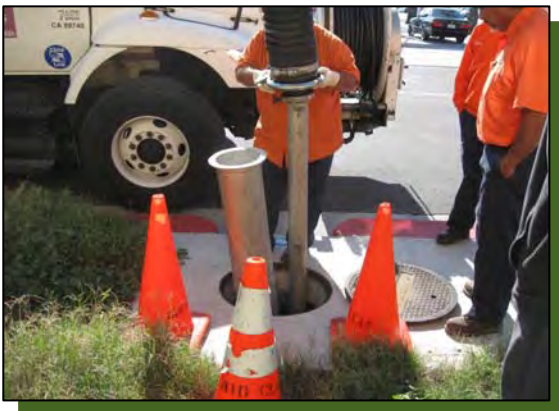
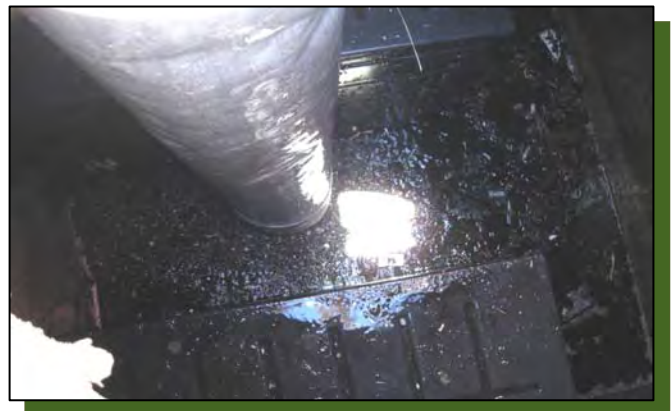
The separation chamber is located directly beneath the screening device. It can be quickly cleaned using a vacuum truck or by hand. A pressure washer is useful to assist in the cleaning process.
