Public Draft
Initial Study & Mitigated Negative Declaration
PENNSYLVANIA AVENUE WIDENING PROJECT

June 2021

City of Beaumont
550 East 6th Street
Beaumont, CA 92223
Contact: Carole Kendrick

moffatt & nichol
4225 E Conant Street
Long Beach, CA 90808
Contact: Stephanie Oslick, AICP, ENV SP

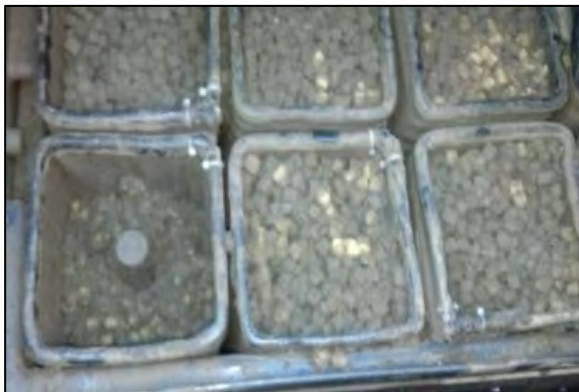
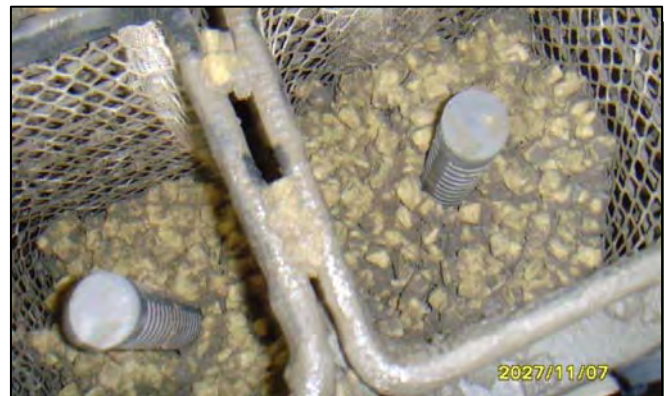
Cartridge Filters

The cartridge filters are located in the Pre-Treatment chamber connected to the wall adjacent to the biofiltration chamber. The cartridges have removable tops to access the individual media filters. Once the cartridge is open media can be easily removed and replaced by hand or a vacuum truck.

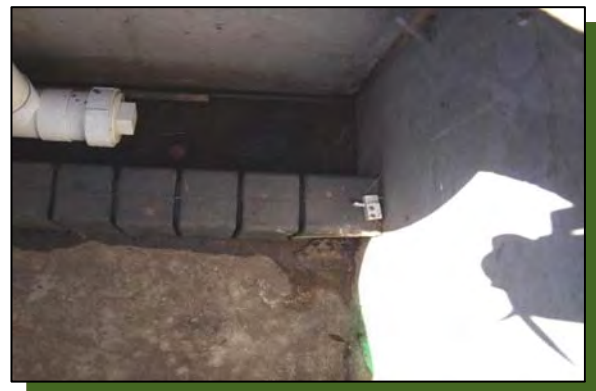
Drain Down Filter

The drain down filter is located in the Discharge Chamber. The drain filter unlocks from the wall mount and hinges up. Remove filter block and replace with new block.

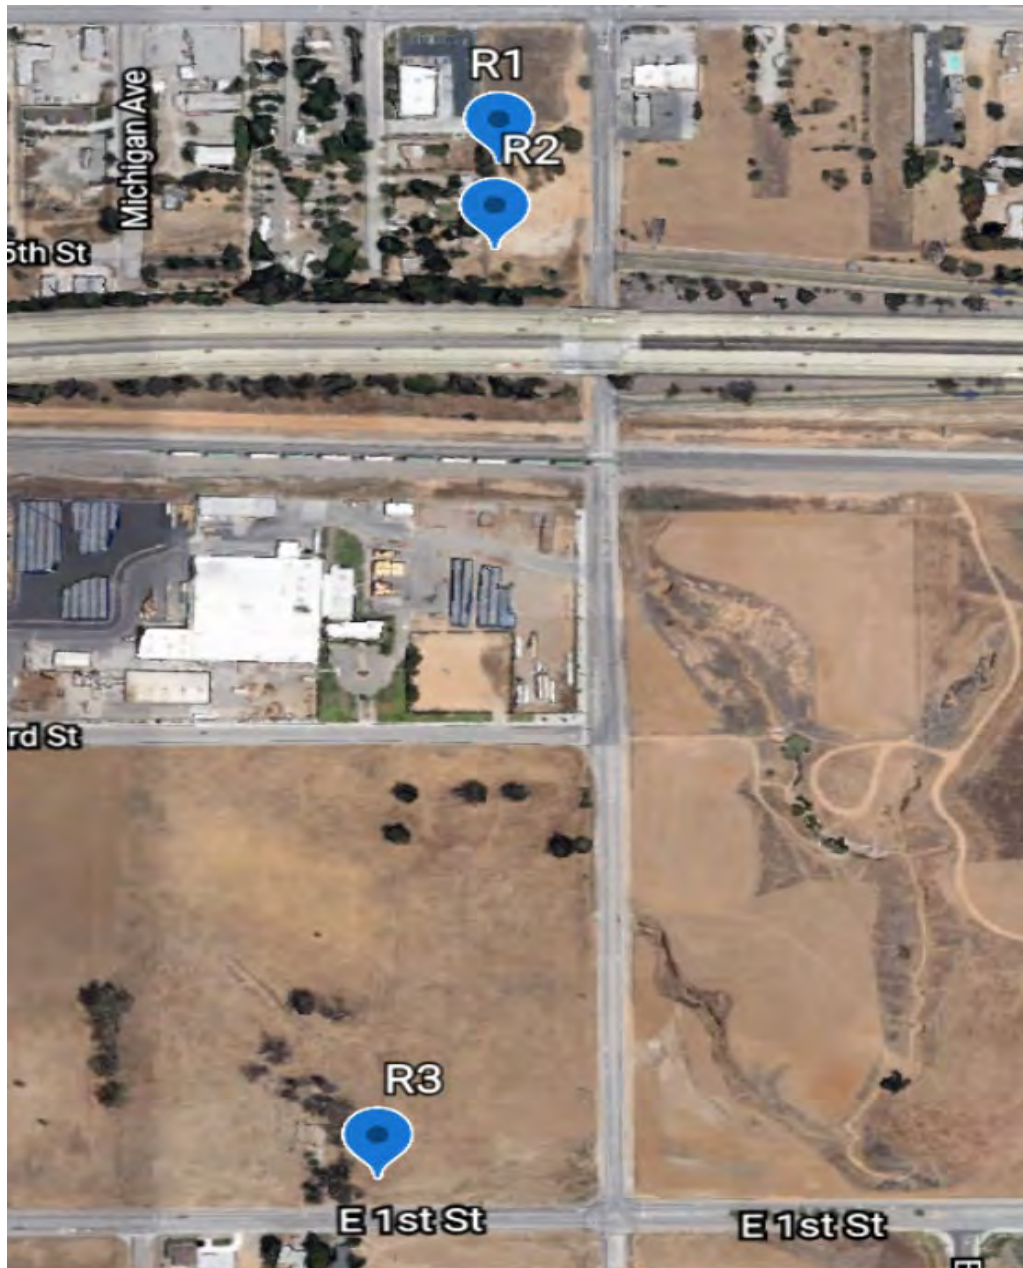
Figure 4. Short Term Measurement Locations

Noise Monitoring Location ID ²	Description	Time of Measurement ³	Primary Noise Source	Noise Levels (L _{eq} dBA)
R-1	Pennsylvania Avenue (S. of East 6 th Street)	10:00 am	Traffic	61.6
R-2	Pennsylvania Avenue (S. of East 6 th Street)	10:30 am	Traffic	67.3
R-3	Pennsylvania Avenue (near East 1 st Street)	11:00 am	Traffic	67.3

1 Noise measurements were taken on June 23, 2020
 2 See Figure 4 for the location of the monitoring sites and Appendix A for Field Monitoring Forms.
 3 Taken with Larson Davis Type 1 noise meter

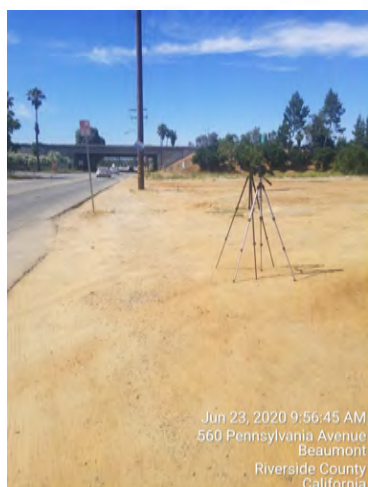
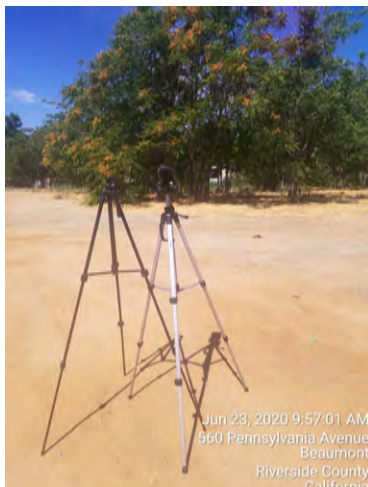
COMMENTS
Flat terrain, dirt ground, open clearing with minimal trees.
Monitor location was \approx 8 feet from the road, (Pennsylvania Ave.)

Jun 23, 2020 9:56:45 AM
 560 Pennsylvania Avenue
 Beaumont
 Riverside County
 California

Jun 23, 2020 9:57:01 AM
 560 Pennsylvania Avenue
 Beaumont
 Riverside County
 California

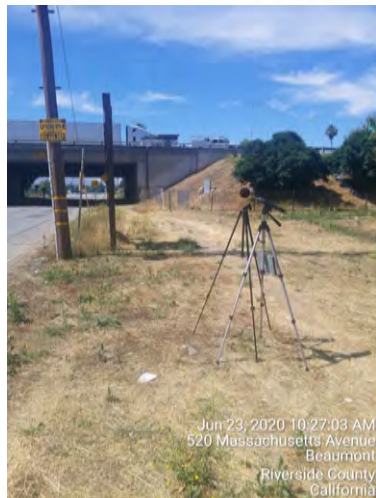
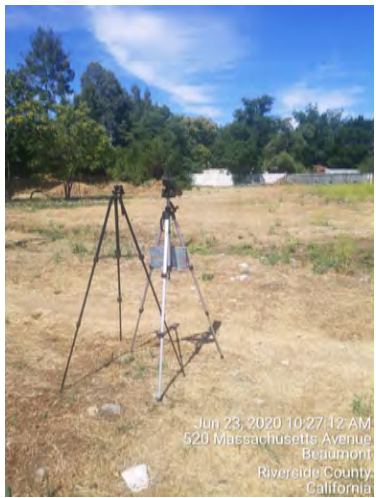
COMMENTS
Flat terrain, dirt ground, open clearing, minimal trees.
Monitor location was ≈ 8 feet from the road (Pennsylvania Ave.)

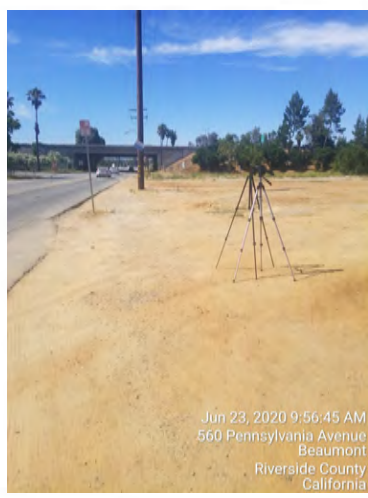
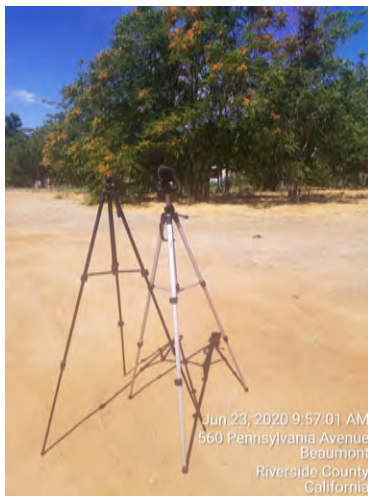
COMMENTS
Flat terrain, dirt ground, open clearing with minimal trees.
Monitor location was \approx 8 feet from the road, (Pennsylvania Ave.)

Jun 23, 2020 9:56:45 AM
 560 Pennsylvania Avenue
 Beaumont
 Riverside County
 California

Jun 23, 2020 9:57:01 AM
 560 Pennsylvania Avenue
 Beaumont
 Riverside County
 California
