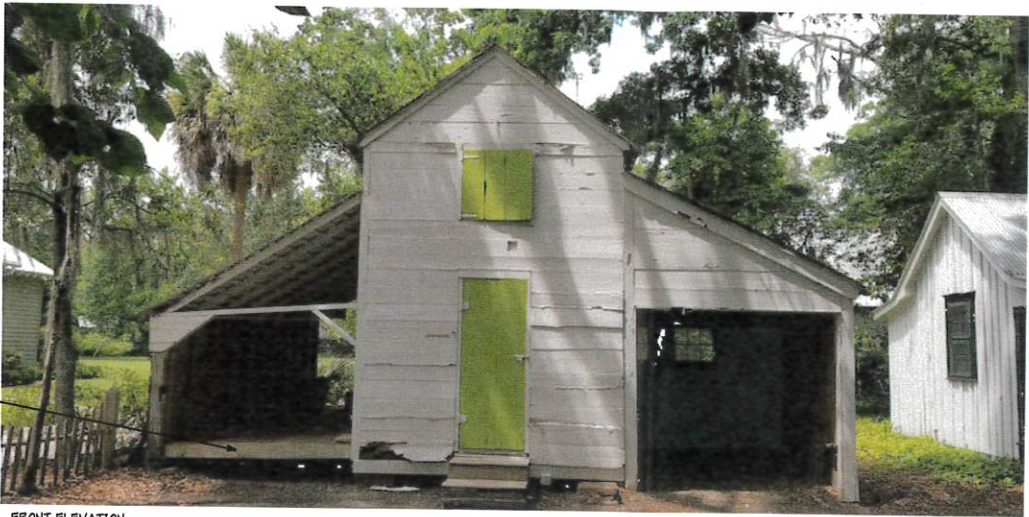
FRONT ELEVATION

RAISED FLOOR OF SIDE BAY, WHICH IS A NEW ADDITION, IS TO BE REMOVED

- REPLACE ROOF WITH NEW CORRUGATED METAL
- REMOVE PAINT WHERE SURFACE DETERIORATION, PREPARE FOR REPAINTING
- PAINT ALL WOOD IN MATCHING COLOR, WHITE SIDING, BLACK WINDOWS, DOORS TO BE BLACK
- PEST MANAGEMENT PLAN HAS BEEN IMPLEMENTED
- REPAIR DAMAGED WOOD COMPONENTS IN PLACE WHERE POSSIBLE. REPLACE IN KIND, EXTENSIVELY DETERIORATED OR MISSING BOARDS. MATCH THE OLD IN MATERIAL, DESIGN, SCALE AND FINISH
- CLEAN AND REPAIR EXISTING WINDOWS AND CASING. PROTECT AND RETAIN HISTORIC GLASS
- NEW CONCRETE SLAB ON GRADE IS TO BE PLACED IN EACH OF THE (2) SIDE BAYS
