WAPAC Meeting Presentation
May River Watershed Action Plan Update & Modeling Report
Quarterly Overview and Status
Created: August 25, 2022
Updated: January 25, 2024

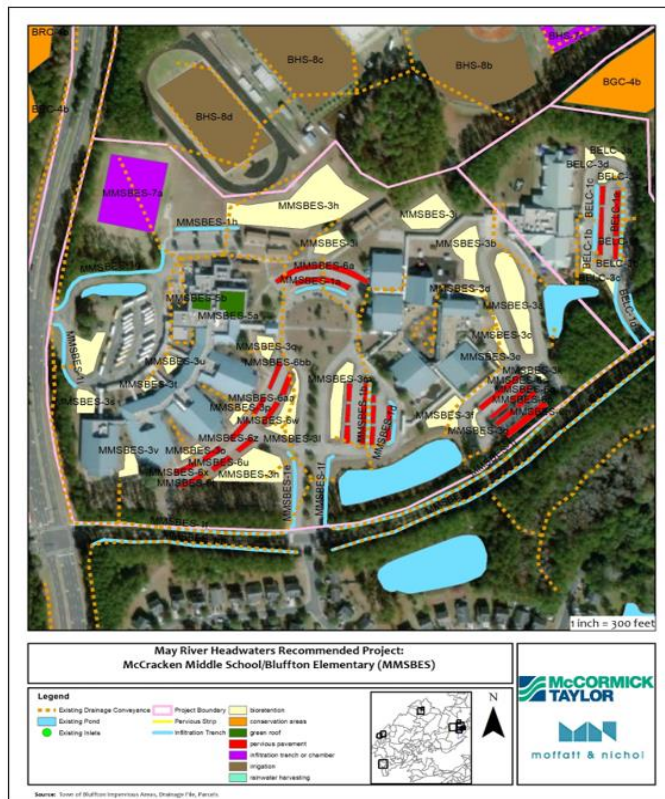
Figure 52. McCracken Middle School/Bluffton Elementary School Proposed Stormwater BMP Retrofits

Example of Impervious Restoration Project evaluation from May River Watershed Action Plan Update & Modeling Report:
