# 125 HOPE STREET

## HISTORICALLY INFORMED RECONSTRUCTION:

# 125 HOPE STREET - PROPOSED

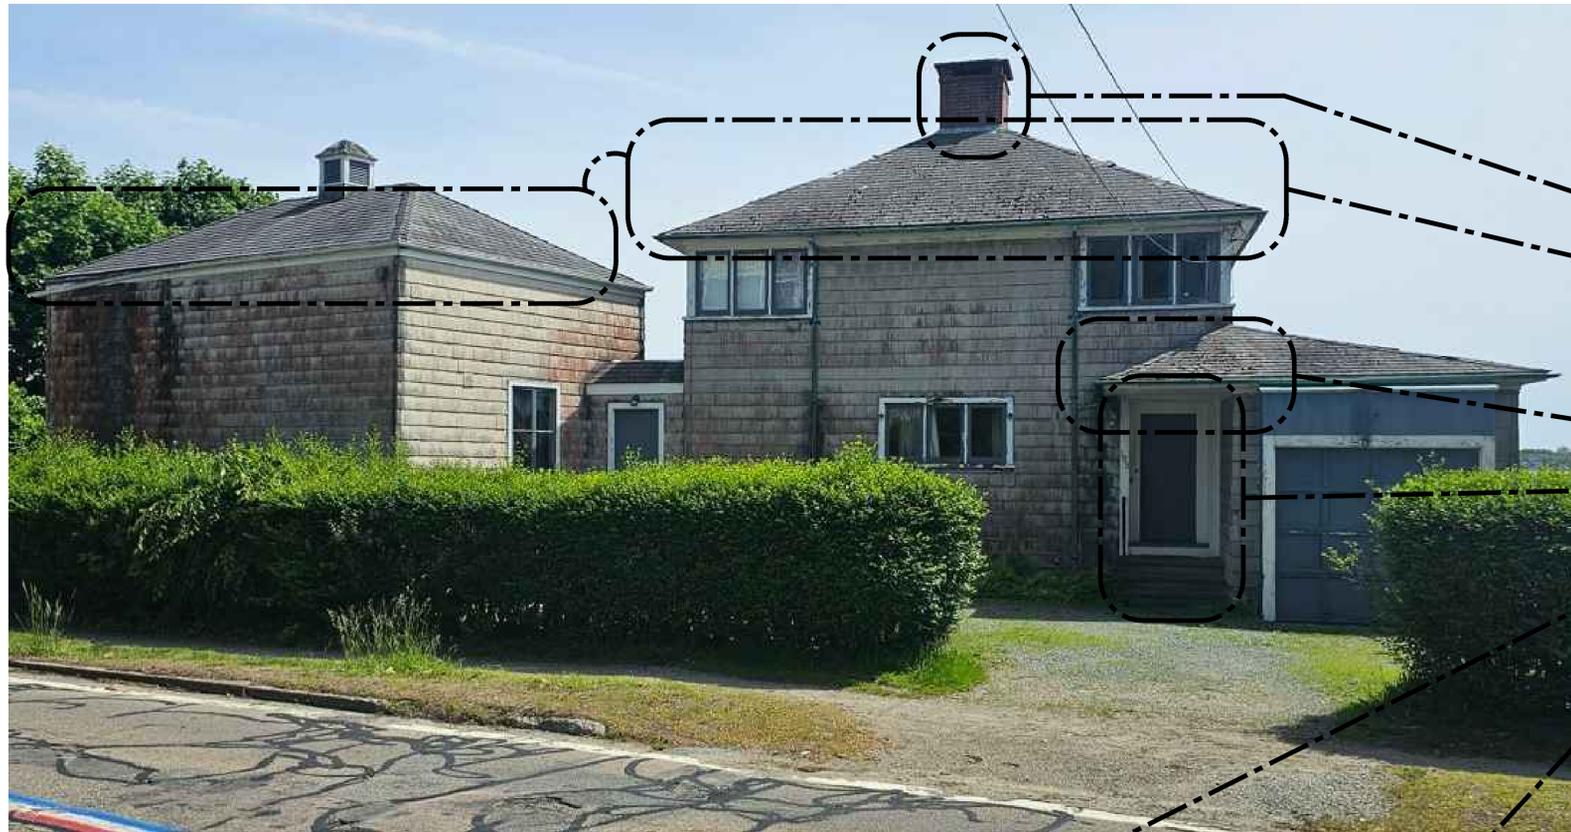
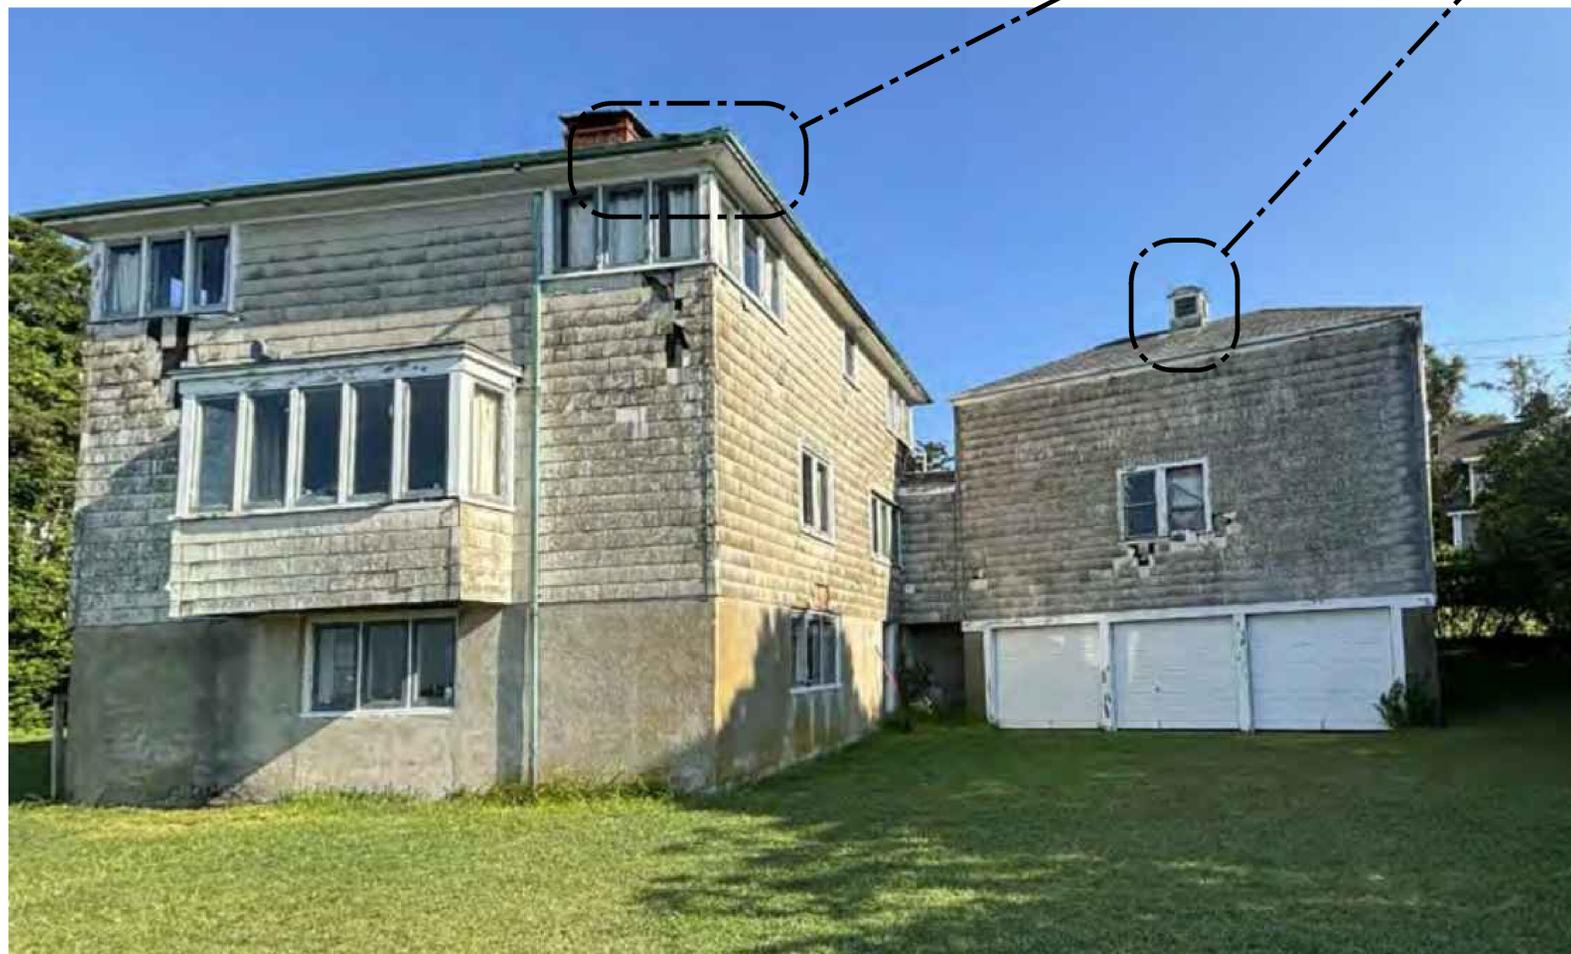
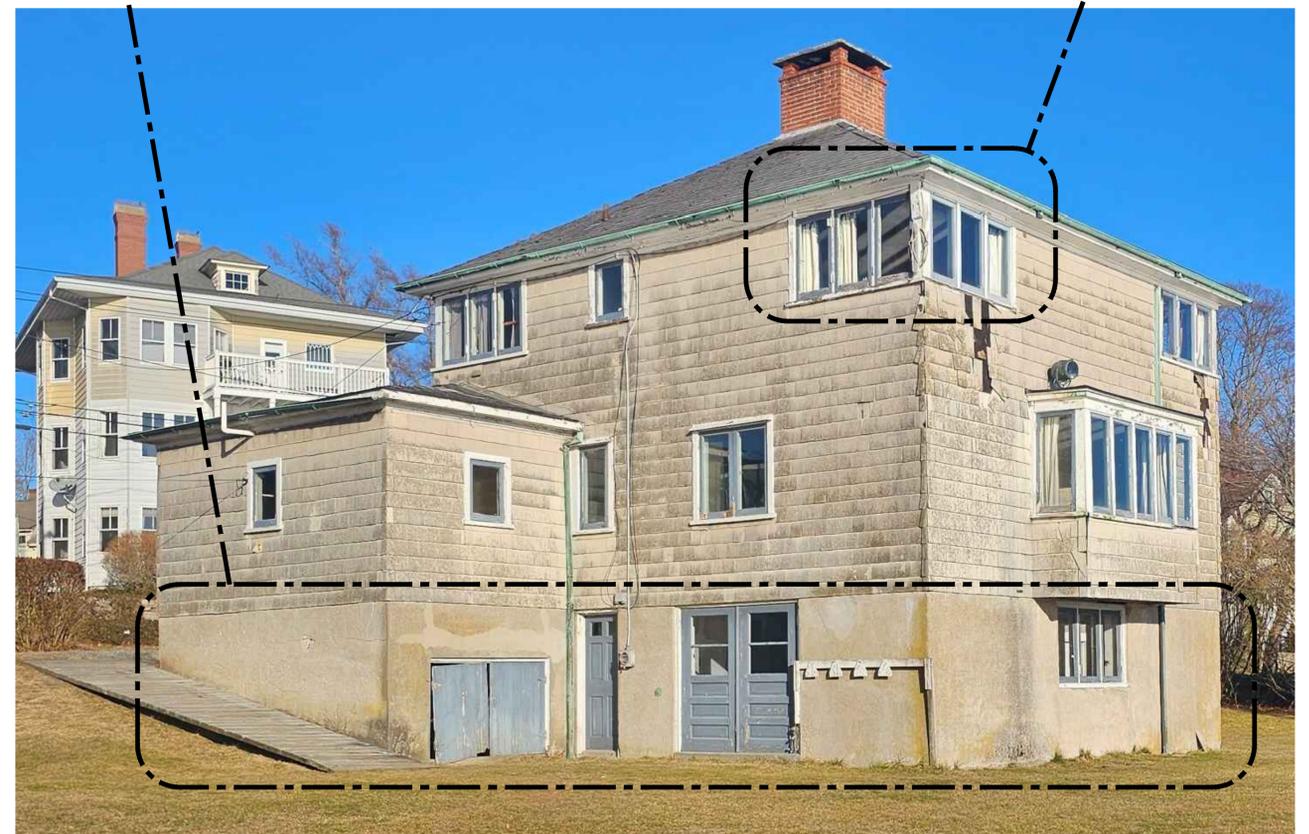
1. CENTRAL BRICK CHIMNEY
2. HIP ROOF
3. JUXTAPOSITION OF STRUCTURES
  - 3.1. RELATIONSHIP TO STREET VS. WATER
4. ROOF CANTILEVER AT ENTRY
5. RECESSED ENTRY
6. ROOF OVERHANG
7. CUPOLA
8. SIMPLE GEOMETRY
9. CORNER/GROUPED WINDOWS
10. MATERIALS
  - 10.1. DISTINCTIVE 'FOUNDATION'
  - 10.2. ASBESTOS SHINGLE SIDING
  - 10.3. ASBESTOS SHINGLE ROOF

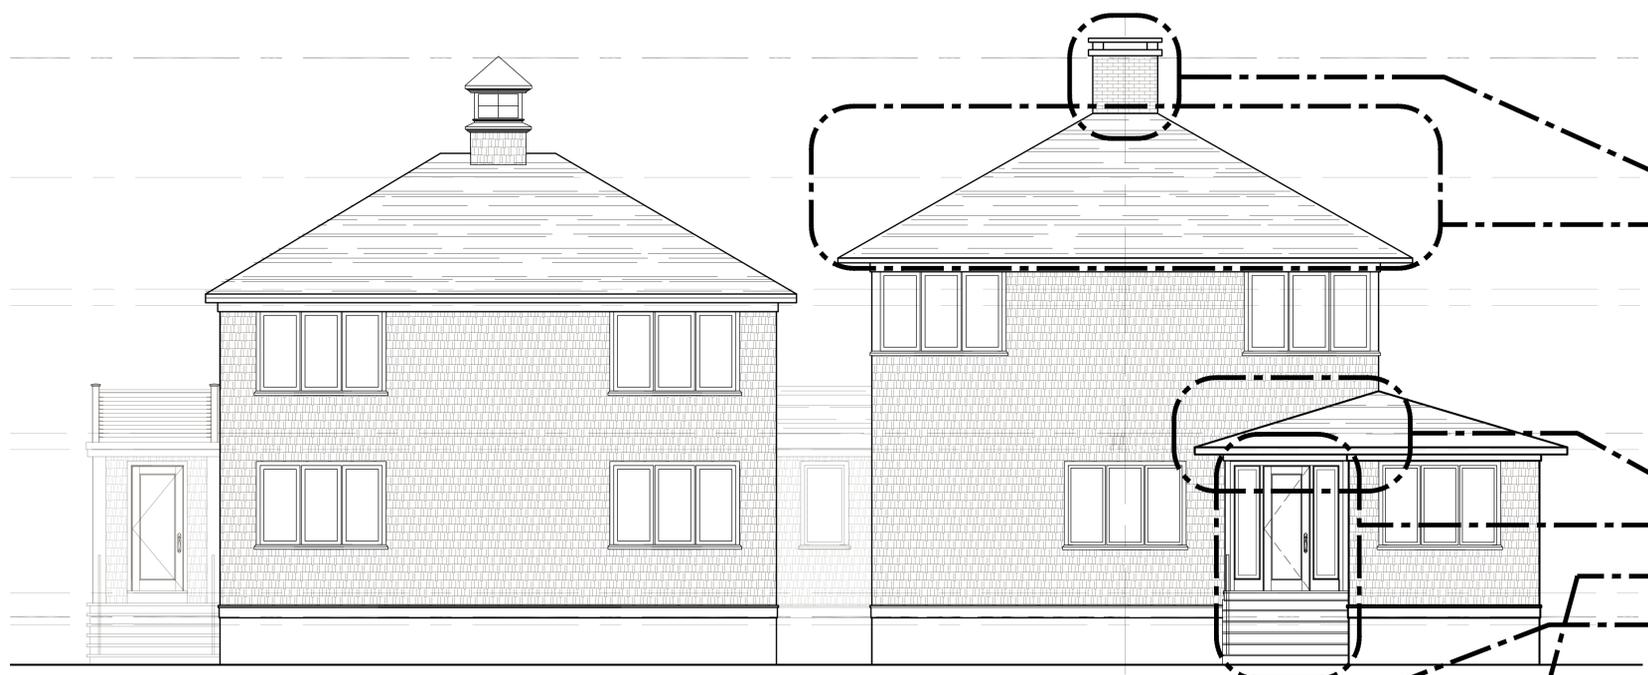
## OPTION A1

TWO STRUCTURES REMAIN  
IN EXISTING  
CONFIGURATION,  
ATTACHED WITH A HYPHEN

ENTRY FOR 'MODEL ROOM'  
ADDED AT THE EAST SIDE,  
SETBACK FROM STREET

GROUPED WINDOW UNITS  
USED WHERE SOLID WALL  
EXISTED

1. CENTRAL BRICK CHIMNEY
2. HIP ROOF
3. JUXTAPOSITION OF STRUCTURES
  - 3.1. RELATIONSHIP TO STREET VS. WATER
4. ROOF CANTILEVER AT ENTRY
5. RECESSED ENTRY
6. ROOF OVERHANG
7. CUPOLA
8. SIMPLE GEOMETRY
9. CORNER/GROUPED WINDOWS
10. MATERIALS
  - 10.1. DISTINCTIVE 'FOUNDATION'
  - 10.2. ASBESTOS SHINGLE SIDING TO COMPOSITE SHINGLE
  - 10.3. ASBESTOS SHINGLE ROOF TO ASPHALT SHINGLE

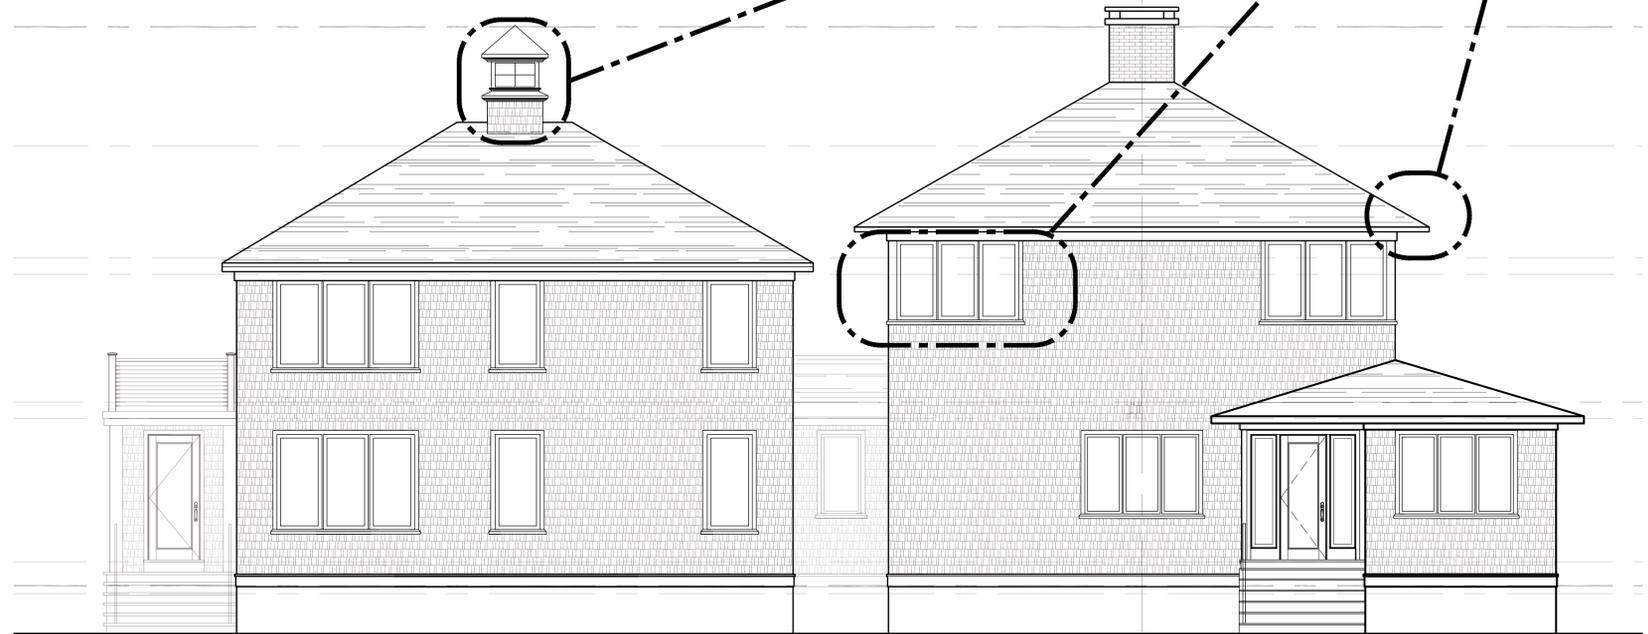
## OPTION A2

SAME; DIFFERENT WINDOW  
CONFIGURATION

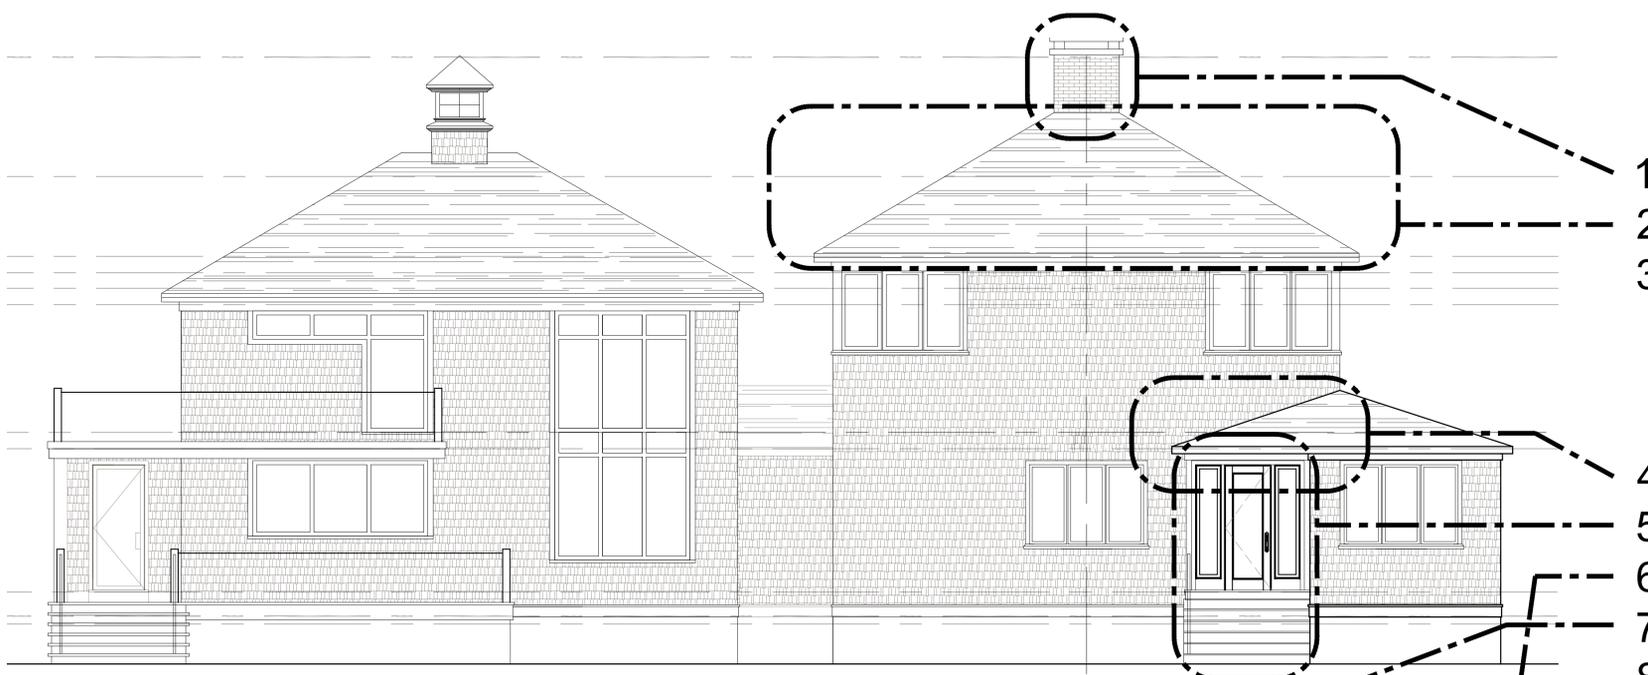
## OPTION B

TWO STRUCTURES REMAIN IN EXISTING CONFIGURATION, ATTACHED WITH A HYPHEN

'MODEL ROOM' IS RE-ENVISIONED TO DISTINGUISH THE ORIGINAL DESIGN FROM THE MODIFIED 'ADDITION'

1. CENTRAL BRICK CHIMNEY
2. HIP ROOF
3. JUXTAPOSITION OF STRUCTURES
  - 3.1. RELATIONSHIP TO STREET VS. WATER
4. ROOF CANTILEVER AT ENTRY
5. RECESSED ENTRY
6. ROOF OVERHANG
7. CUPOLA
8. SIMPLE GEOMETRY
9. CORNER/GROUPED WINDOWS
10. MATERIALS
  - 10.1. DISTINCTIVE 'FOUNDATION'
  - 10.2. ASBESTOS SHINGLE SIDING TO COMPOSITE SHINGLE
  - 10.3. ASBESTOS SHINGLE ROOF TO ASPHALT SHINGLE

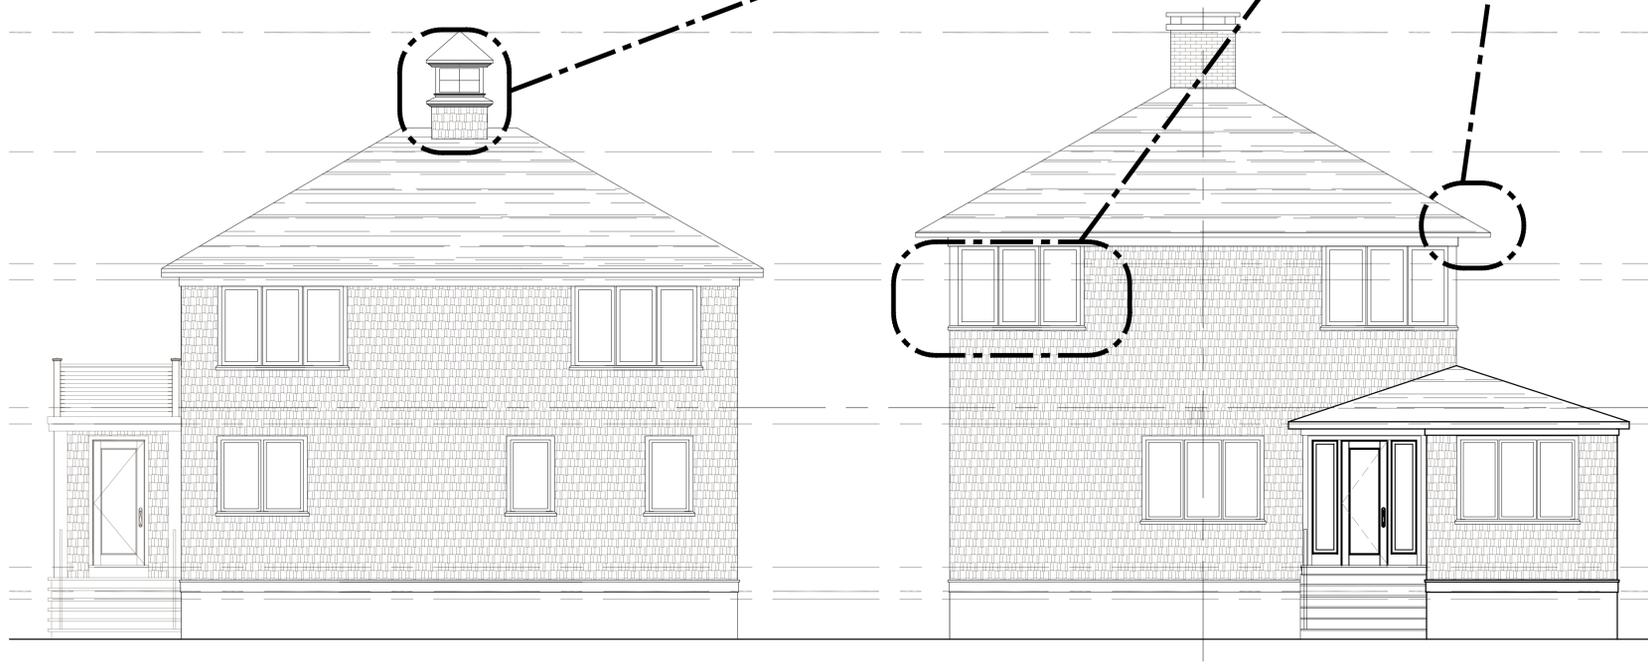
## OPTION C

DETACHED CONFIGURATION SHOWN FOR COMPARISON
