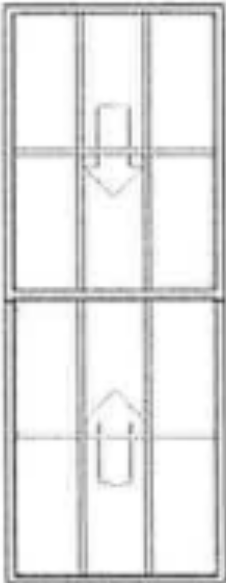
-Damaged window that exists along with the 2 window openings with plywood will be replaced with custom made windows. The windows will be wood on the inside and white enduraclad on the outside. The image shows a spec drawing of the windows.
