CITY OF CAMAS, WA

Athletic Fields and Courts: Strategic Assessment and Recommendations

February 10, 2026

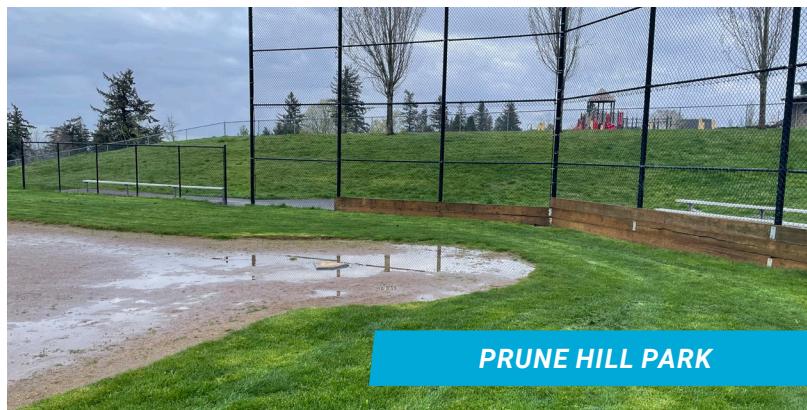
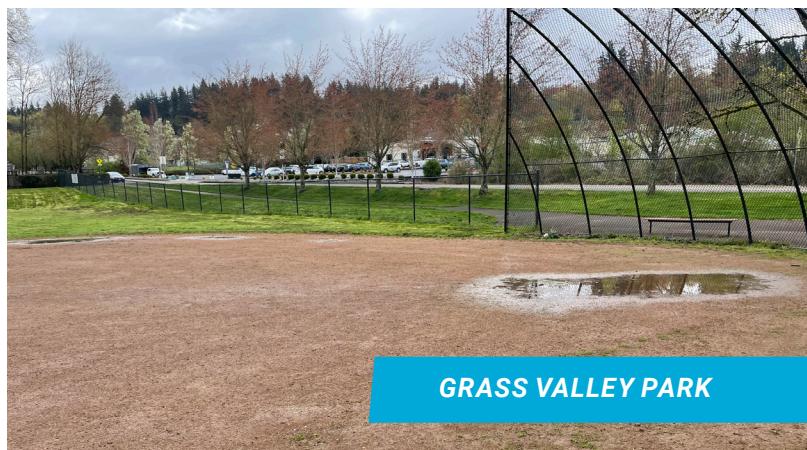
- **Drainage Limitations and Turf Wear:** Many natural grass fields experience poor drainage, particularly during the fall, winter, and spring seasons. Prolonged saturation leads to turf damage, uneven playing surfaces, and frequent closures to prevent long-term degradation. High-use areas, including infields and areas immediately in front of goals, are especially susceptible to wear.

Poor drainage and ponding reduce field reliability and increase weather-related closures.

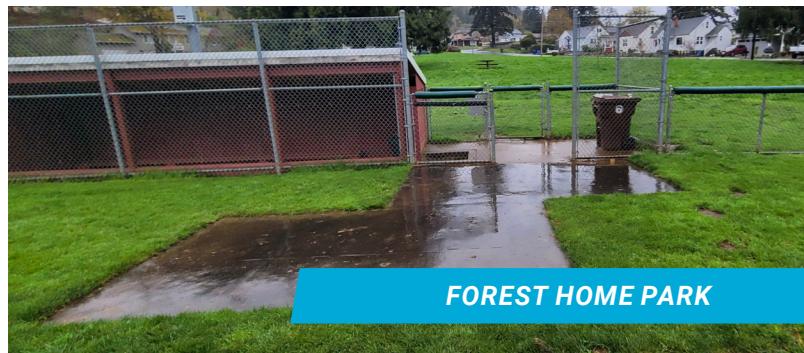
Poor drainage and limited sidewalk connections near the dugouts at Forest Home Park affect accessibility, user safety, and overall field usability.

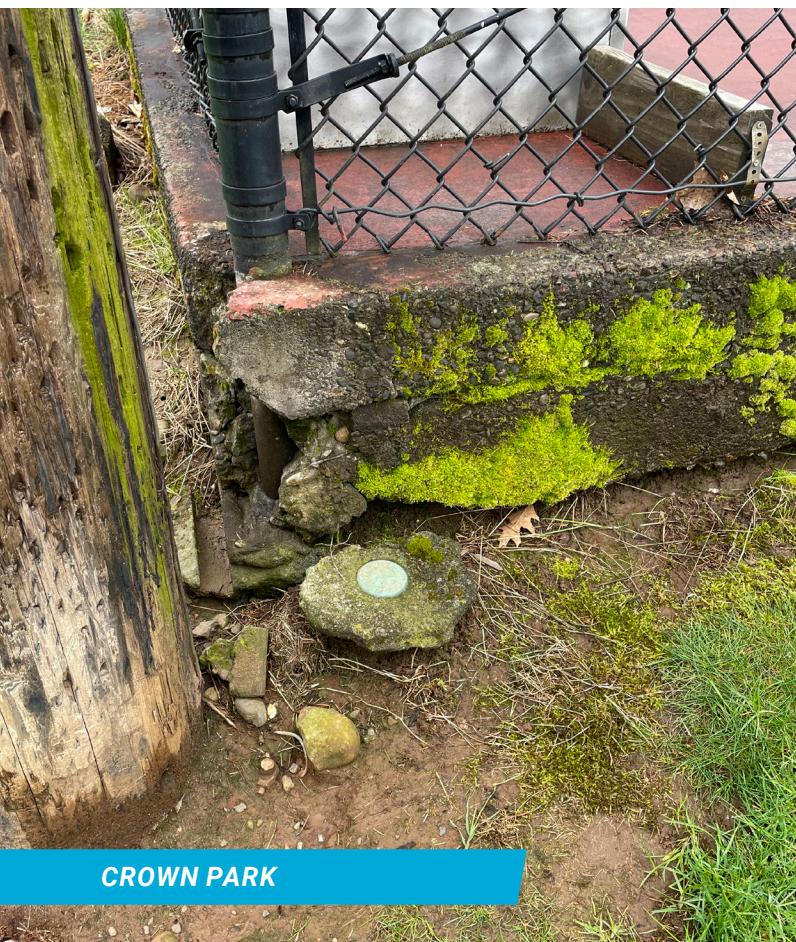
CROWN PARK

Fence repairs are needed to maintain safe and functional athletic facilities.

- Repair of court fencing and footings to address safety and functional concerns

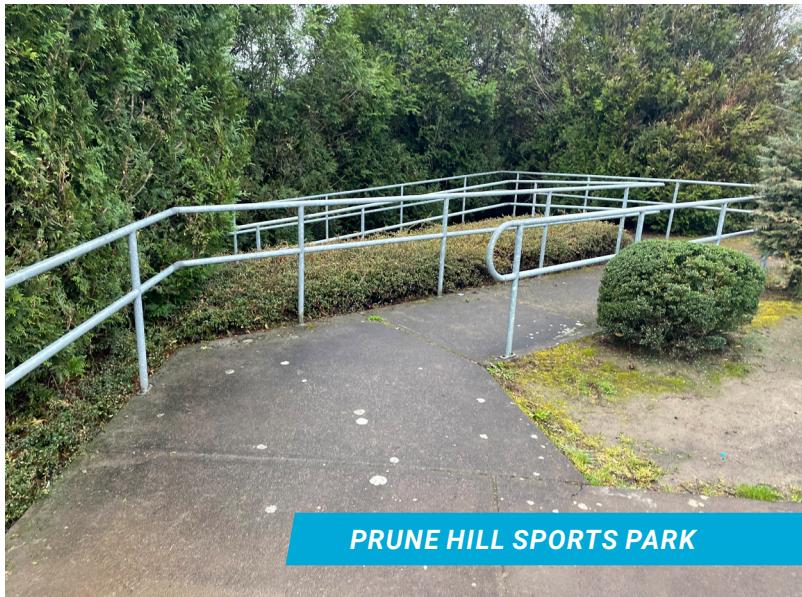
PRUNE HILL SPORTS PARK

Gaps in accessible routes and amenities limit equitable access for users with disabilities and do not meet current accessibility expectations.

- Field drainage improvements, potentially addressing subsurface water issues
- Addition of player benches, bleachers, and backstop fencing
- Soil remediation to improve turf health
- New walkways and improved access to adjacent school facilities
- ADA improvements, including detectable warnings and accessible routes

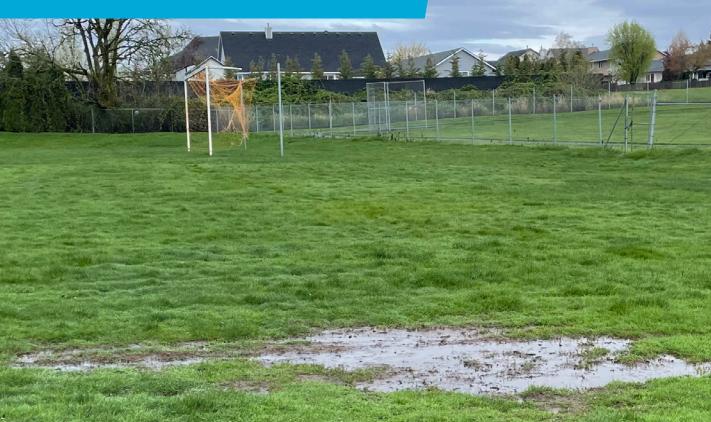
Standing water and saturated turf following rainfall reduce field reliability and increase weather related closures.

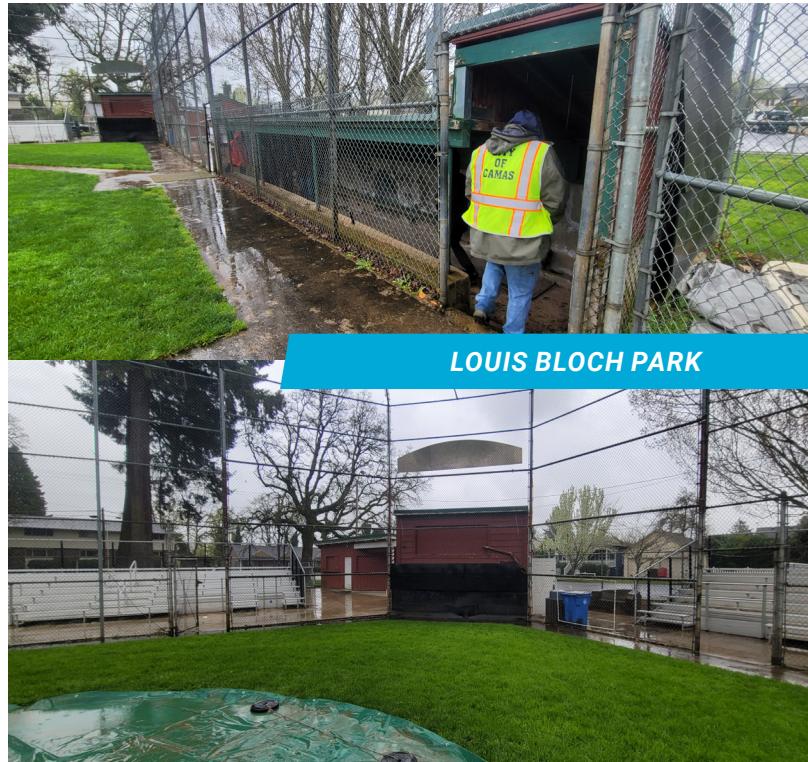
LOUIS BLOCH PARK

Ongoing fence maintenance and repair are necessary to support safe play, reduce ongoing maintenance issues and extend the life of athletic facilities.

- Field drainage improvements and synthetic turf infield conversion
- Flexible field markings and removable bases
- Addition of bullpens and batting cages
- Backstop fencing and net upgrades
- Upgrades to concessions, announcer box, and storage buildings
- ADA improvements to dugouts, restrooms, and spectator access
- Improved access to adjacent basketball court and walkways

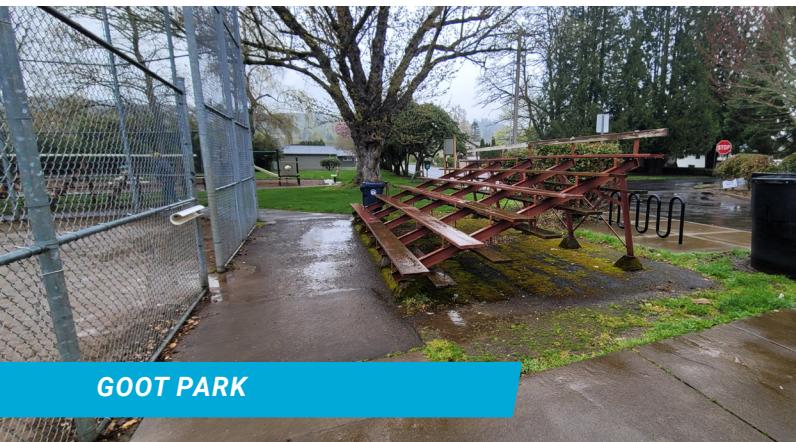
Limited accessible routes and amenities restrict safe and equitable access to athletic facilities.

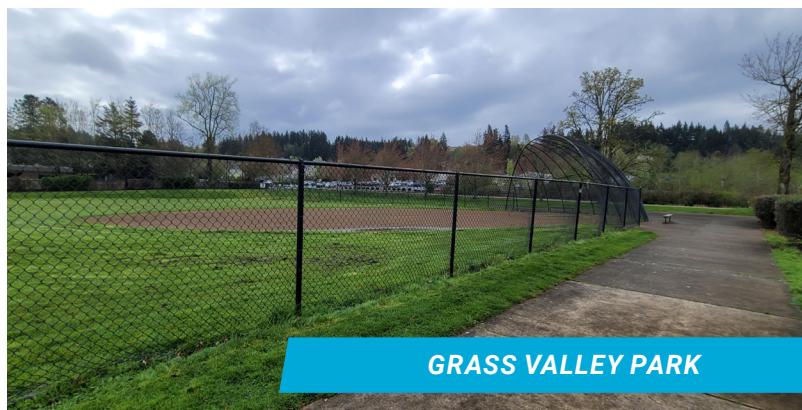
Drainage limitations and ponding reduce playable days and accelerate turf wear, limiting reliable field access.

- Field drainage improvements and synthetic turf infield conversion
- Flexible field markings and removable bases
- Outfield aeration and topdressing
- Fencing, backstop, and bleacher upgrades

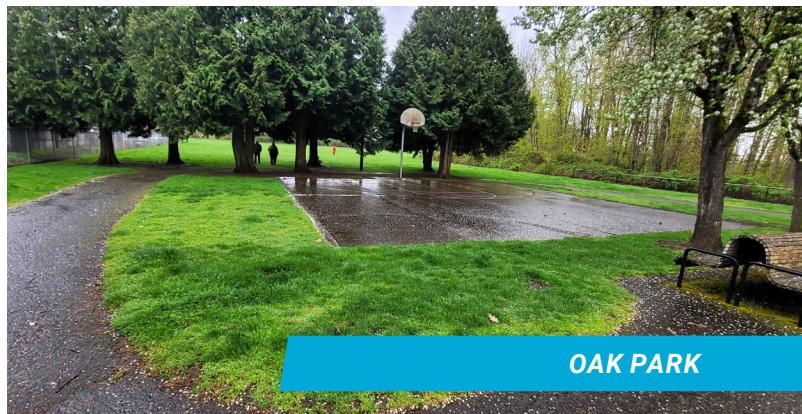
Converting existing basketball court to multi-use courts can improve flexibility and respond to changing recreation demand without expanding the system.

- Repair and resurfacing of the existing basketball court
- Conversion to a multi-use court, including potential pickleball
- Site furnishing improvements and new walkways

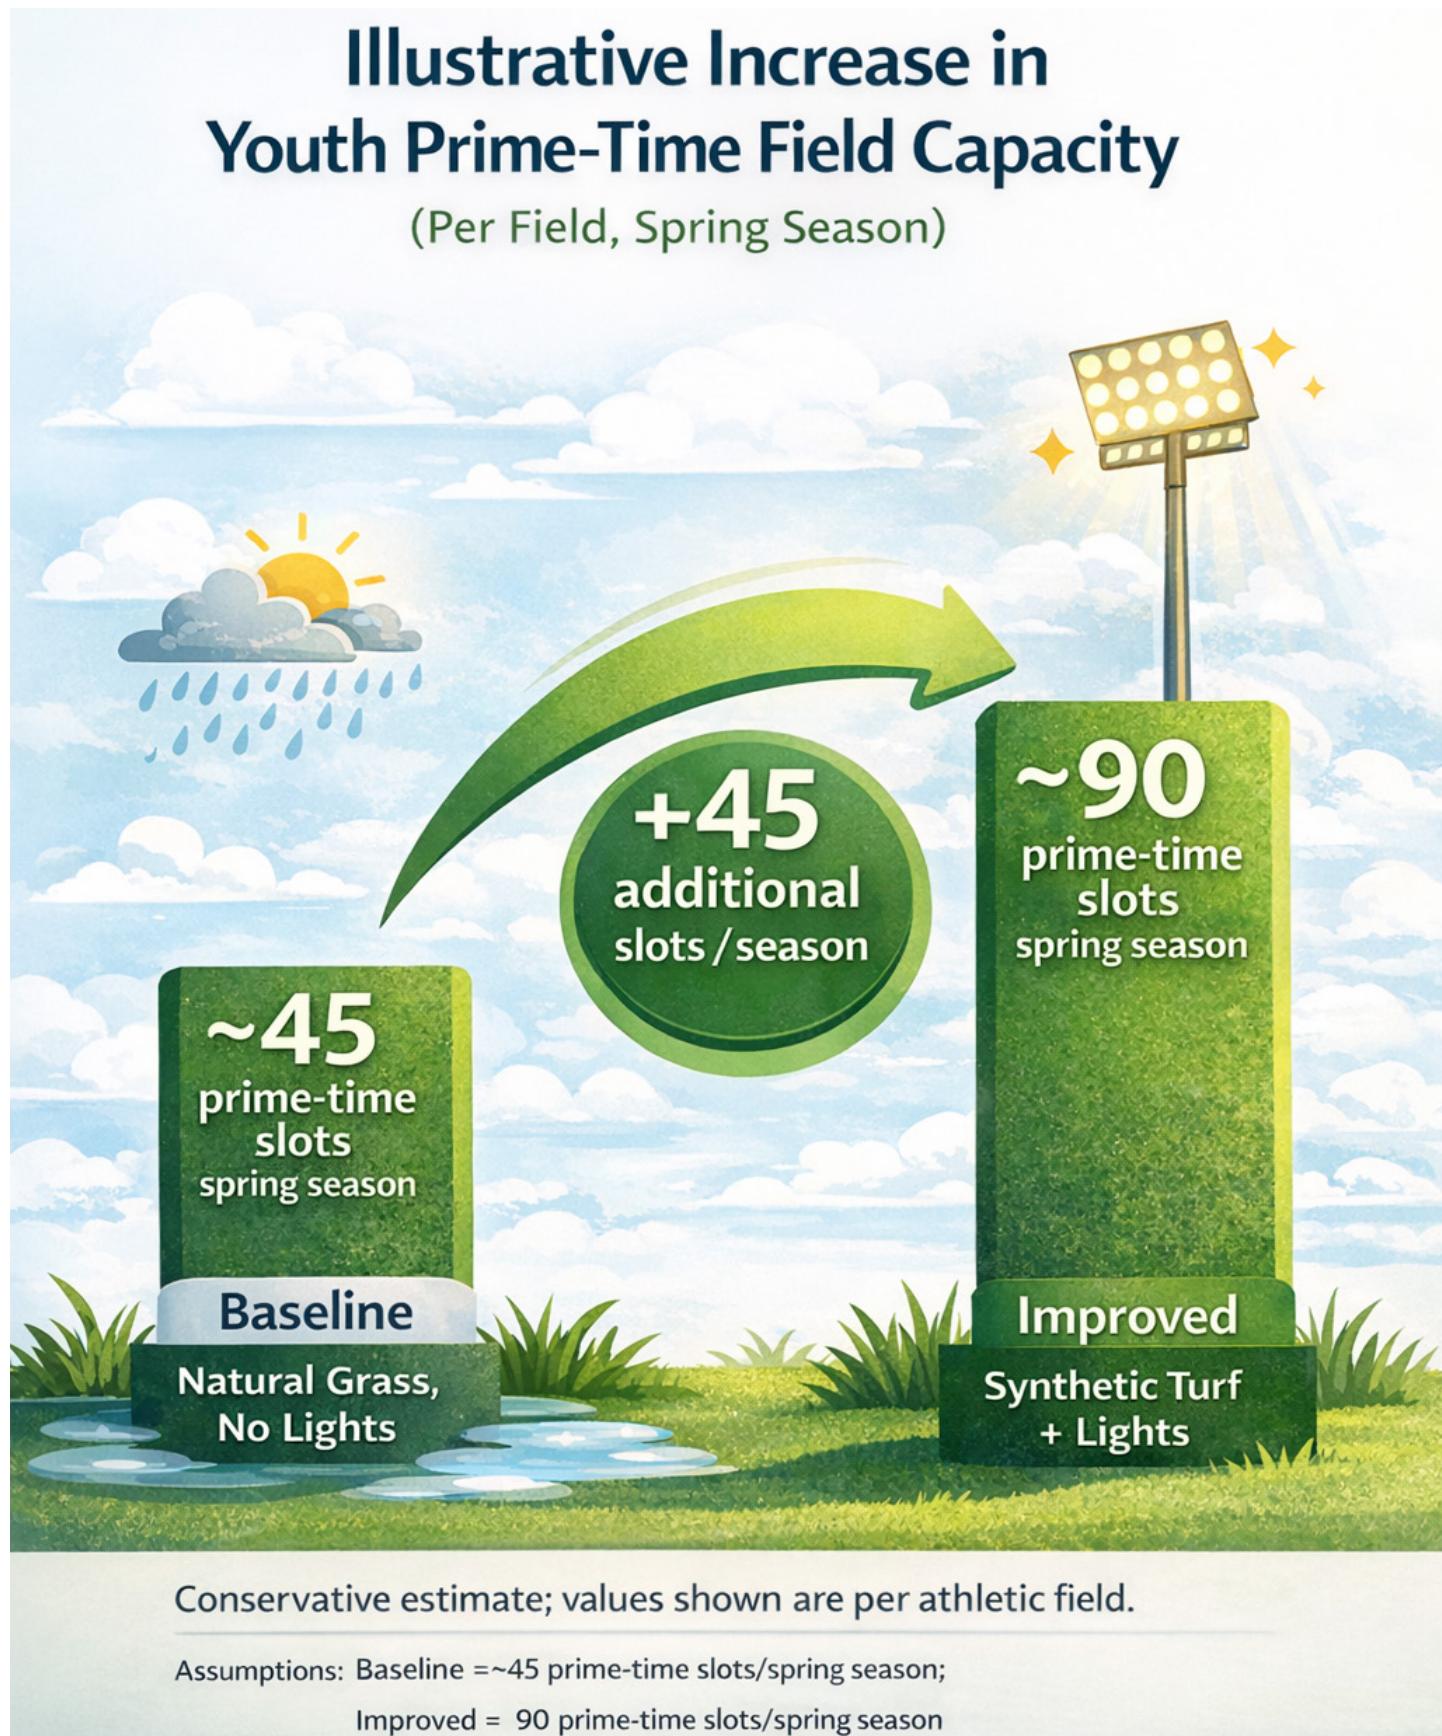
Figure 6-1. Illustrative Increase in Youth Prime-Time Field Capacity with Synthetic Turf and Lighting (Hypothetical Scenario)

Note: Illustrative comparison showing the relative increase in youth prime-time practice and game slots for a single athletic field under typical Camas climate and daylight conditions. Values reflect planning-level assumptions and are not guaranteed outcomes.

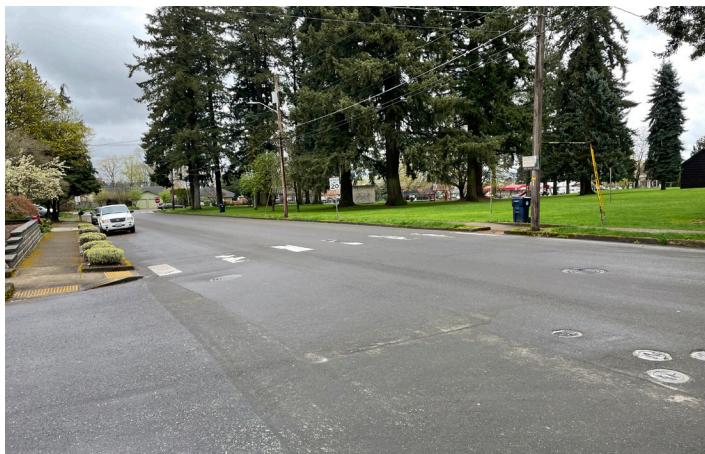
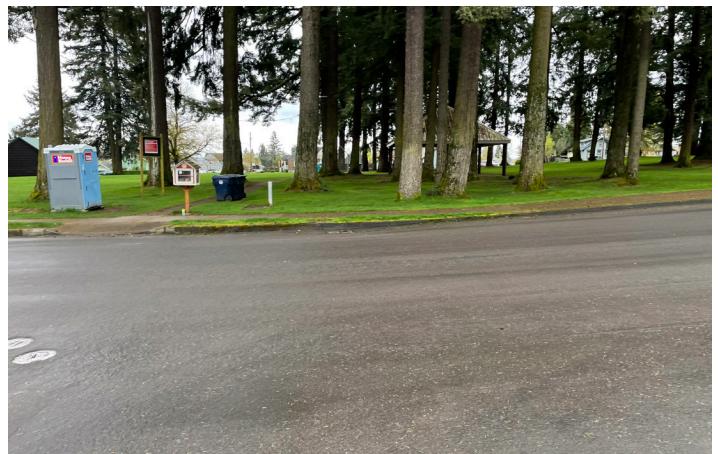
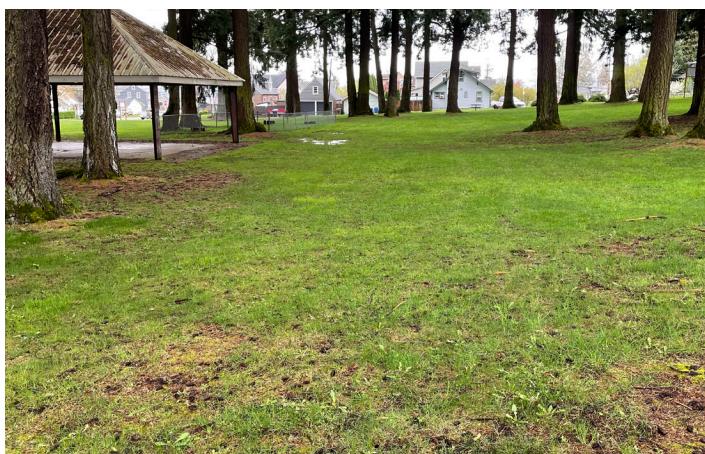
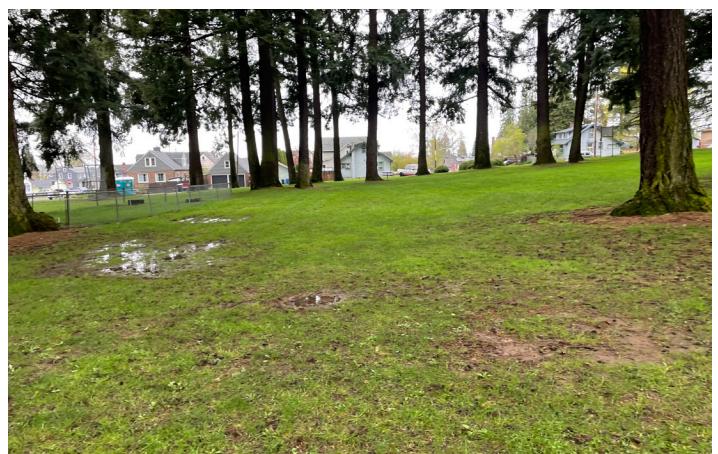
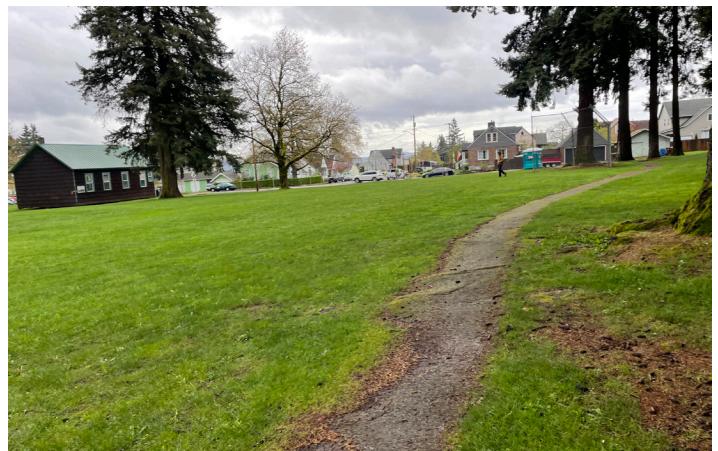
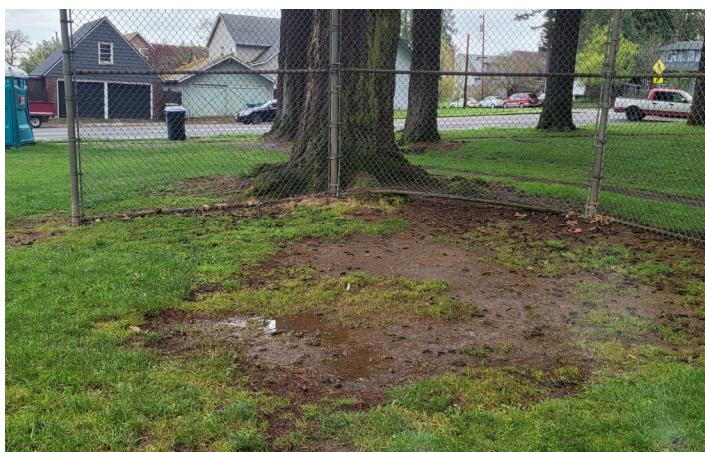
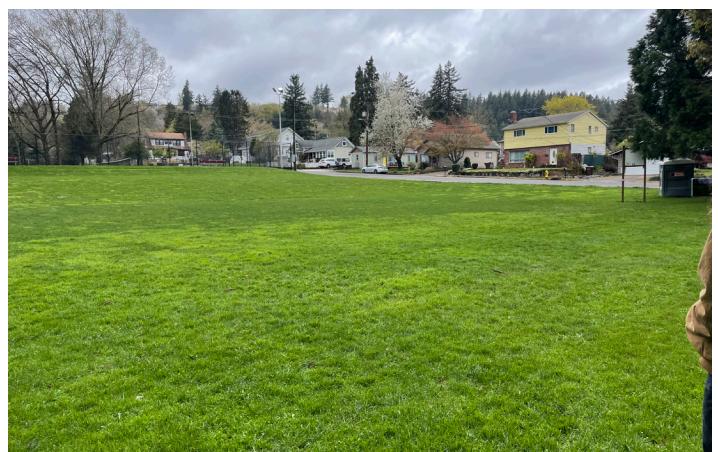
Existing Conditions - Crown Park

1. Describe general site conditions.							
<i>Crown Park is a large recreational park that is mostly grassed with large mature trees. It consists of approximately four blocks, and has onstreet angled parking along its southern property line. A tennis court is located to the northwest of the property. A gazebo and playground in the center of the property. A softball batting area, small building and wall ball structures are located to the east of the site. There is an open level field to the immediate east of the tennis courts that appears to have been graded for field sports.</i>

1. Does the field have existing drainage? If yes, what is the depth, spacing, size, backfill, and sleeved?							
<i>The park has two open fields, an east open area, and a west open area, that are not delineated for organized sports. No area drains were visible. The park seemed to primarily utilize surface infiltrating & sheet flowing to convey runoff to subsurface soils. The tennis court utilized a trench drain along its internal west perimeter. Runoff collected by the trench drain outflows to another earthen portion of the park.</i>

2. General Drainage Condition/Effectiveness:							
<i>Ponding was observed in various portions of the park and tennis courts. Scouring was observed at the outfall of the tennis court's trench drain pipe.</i>

3. Recommendations:							
<i>The drainage appears adequate but could be improved with aeration. Specifically 1" cores, sweep and remove cored material, and backfill holes with sand.</i>							
Public Right-of-Way and ADA Access (Camas Engineering Manager)							
Comments							
<i>City project pending construction.</i>							
Field Evaluation Summary							
Poor: Marginally meets intended purpose	2 - Fair: Several deficiencies	3 - Good: Minor deficiencies	4 - Excellent: field meets/exceeds all requirements				
Athletic Fields & Site Conditions	Describe General Conditions		Poor (1)	Fair (2)	Good (3)	Excellent (4)	
Geometry / Solar Orientation	<i>SW</i>						
Turf Condition	<i>Good condition</i>				<i>x</i>		
Infield Condition	<i>decent grades appear 2 % or so, but not</i>			<i>x</i>			
Planarity							
Drainage	<i>Drainage is Ok, infield sheet flows off infield</i>						
Pitcher mound and rubber	<i>NA</i>

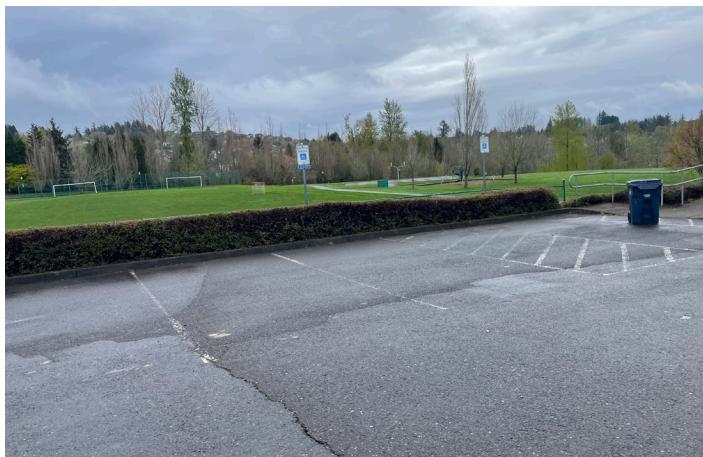
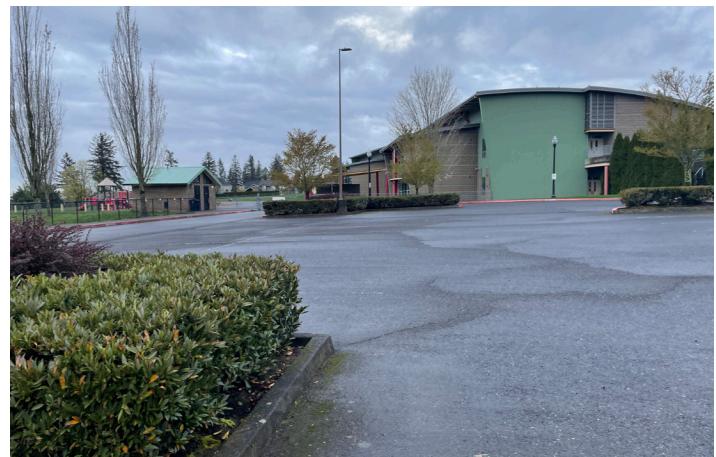
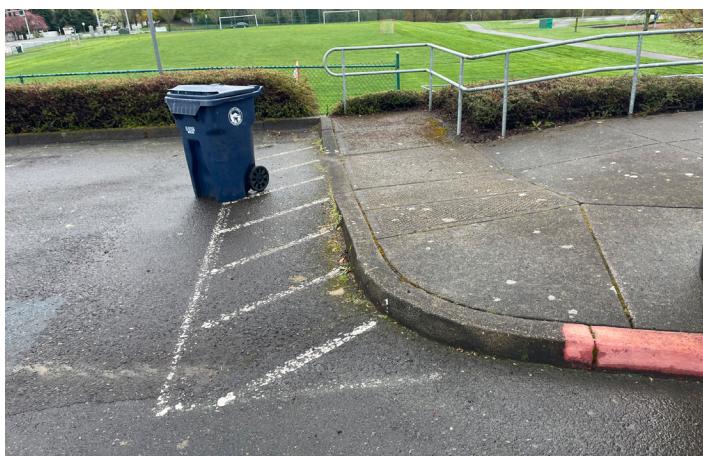
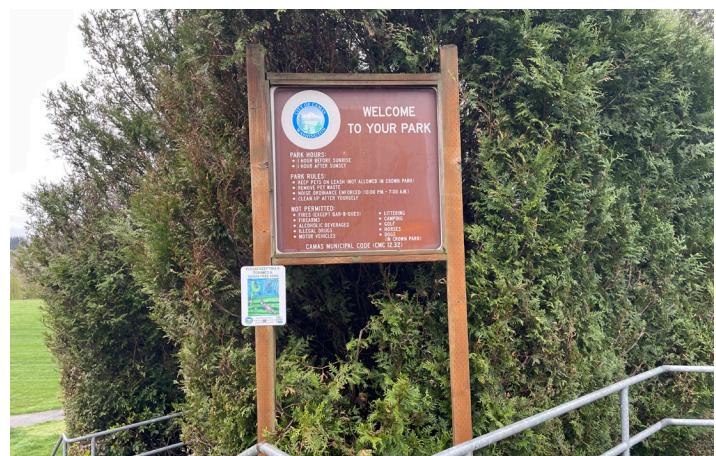
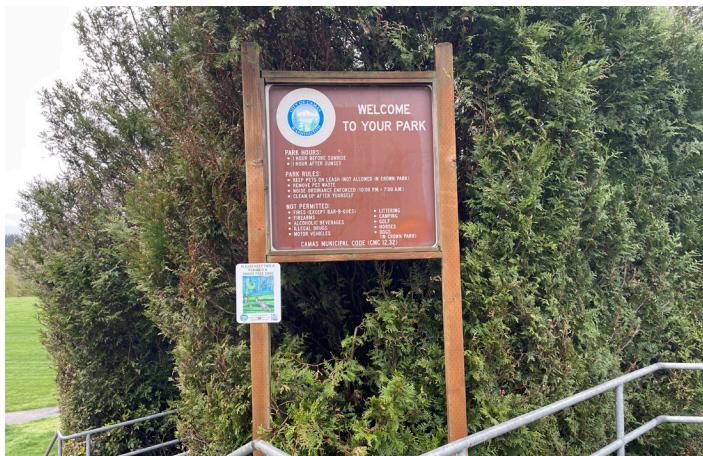
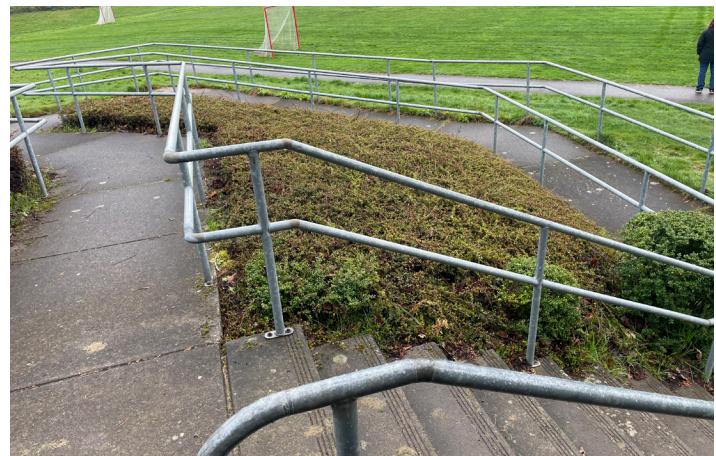
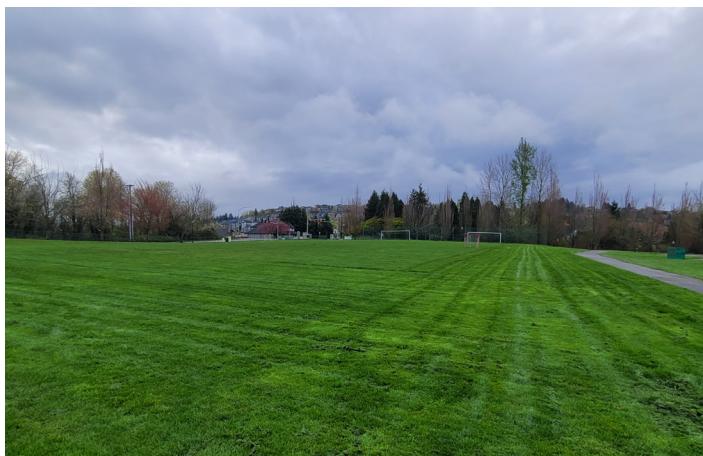
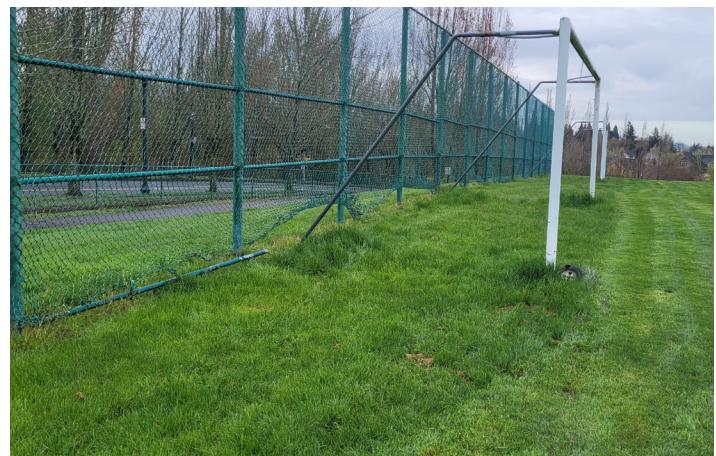
Existing Conditions - Prune Hill

1. Describe general site conditions.							
<i>The park is supplemented by a 47 stall paved parking lot that requires steps or an ADA accessible ramp to access from the sports fields- which are located at a lower elevation. Two of the parking stalls are designated for ADA use. A paved walk path circulates from the parking lot to each field, as well as around the lacrosse field, and to the street to the East. The Baseball field has no dugouts.</i>

1. Does the field have existing drainage? If yes, what is the depth, spacing, size, backfill, and sleeved?							
<i>The Lacrosse field itself does not have a drainage system, and instead relies on direct infiltration from surface runoff. A system of field inlets outside of the circulatory walk path around the lacrosse field. collects excess runoff.</i>

2. General Drainage Condition/Effectiveness: <i>The lacrosse field was found to be saturated with water. The soils were stable, with a degree of softness. The soils and grades of the infield of the baseball field seemed to drain and maintain soil stability for use. However, the grassed outfield was highly saturated, and noticeably more saturated with water.</i>

3. Recommendations: <i>The drainage within the existing field, particularly the outfield, could be improved with aeration. Specifically 1" cores, sweep and remove cored material, and backfill holes with sand. If needed, a subsurface drainage system such as a panel drain system could be implemented.</i>							
Public Right-of-Way and ADA Access (Camas Engineering Manager)							
Comments							
Field Evaluation Summary							
1 - Poor: Marginally meets intended purpose 2 - Fair: Several deficiencies 3 - Good: Minor deficiencies 4 - Excellent: field meets/exceeds all requirements							
Athletic Fields & Site Conditions							
Geometry / Solar Orientation	Describe General Conditions <i>E/W both fields</i>			Poor (1)	Fair (2)	Good (3)	Excellent (4)
Turf Condition	<i>natural grass in decent shape, soggy soils</i>					x	
Infield Condition	<i>Natural clay, soggy, but decent condition</i>					x	
Planarity	<i>Moles and sunken from moles</i>			x

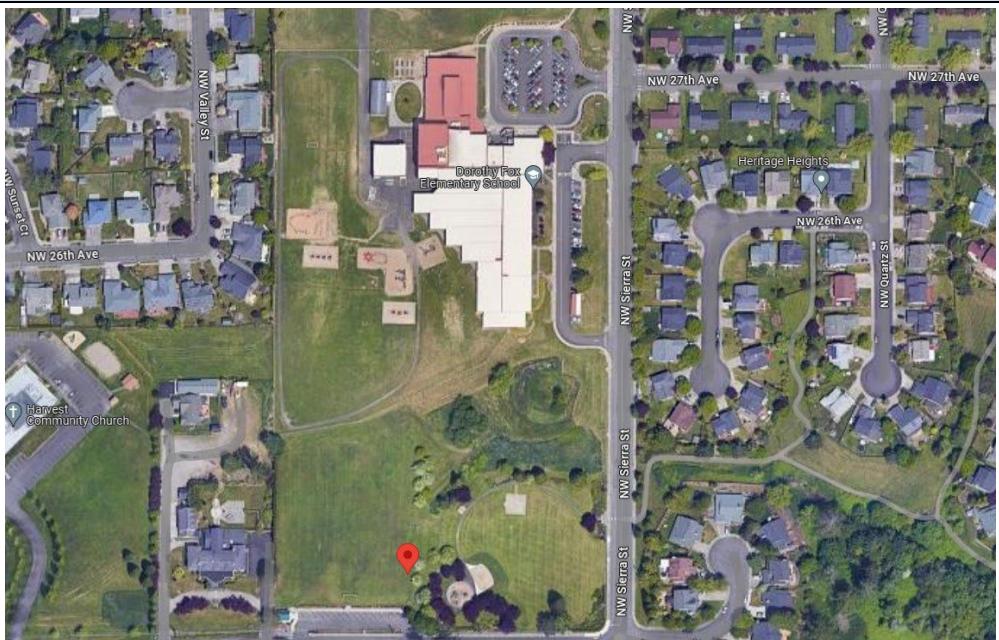
Google Site Aerial: 2121 NW 23rd Ave., Camas, WA. 98607

Turf Condition	<i>natural grass in decent shape, soggy soils</i>				x									
Infield Condition	NA				x									
Planarity	<i>Moles and sunken from moles</i>			x										
Drainage	<i>drainage is in poor condition</i>	x												
Pitcher mound and rubber	NA													
Bases and home plate	NA													
Scoreboards	NA													
Backstop	NA				x									
Dugouts	NA	x												
Batting Cages	NA													
Irrigation	<i>existing style clock, could use ET based clocks</i>		x											
Field Lighting	NA													
Site Lighting	NA													
Fencing	<i>fence on softball decent shape</i>				x									
PA system	NA													
Spectator seating	NA													
Flag pole	NA													
Player benches	NA													
Goals/goal posts	Soccer Goals

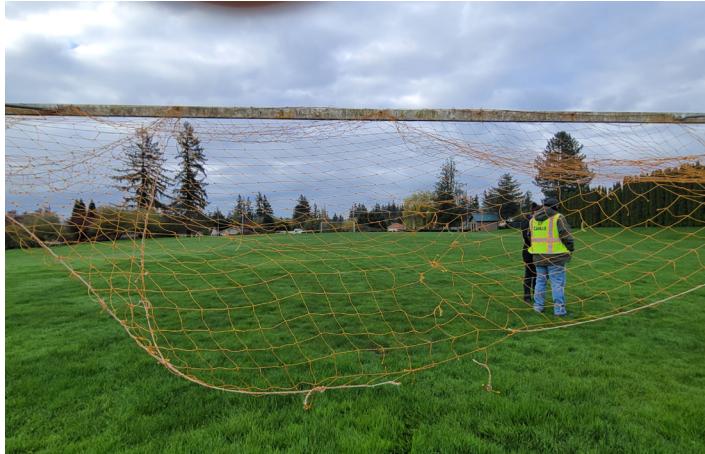
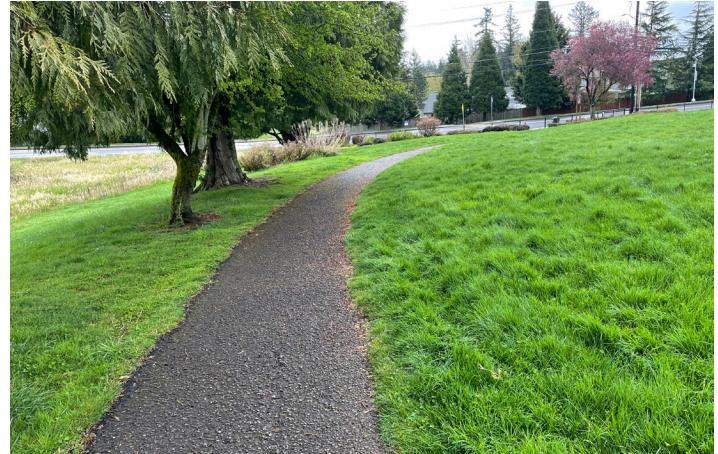
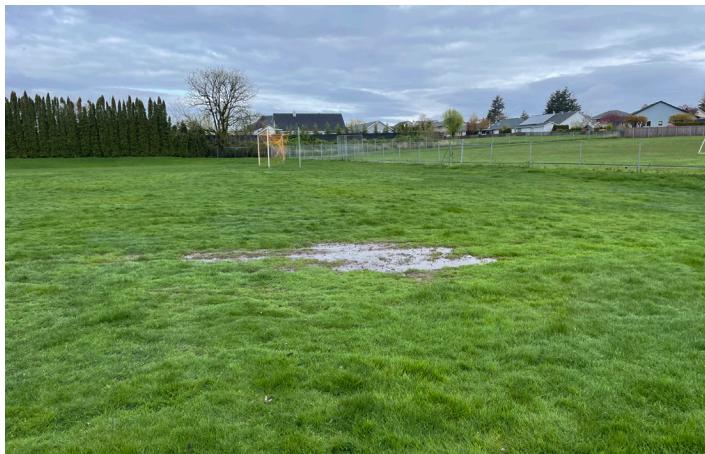
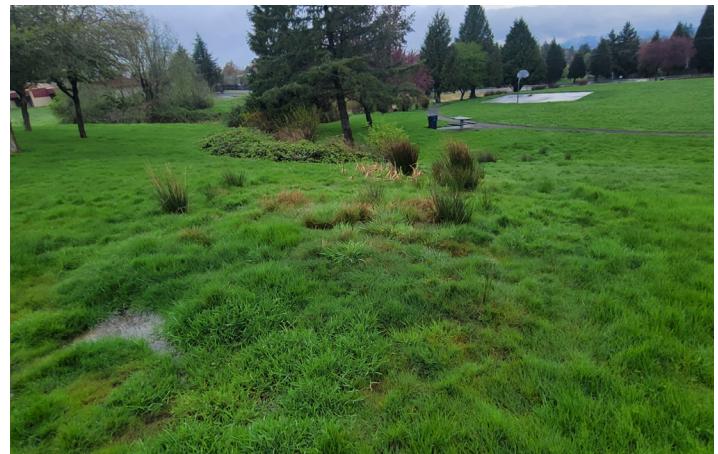
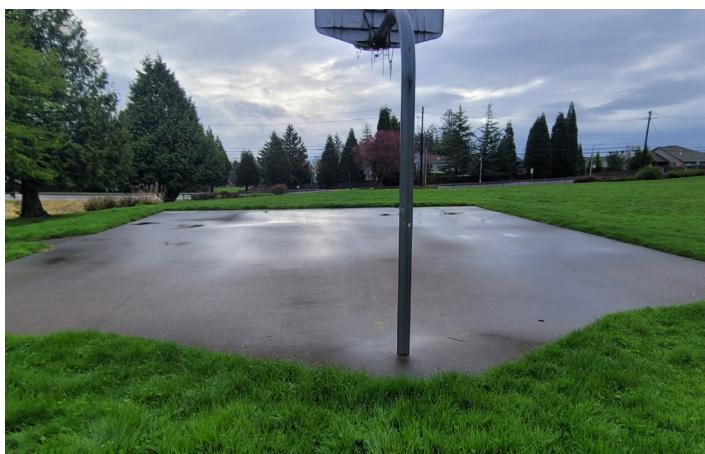
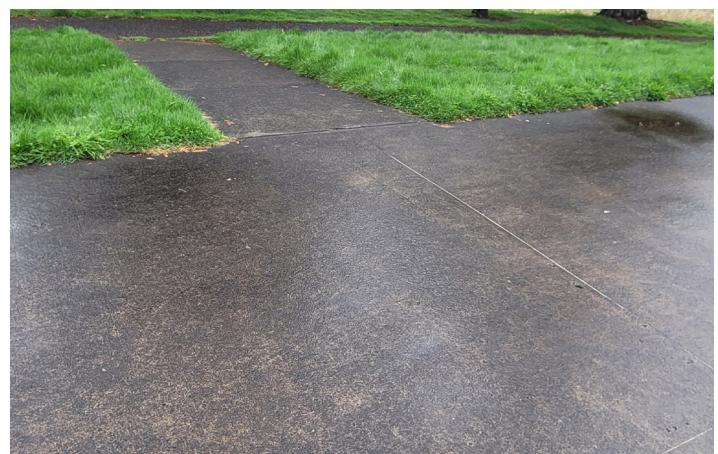
Existing Conditions - Dorothy Fox Park

2. General Drainage Condition/Effectiveness:	<p><i>The Soccer field was saturated with water & was noticeably soft. Ponding was observed in multiple locations despite the field being elevated from its perimeter - this is likely due to an unleveled field and poor draining soils. The field drains were observed to be clean and well drained. The soil within the swale was also noticeably saturated and a non factor.</i></p>

3. Recommendations:	<p><i>The drainage within the existing field could be improved with aeration. Specifically 1" cores, sweep and remove cored material, and backfill holes with sand. If needed, a subsurface drainage system such as a panel drain system could be implemented.</i></p>													
Public Right-of-Way and ADA Access (Camas Engineering Manager)														
Comments														
<p><i>Foot entrance to park path just east of the parking lot on 23rd is not ADA accessible.</i></p> <p><i>Apparent non-compliant ADA ramp near the restrooms</i></p>														
Field Evaluation Summary														
Poor: Marginally meets intended purpose	2 - Fair: Several deficiencies	3 - Good: Minor deficiencies	4 - Excellent: field meets/exceeds all requirements											
Athletic Fields & Site Conditions		Describe General Conditions	Poor (1)	Fair (2)	Good (3)	Excellent (4)								
Geometry / Solar Orientation	N/S

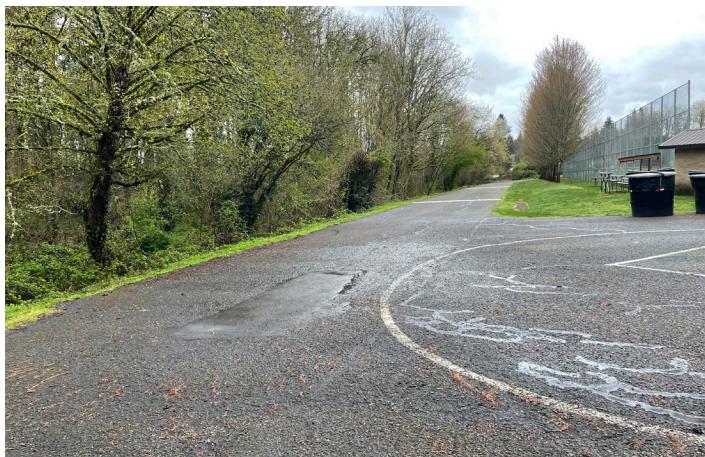
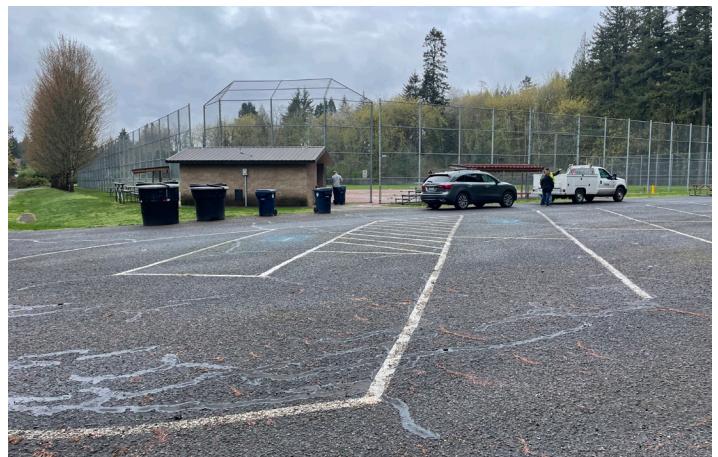
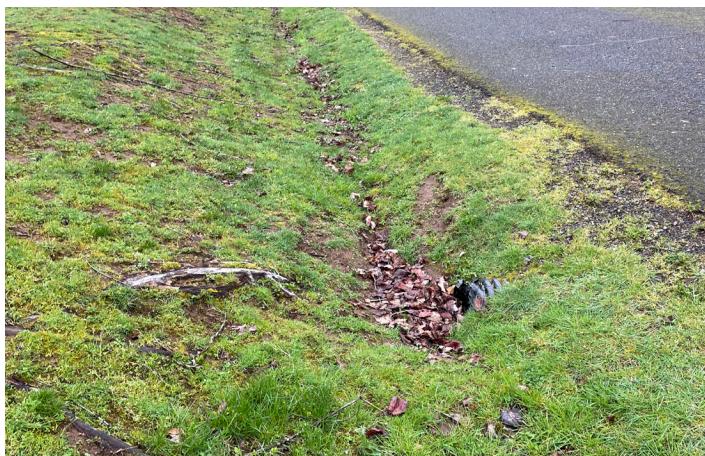
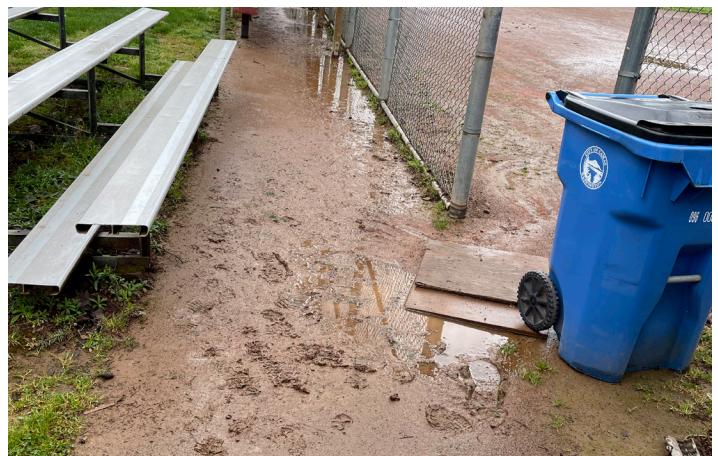
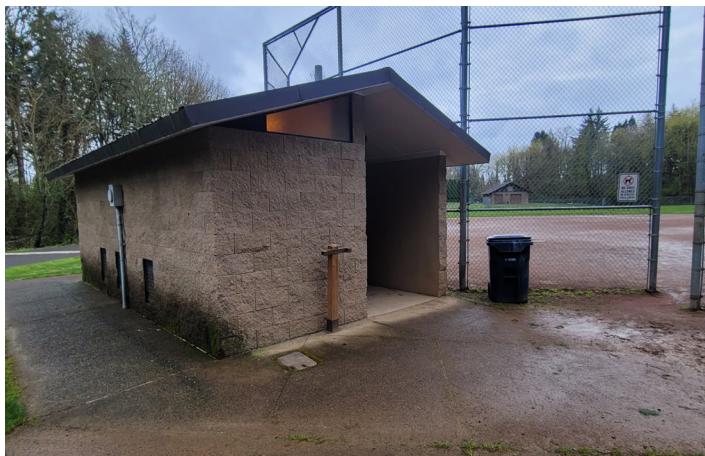
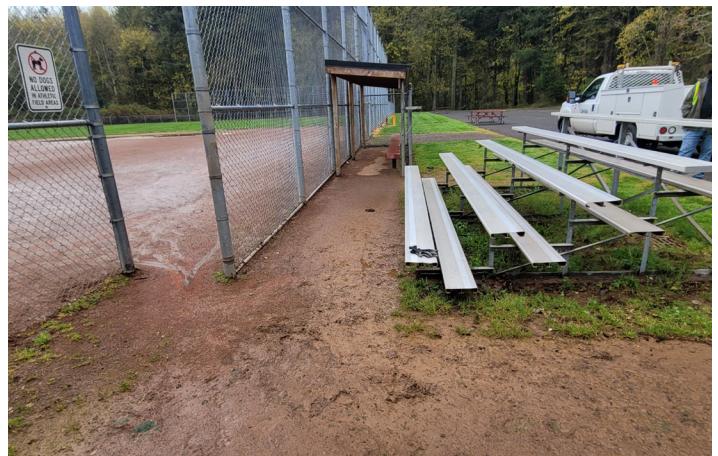
Existing Conditions - Fallen Leaf Park

<table><tr> <th>Athletic Fields & Site Conditions</th> <th>Describe General Conditions</th> <th>Poor (1)</th> <th>Fair (2)</th> <th>Good (3)</th> <th>Excellent (4)</th> </tr><tr> <td>Turf Condition</td> <td><i>Excellent condition</i></td> <td></td> <td></td> <td></td> <td><input checked="" type="checkbox"/></td> </tr><tr> <td>Infield Condition</td> <td><i>Soggy, but grades good, drainage onto conc</i></td> <td></td> <td></td> <td></td> <td><input checked="" type="checkbox"/></td> </tr></table>

*This field is in excellent condition and a top candidate for upgrade to carpet and lighting
moving water in swale below the upper field*

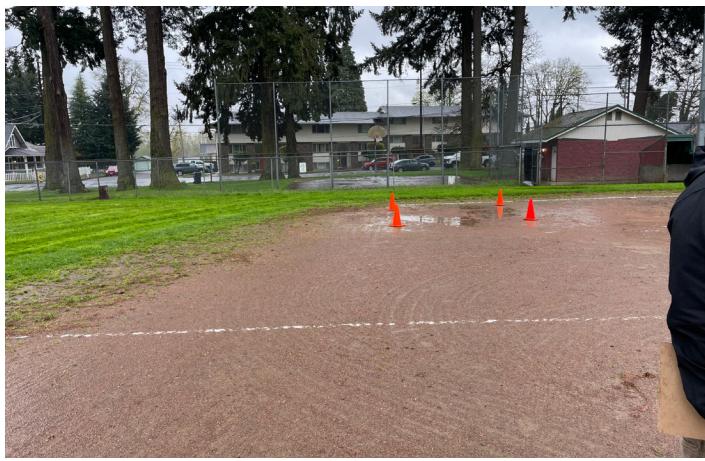
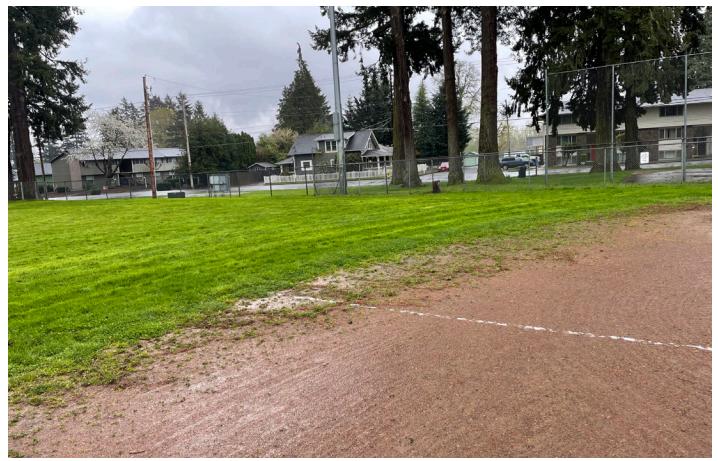
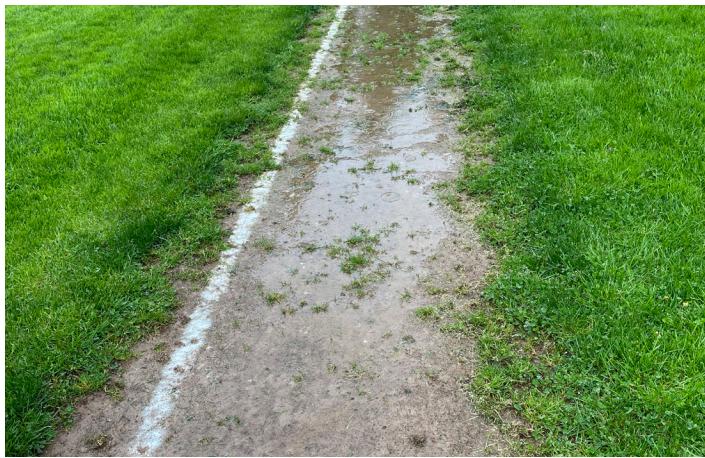
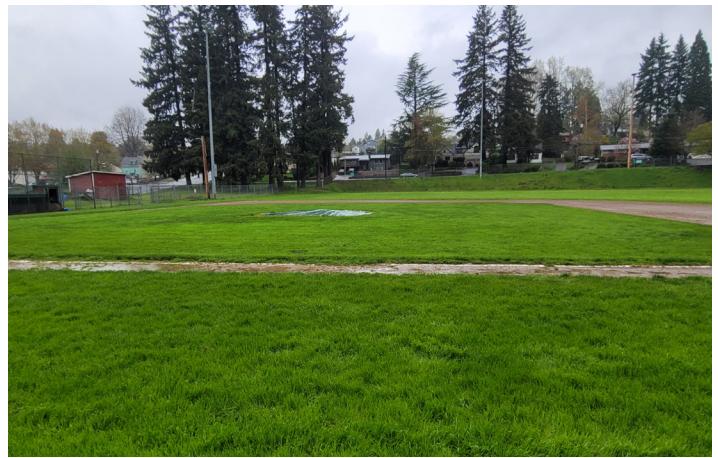
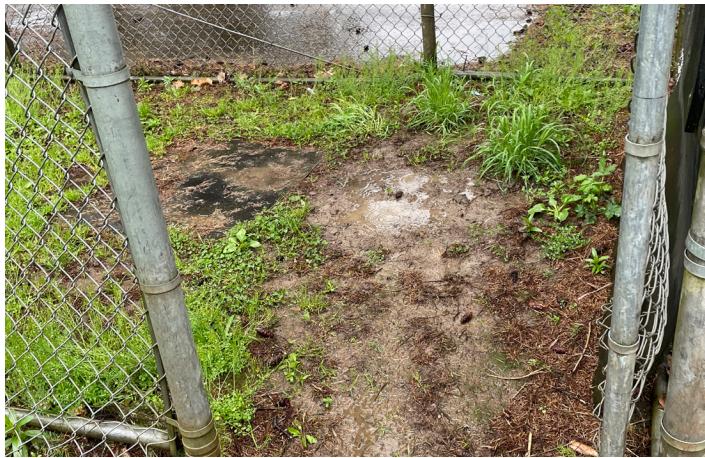
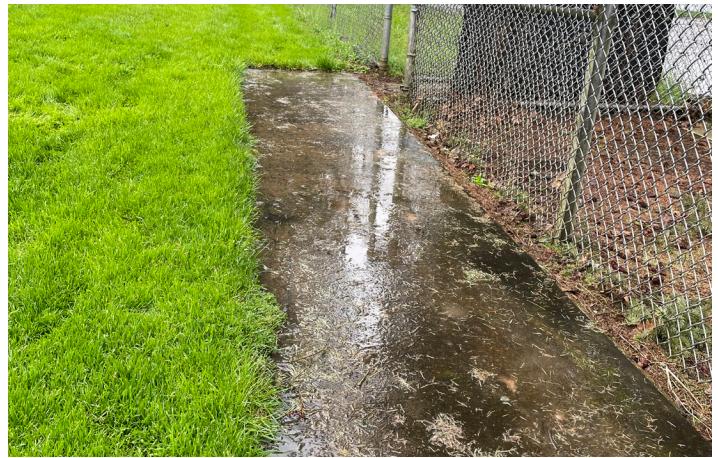
Existing Conditions - Louis Bloch Park

2. General Drainage Condition/Effectiveness:							
The overall grass condition of the field is good. The field was relatively firm with the exception of the south infield and the south east outfield where the conditions were soggy. Ponding was observed by the 1st base.

Scoreboards	<i>located in Center Field</i>		x	
Backstop	<i>Needs to be replaced, older/welded/add ons</i>	x		x
Dugouts	<i>Need ADA access provided. width may meet</i>	x		
Batting Cages	<i>Non existing - bullpens may be an upgrade option</i>			
Irrigation	<i>Existing, old clock on restroom</i>			
Field Lighting	<i>Musco Light Green - 2015 Installation</i>			x
Site Lighting				
Fencing	<i>Backstop should be replaced, welded/adds, 50's</i>		x	
PA system				
Spectator seating	<i>New bleachers and ADA access sidewalks</i>			x
Flag pole	<i>Center Field, Existing</i>			x
Player benches	<i>Consider new with ADA upgrades</i>		x	
Goals/goal posts				
Field marking/striping	<i>Natural Chalk/Paint, adequate.</i>			
Parking facilities	<i>See Civil</i>			
Site accessibility / ADA compliance	<i>dugouts need ADA access</i>			
Site safety (run-outs, lack of obstructions, etc.)	<i>Seem safe and adequate</i>			
Site buildings	<i>Some rot from water off roofs, no gutters.</i>		x

3. Recommendations:							
The existing storm sewer could be extended to the south end of the field and a subsurface drain such as a panel drain could be added to dry out that area if an artificial turf field with subdrainage system is not implemented. The drainage within the existing sport fields could also be improved with aeration. Specifically 1" cores, sweep and remove cored material, and backfill holes with sand. This would also help minimize surface flows to the lower area at the south end of the field and would likely improve the softer/soggy areas within the field. May also relocate and possibly add a few inlets in and around the sidewalk areas to improve the drainage in those areas.							
Public Right-of-Way and ADA Access (Camas Engineering Manager)							
Comments
