CITY OF CAMAS, WA

Athletic Fields and Courts: Strategic Assessment and Recommendations

February 10, 2026

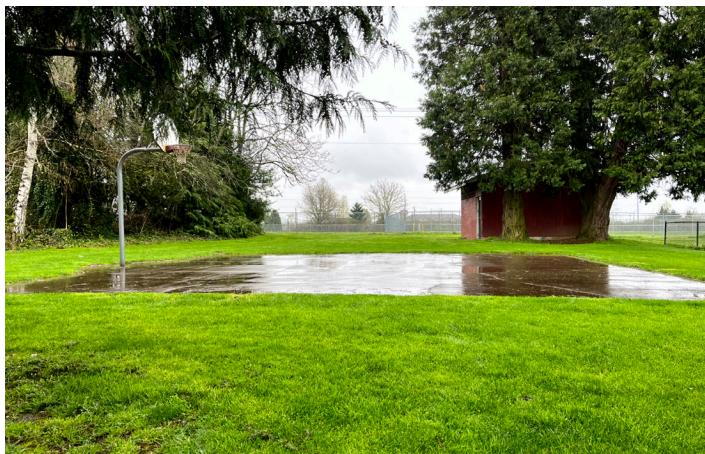
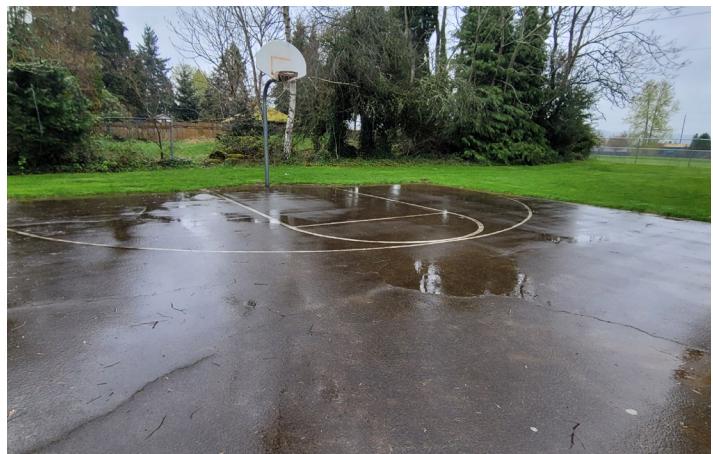
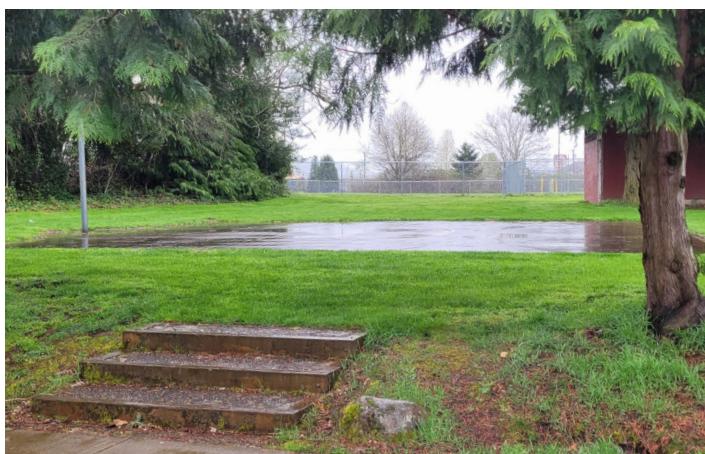
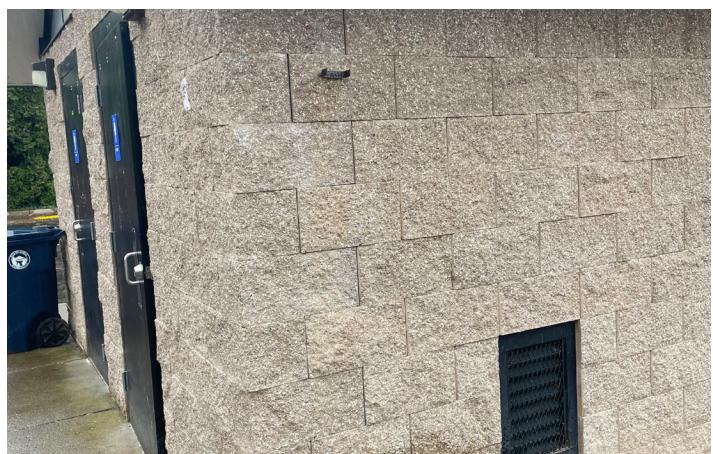
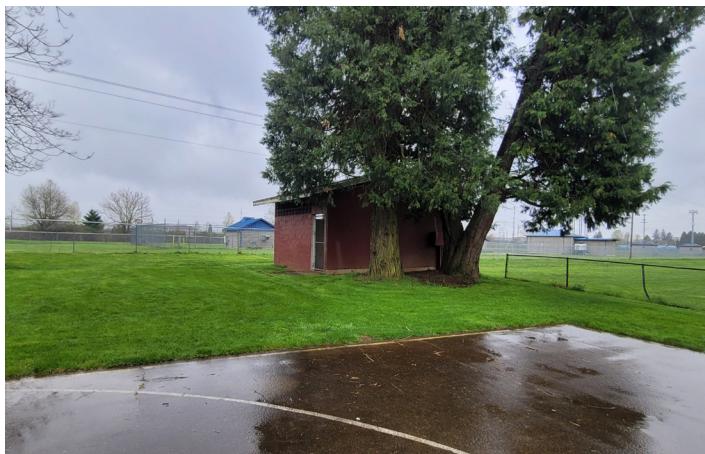
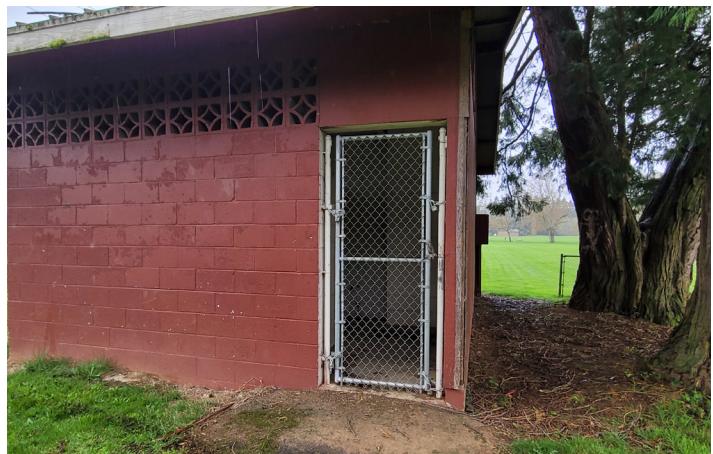
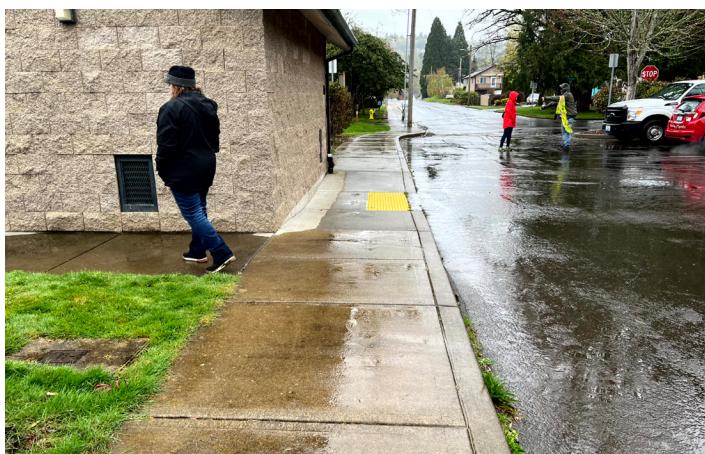
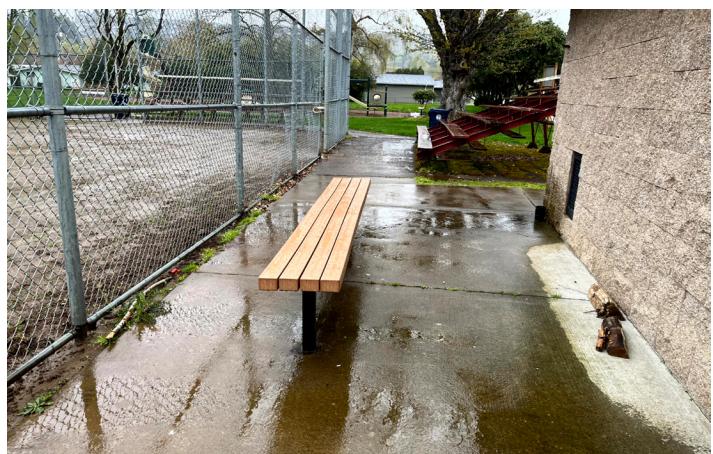
Existing Conditions - Goot Park

2. General Drainage Condition/Effectiveness:							
<i>The overall grass condition of the field is good. Runoff appears to naturally infiltrate or sheet flow to the existing open space area to the west.</i>

Drainage	<i>No apparent or obvious conditions, field firm</i>			x			
Pitcher mound and rubber	<i>None on site</i>						
Bases and home plate	<i>None on site</i>						
Scoreboards	<i>NA</i>						
Backstop	<i>good condition, low for foul balls</i>			x			
Dugouts	<i>bench behind backstop, none in place</i>						
Batting Cages	<i>none in place</i>						
Irrigation	<i>installed, works, old style clock</i>			x

great large mature trees nice to keep and remain, makes for great place for tournament fields. Consider large multi purpose, parking is an
 Parking stall count is short/small if field is improved, additional parking would need to be considered
 Minor ponding observed in the basketball court

3. Recommendations:							
<i>The drainage within the existing sport fields could be improved with aeration if artificial turf fields with subdrainage systems are not implemented. Specifically 1" cores, sweep and remove cored material, and backfill holes with sand.</i>							
Public Right-of-Way and ADA Access (Camas Engineering Manager)							
Comments							
Field Evaluation Summary							
1 - Poor: Marginally meets intended purpose 2 - Fair: Several deficiencies 3 - Good: Minor deficiencies 4 - Excellent: field meets/exceeds all requirements							
Athletic Fields & Site Conditions	Describe General Conditions	Poor (1)	Fair (2)	Good (3)	Excellent (4)		
Geometry / Solar Orientation	<i>SW - but mature shade trees along N/W</i>			x			
Turf Condition	<i>excellent stand, core aerify topdress</i>				x		
Infield Condition	<i>firm w moisture, good for softball</i>			x			
Planarity	<i>excellent condition</i>				x

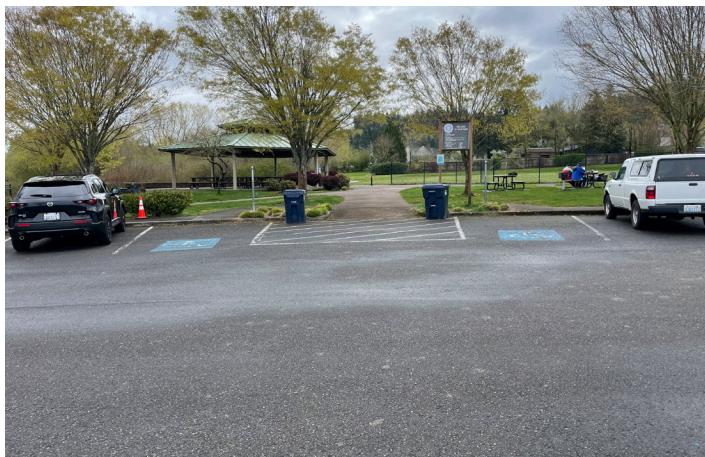
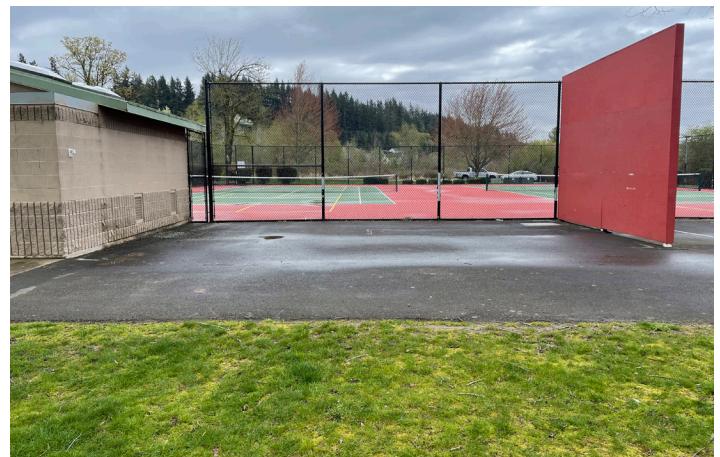
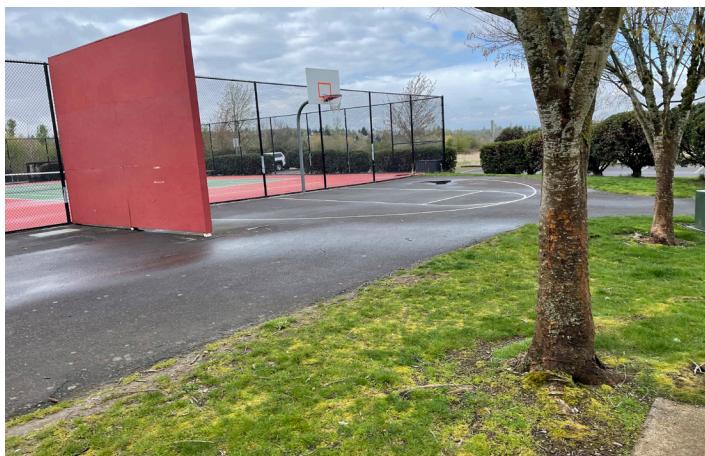
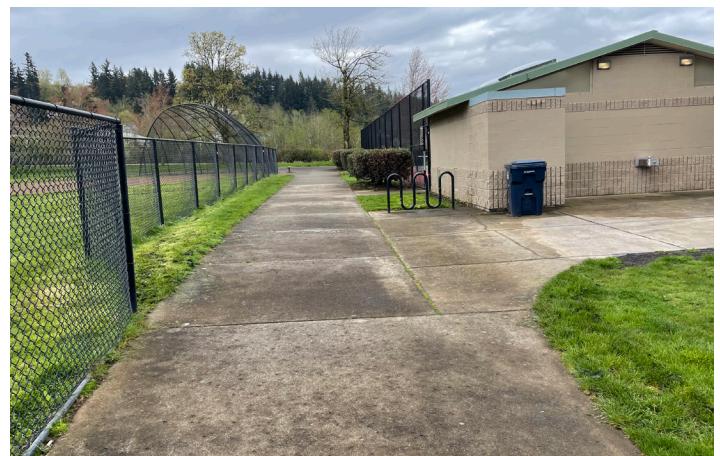
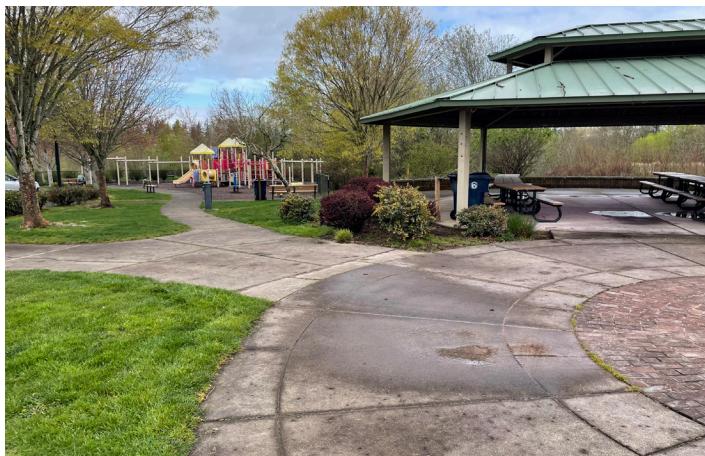
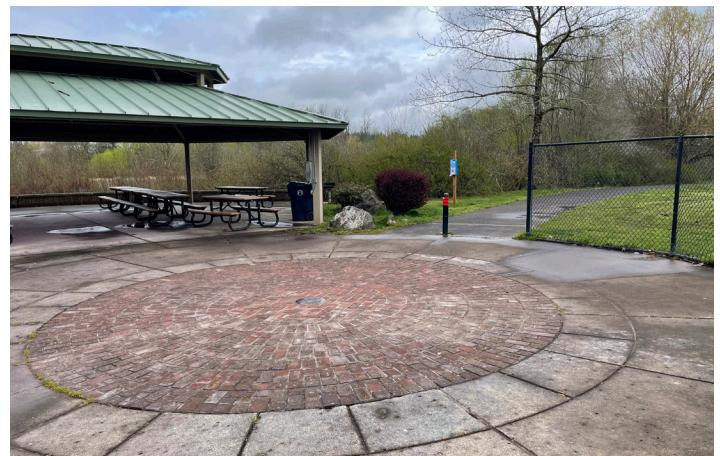
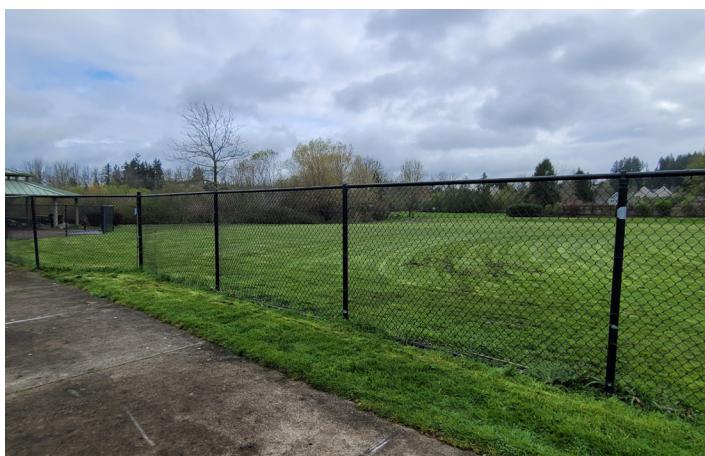
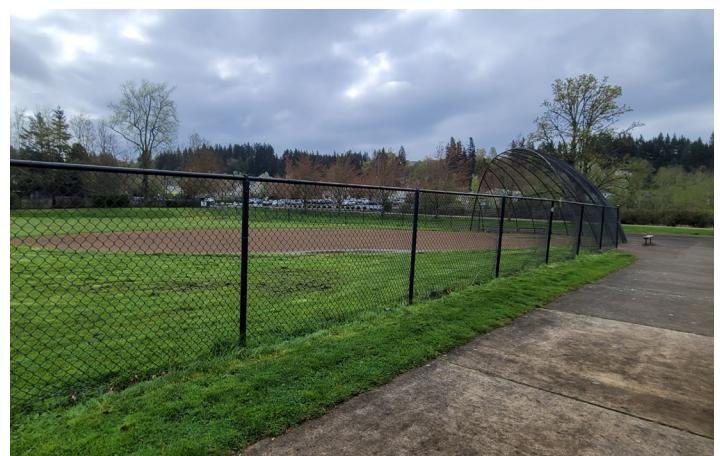
Existing Conditions - Grass Valley

2. General Drainage Condition/Effectiveness: <i>Ponding was observed in the infield of the softball field. The outfield of the softball field was saturated, but stable. The extreme north and east portions of the outfield that were located closer to the circulating paved path however was noticeably more saturated with water, and was softer to stand in. Ponding was noticed in the paved walk path between the two fields. The park representative stated that runoff during high storm events flows to the west over the tennis courts.</i>

Tennis courts in decent condition, some infield runoff from infield to courts needs to be addressed.

Playground was observed to be eroded down & require upkeep/additional mulch surfacing

3. Recommendations: <i>The drainage within the existing field could be improved with aeration. Specifically 1" cores, sweep and remove cored material, and backfill holes with sand. If needed, a subsurface drainage system such as a panel drain system could be implemented.</i>							
Public Right-of-Way and ADA Access (Camas Engineering Manager)							
Comments							
<i>Looks okay and City is improving 38th in 2024-2025</i>							
Field Evaluation Summary							
1 - Poor: Marginally meets intended purpose 2 - Fair: Several deficiencies 3 - Good: Minor deficiencies 4 - Excellent: field meets/exceeds all requirements							
Athletic Fields & Site Conditions							
Geometry / Solar Orientation	Describe General Conditions <i>NE</i>	Poor (1)	Fair (2)	Good (3)	Excellent (4)		
Turf Condition	<i>good condition, till soggy near trail</i>			<i>x</i>			
Infield Condition	<i>Soggy, but grades good, drainage onto conc</i>		<i>x</i>

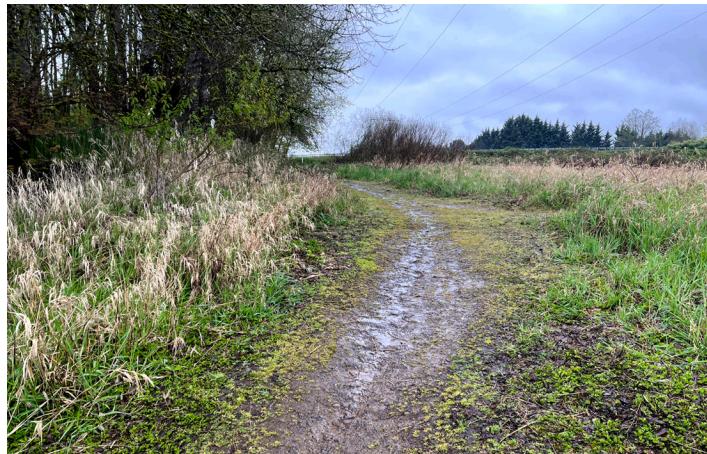
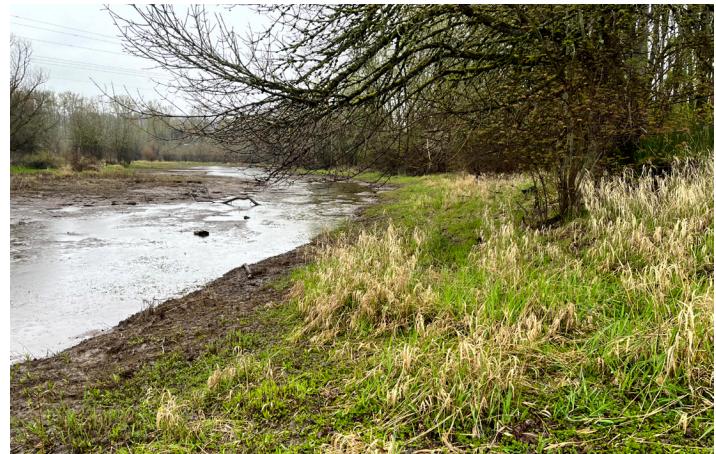
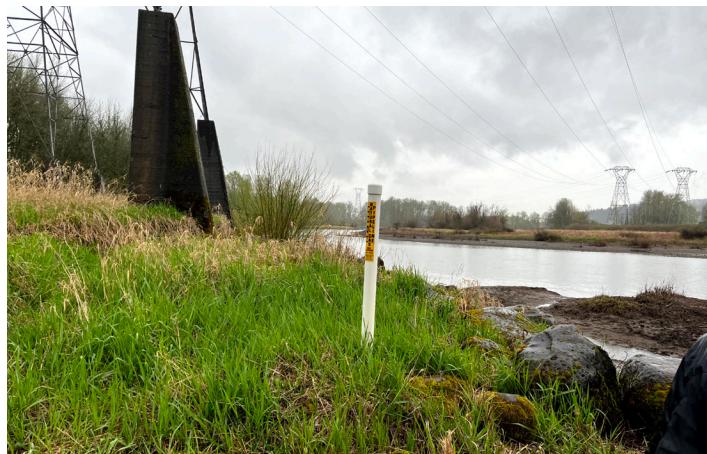
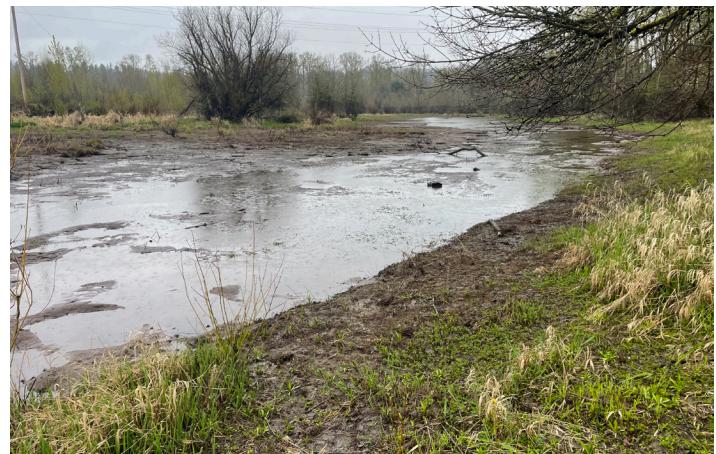
Existing Conditions - Oak Park

1. Describe general site conditions.							
<p>At the end of SE 8th Ave. there is a cul-de-sac and parking lot that includes approximately 8 standard parking stalls all connected with sidewalk access. There is no visible striping for the parking stalls and no indication of ADA parking stalls, loading areas, or associated signage. Existing ADA ramp at park entrance is not ADA compliant and needs to be replaced. There are two ADA ramps at the east end of the parking that appear to have been replaced relatively recently and look to be ADA compliant.</p>

2. General Drainage Condition/Effectiveness:							
<p>The overall grass condition of the field is fair. The turf is wet and soggy with moles hills. Runoff appears to naturally infiltrate (minimal) or sheet flow to the existing open space area to the west. Moles appear to be a problem within this site.</p>

3. Recommendations:							
<p>The drainage within the existing sport fields could be improved with aeration. Specifically 1" cores, sweep and remove cored material, and backfill holes with sand. The moles will need to be exterminated and hills leveled and seeded.</p>							
Public Right-of-Way and ADA Access (Camas Engineering Manager)							
Comments							
<p> </p>							
Field Evaluation Summary							
1 - Poor: Marginally meets intended purpose 2 - Fair: Several deficiencies 3 - Good: Minor deficiencies 4 - Excellent: field meets/exceeds all requirements							
Athletic Fields & Site Conditions		Describe General Conditions	Poor (1)	Fair (2)	Good (3)	Excellent (4)	
Geometry / Solar Orientation		N/S but no real field here					
Turf Condition		moles, very wet/soggy, decent condition		x			
Infield Condition		NA					
Planarity		Some ups and downs, if used for field could		x			
Drainage		soggy, holds water, topdress/core aerify		x

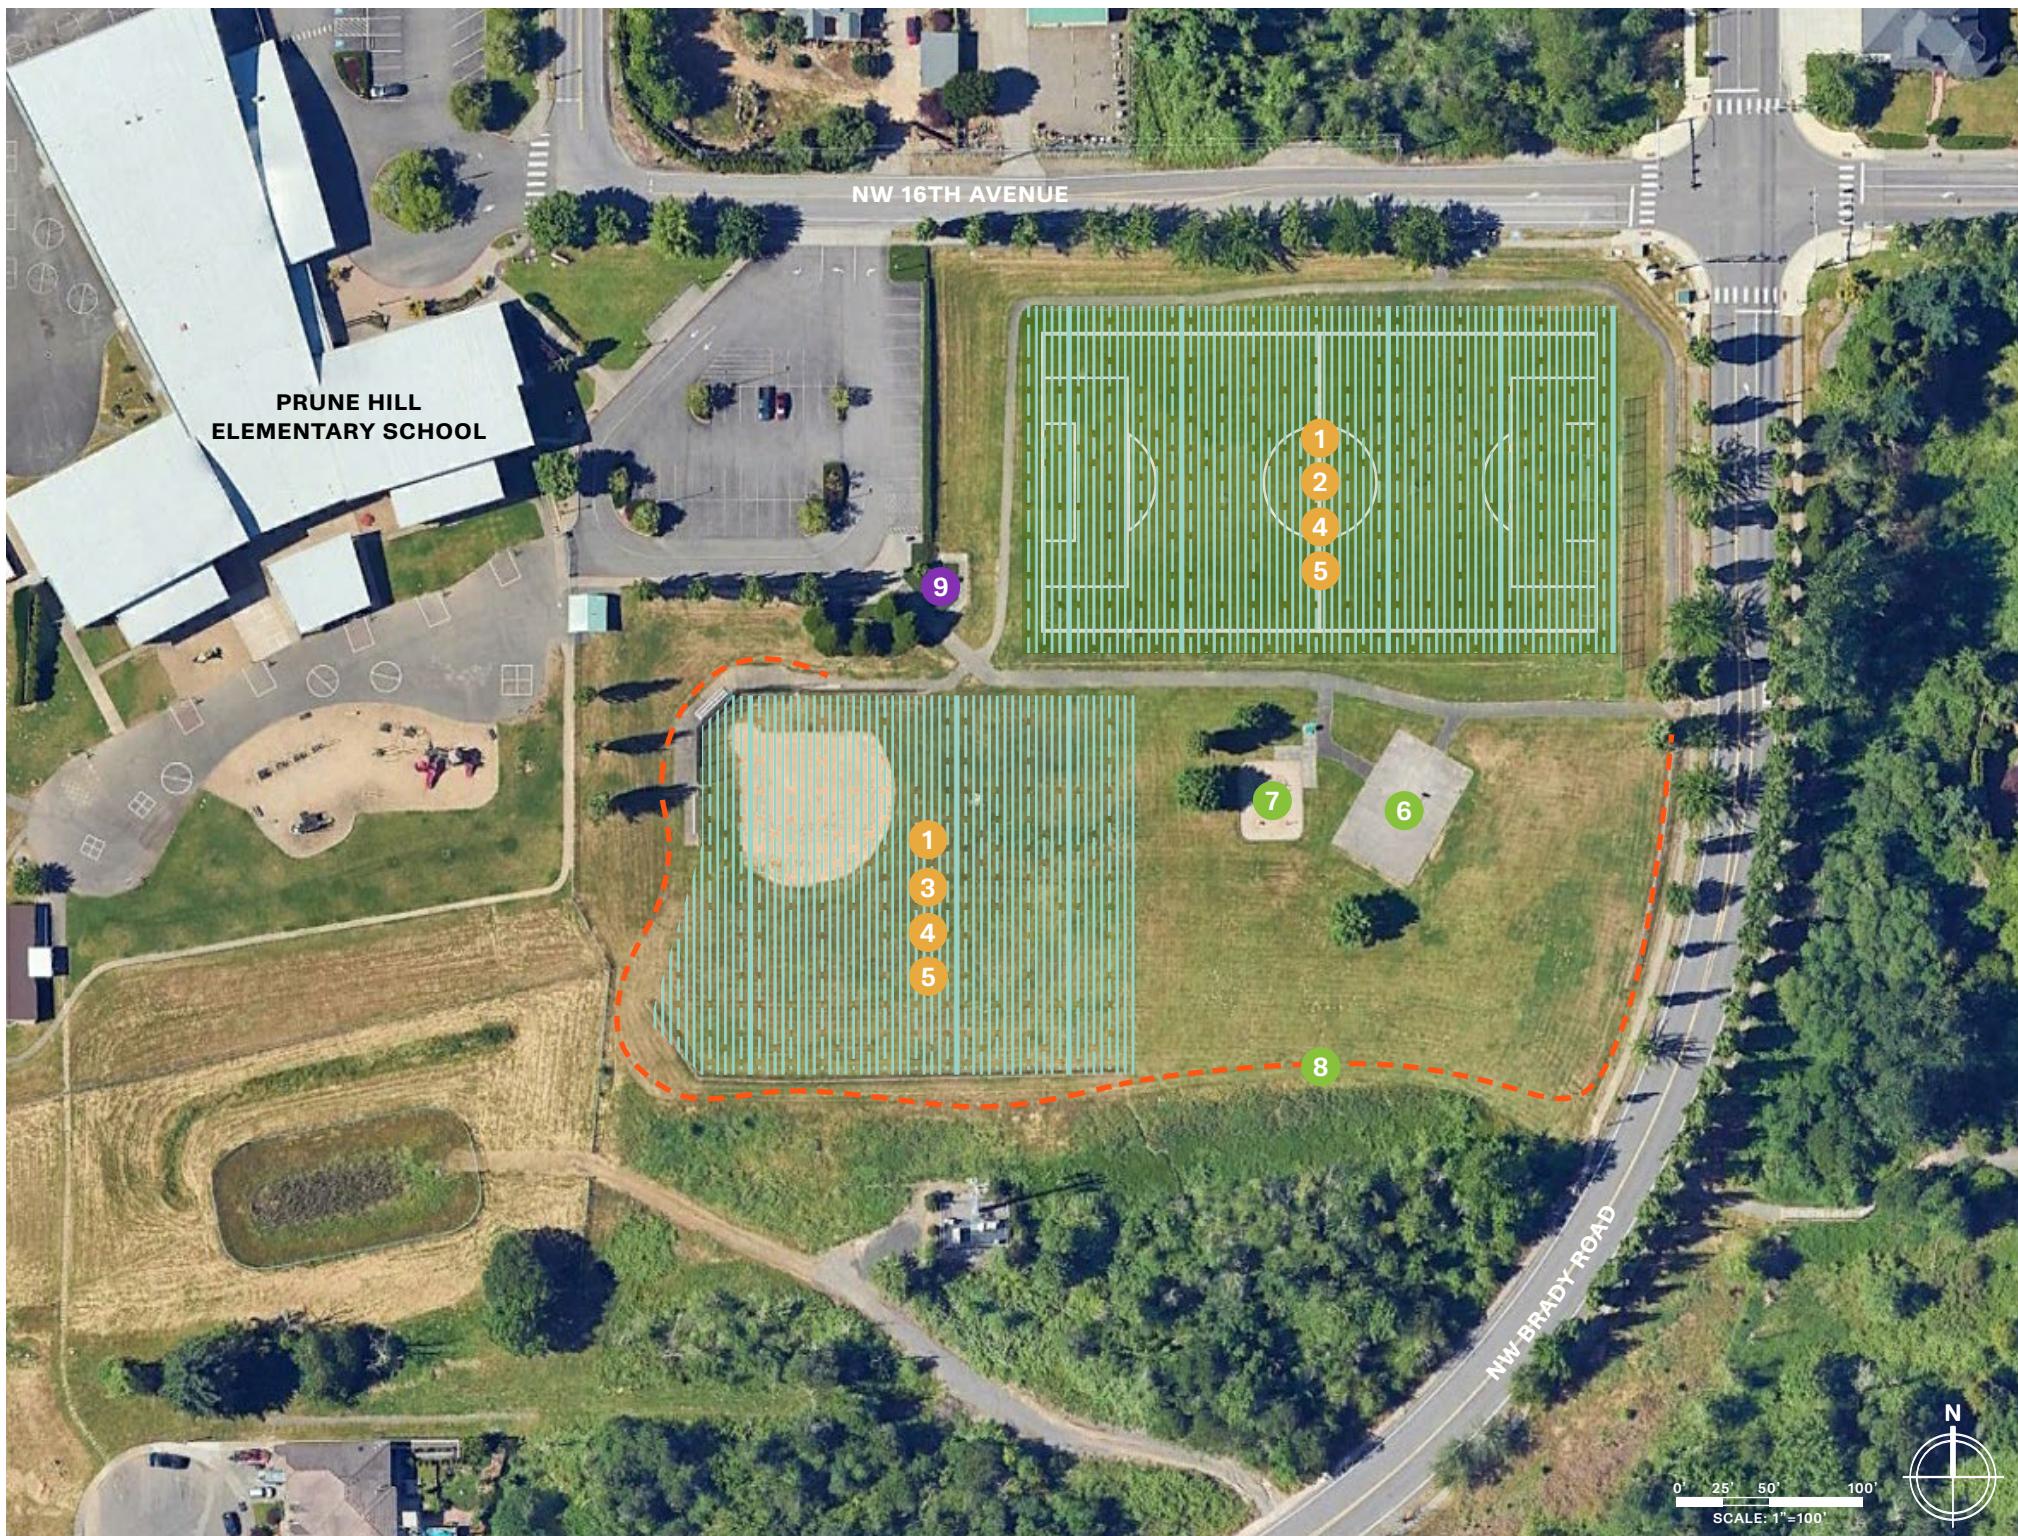
Dorothy Fox Park – soccer field with major drainage issues, underutilized.

Primary User: No designated user

- 9 ROW ADA Improvements
(Detectable Warning)

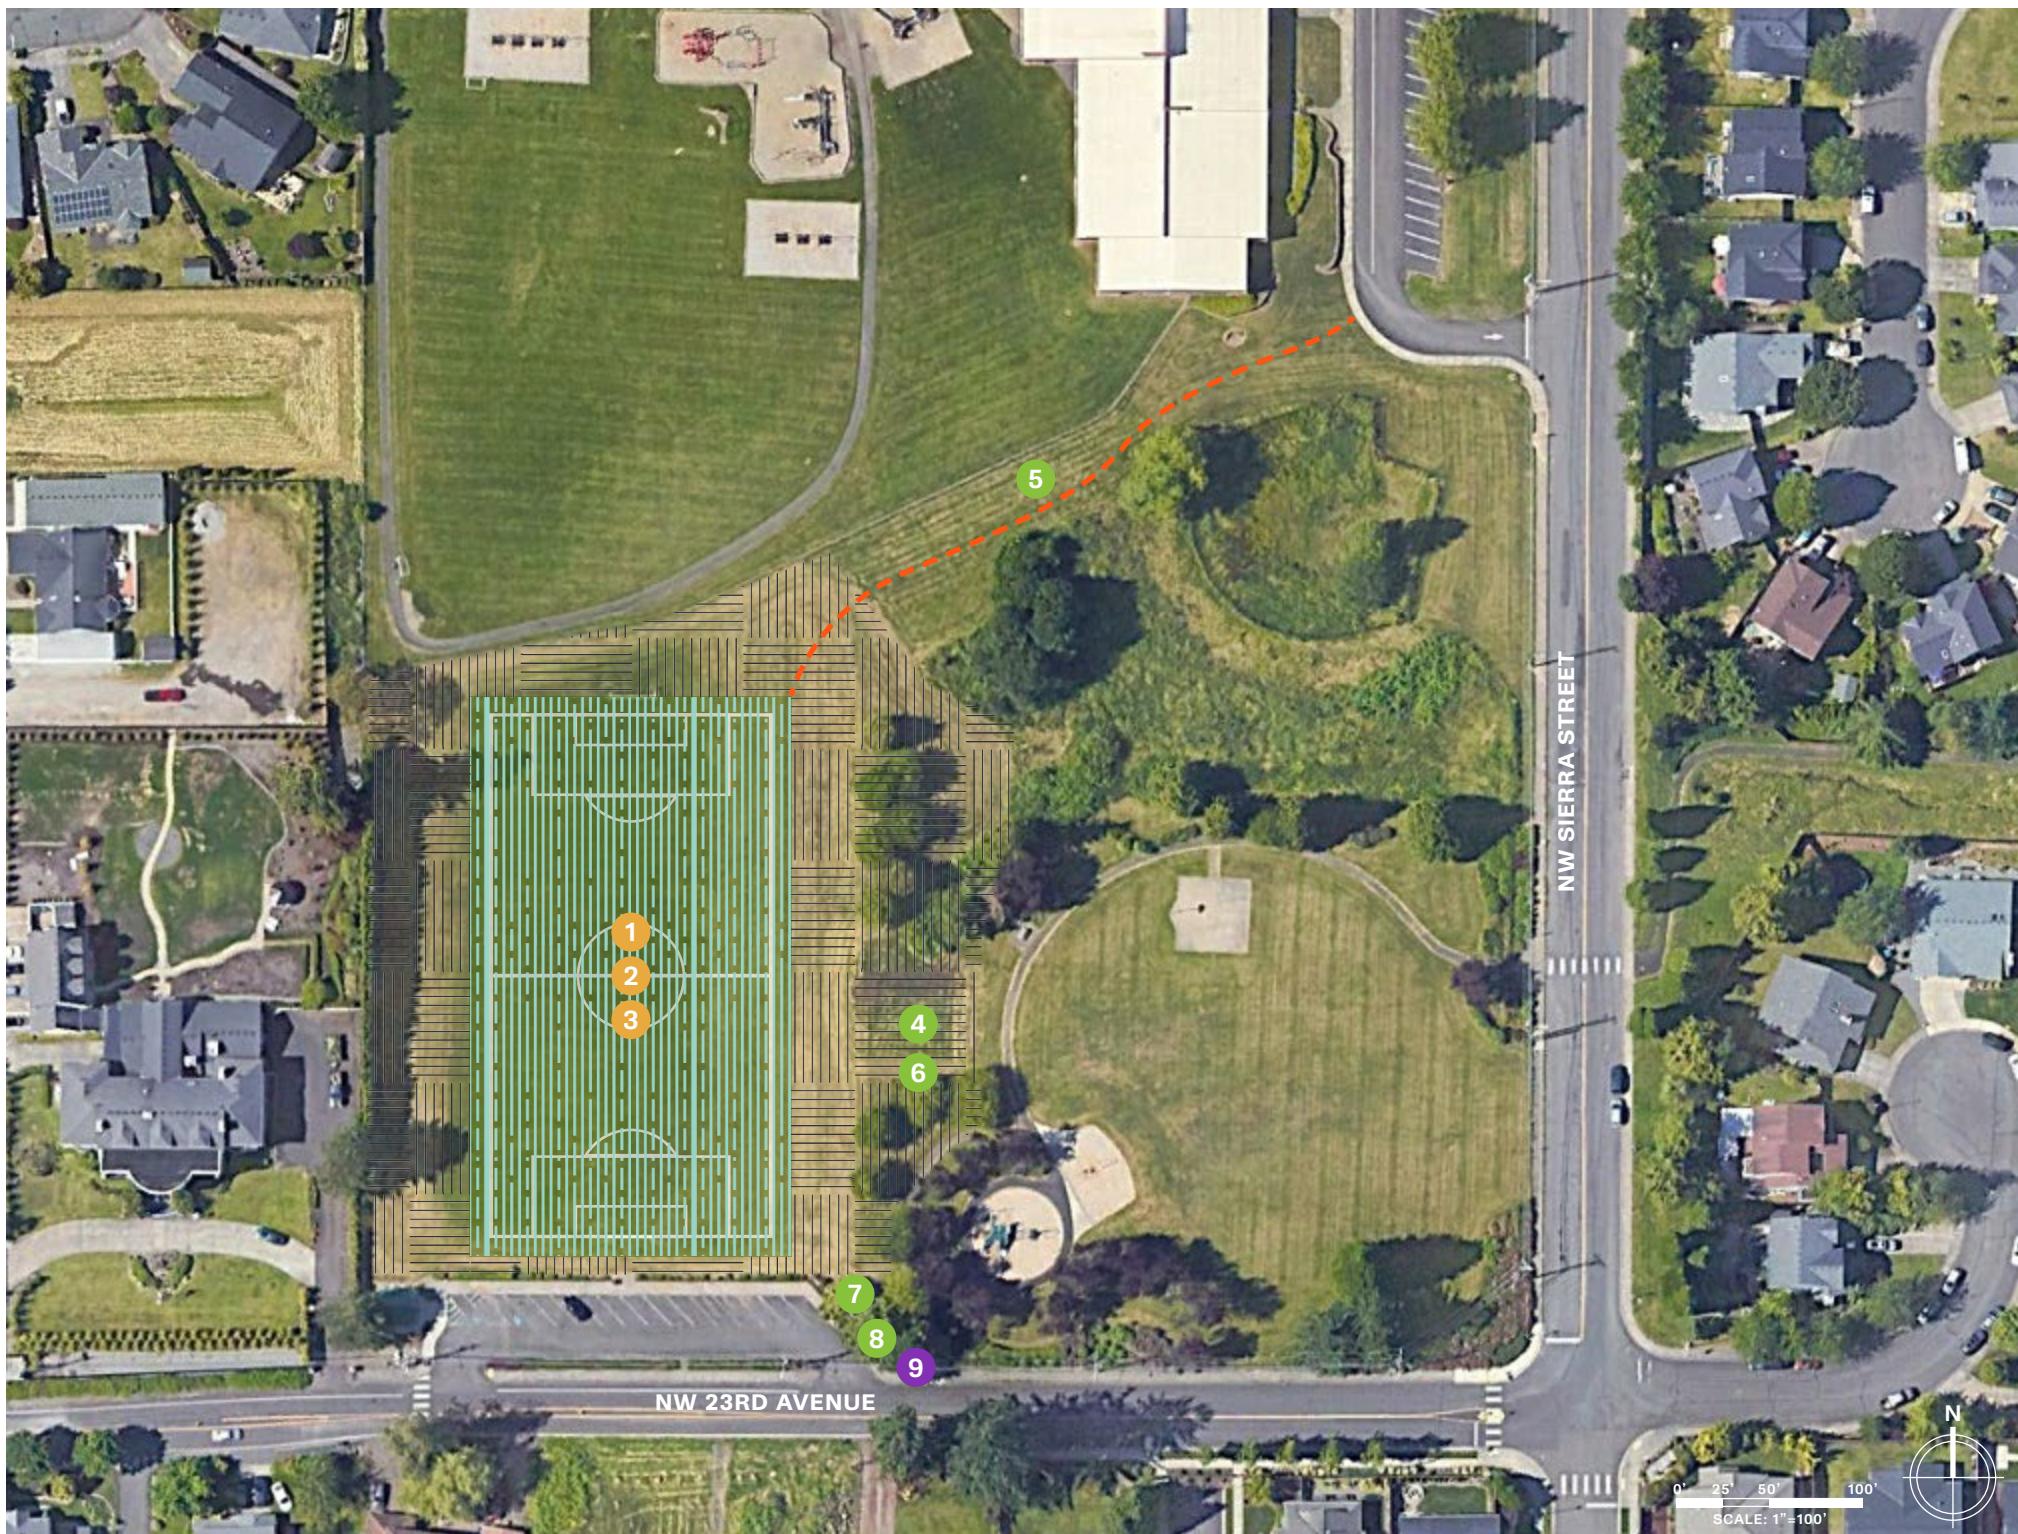
Fallen Leaf Park – softball field underutilized (Rugby user would love this to be their primary field) – good field for adult user groups

Primary User: Often closed and has no dedicated user, only park the city manages and usually locked gates

- 9 Improve Bleacher Access

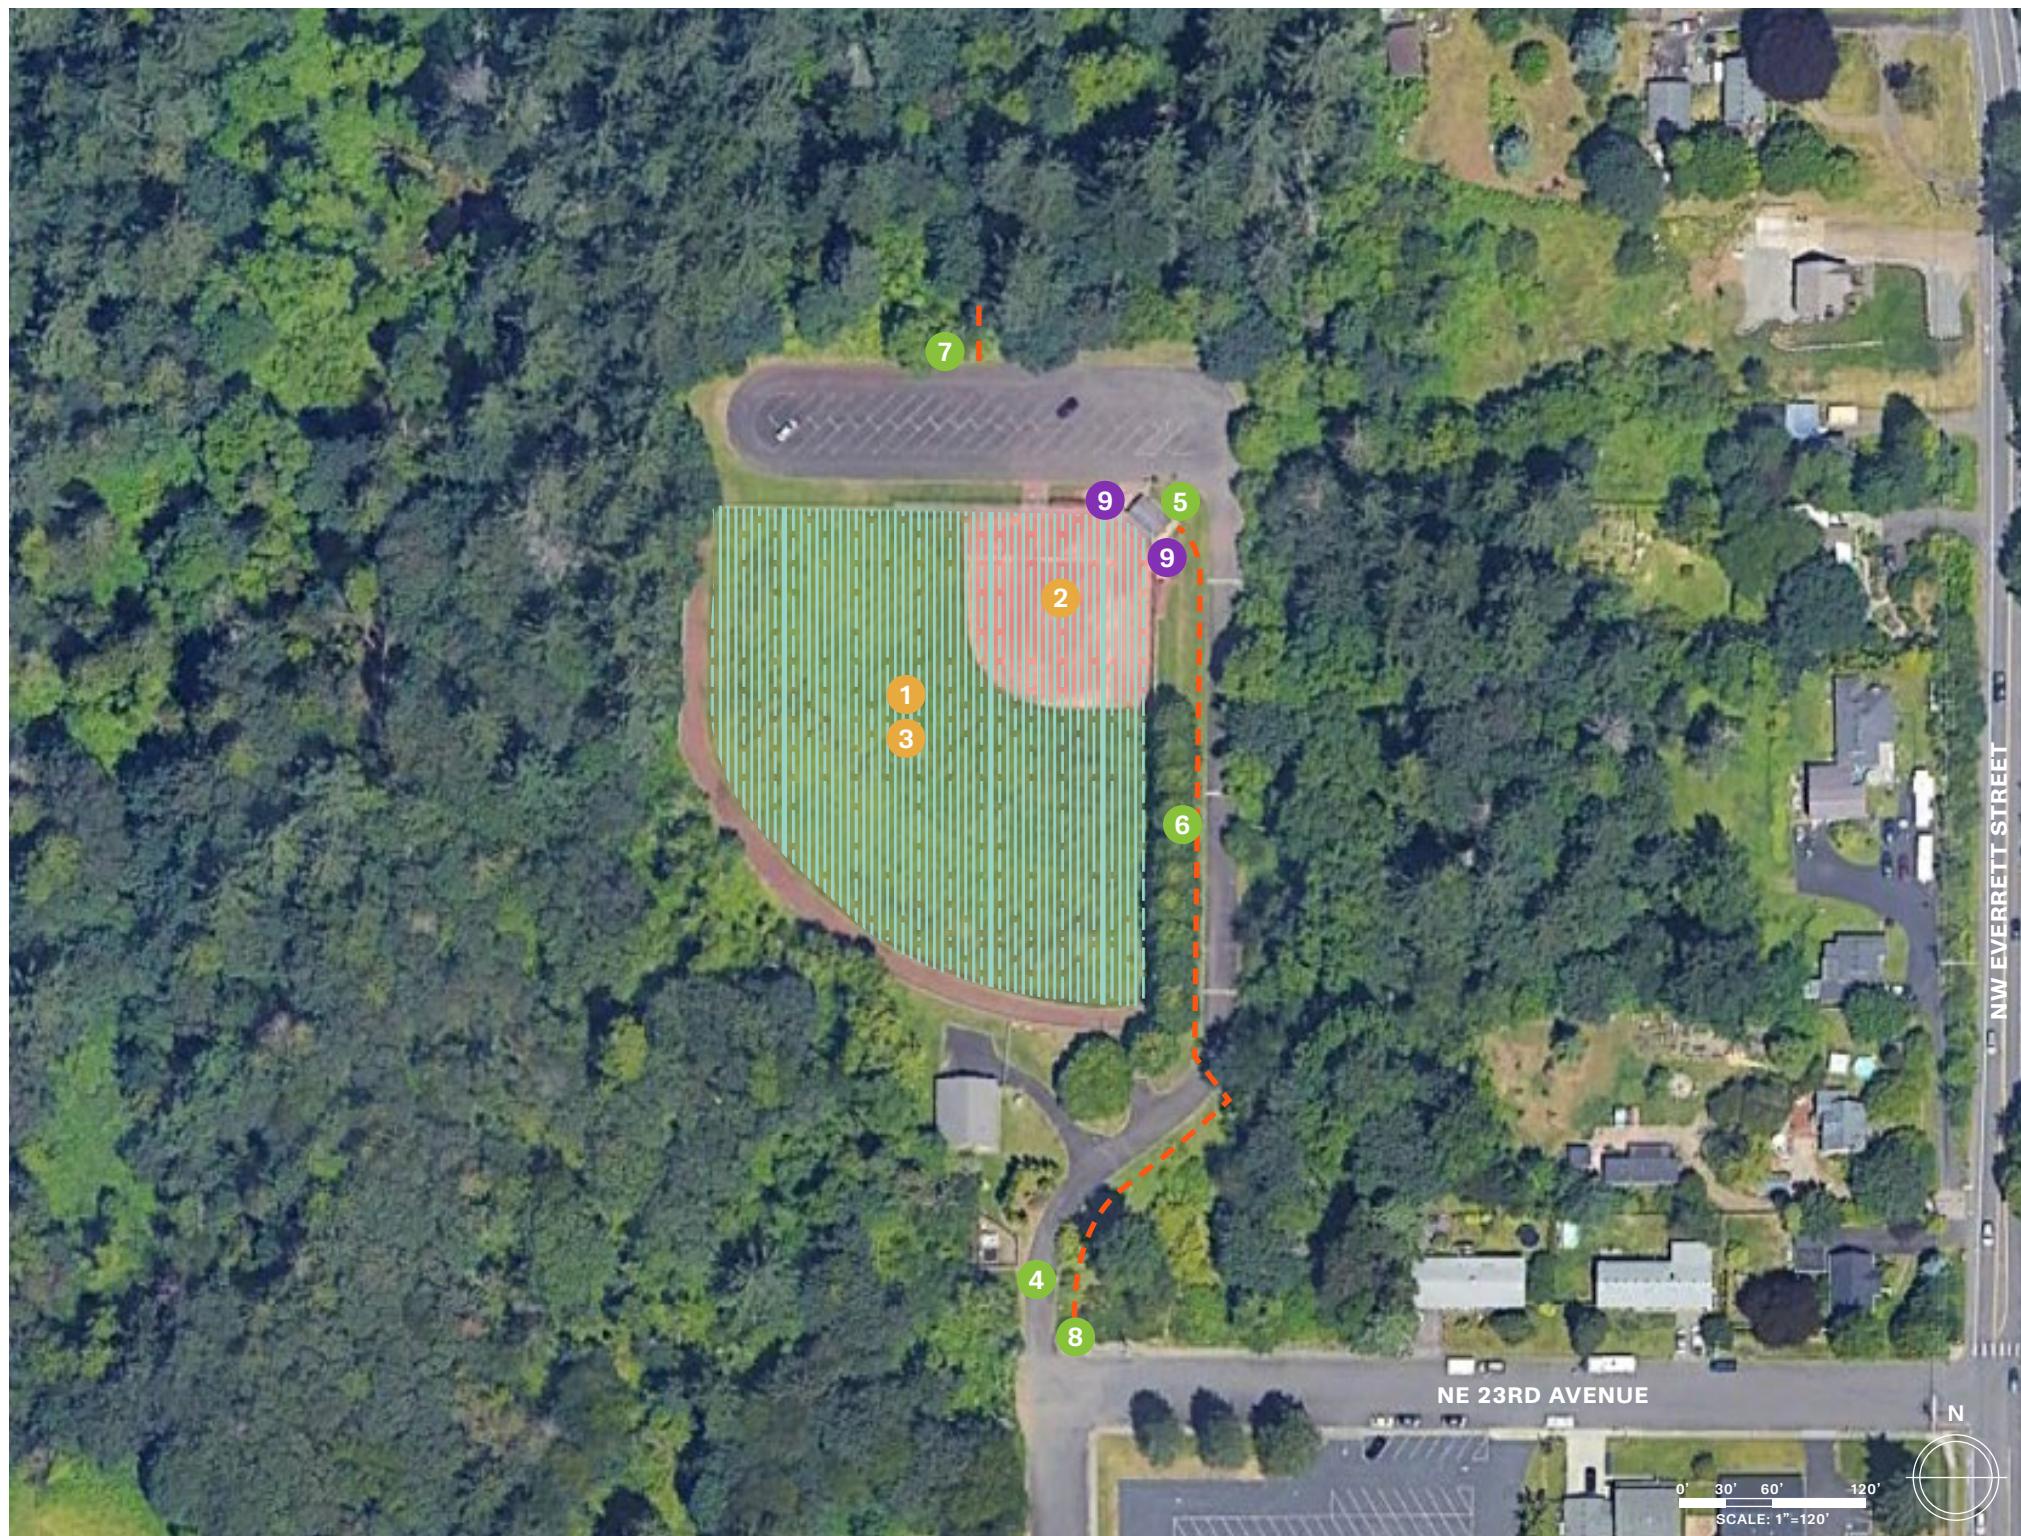
Louis Bloch Park – baseball fields primarily used by Babe Ruth.

Primary User: Babe Ruth

- 7 Improve Dugout Access
- 8 Upgrade Restroom
- 9 Access to Basketball Court
- 10 Improve Frontage Walkways

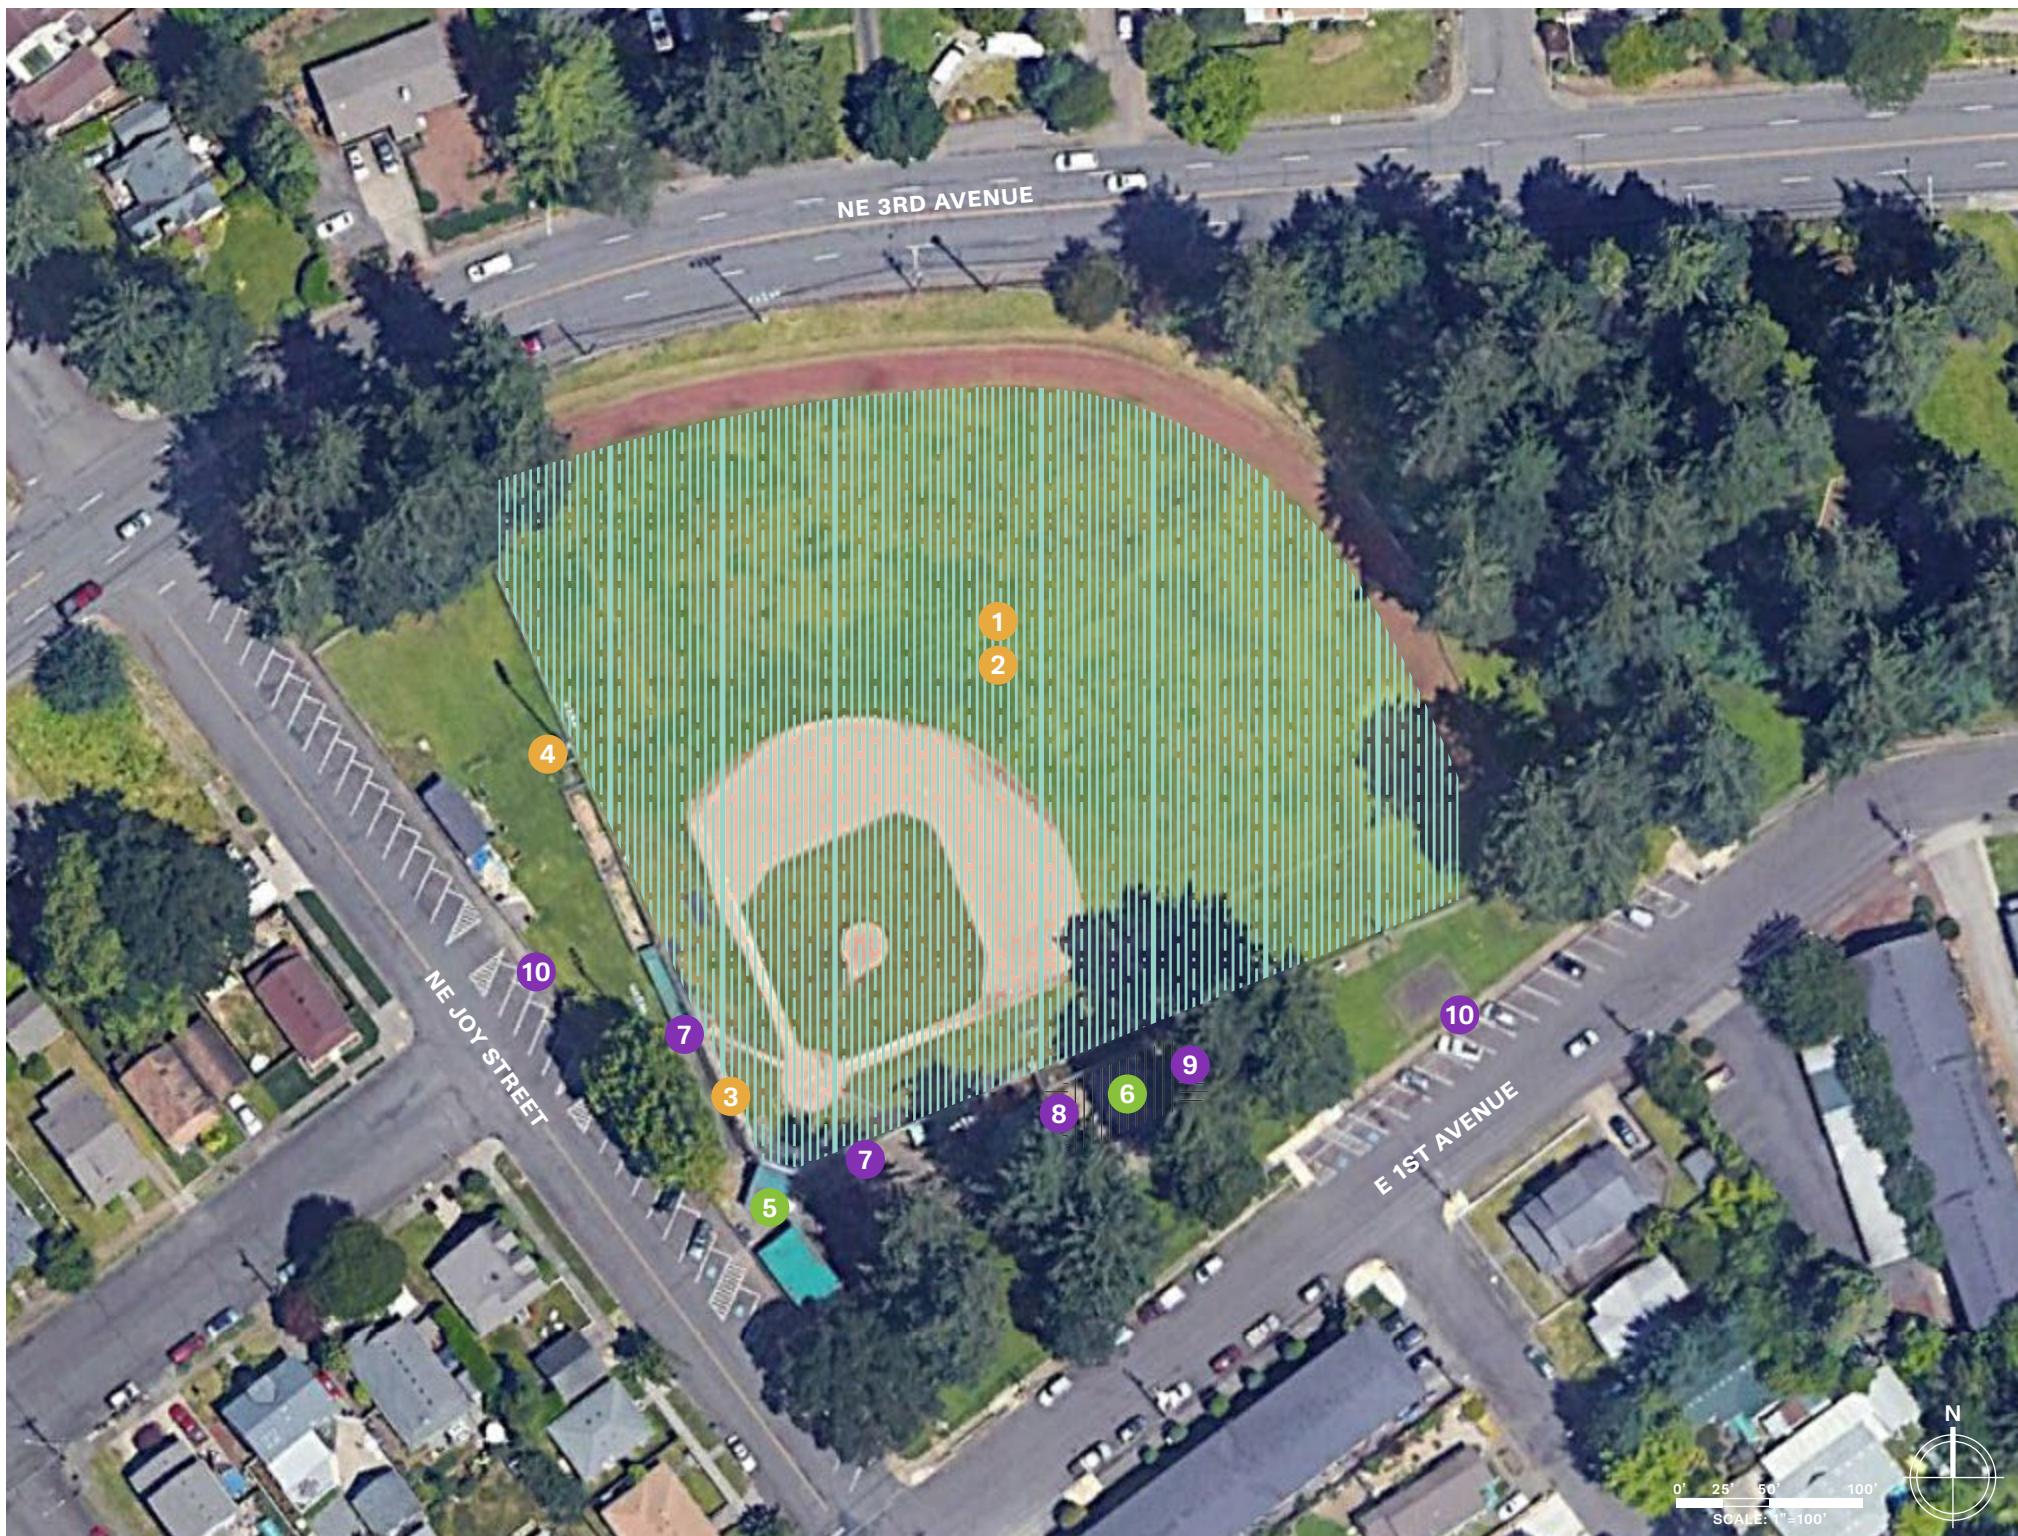
Goot Park – underutilized baseball/softball field – long term consideration for a multi-use sport plex, short term to increase current field capacity.

Primary User: baseball/soccer as a practice field, no designated user

- 11 ADA Access to Bleachers and Field
