CITY OF CAMAS, WA

Athletic Fields and Courts: Strategic Assessment and Recommendations

February 10, 2026

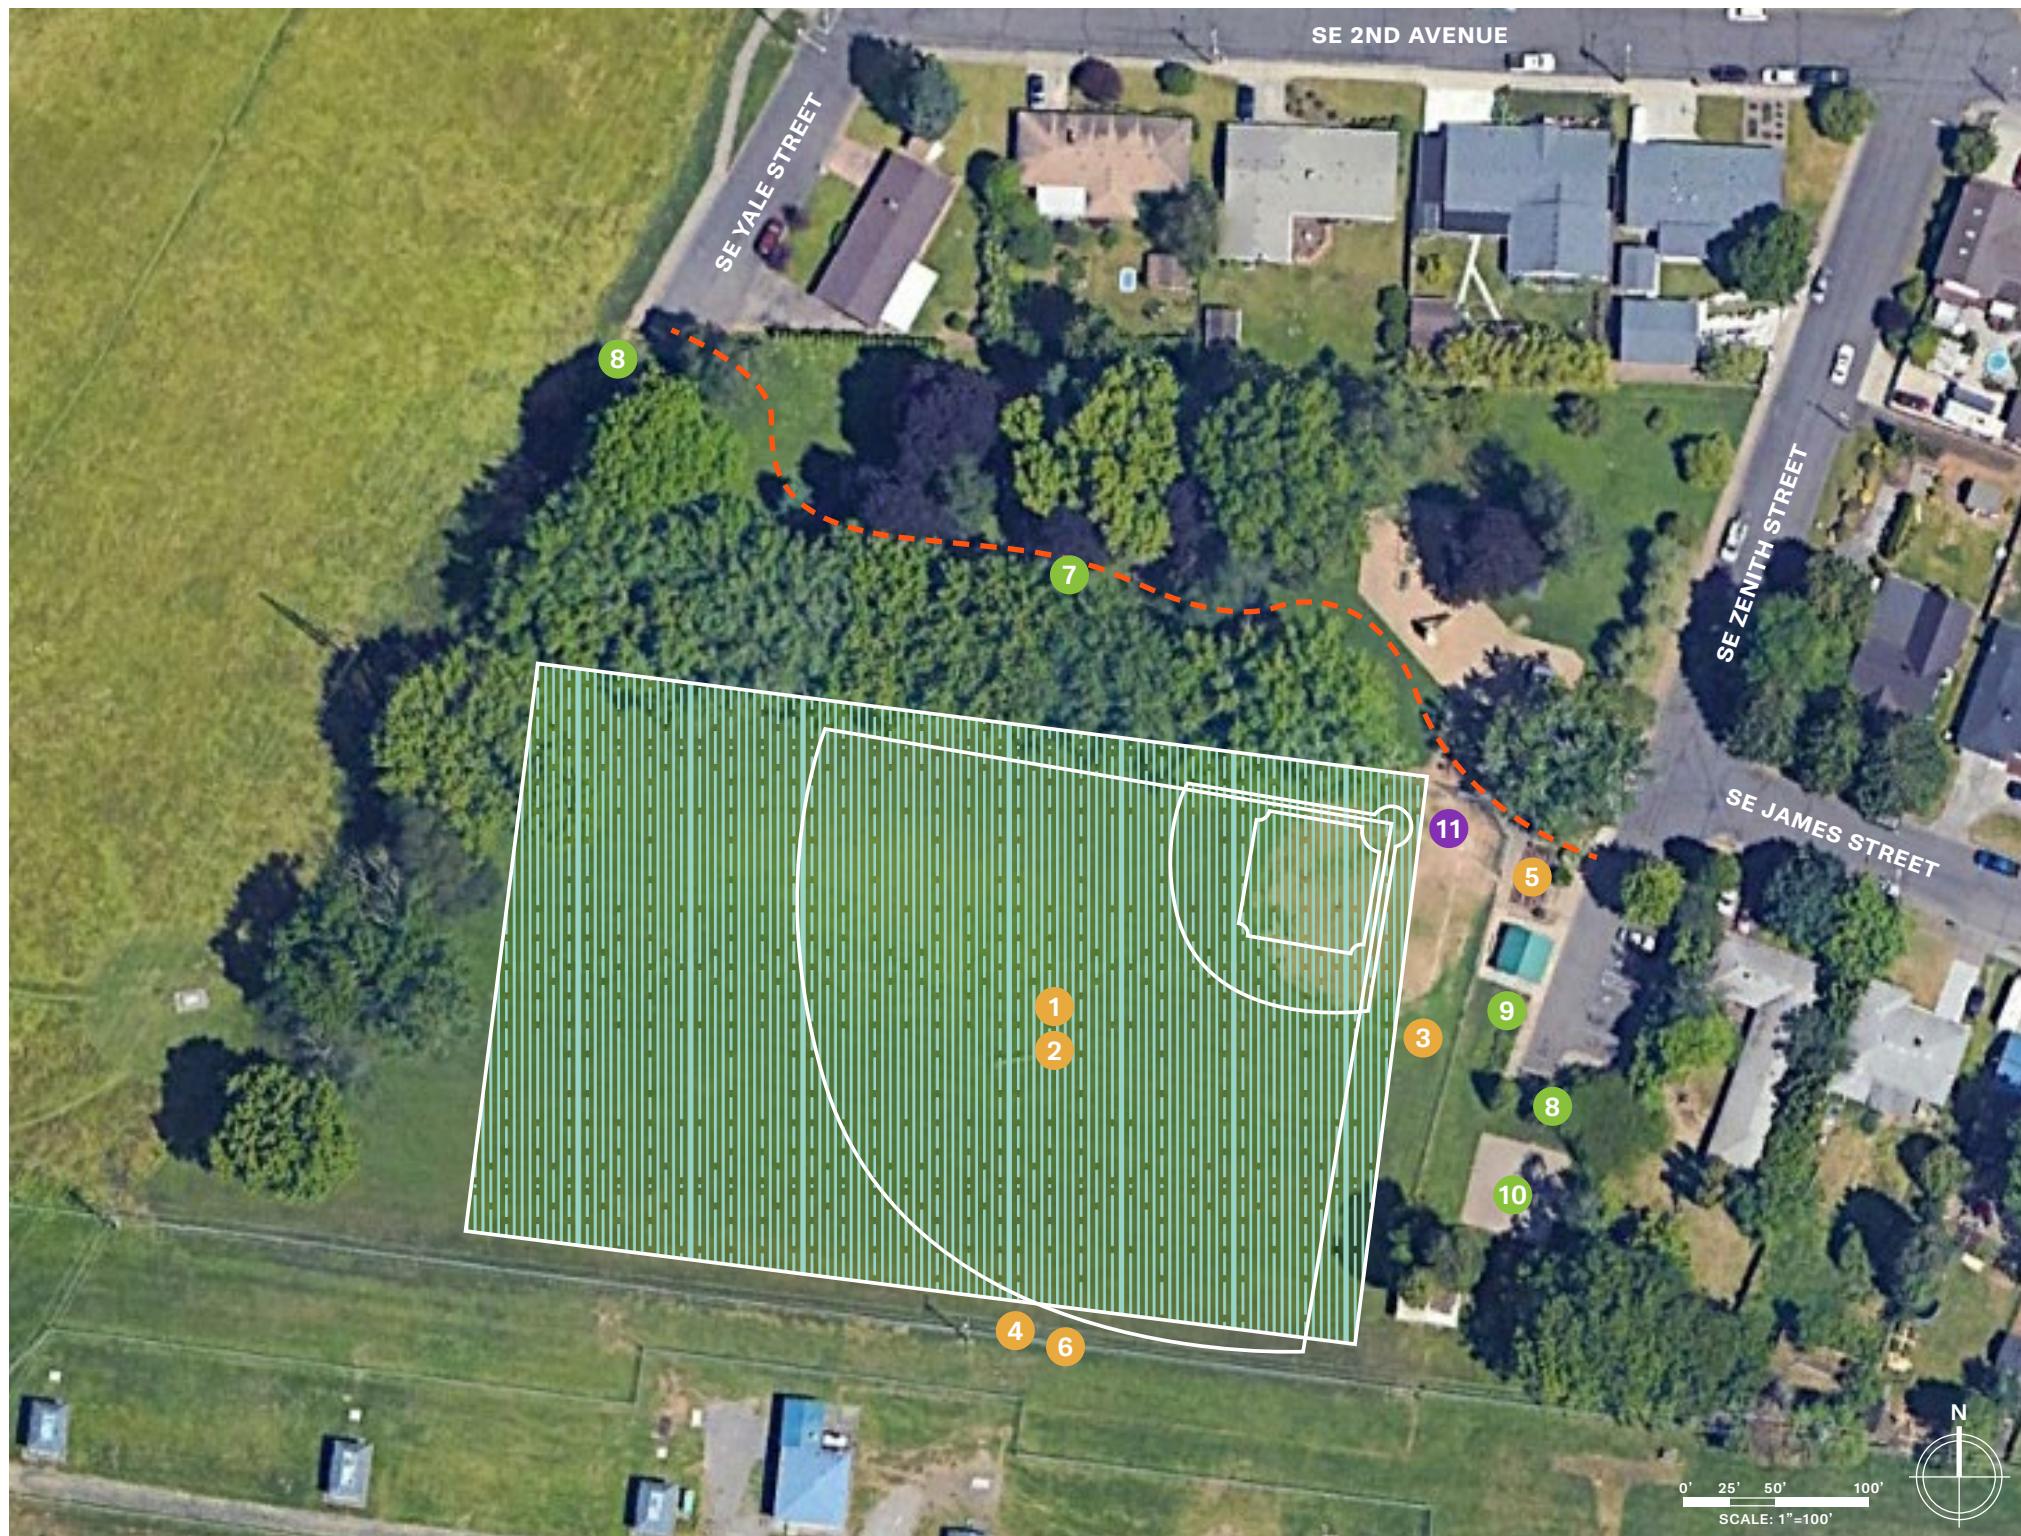
Grass Valley Park – underutilized baseball/softball field – long term consideration for a multi-use sport plex, short term to increase current field capacity.

Primary User: baseball/softball, tennis, basketball

- 2 Infield Conversion to Synthetic Turf
- 3 Topdress/Core Aerify
- 4 Upgrade Fencing
- 5 Upgrade Backstops
- 6 Upgrade Bleachers

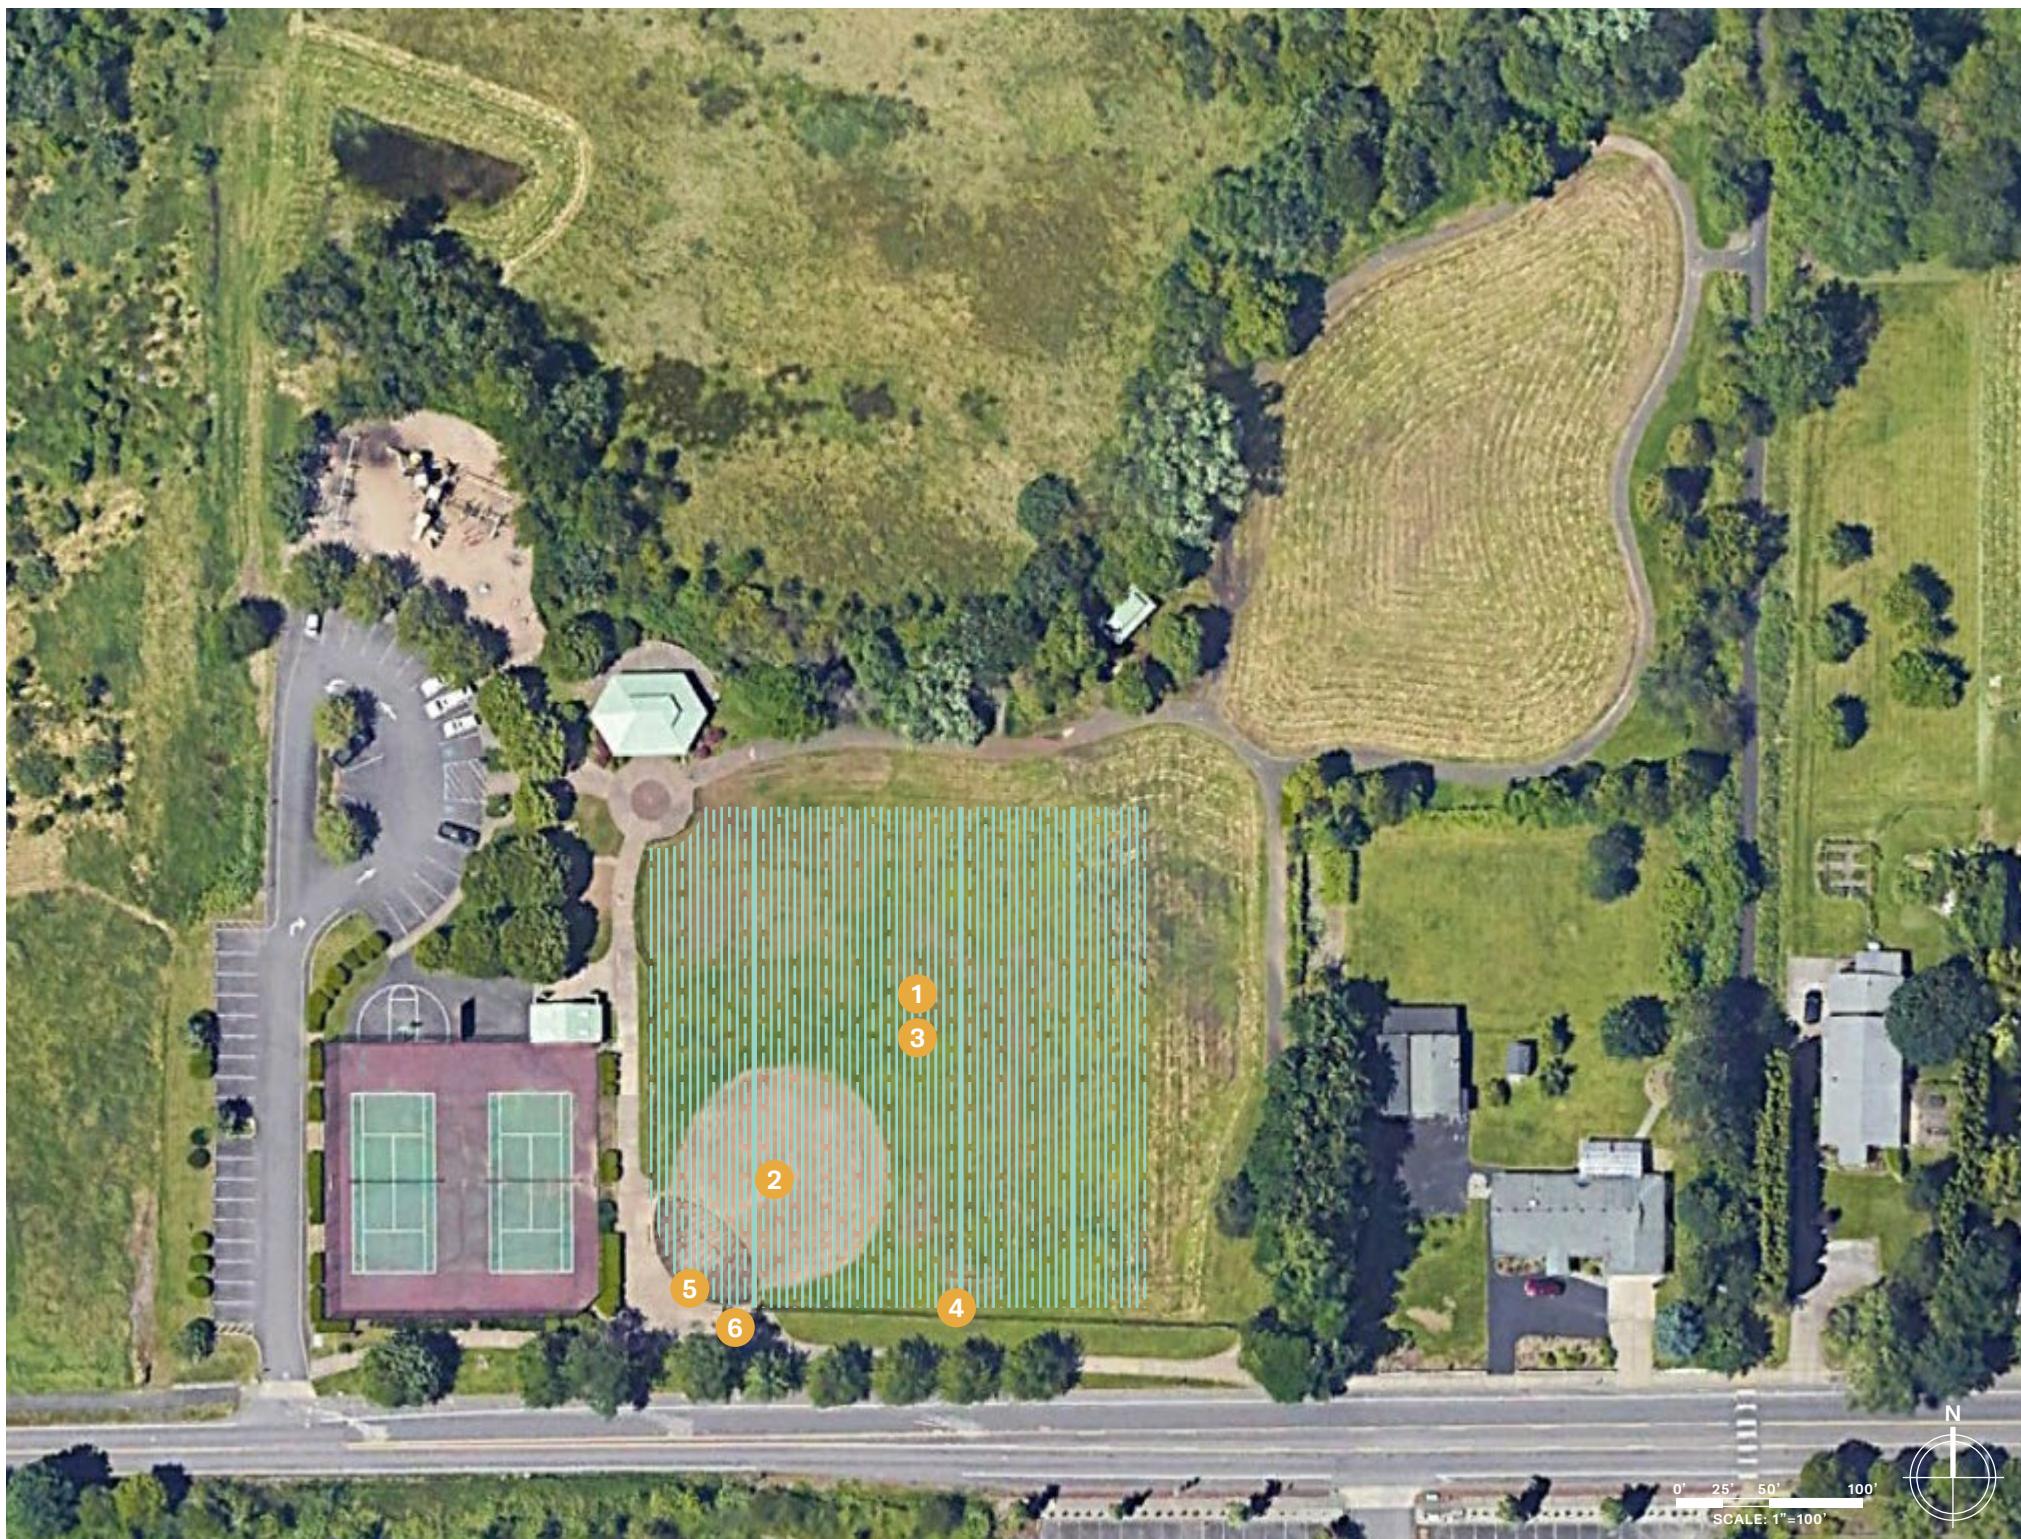
Oak Park – Minimal parking limits utilization of open lawn area for sports field use.

Primary User: No designated users

- 1 Basketball Court Improvements
- 2 Site Furnishing Improvements
- 3 New Walkways
