Staff Report

\$154,894.60 Endicott Street Culvert Rehabilitation Bid Award to Iron Horse, LLC with up to 10% Change Order Authorization (Submitted by Will Noonan, Public Works Operations Manager)

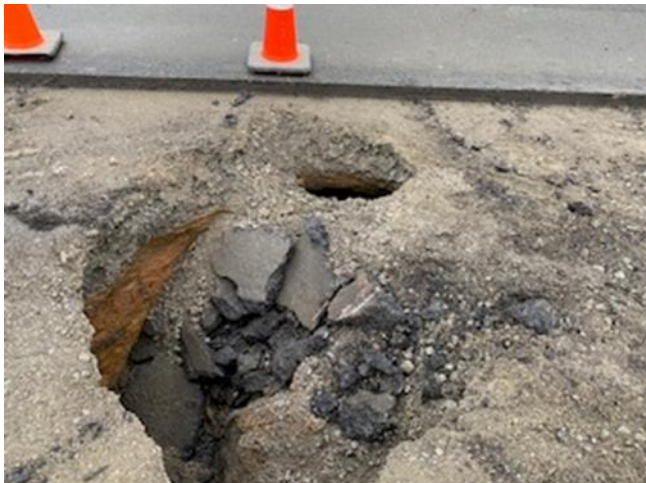
Figure 1. Sinkhole under Endicott St.

BACKGROUND: In 2022, a sink hole opened up on Endicott Street near the intersection with Pac Rim Drive. Crews repaired the street and looked for the reason the sink hole developed. Upon TV inspection of the 42 inch corrugated metal culvert under Endicott, it was found the bottom had deteriorated to failure and the structural integrity of the culvert was compromised. This needs to be addressed to avoid future failure.

SUMMARY: The most cost effective and least impactful way of repairing this culvert and restoring its structural integrity is through a process called Cured-in-Place Pipe (CIPP). CIPP is a trenchless method of rehabilitating a pipe or culvert. A flexible liner is inserted into the culvert, inflated with air and exposed to heat or ultraviolet light to dry and harden as a liner inside the pipe. There will be two sections of this culvert to receive the CIPP with access through manhole on the east side of Endicott, off the street. Through the competitive bid process Iron Horse LLC has submitted the lowest responsive bid for this project.
