Project: Lower Prune Hill BP and Reservoir Improvements for City of Camas
616 NW 18th Loop, Camas WA

Arborist Report

A site visit was made on March 24, 2022

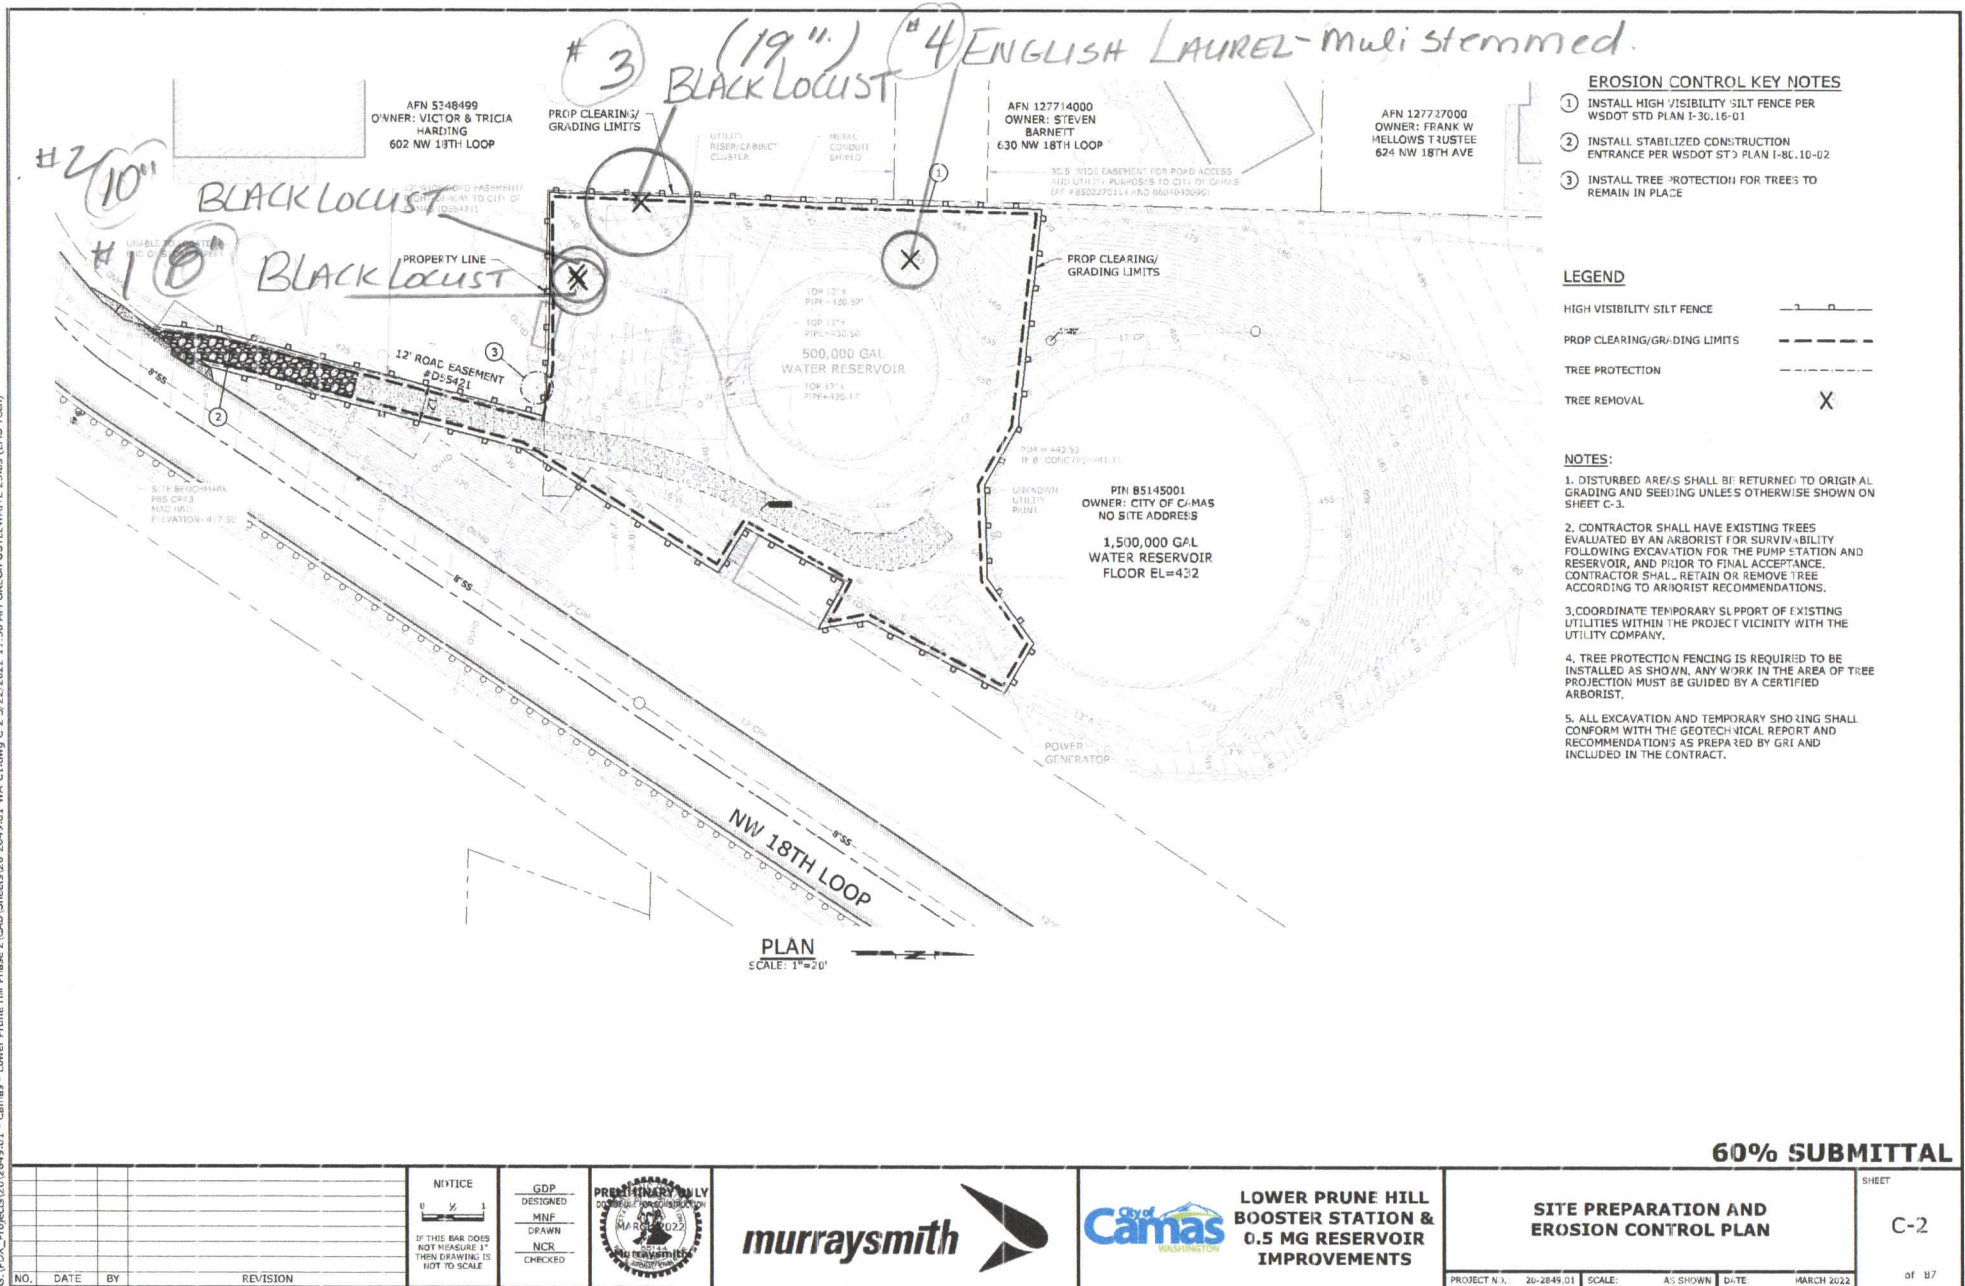
G:\PDX_projects\2020\2849.01 - Camas - Lower Prune Hill Phase 2\CAD\Sheets\20-2849.01-WA-CL.dwg C-2 3/22/2022 11:56 AM GREG.POSTLEWATE 23.0s (LMS Tech)

This site will continue to be used by the City of Camas for the current reservoir facility. Improvements are proposed on the south side that will require the removal of 3 trees and a large shrub. The 3 trees and overgrown shrub are good candidates for removal. The Black locust and English laurel are considered invasive species. See the tree survey following.

Tree #	Species	DBH (inches)	Condition and Health	Location on property	Action
1	Black Locust - Robinia pseudoacacia	8"	Fair- structurally stable - some die back present in canopy . Invasive Species	Along South fence line - south side of the chain link fence	Remove
2	Black Locust - Robinia pseudoacacia	10"	Fair- structurally stable - some die back present in canopy . Invasive Species	Along South fence line - south side of the chain link fence	Remove
3	Black Locust - Robinia pseudoacacia	adjusted DBH - 19"	Poor- has co dominate stems 12" and 15".Potential to split in wind or ice. Invasive Species	SW corner of property	Remove
4	English Laurel - Prunus laurocerasus	Multi stemmed large evergreen shrub	Fair - overgrown shrub multiple stems that emerged from previously made pruning cuts .Invasive species	West side of small tank	Remove
