### **Pacific Lifestyle Homes Geotechnical Engineering Evaluation**

**Reserve at Green Mountain (Formerly Bahu Property)  
2625 NE Goodwin Road  
Camas, Washington**

**True North Project No. 24-0368-2**

**April 2025 (revised May 2025)**

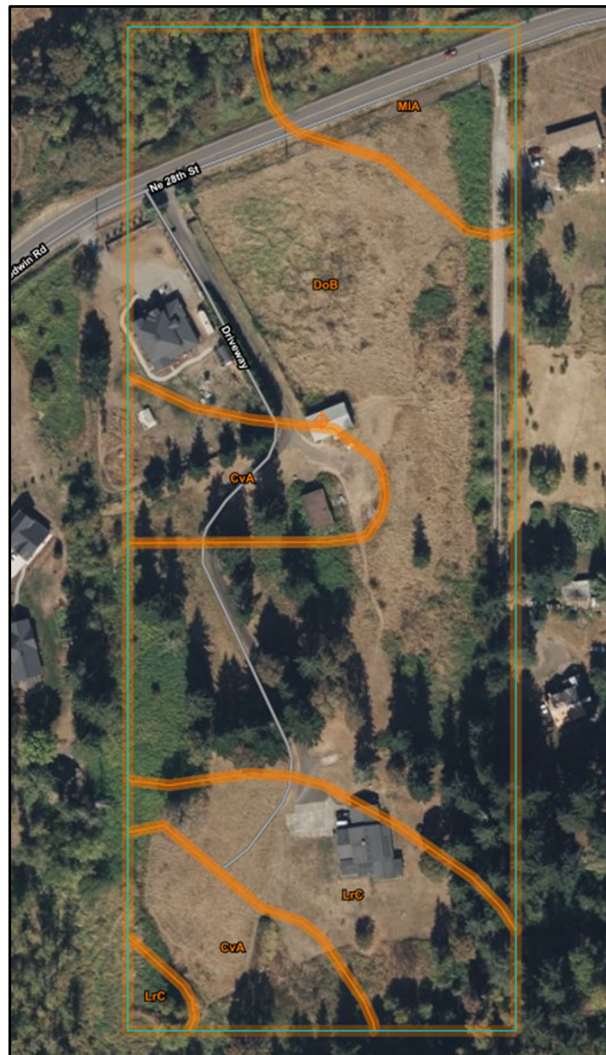
**Exhibit 1:** USDA mapped surficial soils at the site

In the northeastern corner of the site, surface soils are mapped as the “MIA: McBee silt loam, coarse variant, 0 to 3 percent slopes”. The McBee series consists of somewhat poorly drained soils that permeate at a moderately high to high rate. These soils formed in alluvium and are found in
