# Village at North Shore Preliminary Tree Report

**Date:** July 2025

**Site Information:** 313 SE Leadbetter Road  
Camas, WA 98607  
Parcel #177885-000, 178175-000

PRELIMINARY TREE PRESERVATION & REMOVAL PLAN  
VILLAGE AT NORTH SHORE  
HSR DEV - MILLS, LLC  
CAMAS, WASHINGTON

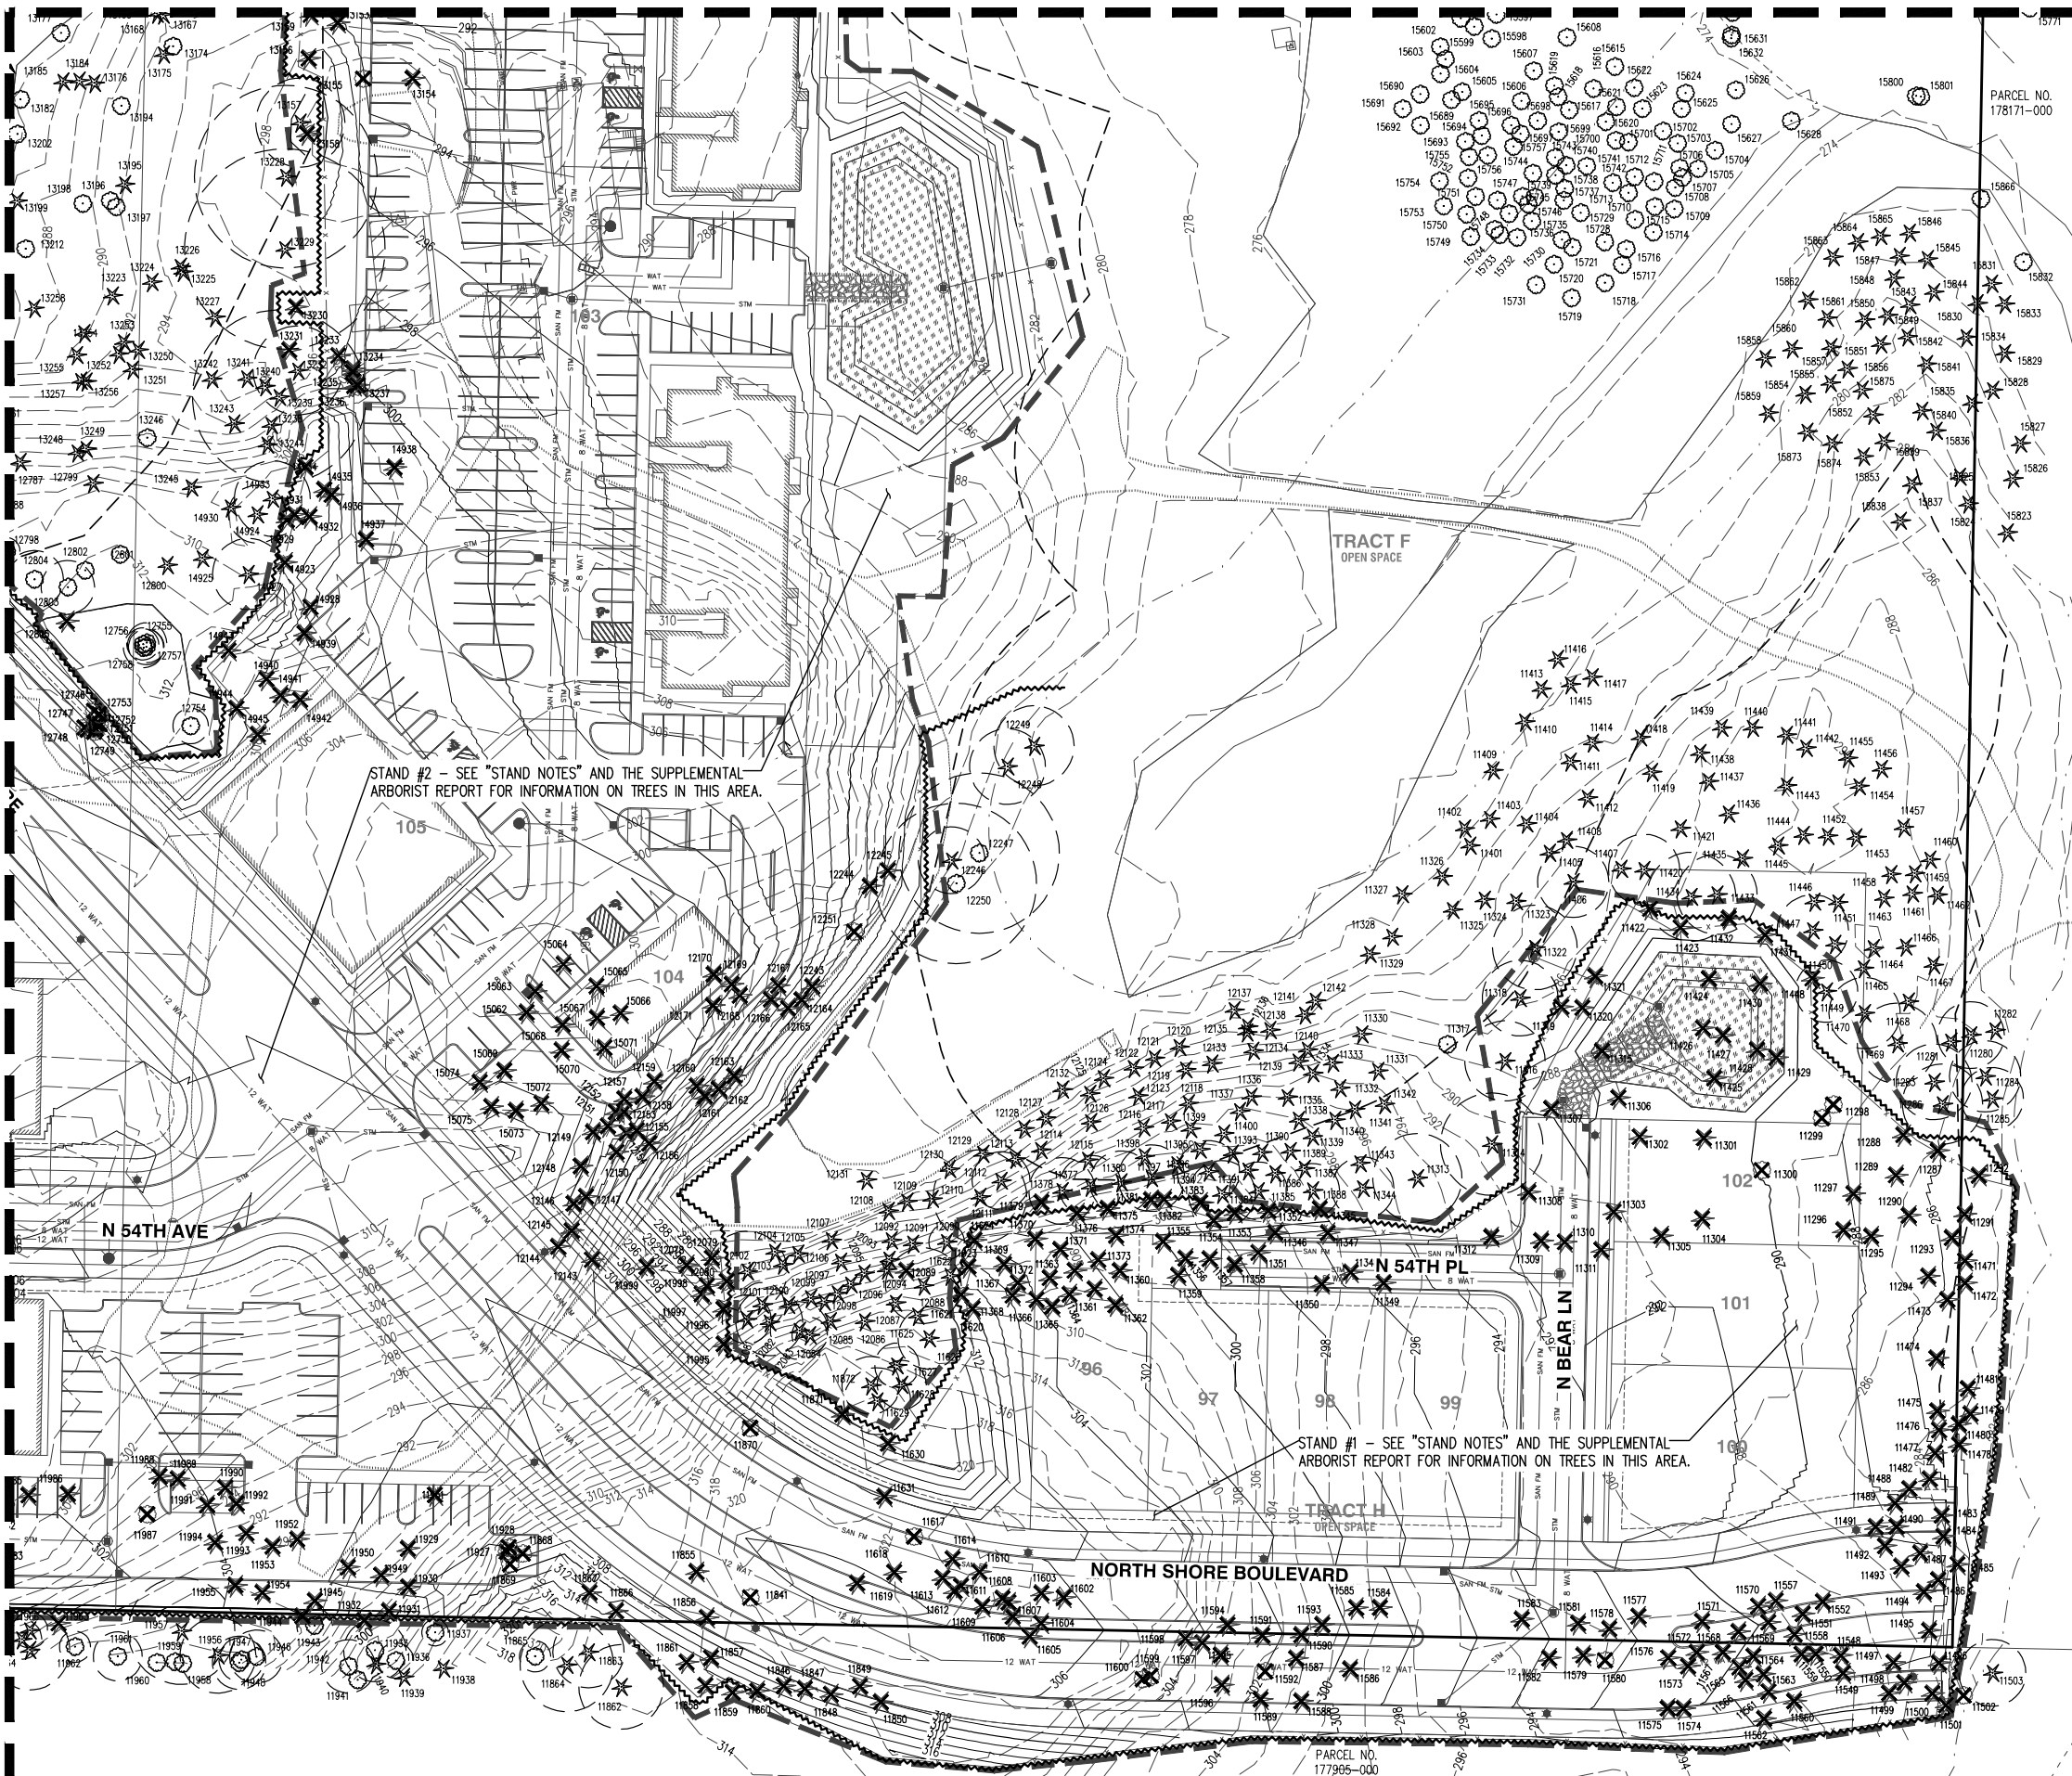
STAND #2 - SEE "STAND NOTES" AND THE SUPPLEMENTAL ARBORIST REPORT FOR INFORMATION ON TREES IN THIS AREA.

STAND #1 - SEE "STAND NOTES" AND THE SUPPLEMENTAL ARBORIST REPORT FOR INFORMATION ON TREES IN THIS AREA.

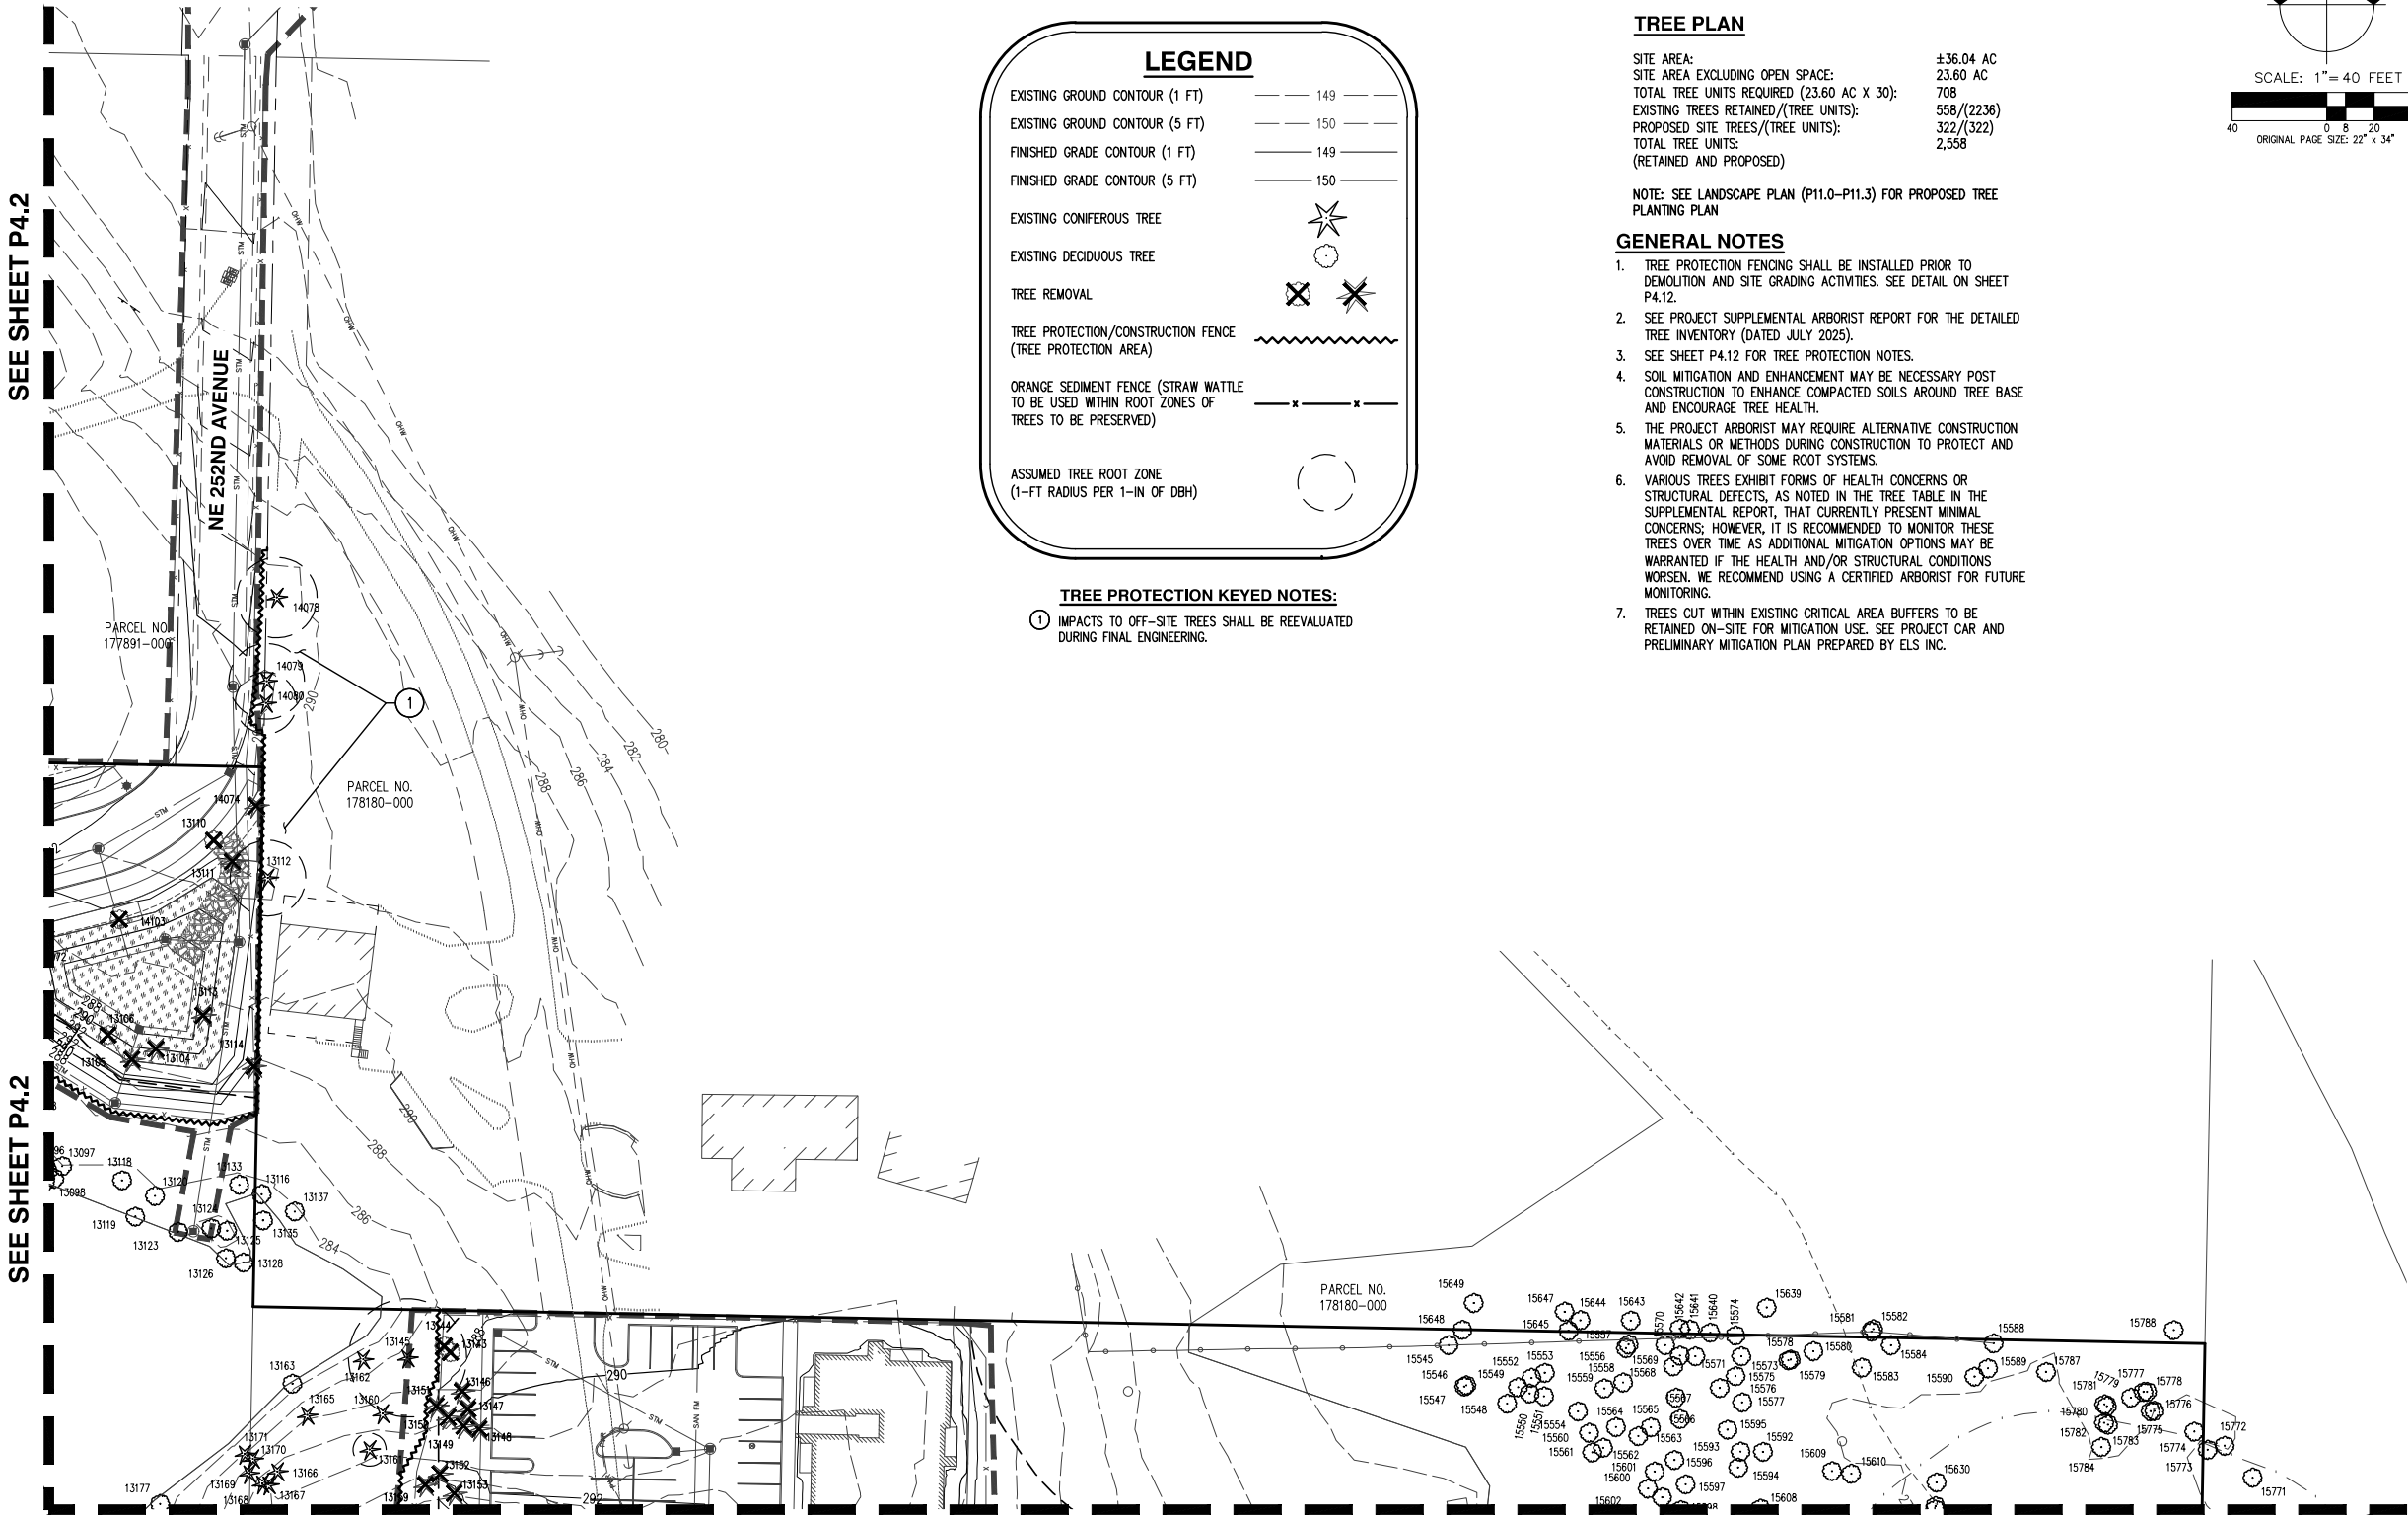
TREE PROTECTION KEYED NOTES:

- ① IMPACTS TO OFF-SITE TREES SHALL BE REEVALUATED DURING FINAL ENGINEERING.
