Staff Report

Endicott Street Culvert Rehabilitation with Iron Horse LLC. (Submitted by Will Noonan, Public Works Operations Manager)

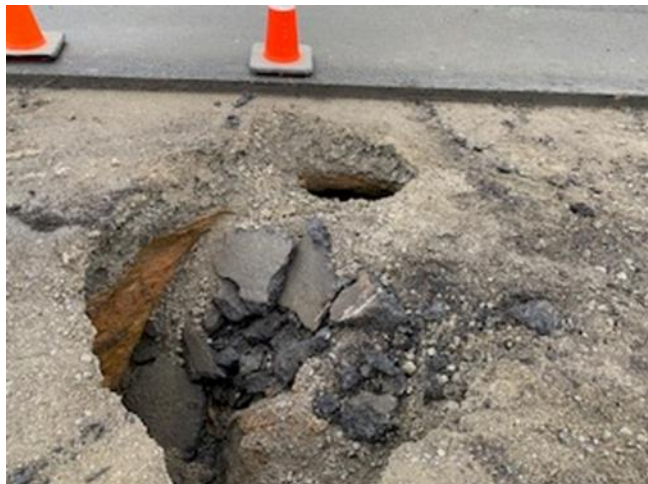
BACKGROUND: In 2022 a sink hole opened up on Endicott Street. Crews repaired the street and looked for the reason the sink hole developed. Upon TV inspection of the 42" corrugated metal culvert under Endicott, it was realized the bottom had deteriorated to failure and the structural integrity of the culvert was compromised. This needs to be addressed to avoid future failure.

Figure 1. Sinkhole under Endicott St.

SUMMARY: The most cost effective and least impactful way of repairing this culvert and restoring its structural integrity is through a process called Cured-in-Place Pipe (CIPP). CIPP is a trenchless method of rehabilitating a pipe or culvert. A flexible liner is inserted into the culvert, inflated with air and exposed to heat or ultraviolet light to dry and harden as a liner inside the pipe. There will be two sections of this culvert to receive the CIPP with access through manhole on the east side of Endicott, off the street. Through the competitive bid process Iron Horse LLC has been awarded the contract for this project.

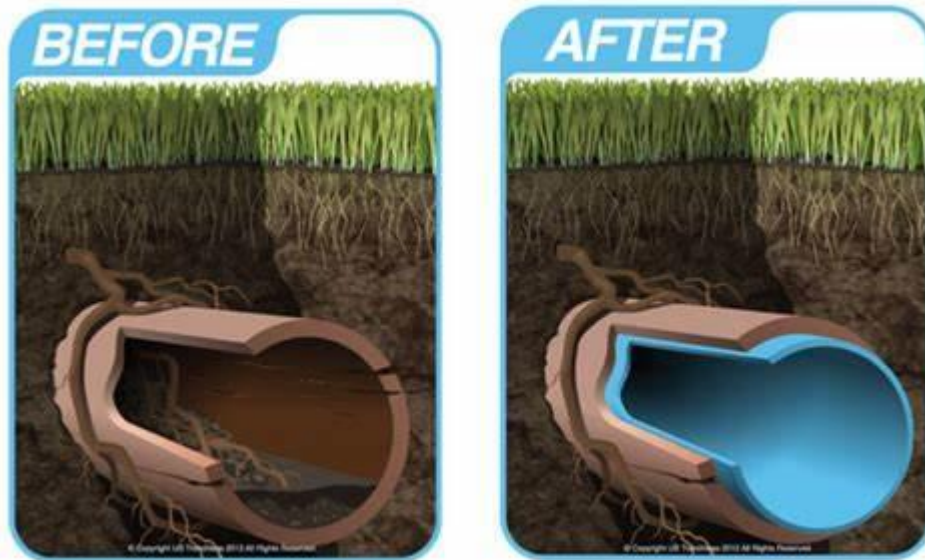
Figure 2. Illustration of before and after CIPP
